HOMER BRIDGE OVER

WELLAND CANAL

HOMER BRIDGE
OVER
THE WELLAND CANAL
PILE TEST CONTRACT 59-530

REPORT
ON THE
PILE TEST CONTRACT
AT THE
HOMER BRIDGE
OVER
THE WELLAND CANAL

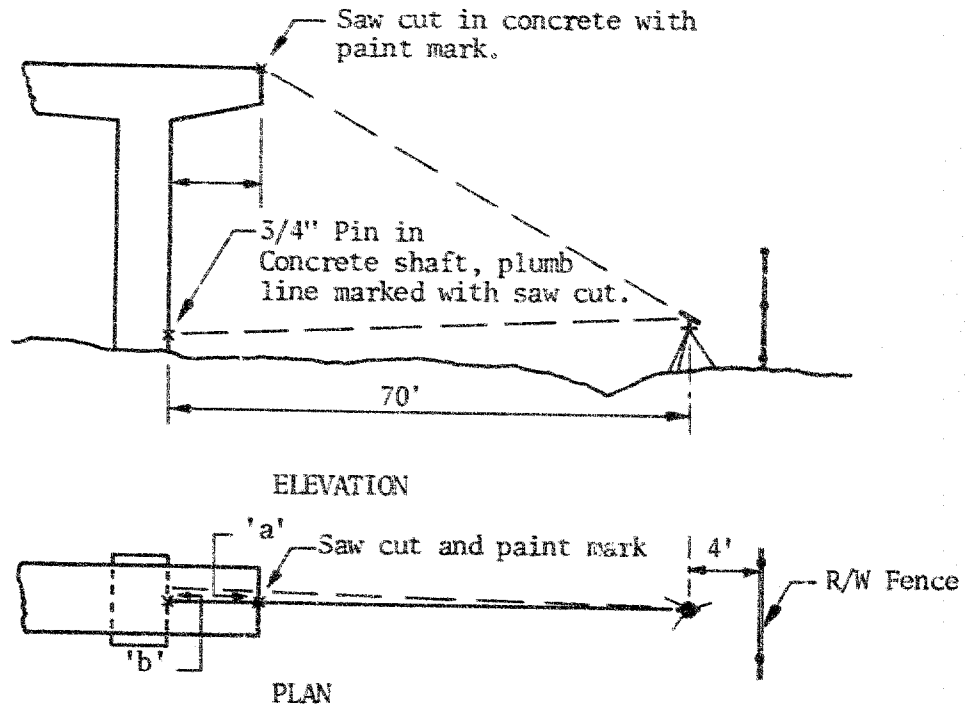
FIGURE I

NOTE: Read out on face of shaft, use formula $\text{Lean 'a'} = \frac{6}{7} \text{'b'}$

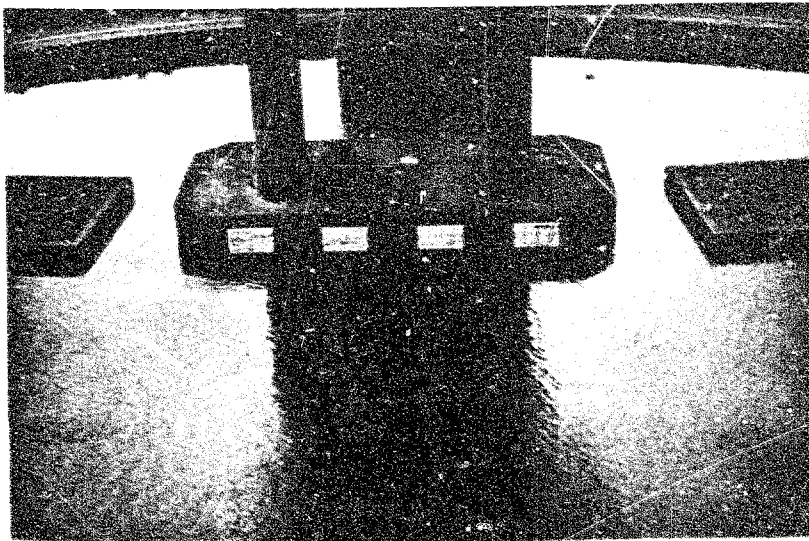
The timber glancing structures (bumpers) were observed to be in good condition. The massive steel plates and chains are rusting and will require a coat of paint in the future. The neoprene cushions are like new.

No. 1
CRIBS AND BUMPERS
IN GOOD CONDITION

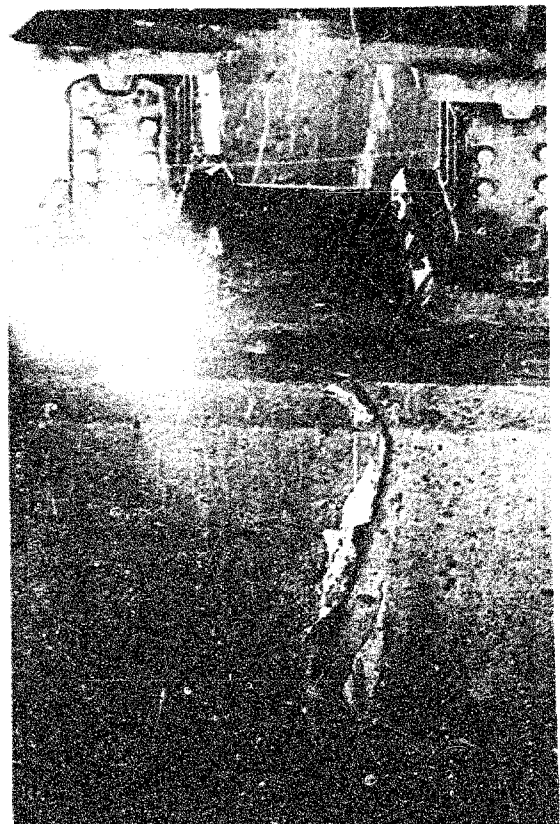
A number of the concrete bearing pedestals were originally fractured as a result of ice expansion in the anchor bolt holes during construction. This was particularly prevalent on piers W13 to W30 where high pads were required for the super-elevated deck. These cracks were previously repaired with epoxy cement, which now appears to have deteriorated permitting the cracks to open. Listed below are the pedestals which require repair or should be kept under surveillance.

No. 2
BROKEN BRIDGE SEAT
TYPICAL FOR PIERS W-17, 18, 19

The badly cracked bridge seats on piers W17, W18 and W19 should be patched with concrete and sealed against further intrusion of moisture. There appears to be sufficient bearing area available at this time to preclude the need of constructing new seats at this time. Jacking will not be required to carry out these repairs.

All bearing seats that have cracked should be sealed to prevent water seeping into the loosely packed anchor bolt holes. Sealant should also be applied on top of the plate adjacent to the anchor bolt.

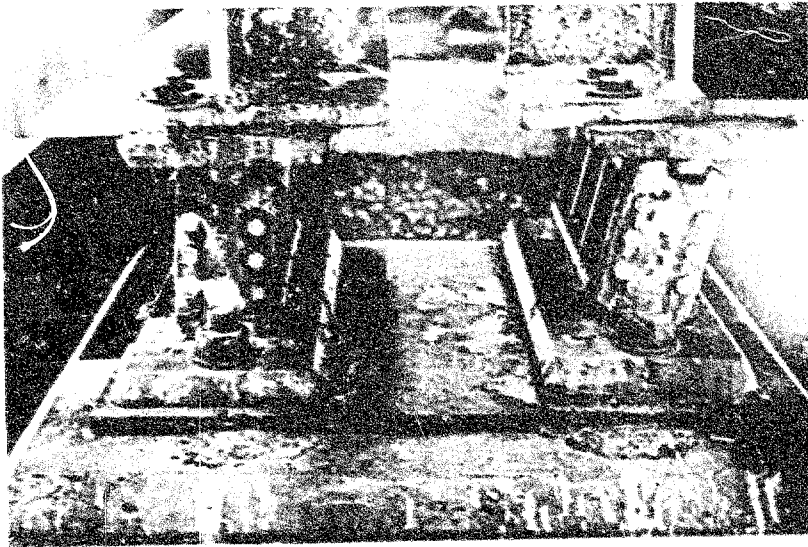
No. 3
BEARINGS
ON PIER W-II
LOOKING NORTH

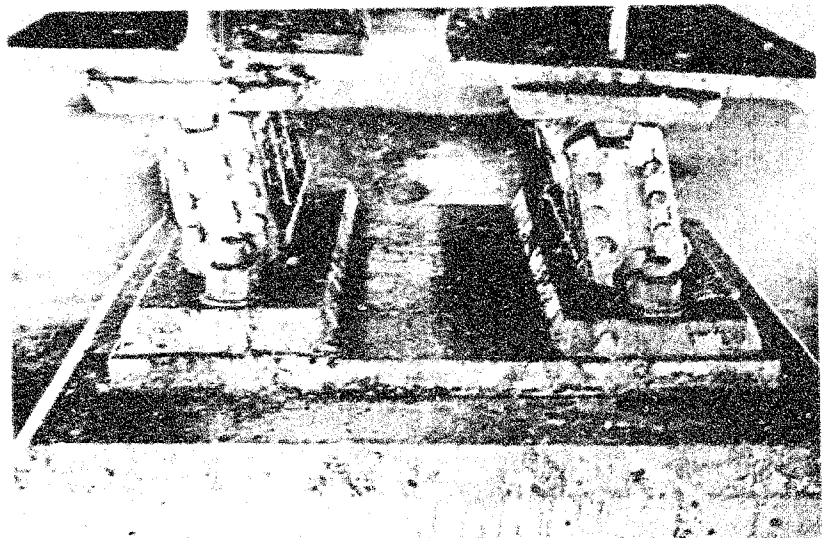
No. 4
BEARINGS
ON PIER W-13

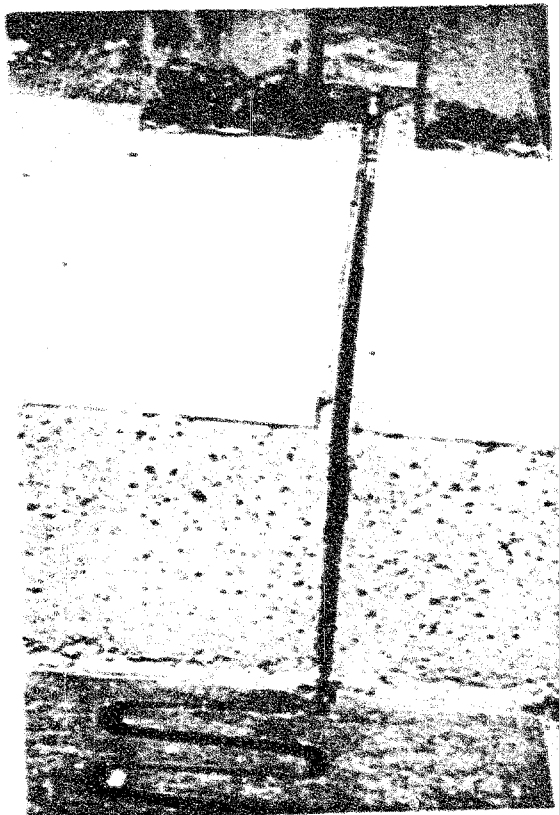
No. 5

All finger plates were found to be in good condition and free to expand or contract as intended except at pier W9 which was closed at a temperature of 60°F. At this location the concrete was in contact at the north sidewalk and at the median.

NORTH SIDEWALK GAP
CLOSED AT PIER W-9 AT 63°F

The effect of the closing of the expansion joint at Pier W9 at temperatures greater than 63°F will be to exert lateral forces at the fixed bearings of Piers W10 and W8 and the expansion movement can be absorbed by flexing of the pier shafts. The amount of flexure required to accommodate the anticipated temperature movements is such that it will not seriously overstress the reinforced concrete shafts. It is advisable, however, that this action be carefully observed, particularly during periods of extreme high temperatures.

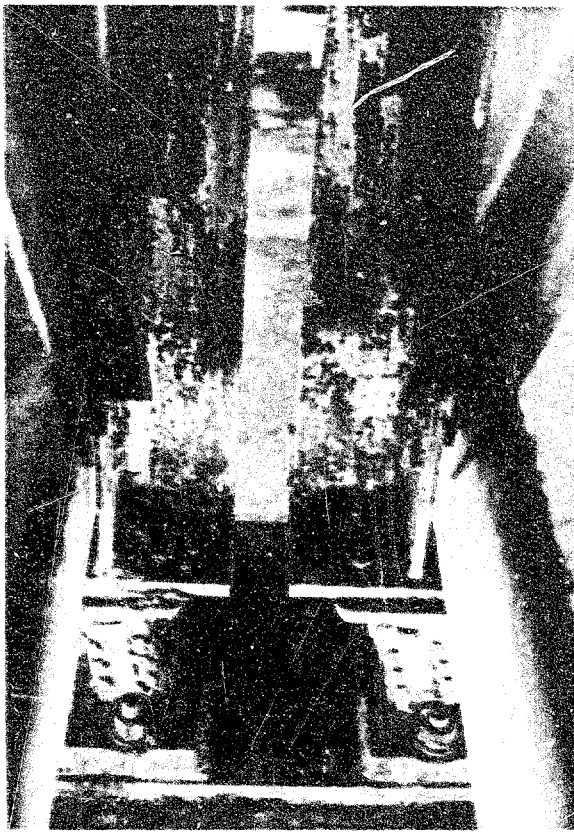
No.7

Rusting was in evidence on the ends of the girders and on the bearing plate assemblies under the finger plates and most of the fixed joints. Although the remainder of the painted areas exhibited some peeling of the finish coat, the light grey field undercoat was noted to be intact. More than usual paint deterioration was observed between piers E5 to E10. It is suggested that the extremities of the girders should be repainted at this time but the balance of the painting could be deferred until a complete repainting programme is initiated.

TYPICAL OF RUST
UNDER FINGER PLATES

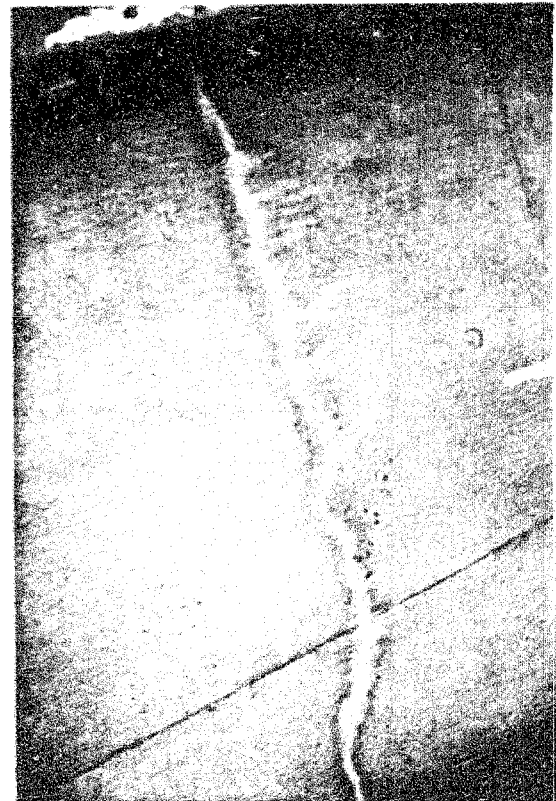
No.8
ORIGINAL SHRINKAGE CRACKS
ON UNDERSIDE OF
CENTRE SPAN DECK
NEARLY SEALED

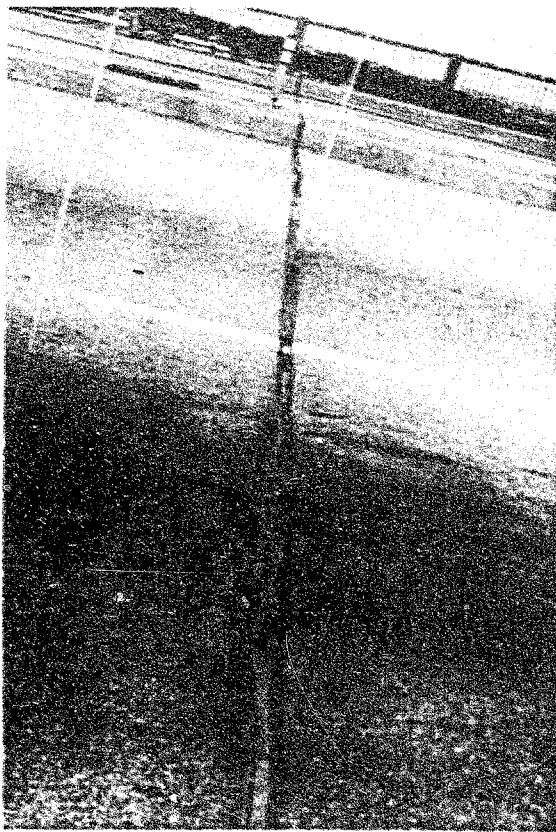
No. 9

The Rodofix joint filler in the fixed joints and the construction joints of the continuous spans at W5-W2 and E5-E2 has tended to work loose, and in spite of the waterstops in the deck, has permitted leakage to occur. No further broken joint edges were observed however, at piers W12, W18, W20 and W26.

LOOSE RODOFIX
IN FIXED JOINT

The grooved joint faces in the deck are still in good condition thus permitting replacing of the Rodofix filler in the future. Any broken edges that might appear in the future should be repaired as soon as possible to prevent progressive deterioration since traffic tends to completely remove the spalled concrete from the joint.

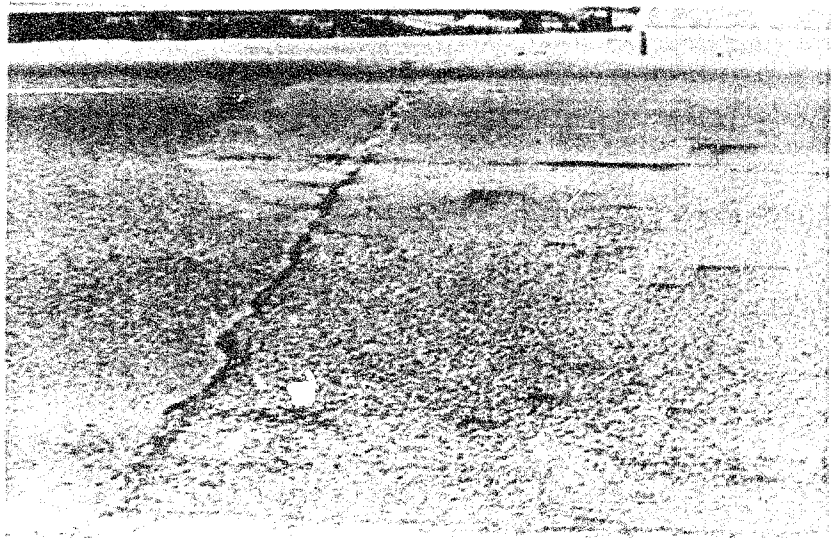
No. 10

Some dishing of the pavement surface, located on fill near the west abutment, was noted and will ultimately need to be corrected.

WEST APPROACH SLAB
SETTLED-JOINT CRACKED

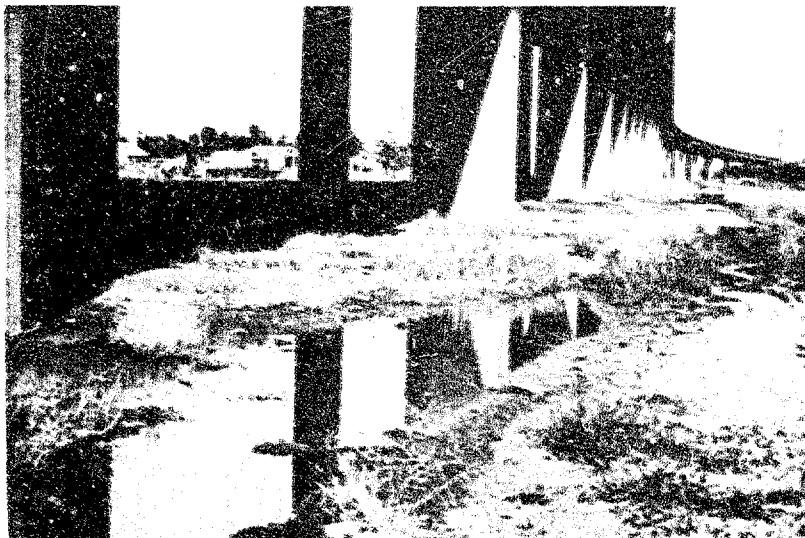
The 1969 inspection indicated that pier W10 was leaning approximately 2 inches to the east. Our preliminary inspection in May of this year indicated that this tilting had increased slightly by $\frac{1}{4}$ to $\frac{1}{2}$ inch approximately. At that time we again recommended regrading of the area under the structure to eliminate surface water ponding as noted in our letter of June 8, 1971, appended to this report. Subsequent to this data the site on the west side of the structure has been regraded resulting in some of the reference points used for settlement readings being buried.

No. 11
PIER W-10
BEFORE GRADING

In view of the above noted conditions we strongly recommend that immediate measures be taken to improve the drainage of the area under the bridge as recommended in our 1969 Inspection Report. The improvement of the drainage should alleviate the conditions causing the pier to tilt. In addition, marks should be set up on Piers W8, W9 and W10 to check future tilting of these piers by plumbing with a transit. These marks will be set up by FENCO as part of our 1971 inspection to be carried out in the near future.

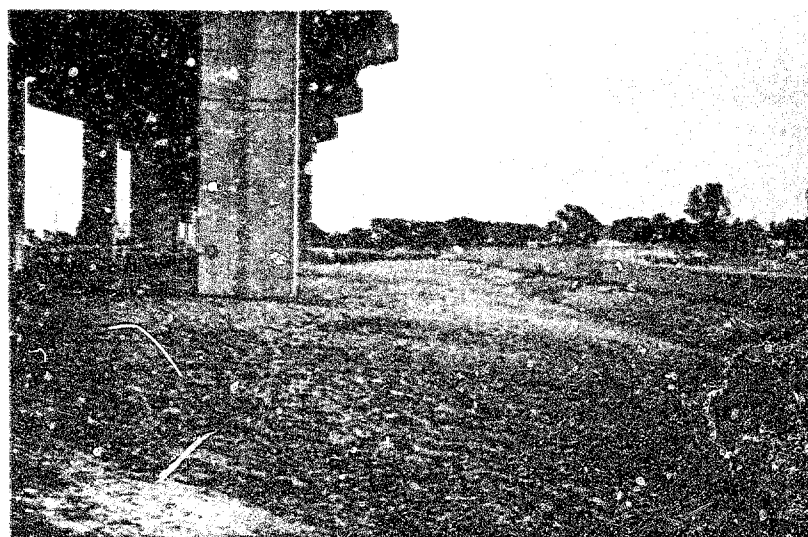
No. 12
RECENTLY GRADED AREA
UNDER STRUCTURE

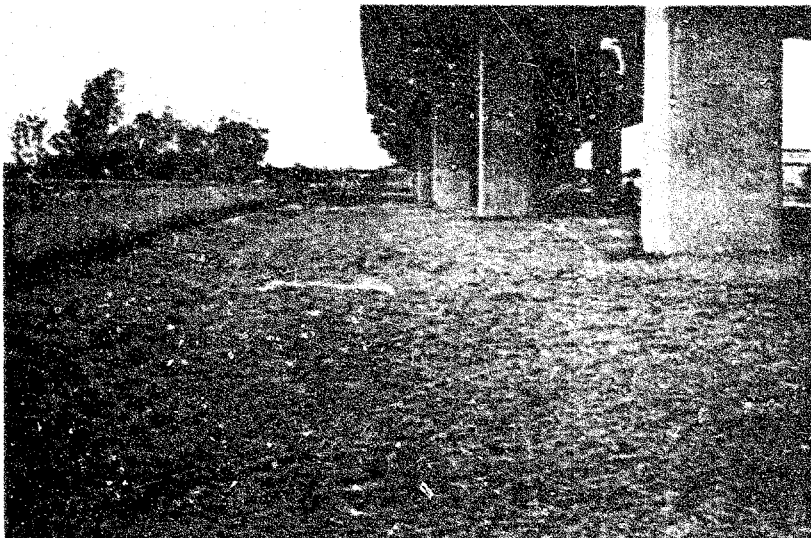
No.13

RECENT GRADING
SOUTH OF STRUCTURE
NEAR WEST ABUTMENT

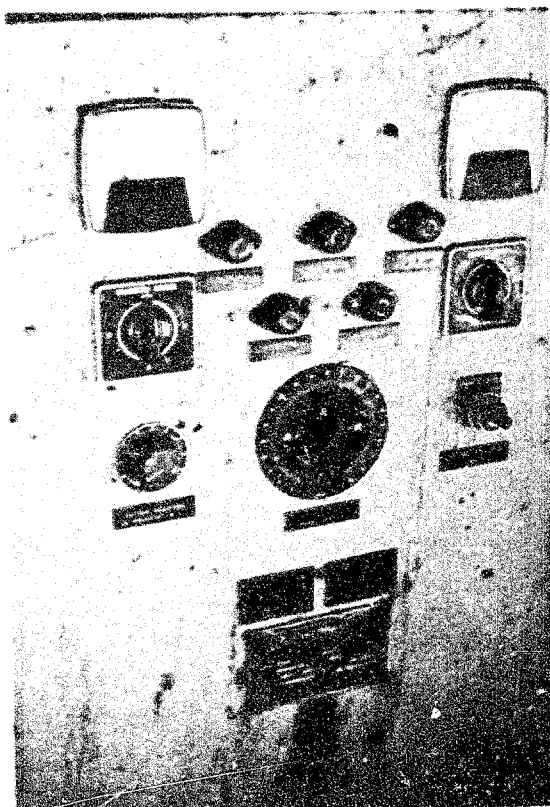
No.14

The travellers have been parked at pier W5 and as a result exposed to the drainage passing through the finger plate in the deck above. This has resulted in a general deterioration of the motor-generator, control and power panel. Continued exposure in the same environment will probably lead to a complete loss of the power and drive system very shortly.

TRAVELLER POWER PANEL
RUSTING

- a) Immediately remove the motor-generator set and power and drive panel and overhaul in the shop.
- b) Repair the lateral movement drive and carriages. It was not possible to move laterally, with the hand chain drive, since it appears the frame is bent.

- c) Modify power panel and drive panel assembly so that panels can be easily enclosed in a moisture proof wrapping when not in use.
- d) Extend exhaust pipe downwards so that exhaust gases are not discharged into the face of the operator.

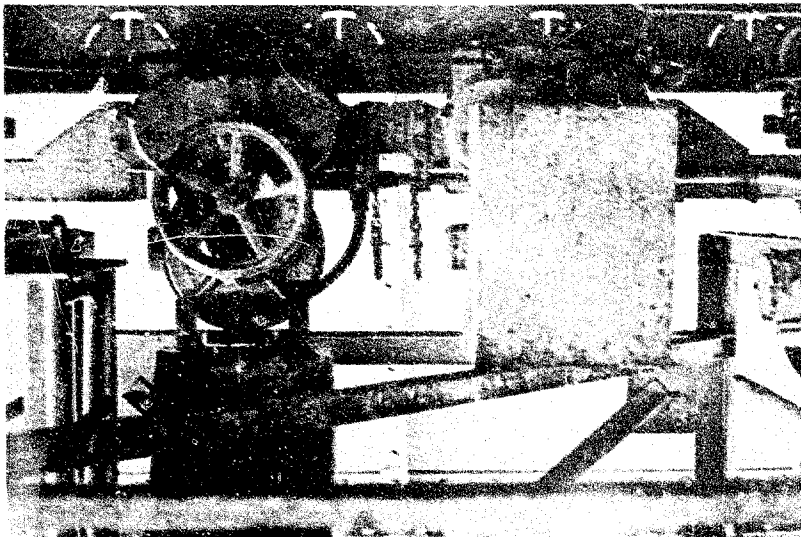
During this inspection only the centre traveller was barely useable after some initial repairs. The straight forward and reverse drive switches were working but the jogging switches were out of order. The motor could not be readily started and it could only be shut off by manually stopping the gas flow to the pumps.

No. 15
CENTRE TRAVELLER
DRIVE MOTORS
AND HAND CRANK

It is recommended that the centre traveller be put in useable order with a power drive system and used exclusively for major repainting programs. Access to the underside of the deck for inspection purposes etc. could be accomplished by a series of existing and new manholes. The following should be carried out to meet these requirements.

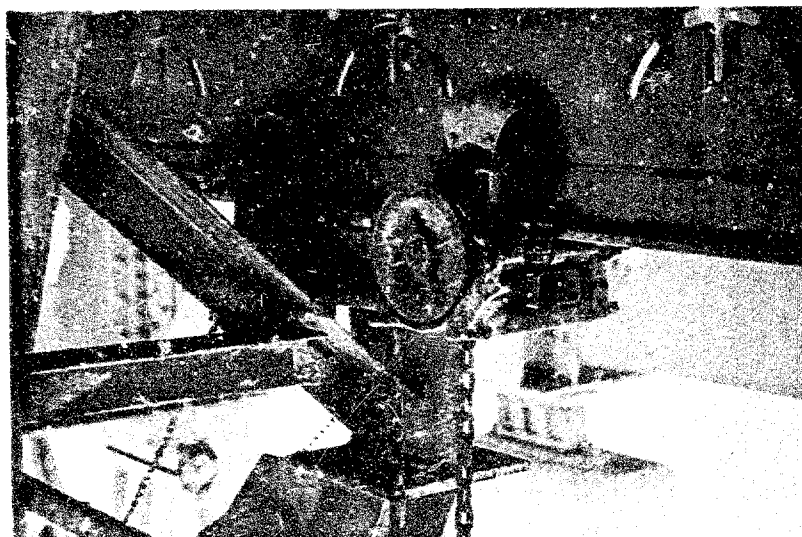
No. 16
LATERAL MOVEMENT
CARRIAGE
PRESENTLY INOPERATIVE
