**REPORT ON**

**ROCKFALL HAZARD ASSESSMENT  
HIGHWAY 6 WIDENING  
BETWEEN HIGHWAYS 403 AND 5  
G.W.P. 19-95-00**

August 2005

001-1141F-11

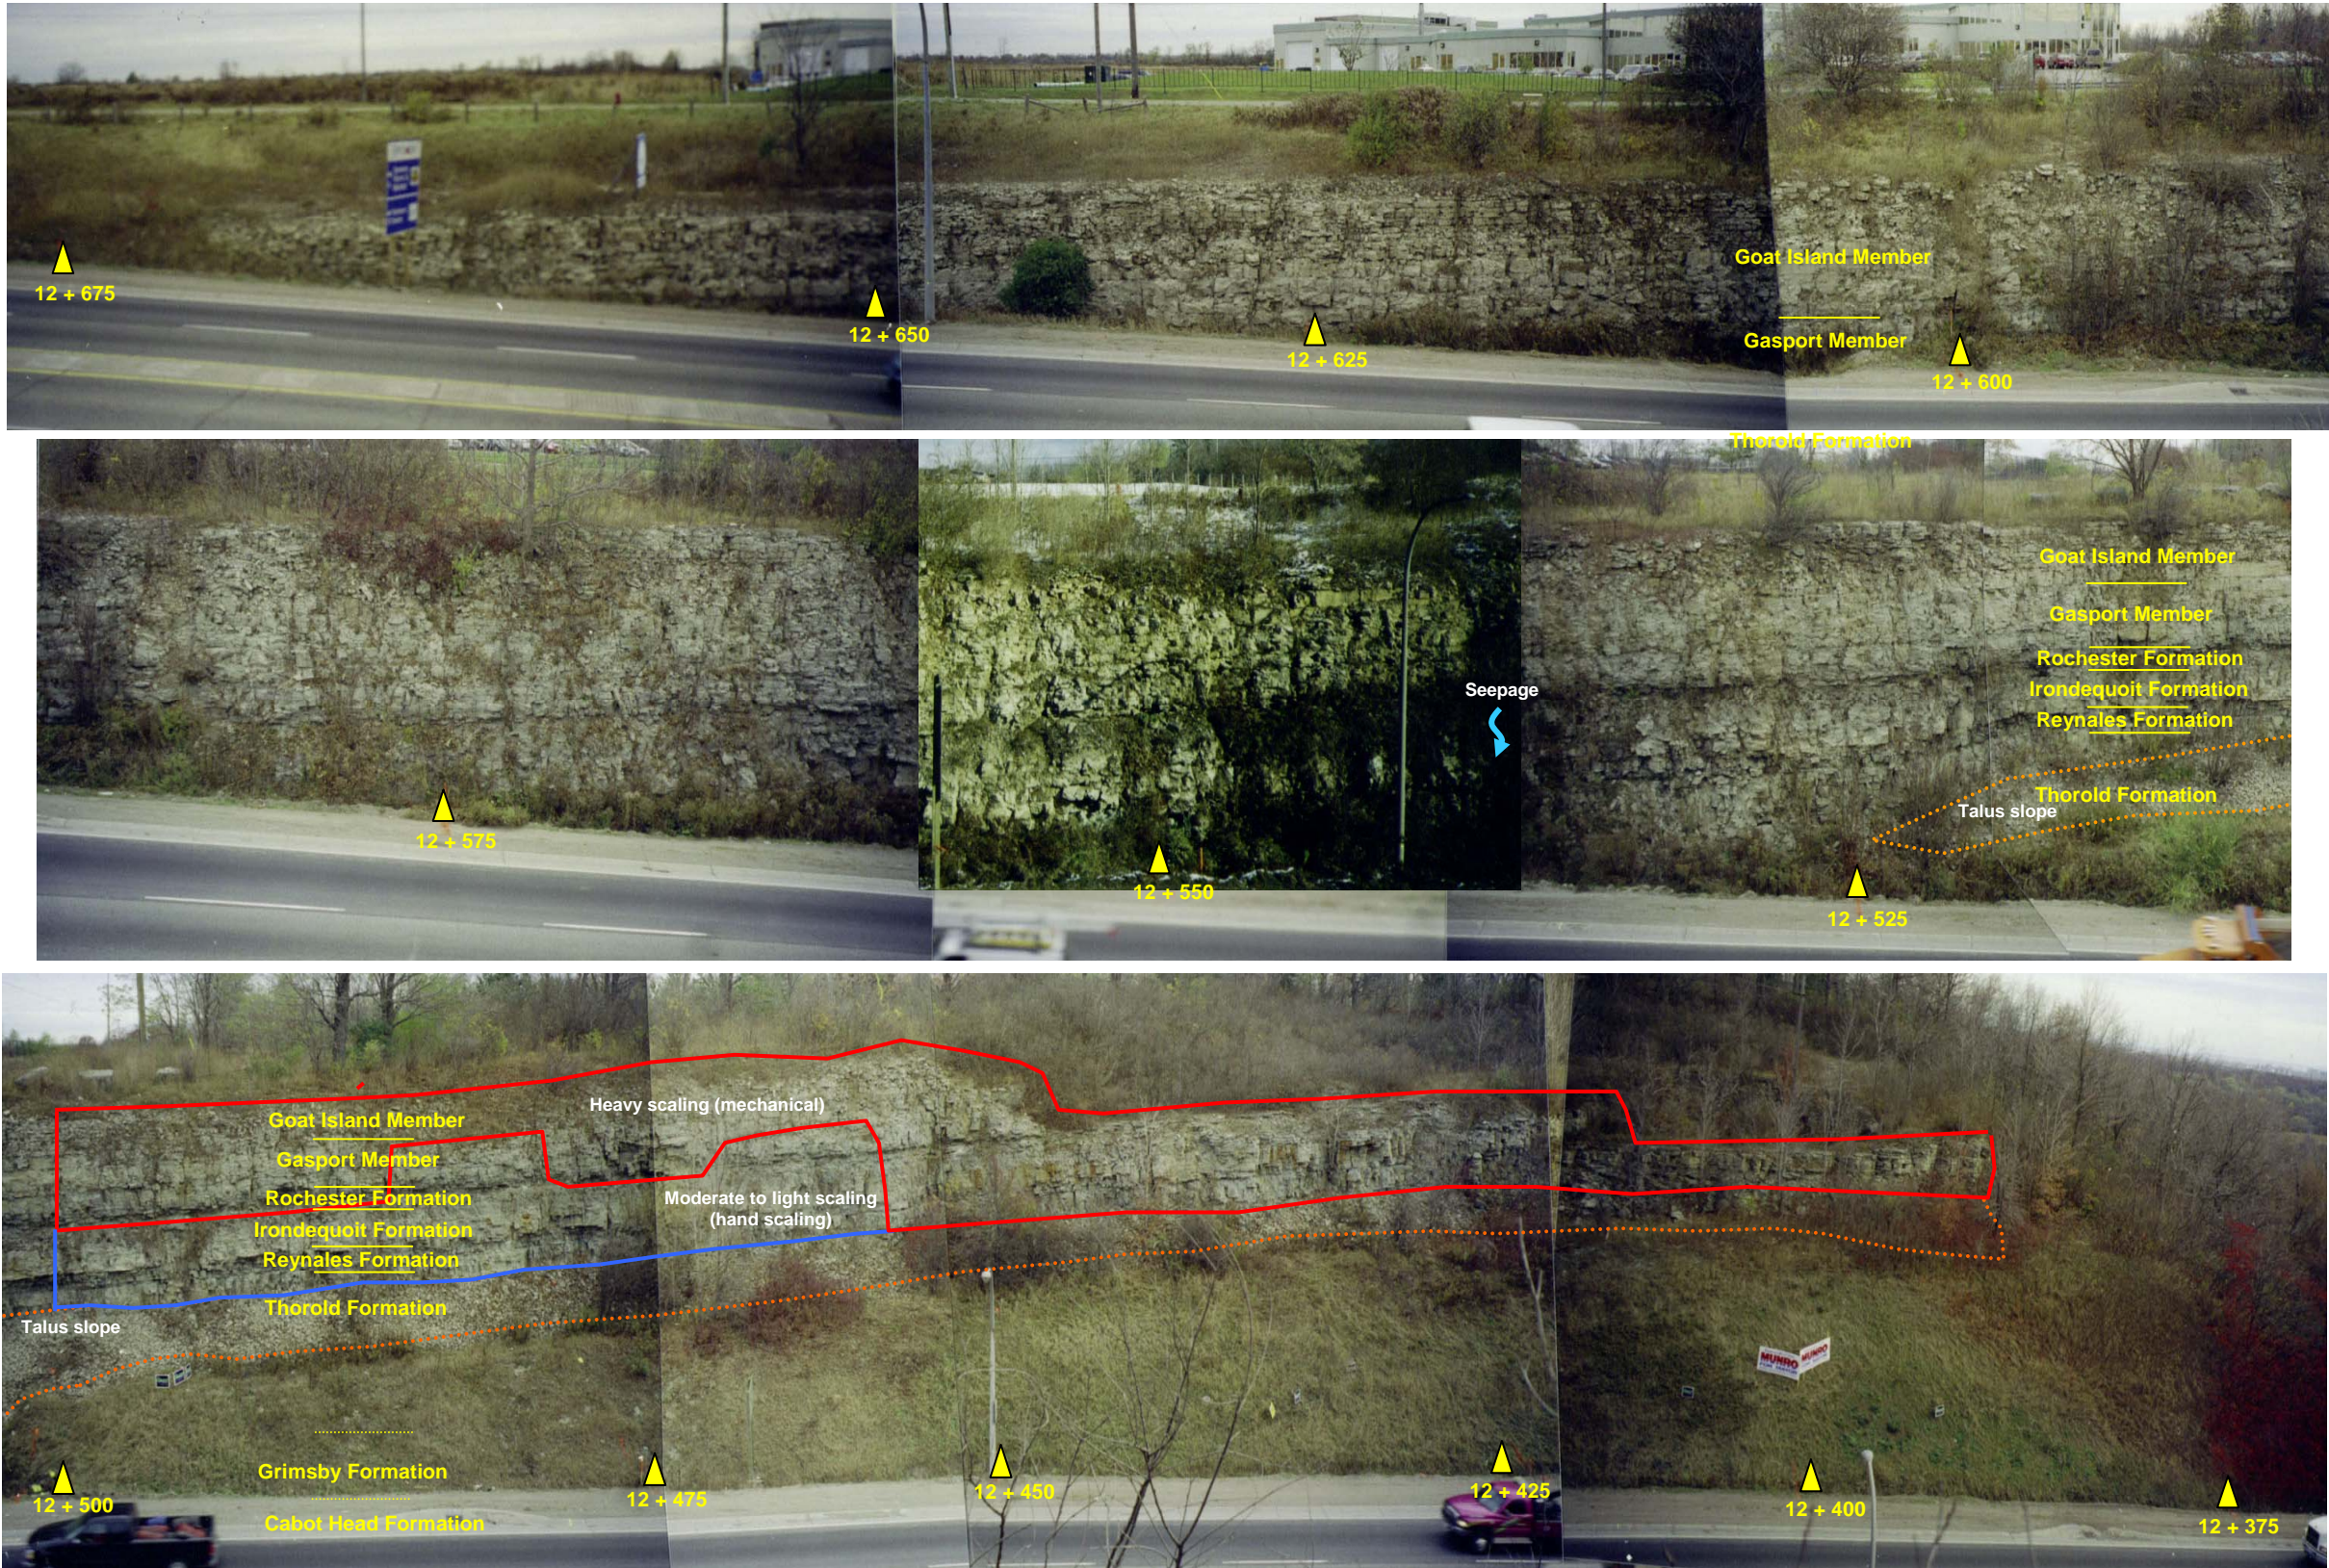
PLATE 1

The rock mass conditions on either side of Highway 6 are shown in Plates 1 and 2. Common lithostratigraphic units can be identified in both road cuts as shown on the Plates. Both cuts exhibit slight blast damage (likely from original construction) and extensive weathering and ravelling due to frost action.

At the time of the inspection some minor seepage was noted, primarily along the upper contact of the Rochester Shale as shown on Plates 1 and 2. It should, however, be noted that groundwater levels are expected to fluctuate seasonally and are expected to be higher during wet periods of the year.

Some minor undercutting in the Rochester shale within the existing rock cuts was noted during the field inspection. To date, this has not developed into a major stability problem for the overlying units due to the very limited extent (depth) of the undercutting which is estimated to be less than 0.5 m.

EAST ROCK CUT - HIGHWAY 6  
STATION 12+375 to 12+675

The condition of the existing rock cuts and the recommended remedial works are shown on Plates 1 and 2. As shown on these plates, scaling of loose, weathered rock from the face of the existing cuts is required in the following areas (which are located south of the cut widening area), in order to minimize the risk of rock ravelling and rolling or bouncing and eventually reaching the roadway, as well as to reduce ongoing maintenance costs associated with clean-out of the ditches/catchment areas.

- South of Station 12+530 on the west side of Highway 6; and
- South of Station 12+500 on the east side of Highway 6.

The rock scaling shown on Plates 1 and 2 has been divided into two broad types (in general agreement with existing MTO Special Provisions): heavy mechanical scaling and light to moderate hand scaling. Heavy mechanical scaling would normally require the use of a backhoe bucket and in some cases a large hoe-ram to remove larger blocks near the crest. Light hand scaling, as the name implies, is generally best carried out from a crane supported platform using hand tools (hand scaling bars). For the scaling shown on Plates 1 and 2, it is estimated that there would be approximately 45 hours of heavy scaling and about 25 hours of light scaling required.

These scaling categories have been assigned based upon the visual inspection of the existing rock faces. The loosening effect of physical weathering is expected to be less than 1.0 m in the areas designated as requiring heavy mechanical scaling, and less than 0.5 m in areas requiring light to moderate hand scaling. It should however be noted that due to the blocky nature of the rock mass, that over-scaling (particularly by mechanical methods) is a concern. With this in mind, it is recommended that the scaling be directed and supervised by qualified geotechnical personnel.

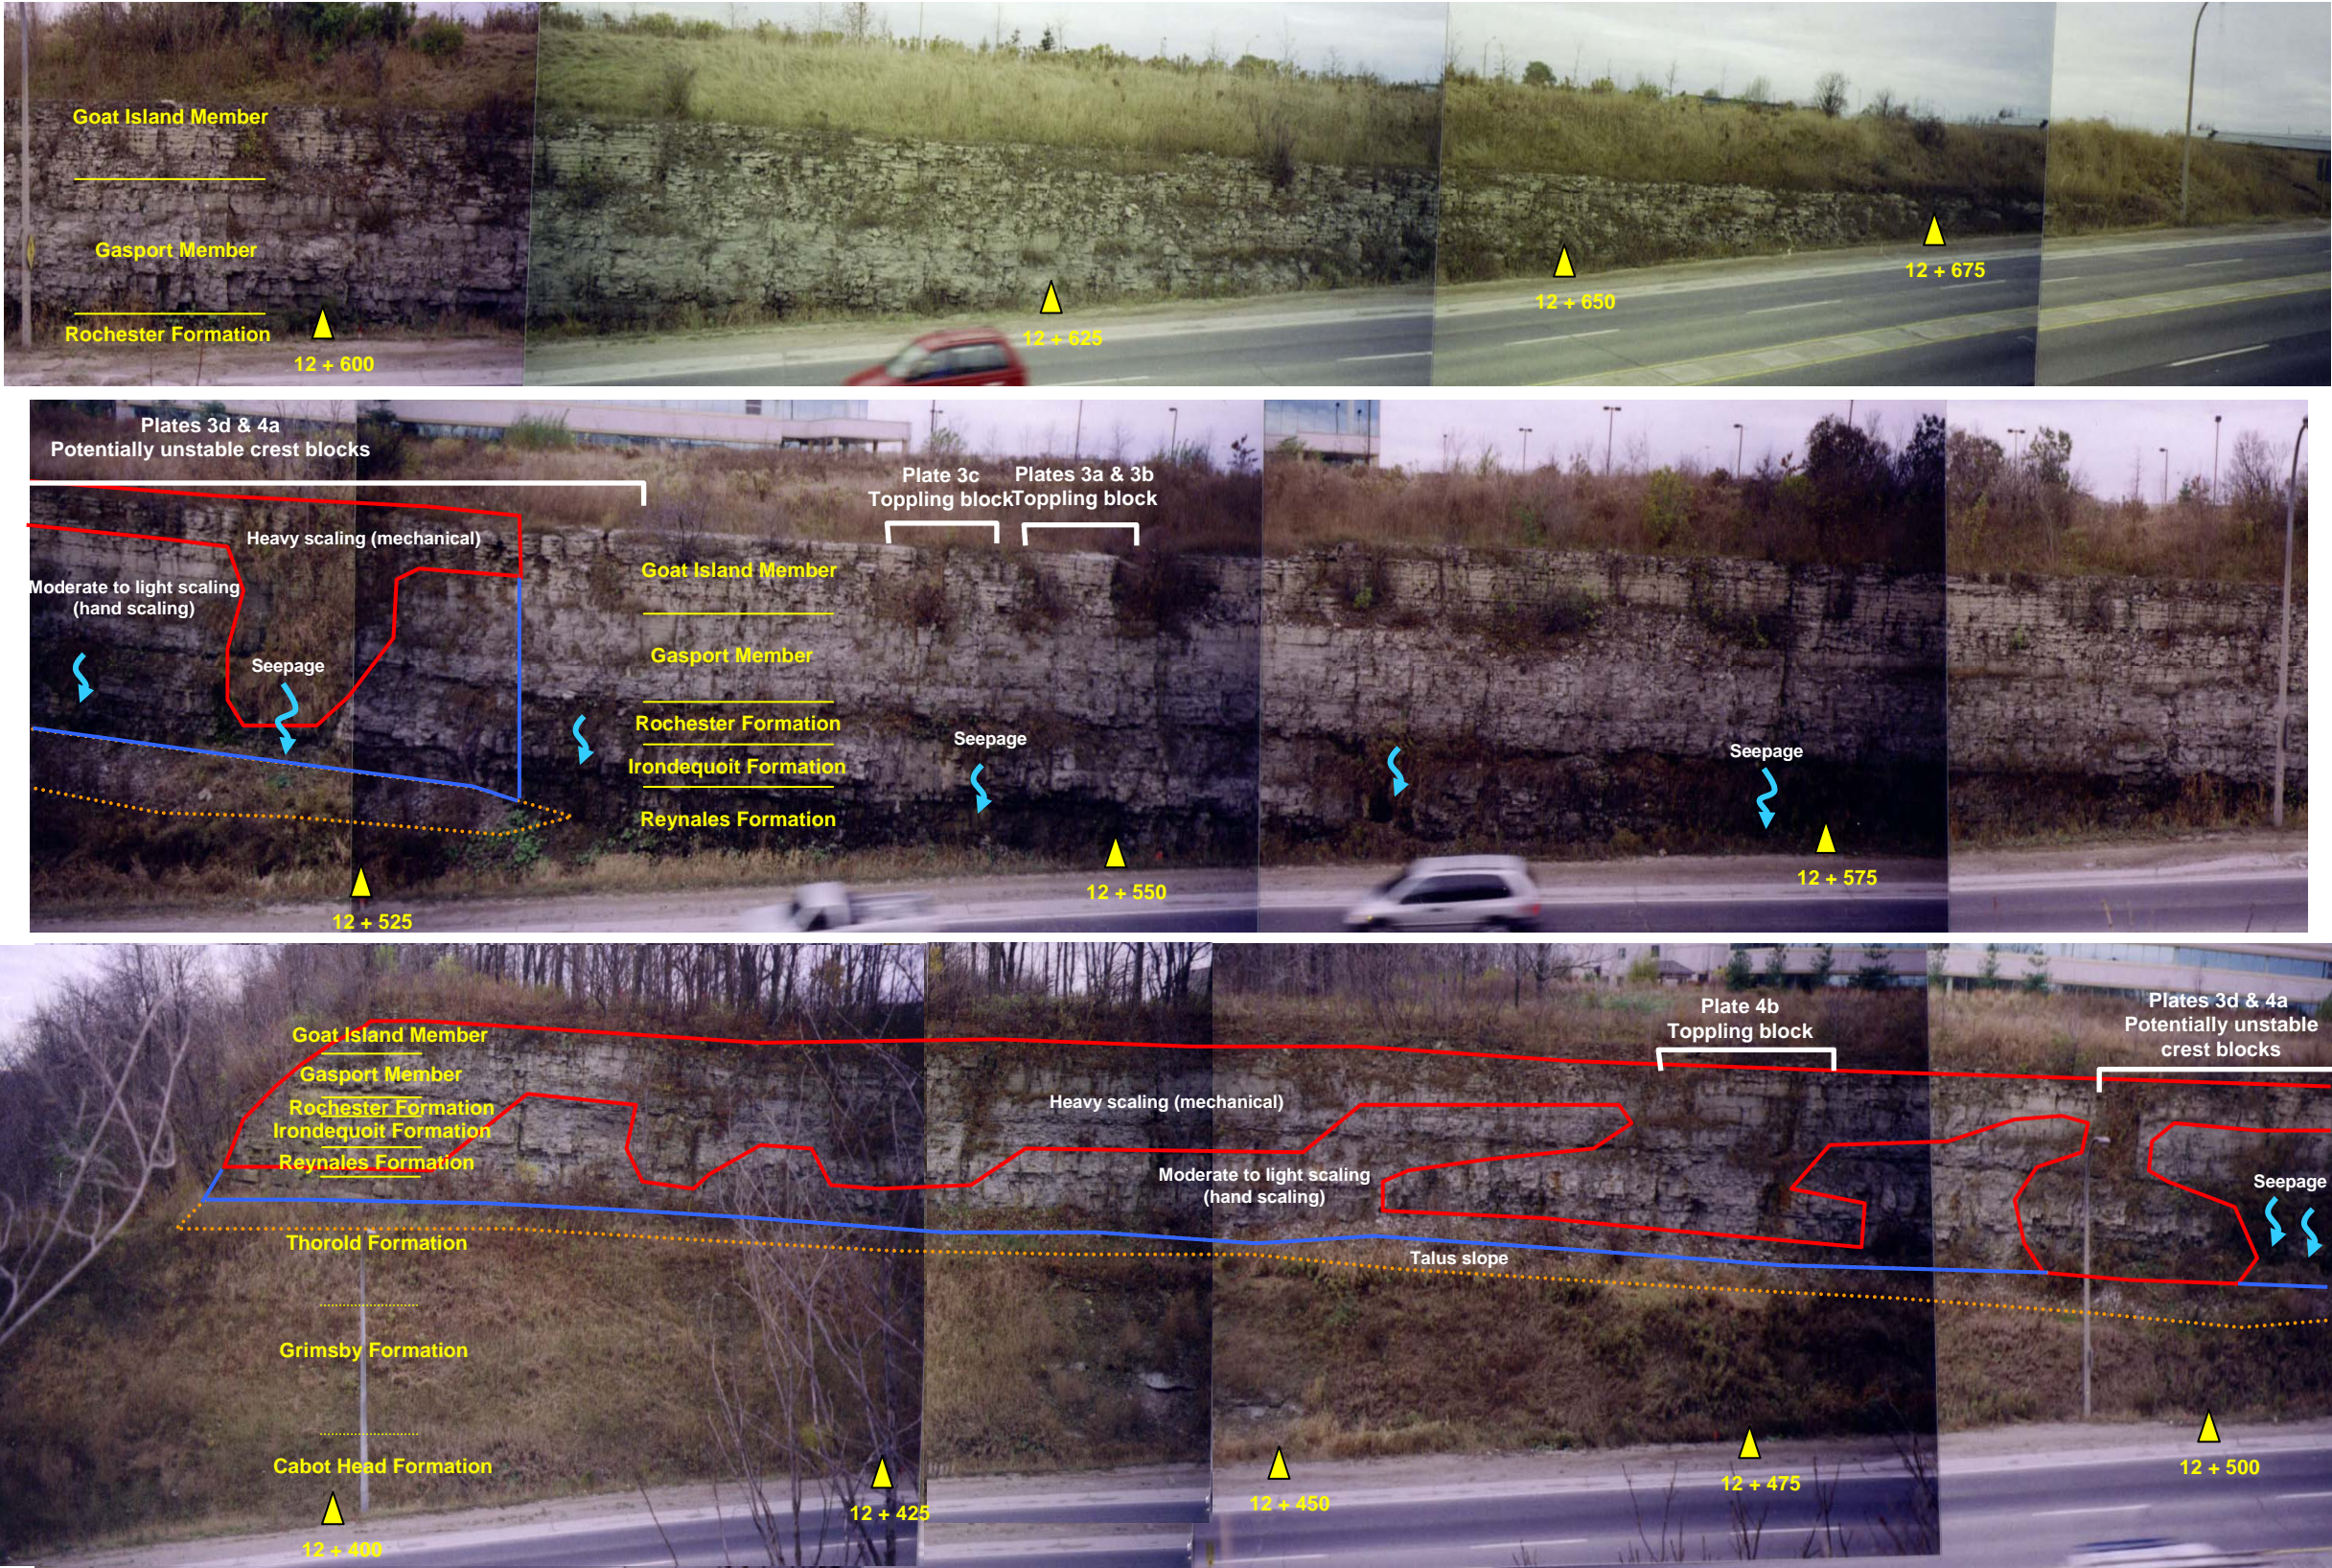
PLATE 2

It should also be noted that some open joints were identified along the crest of the west rock cut during the field inspection (refer to Plates 3 and 4). Further opening of these joints through blasting or ice-jacking could result in toppling failure.

WEST ROCK SLOPE - HIGHWAY 6  
STATION 12+375 TO 12+675

The larger toppling blocks of rock located near the crest of the west rock cut (refer to Plates 2 to 4) should also be removed using a backhoe, possibly requiring a hoe-ram. Access to the crest may be difficult depending on the equipment used and therefore this work may require temporary ramps constructed at the toe of the slope using blast rock.

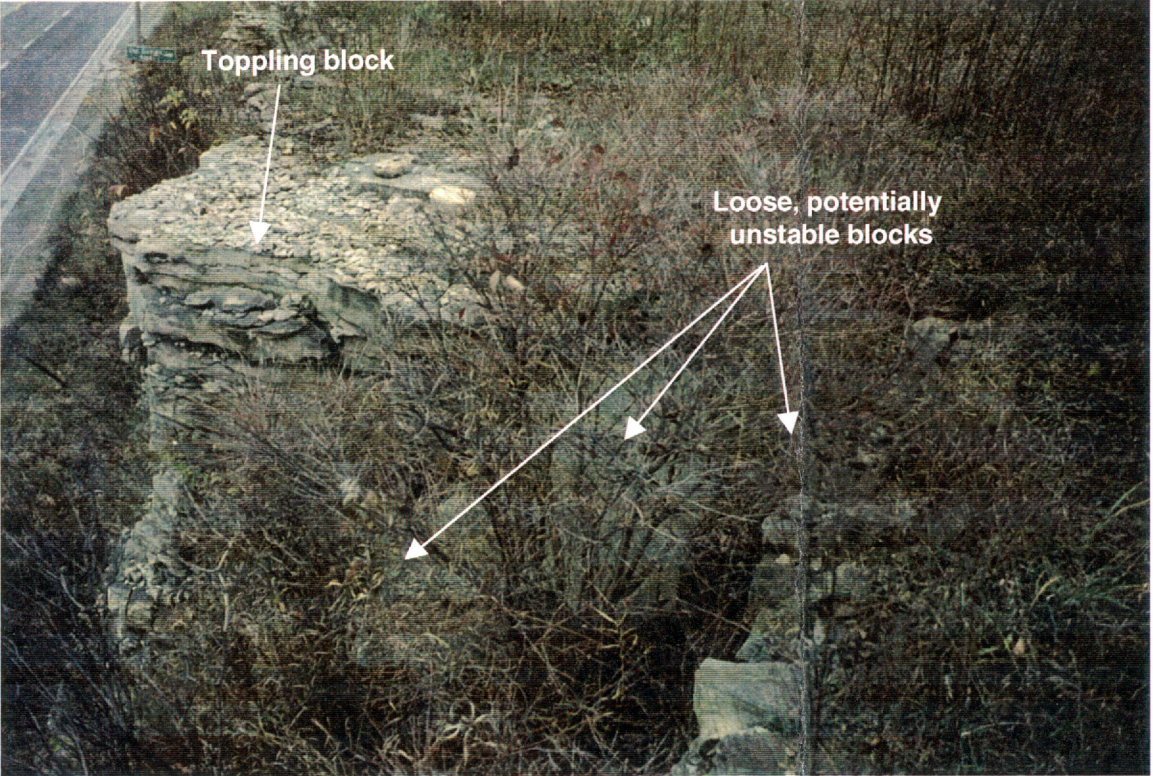
3a) Potential toppling block (Approx. CH 12+550)

**Notes:**  
1) The typical toppling and potentially unstable blocks shown, are to be removed.  
2) Other unstable blocks may become loosened or identified during scaling, and these should also to be removed

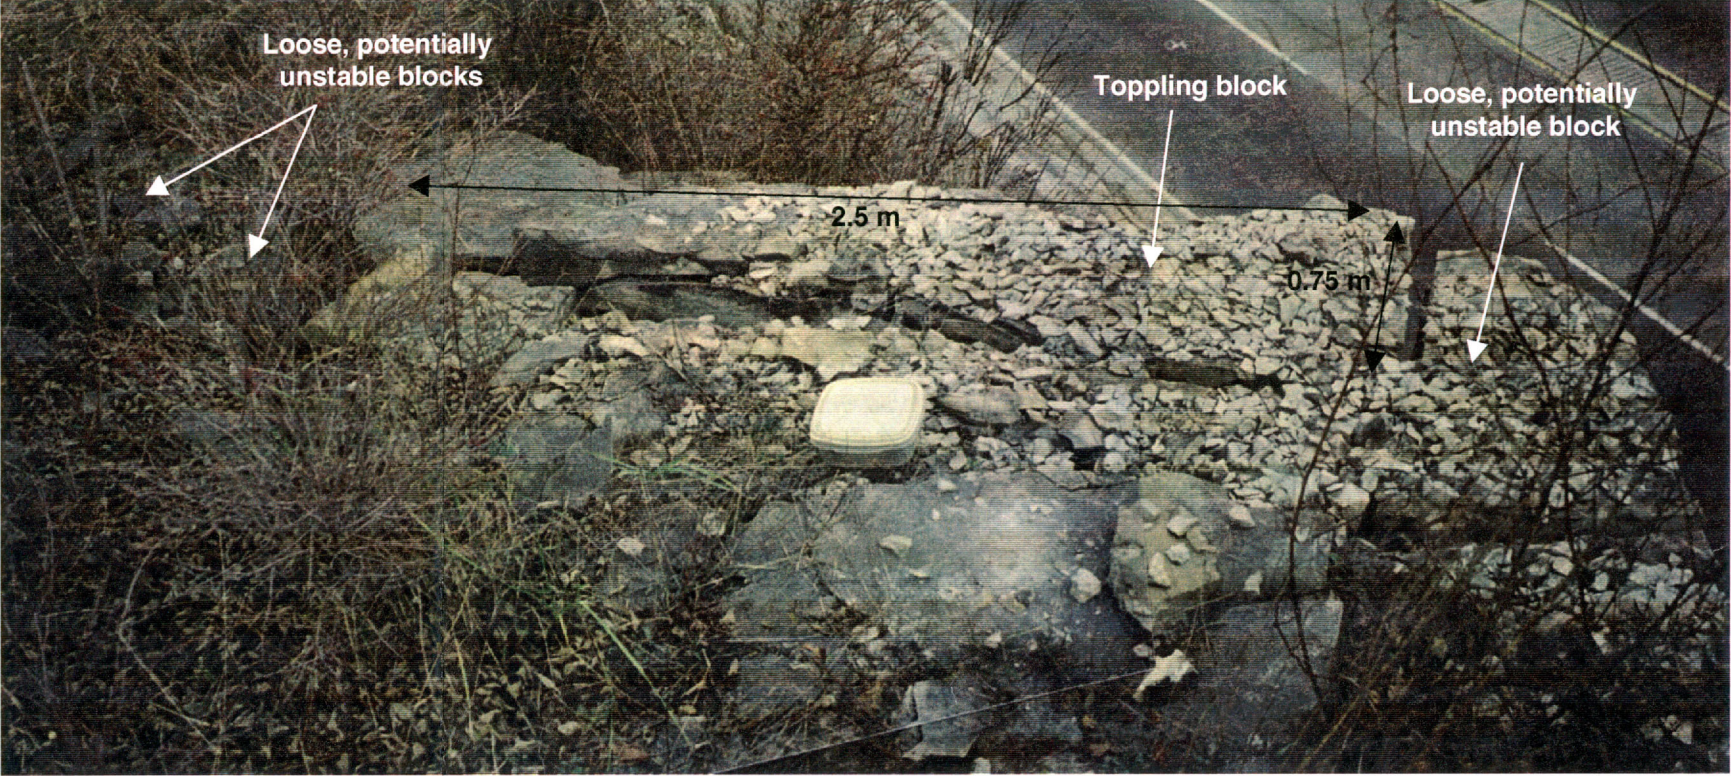
3b) Potential toppling block (Approx. CH 12+550)

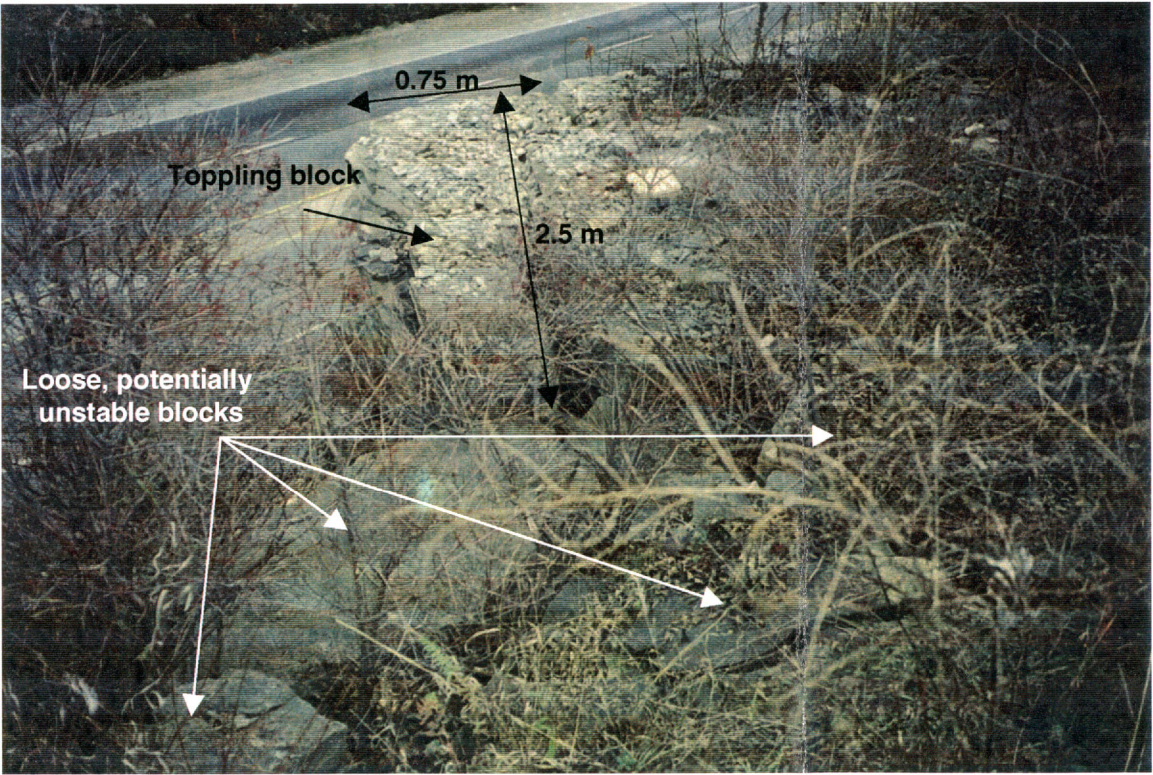
3c) Potential toppling block (Approx. CH 12+550)

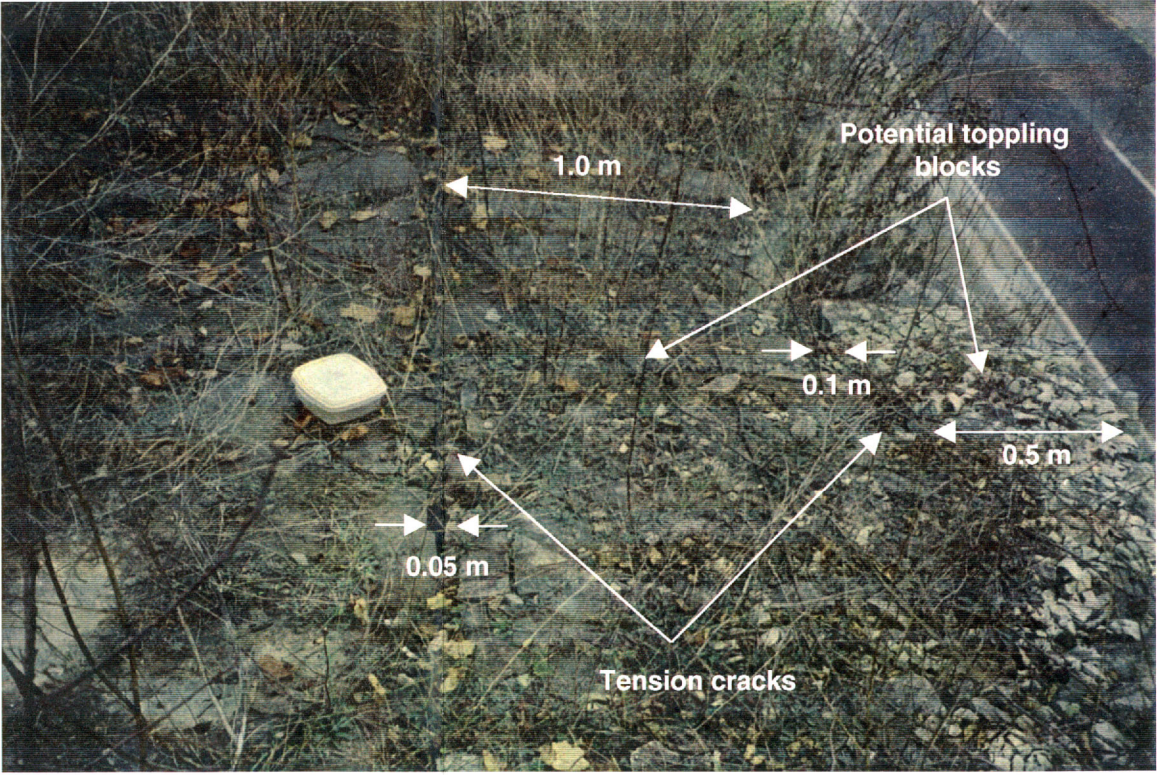
3d) Potential toppling blocks with open tension cracks (Approx. CH 12+545)

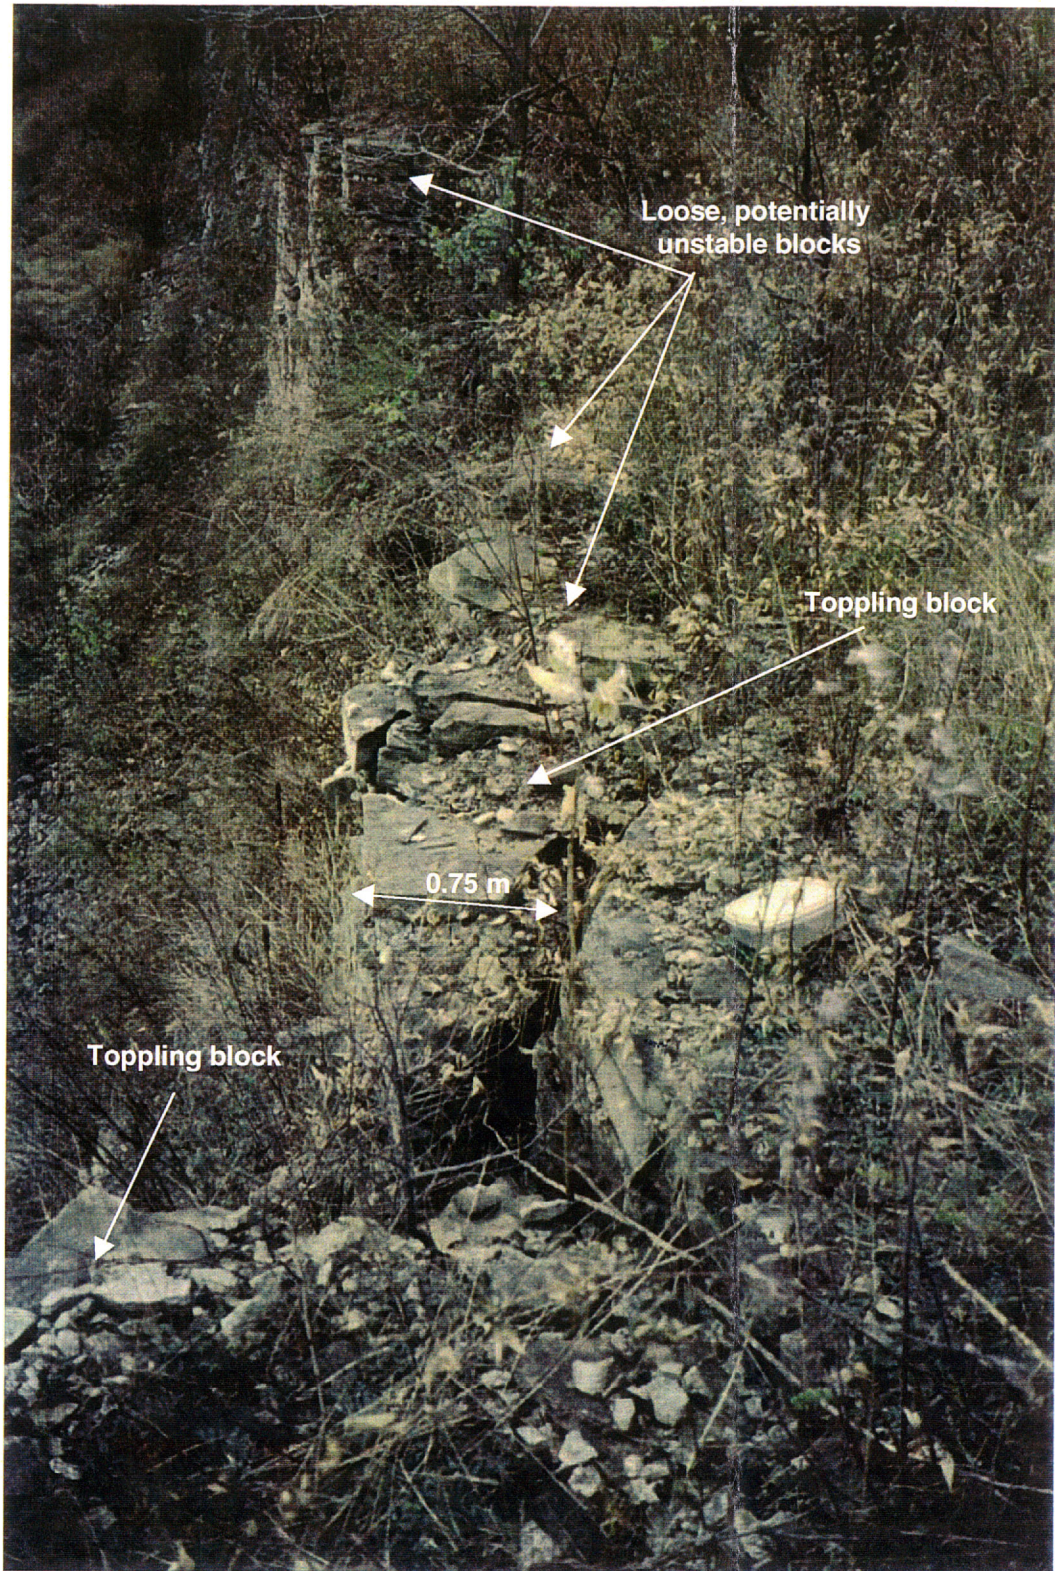
4a) Potential toppling blocks (Approx. CH 12+530)

- 1) The typical toppling and potentially unstable blocks shown, are to be removed.
- 2) Other unstable blocks may become loosened or identified during scaling, and these should also be removed

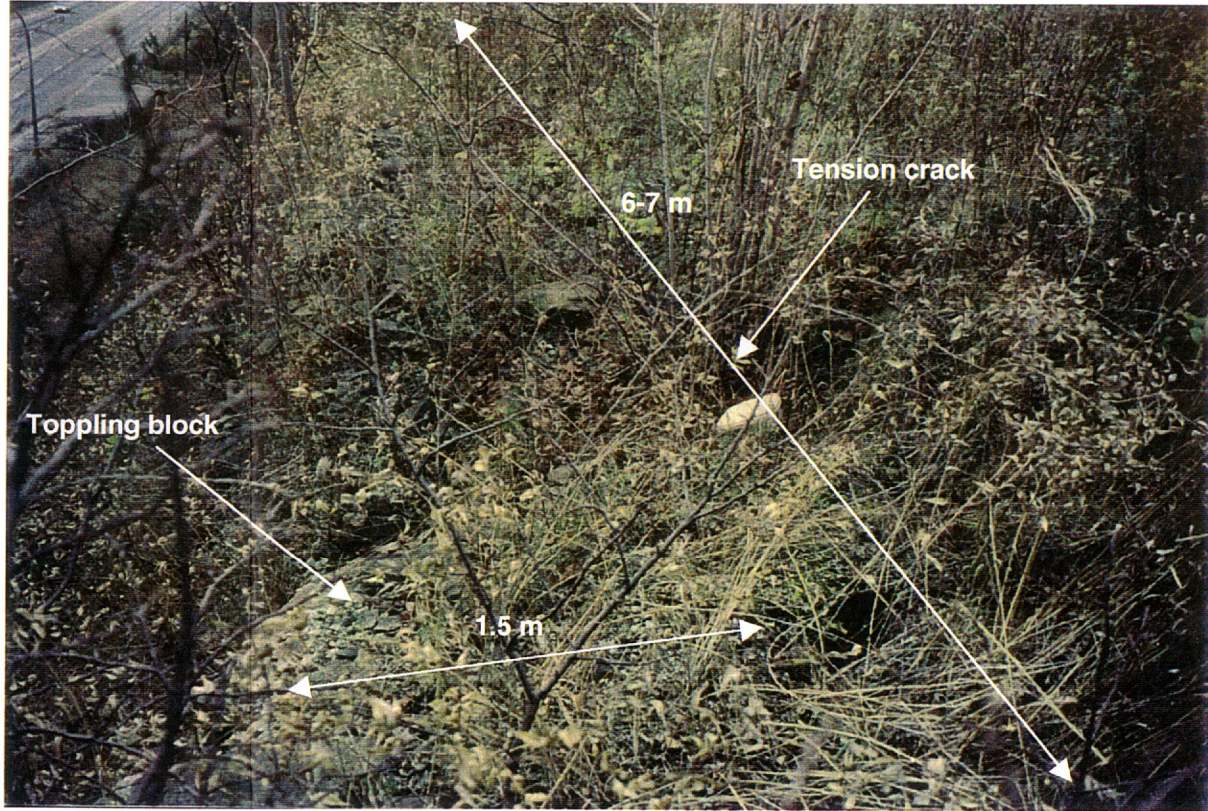
4b) Potential toppling block (Approx. CH 12+475)

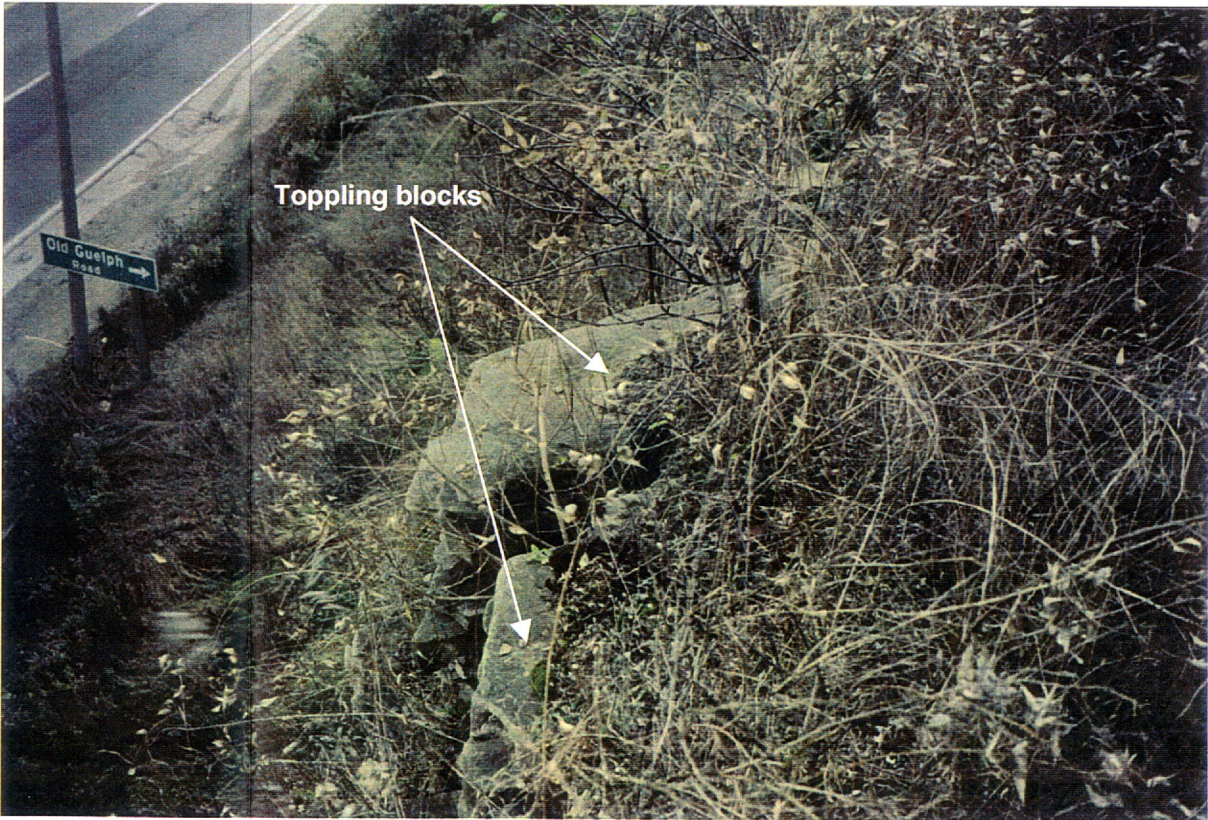
4c) Potential toppling blocks (Approx. CH 12+520)

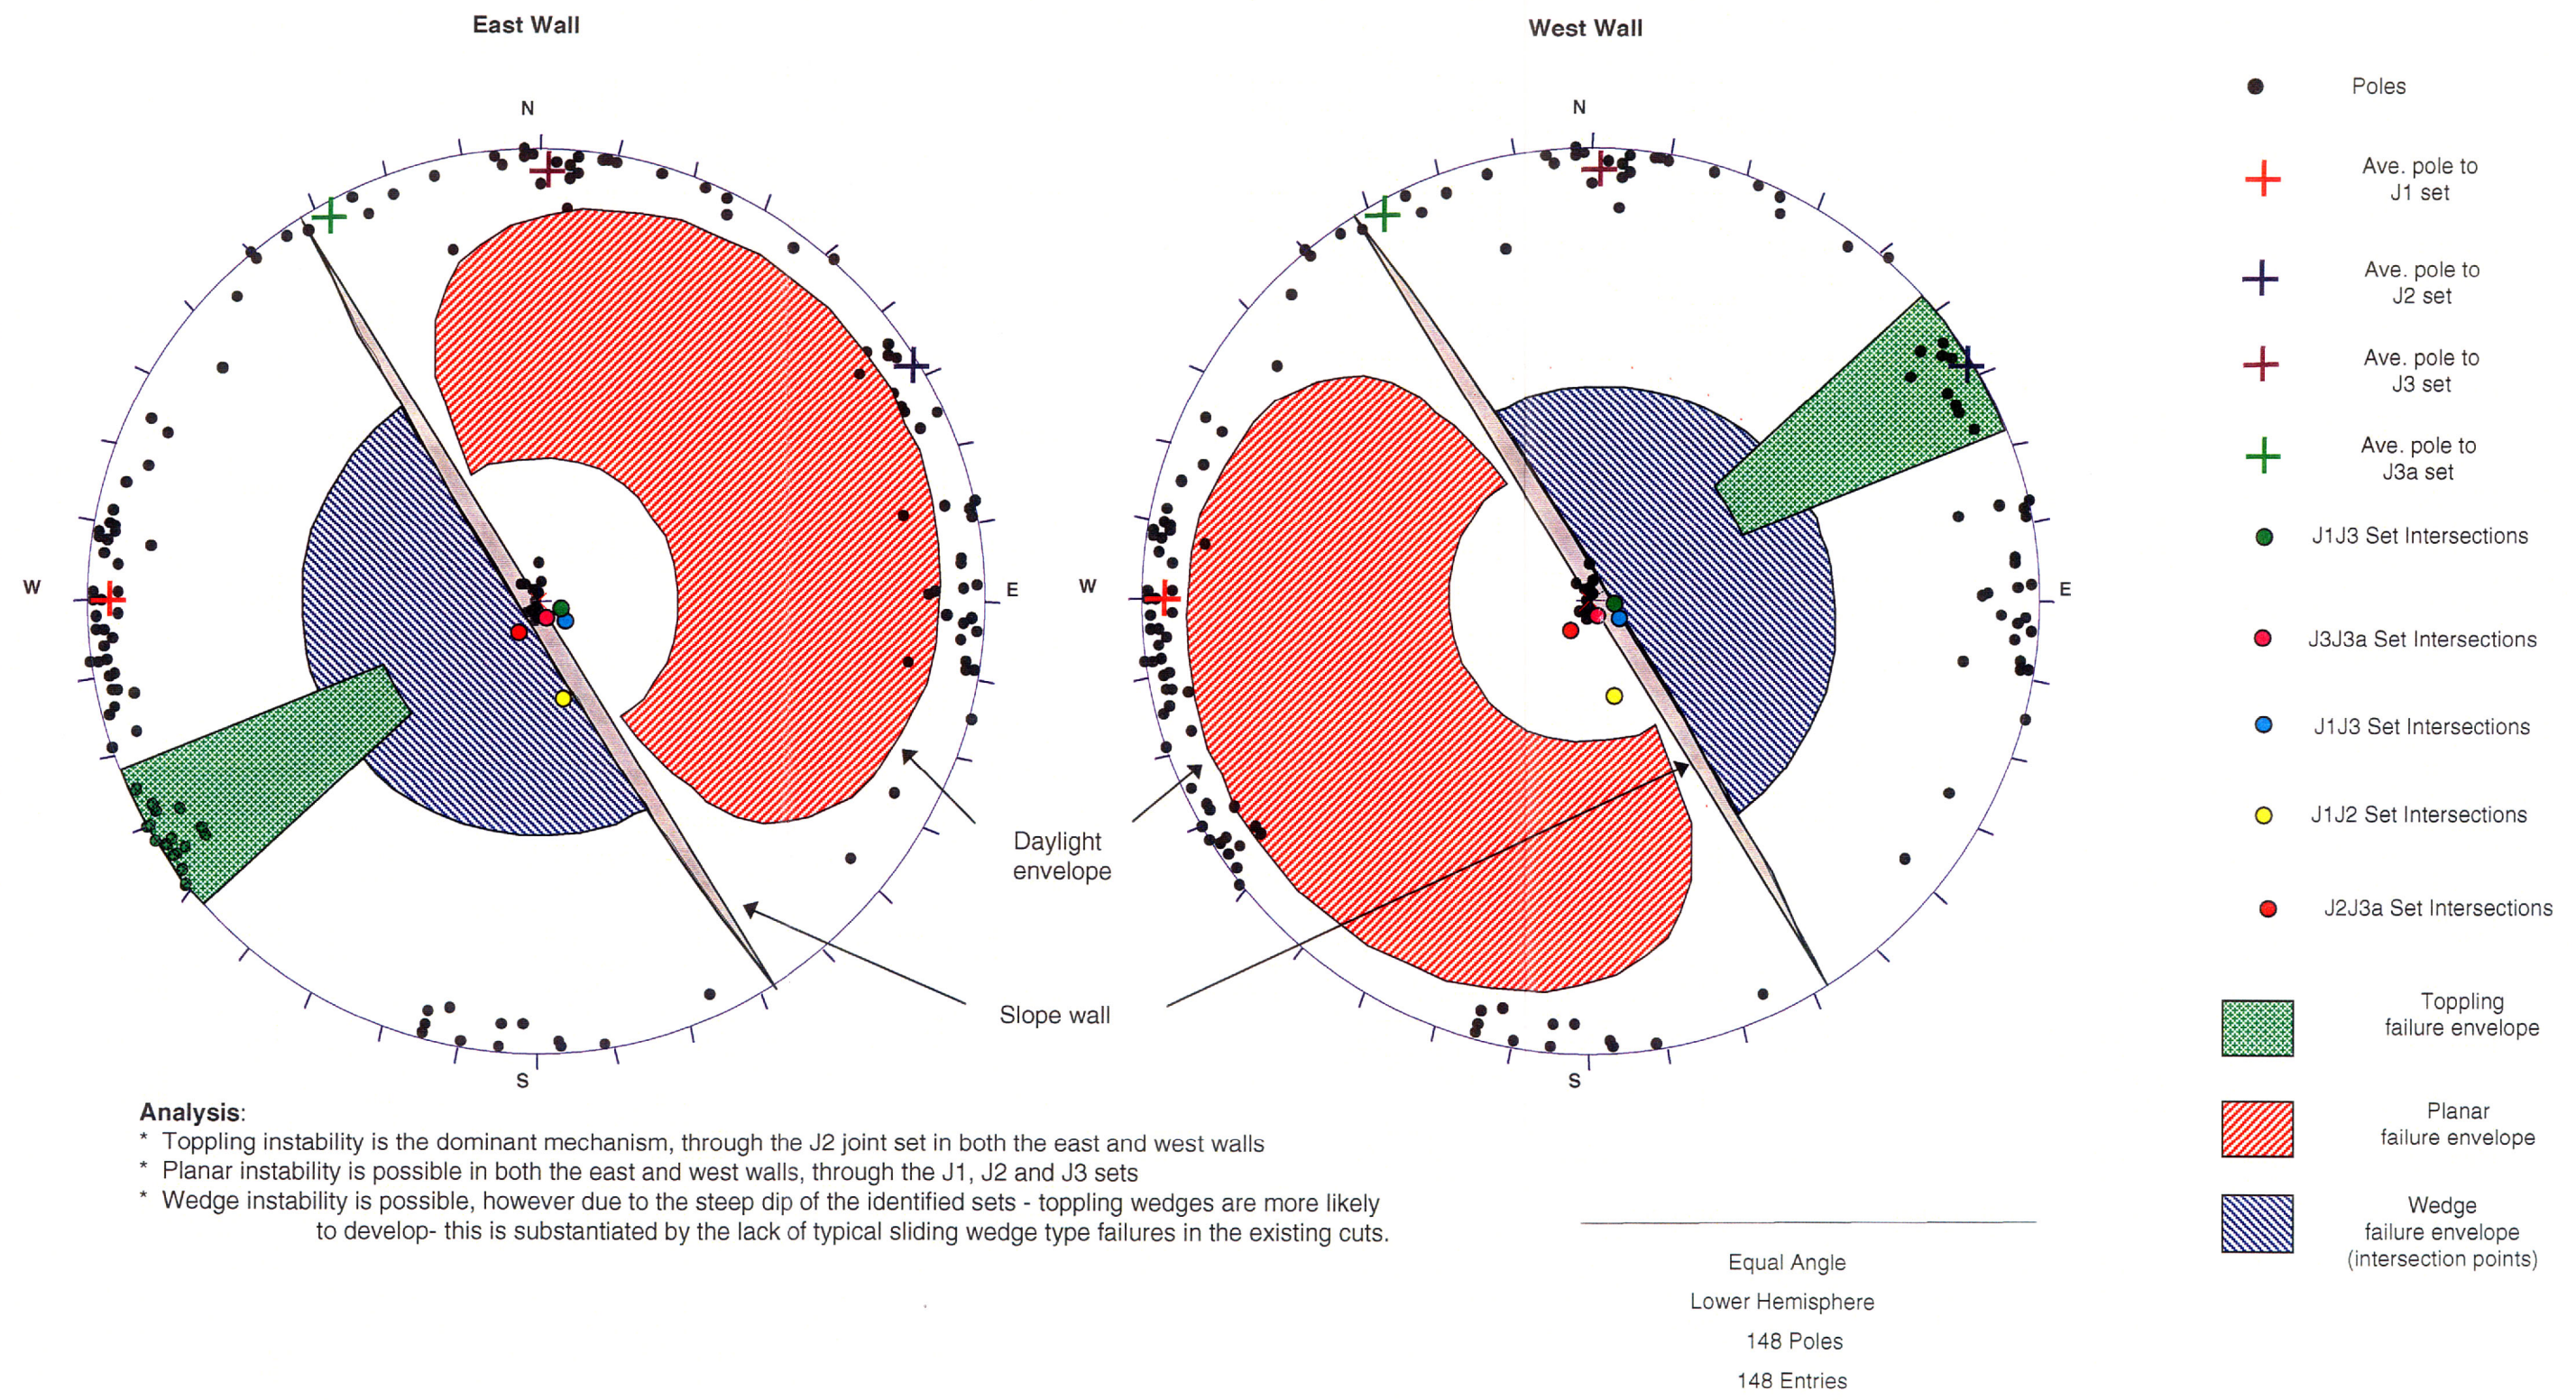
In terms of kinematic stability, wedge and planar type failures are unlikely along both the east and west rock cuts at Highway 6 due to the typically sub-vertical joint sets (refer to Figure 3). During excavation of the new road cuts there is a slight possibility of toppling failure, since the J2 set is nearly parallel to the orientation of the cut. However, it is likely that most unstable blocks would be dislodged during blasting and subsequent scaling. The prominent J1 and J2 sets may have an adverse affect on overbreak during blasting wherever they are present. Stability of the ultimate rock slopes will be mostly affected by the quality of the controlled blasting.

- \* Toppling instability is the dominant mechanism, through the J2 joint set in both the east and west walls
- \* Planar instability is possible in both the east and west walls, through the J1, J2 and J3 sets
- \* Wedge instability is possible, however due to the steep dip of the identified sets - toppling wedges are more likely to develop- this is substantiated by the lack of typical sliding wedge type failures in the existing cuts.
