**FOUNDATION INVESTIGATION AND DESIGN REPORT
SLOPE FAILURE AT W-N/S RAMP
FORMER HIGHWAY 403 (GARDEN AVENUE)/
HIGHWAY 403 INTERCHANGE
GWP 30-00-00, AGREEMENT NO. 3005-E-0017
MINISTRY OF TRANSPORTATION - SOUTHWESTERN REGION**

February 10, 2006

05-1130-139
Geocres No. 40P1-92

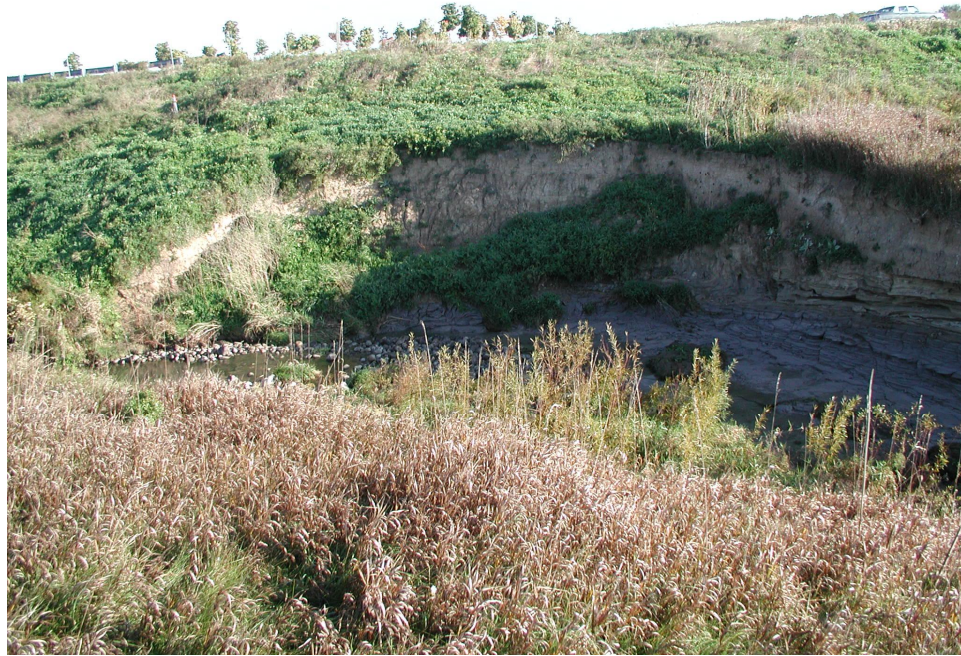
metre high near vertical failure scarp had developed due to undercutting of the toe and subsequent slumping. The failure scarp extended approximately 10 metres upstream and downstream of Station 10+310.

Further, it was observed that most of the geotextile and rip-rap erosion protection which was placed in the discharge area of the 4.0 x 3.1 metre culvert had failed and the stone had been washed downstream.

Photo 1 View of failure scarp below W-N/S ramp from west bank of creek. Cobbles washed downstream from original channel works are evident in left side of photo.

The treatment should extend at least 1 metre into the creek and 1 metre up the slope. The lateral limits should extend at least 1 metre beyond the limits of the current failure as shown on Drawing 1. This work should be carried out as soon as feasible and no later than the spring of 2006.

Stabilization of the existing failed slope is required to preserve the integrity of the W-N/S ramp. Further, the W-N/S ramp cannot be widened if the slope remains in its original configuration or if it is flattened. In order to provide a minimum factor of safety of 1.3, the creek should be realigned and the failed area should be restored to a 2 horizontal to 1 vertical slope using compacted Granular B Type III properly benched into the existing bank. A 2 metre wide bench is required at mid-height should the height of the cut slope be in excess of 6 metres. The slope restoration should extend 3 metres upstream and downstream of the failure scarp in order to properly key in the backfill. The approximate limits of the required slope restoration are shown on Drawing 1. It is recommended that the stabilization measures be implemented early in 2006 or combined with the immediate response work detailed above.

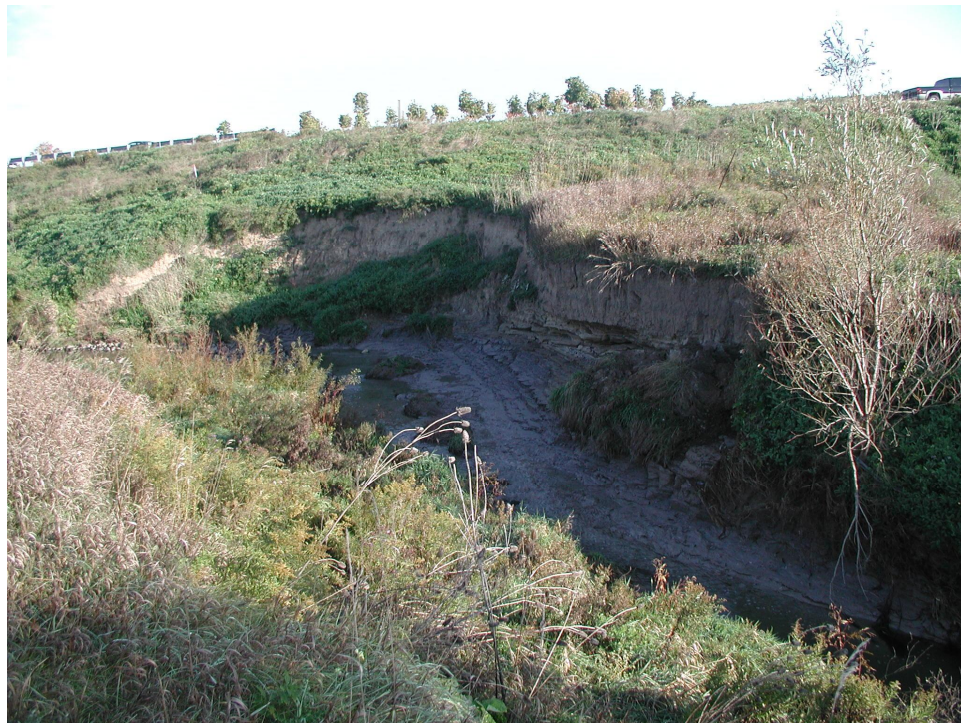
Photo 2 View of failure scarp looking upstream from west bank of creek.
