FOUNDATION INVESTIGATION AND DESIGN REPORT

**REHABILITATION OF NORTH EMBANKMENT AND APPROACH
HIGHWAY 140 / CNR OVERPASS
PORT COLBORNE, ONTARIO**

MINISTRY OF TRANSPORTATION, ONTARIO

GEOCREs No. 30L14-50

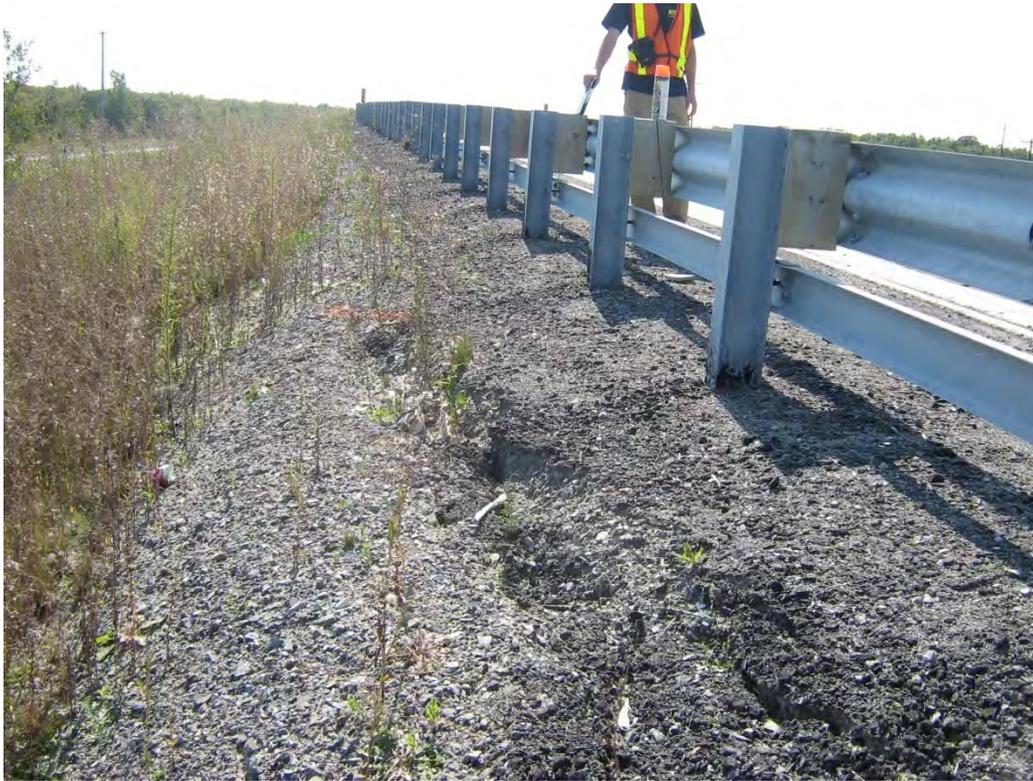
Photo #5: Tension crack along crest of east slope of north embankment, facing south.

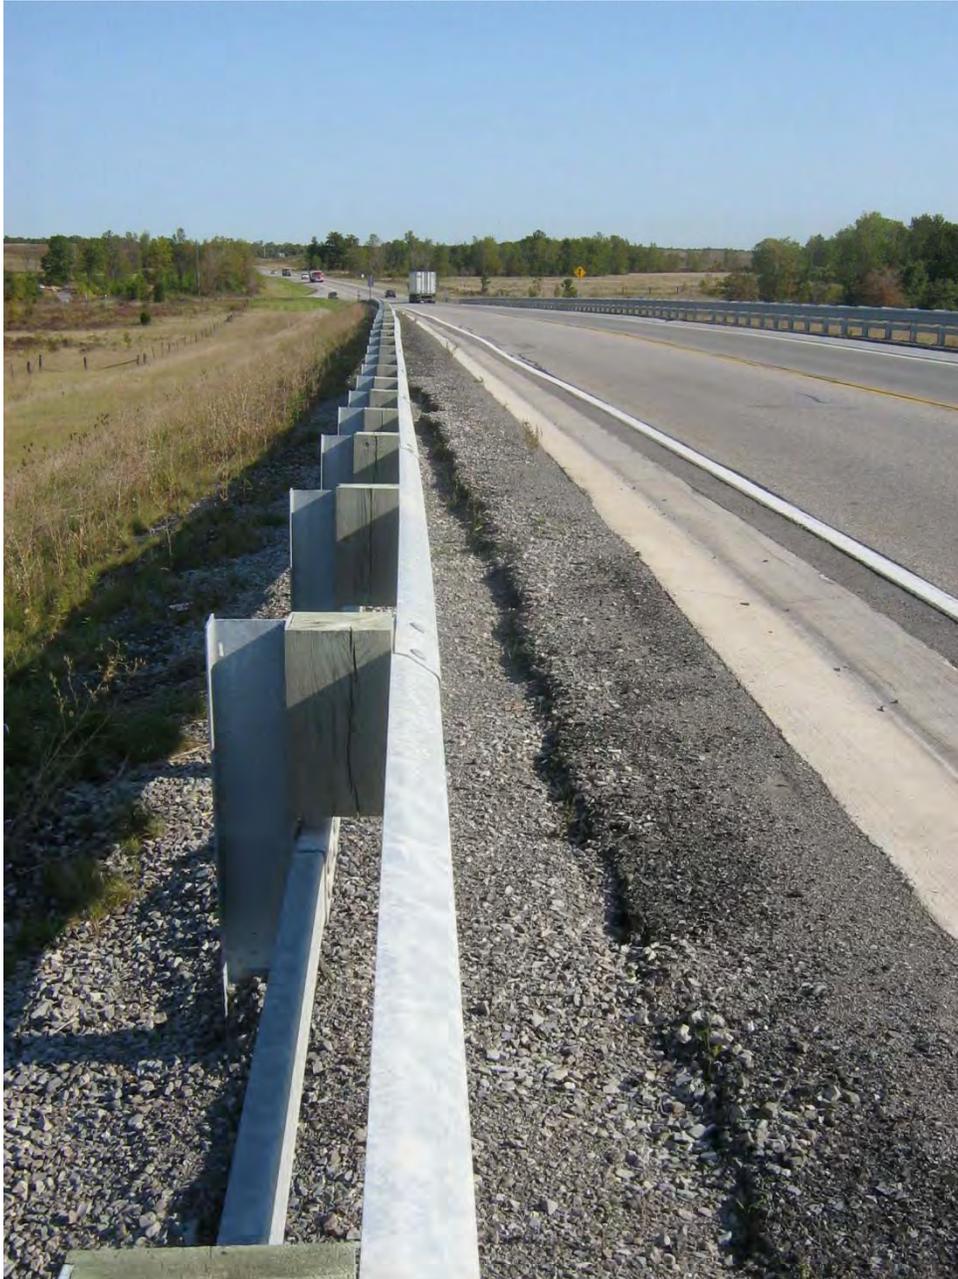
Photo #3: Sloughing of granular at crest of slope, west side of north embankment facing north.
