Geotechnical Investigation and Design Report Slope Stabilization at Station 13+500 Highway 102, Kaministiquia

**GWP 6019-05-00
WP 6082-05-01**

GEOCRES No. 52A-137

June 26, 2009

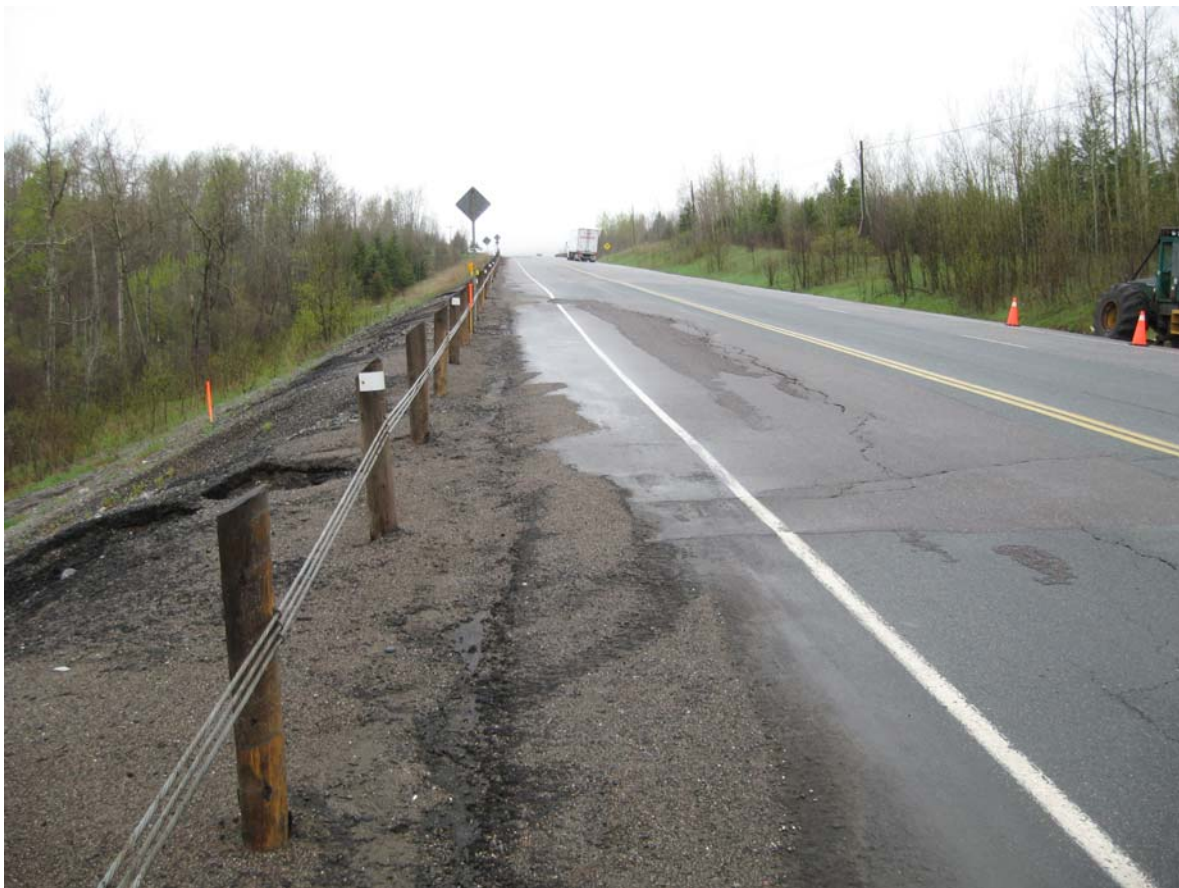
At the time of this investigation, the scarp of the slope movement area was evident as arc-shaped pavement cracking, between station 13+450 and station 13+500, extending across the east bound lane to the centre line. No toe bulge was observed down slope (likely obscured due to the presence of trees and shrubs).

Highway 102 near station 13+500 May 30, 2008 Cracking and Asphalt Patching - Looking West

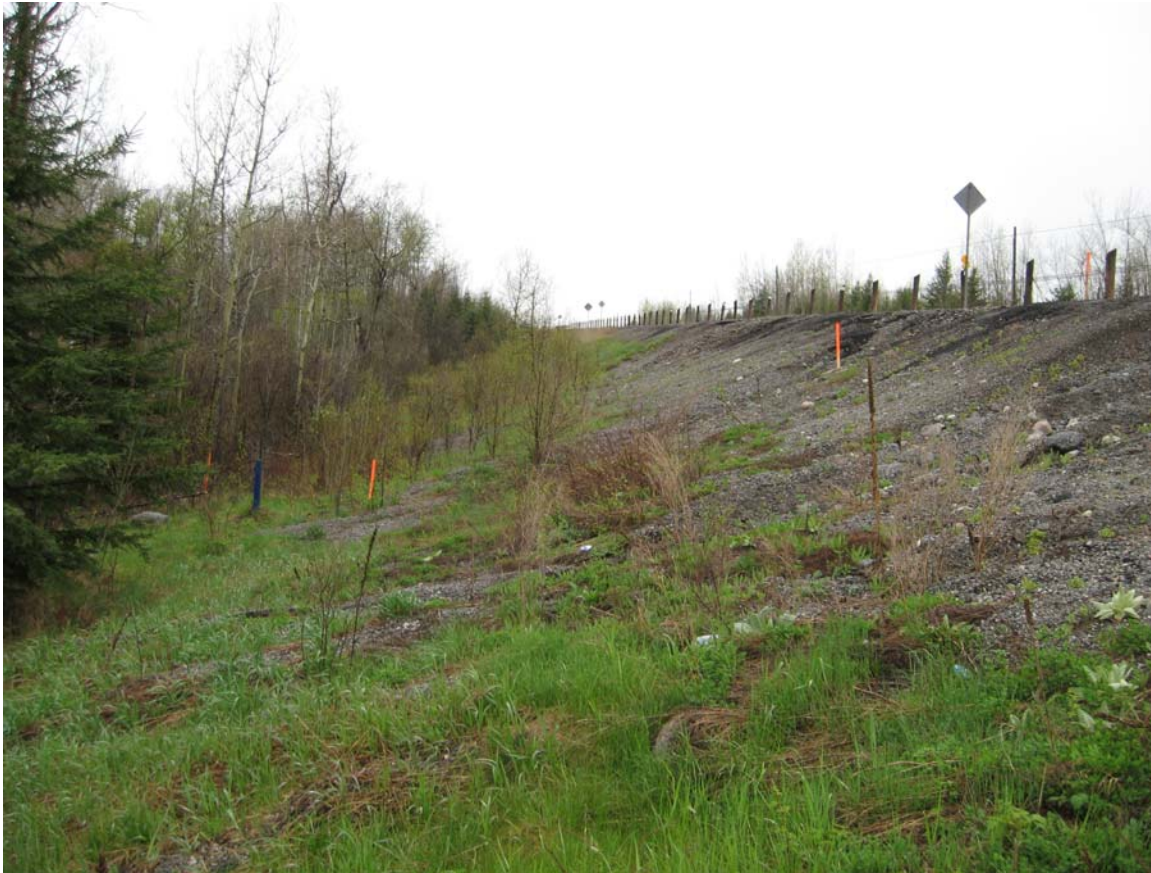
Highway 102 near station 13+500 May 30, 2008 Right Side Slope - Looking West

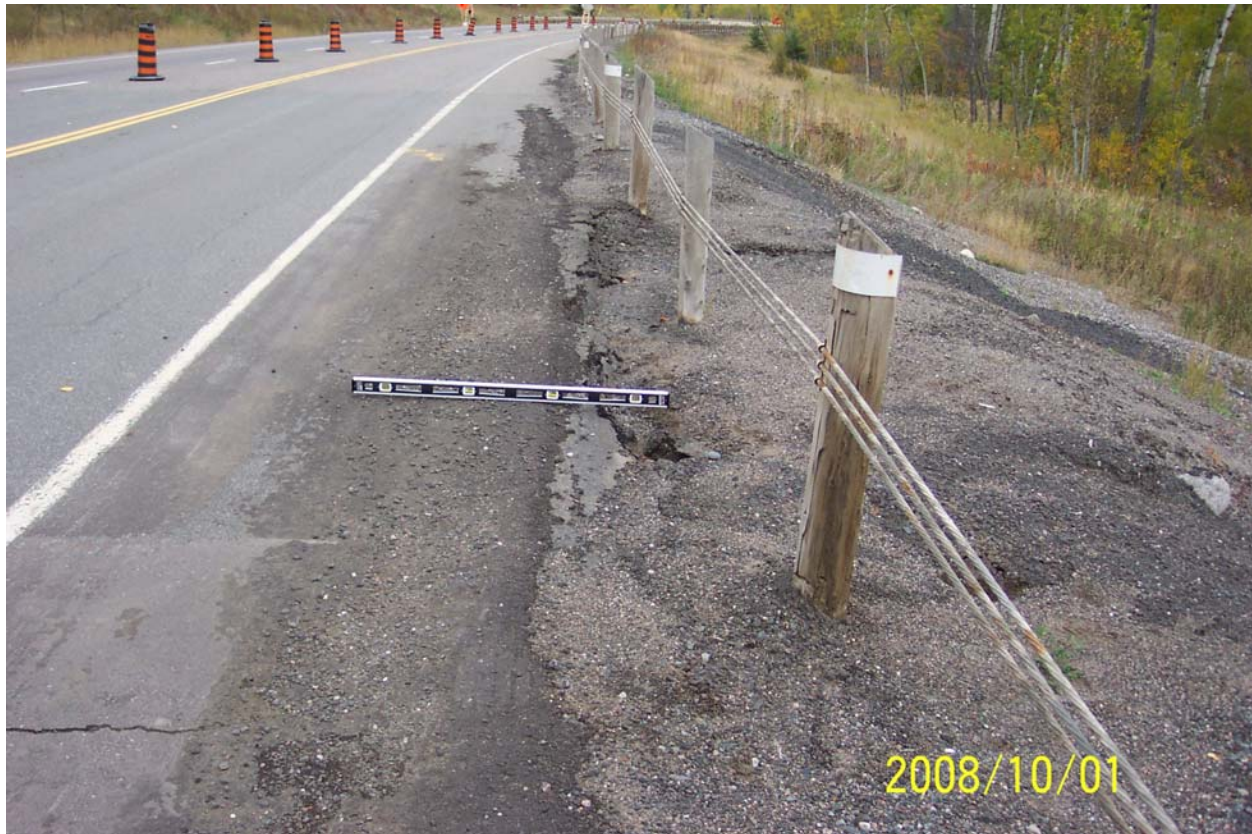
On October 1, 2008, a 180 mm vertical drop was observed at this site along the right side shoulder rounding. A heaving rain fall event occurred several days prior to this movement. Environment Canada reported that 68.8 mm of rainfall occurred on September 26, 2008 as recorded at the Thunder Bay Burwood weather station located approximately 28 km southeast of the subject site. The short term remedial action plan developed at that time involved removal of excess granular material from the south crest (followed by sealing) to lessen the total mass on the slope movement area. In addition, the north side ditch was to be cleaned out above the subdrain to ensure positive drainage and a shallow layer of Granular “A” (50-100 mm) was to be placed with granular sealing to reduce potential surface water infiltration.

Highway 102 near station 13+500 October 1, 2008, a 180 mm vertical drop at the Rt. shoulder

The main cause of embankment movement at its current state is due to a loss of strength within the clay foundation soils. The loss of strength can be attributed to a low level of stability and the strain softening characteristics of the clay foundation soils. Prior to embankment movements, the embankment had a relatively low level of stability which was likely further reduced due to fluctuating and high groundwater conditions within the embankment. Groundwater levels within the embankment may have been influenced by groundwater infiltration from via the north side

Option 3B is recommended. This involves removing a significant portion of the weakened foundation soils and replacement with granular fill. This option provides a sufficient level of stability and is considered to be the most cost effective.
