**Burford Creek Culvert Rehabilitation
Highway 94
Site No. 44-316
Station 11+652 - Township of North Himsworth
GWP 5090-06-00**

FINAL FOUNDATION INVESTIGATION AND DESIGN REPORT

Date: December 23, 2016
Ref. N^o: 16/02/16014-F3

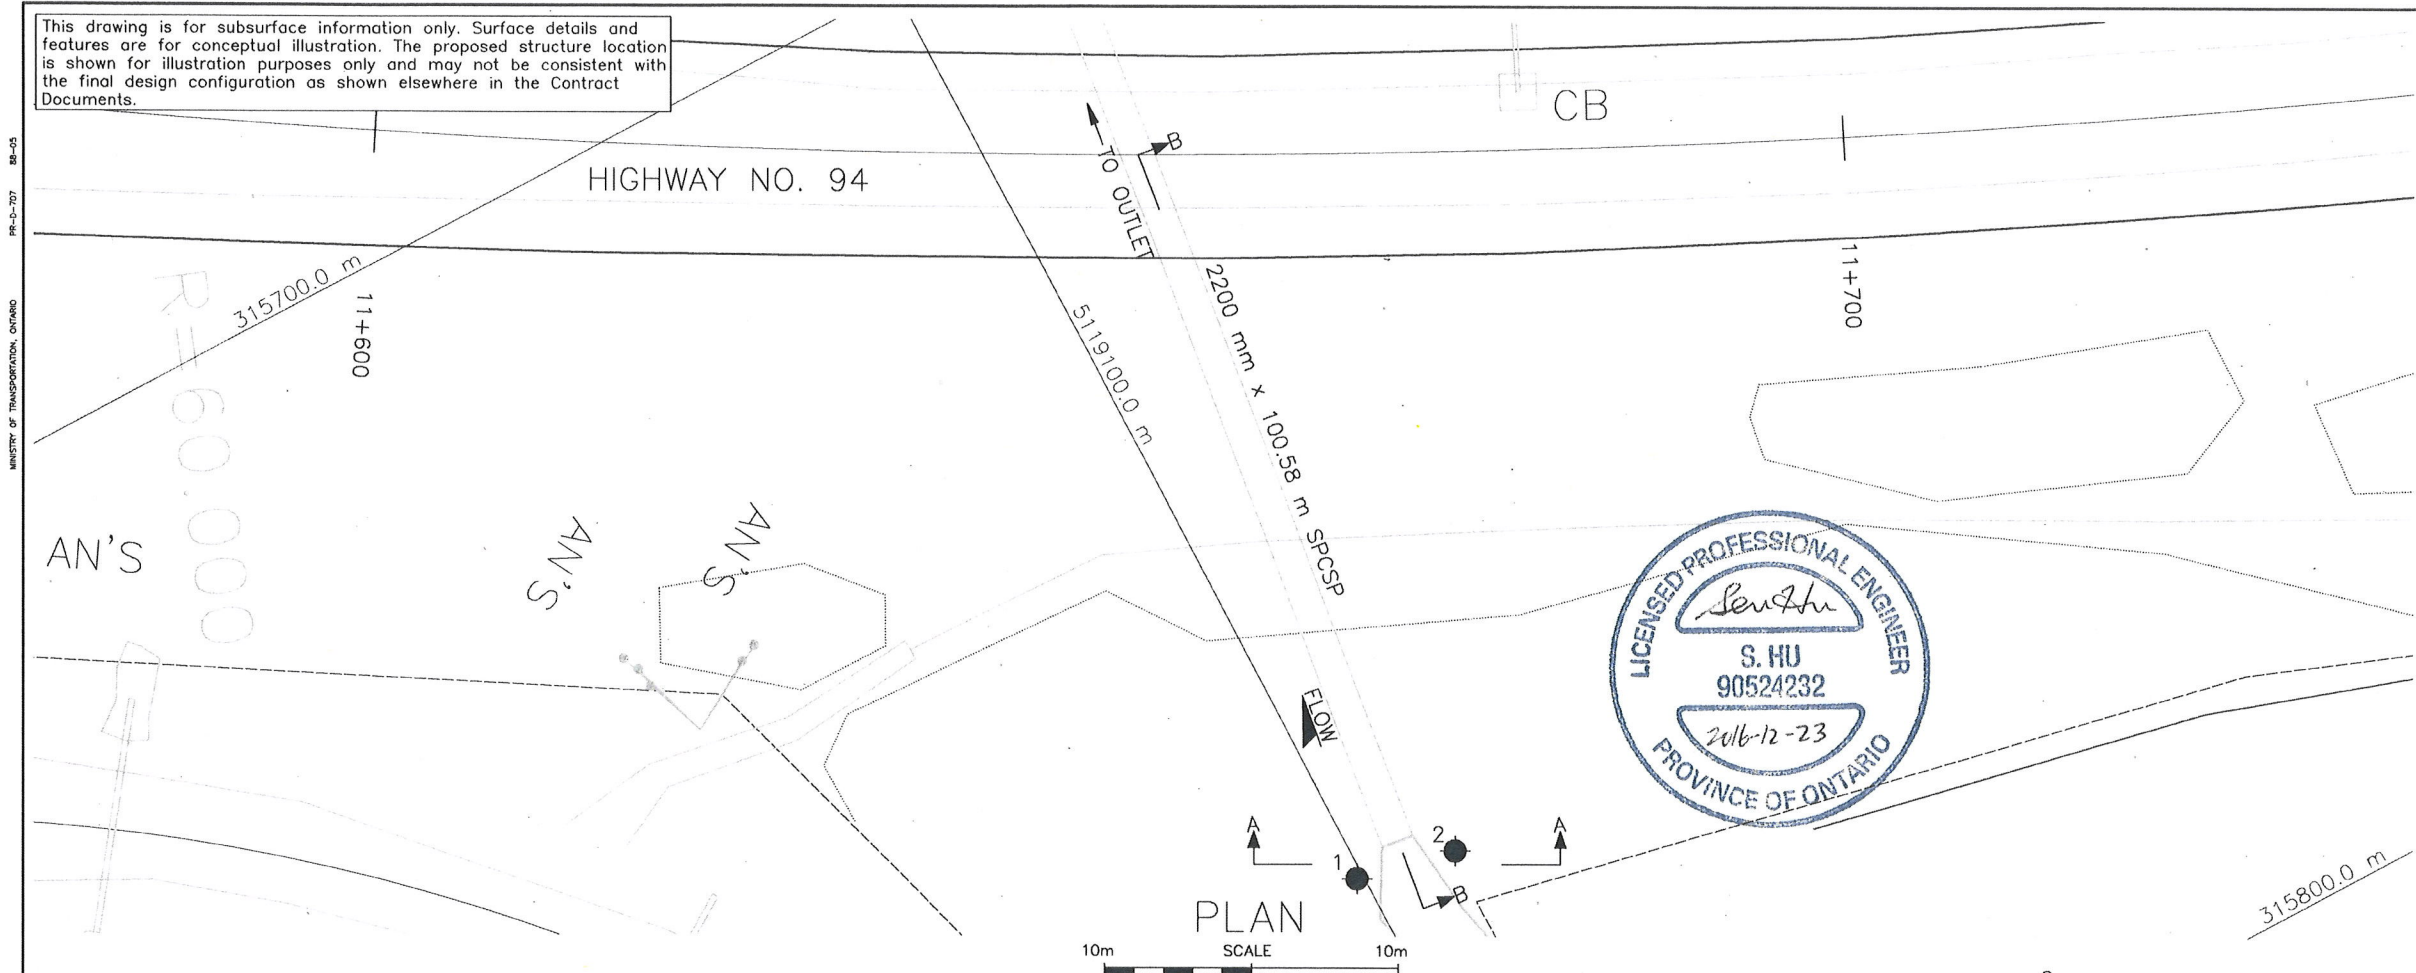
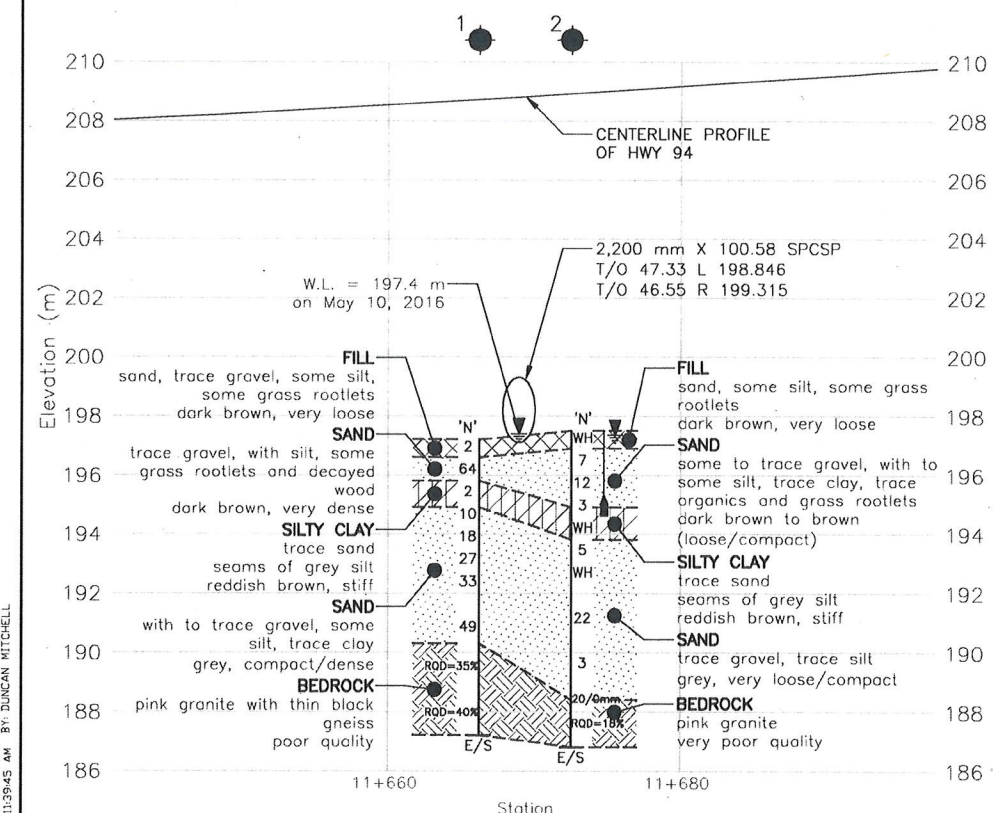
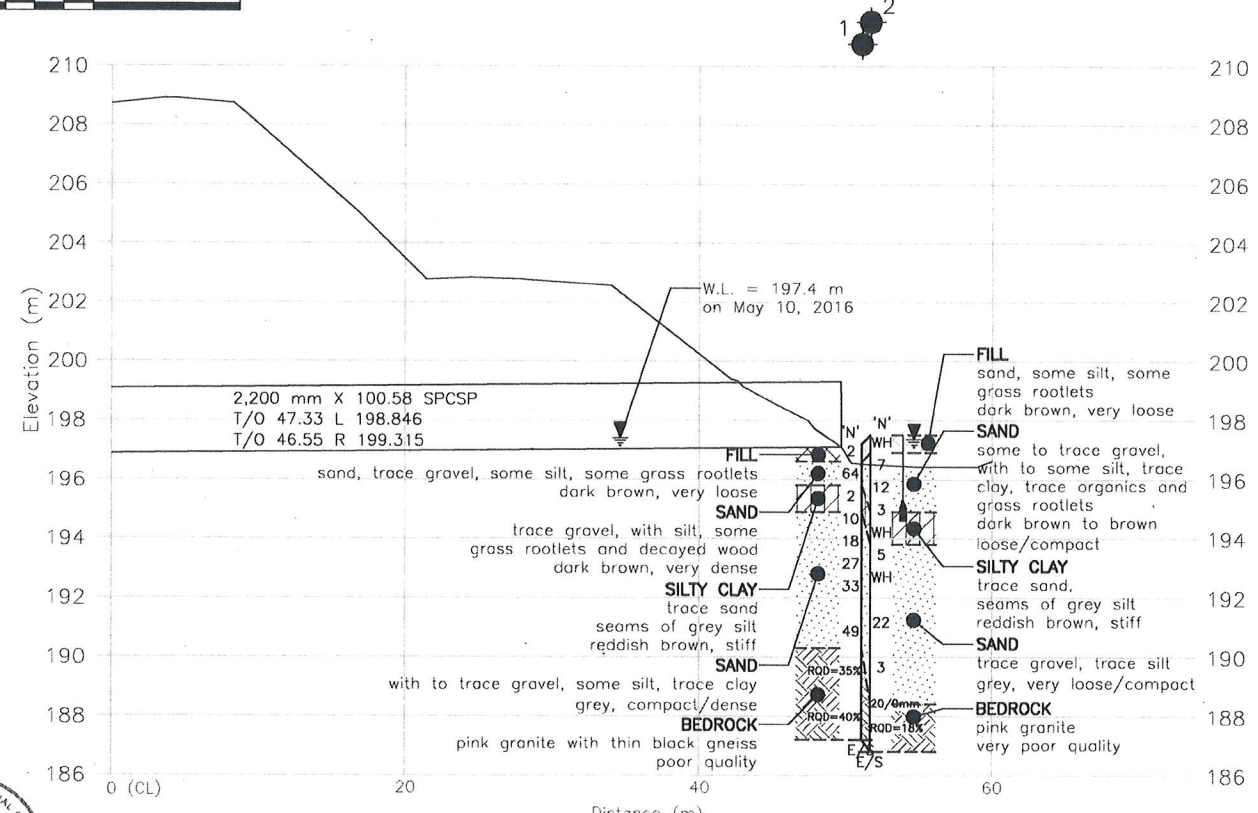
DISTRICT CONT. No. GWP No. 5090-06-00	DRAWING 2
HWY 94 CULVERT STA. 11+652 BURFORD CREEK	
BOREHOLE LOCATIONS AND SOIL STRATIGRAPHY

A plan and profile illustrating the borehole locations and stratigraphic sequences is shown on Drawing No. 2, Appendix 3. During the course of the exploration program, two (2) sampled boreholes were put down at this site, with Borehole Nos. 1 and 2 advanced adjacent to the culvert inlet. At the time of the subsurface investigation, the ground surface elevations at Boreholes Nos. 1 and 2 were recorded at Elevations 197.2 and 197.5 m, respectively.

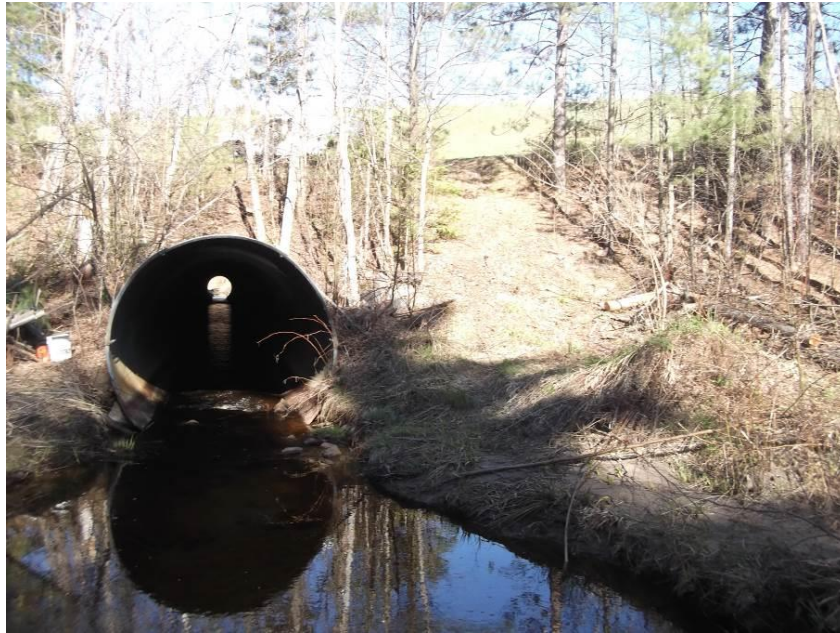
Photo: 1

The structure is presently in poor condition with severe corrosion of the invert and multiple cracks in the structural corrugated plates at the bolt connections. It is understood that, presently, it is proposed to rehabilitate the culvert by providing concrete reinforcement at the bottom of the culvert, installation of sheet pile cut off walls, and concrete lining of the barrel. This will likely require the placement of a cofferdam at the inlet. The purpose of this investigation was to determine the subsurface conditions in the area of the inlet relative to installation of a cofferdam.

Existing Culvert Inlet – Looking West

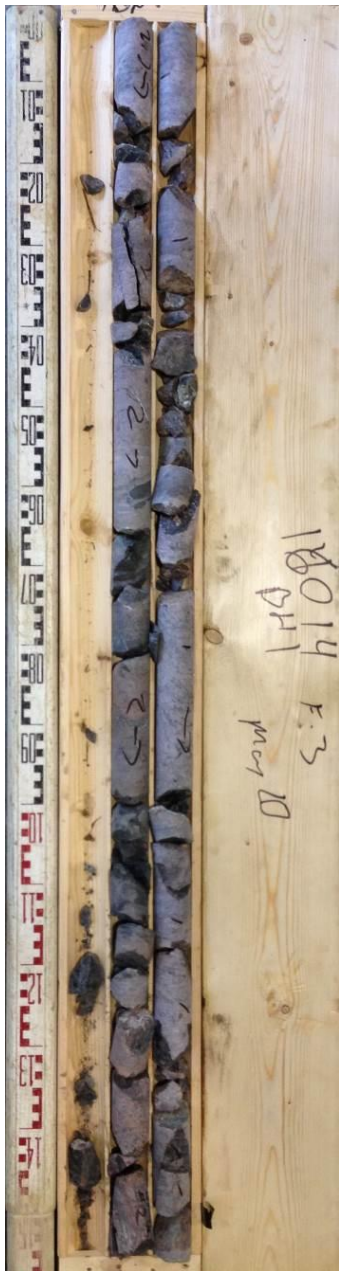
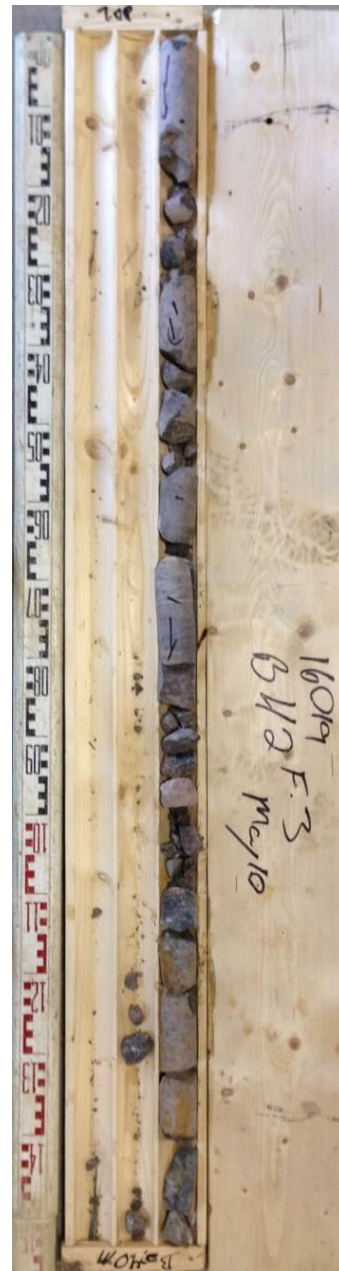
Photos: 2 and 3

Underlying the lower sand deposit at Borehole Nos. 1 and 2, bedrock was proven by diamond core drilling. The bedrock was described as pink granite. Based on RQD values of 18 to 40%, the bedrock was described as very poor to poor quality. Based on visual review, the bedrock generally showed negligible weathering. Sampling in the bedrock was terminated at depths of 10.0 and 10.7 m below grade at Borehole Nos. 1 and 2, respectively (Elevations 187.2 and 186.8 m, respectively). Photos of rock cores recovered at Borehole Nos. 1 and 2 are shown in Enclosure No. 4, Appendix 4. It should be noted that, when encountered, the underlying bedrock surfaces in this area can be very erratic in nature, varying substantially in elevation over short horizontal distances.

Rock Cores – Borehole 1 (left) and Borehole 2 (right)
