CREDIT RIVER VALLEY ROCK EXCAVATION CUT FOR CONSTRUCTION OF ACCESS ROAD

ROCK SLOPE HAZARD ASSESSMENT Contract 2011-2003

Report Number: 11-1117-0052

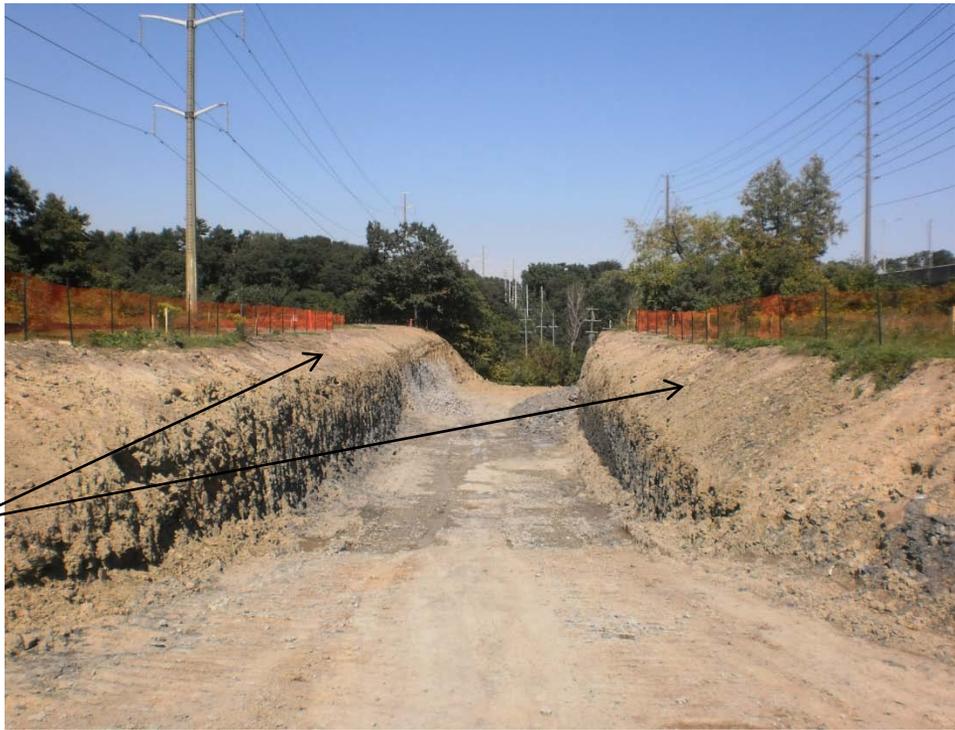
PLATE 1

Sloped
Overburden at
Crest of Cuts

View of Construction Access Road Looking East

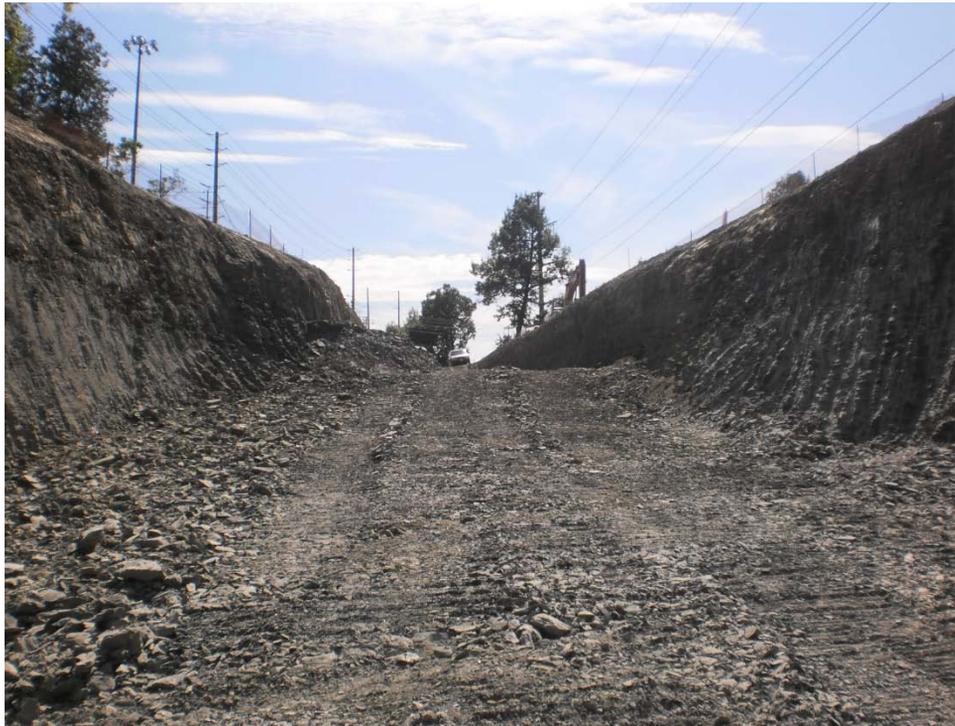
View of Construction Access Road Looking West

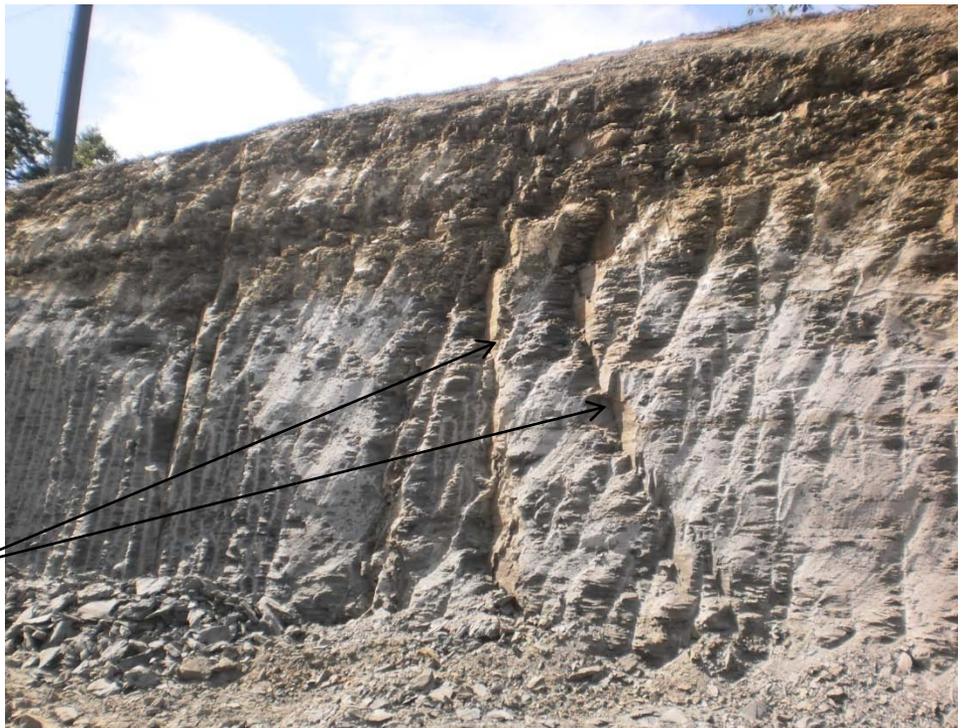
PLATE 2

Upper Weathered Zone
(1.5 m deep)

Prominent Near
Vertical Joint Set
Striking NW-SE

Typical Rock Cut Face Showing the Upper Weathered Zone at the Top of the Cut

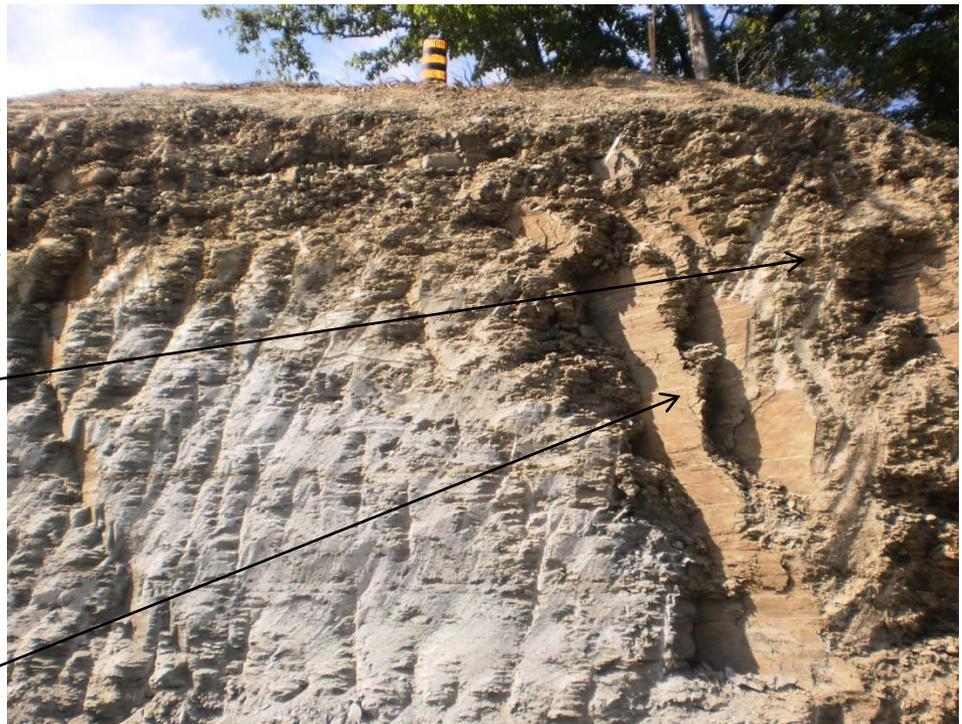
Upper Weathered Zone
(1.5 m deep)

Deeper Weathered
Zone Near the River Bank

Prominent Near
Vertical Joint Set
Striking NW-SE

View of the North Face Showing Prominent Joint Sets and Deeper Weathering Near the River Bank

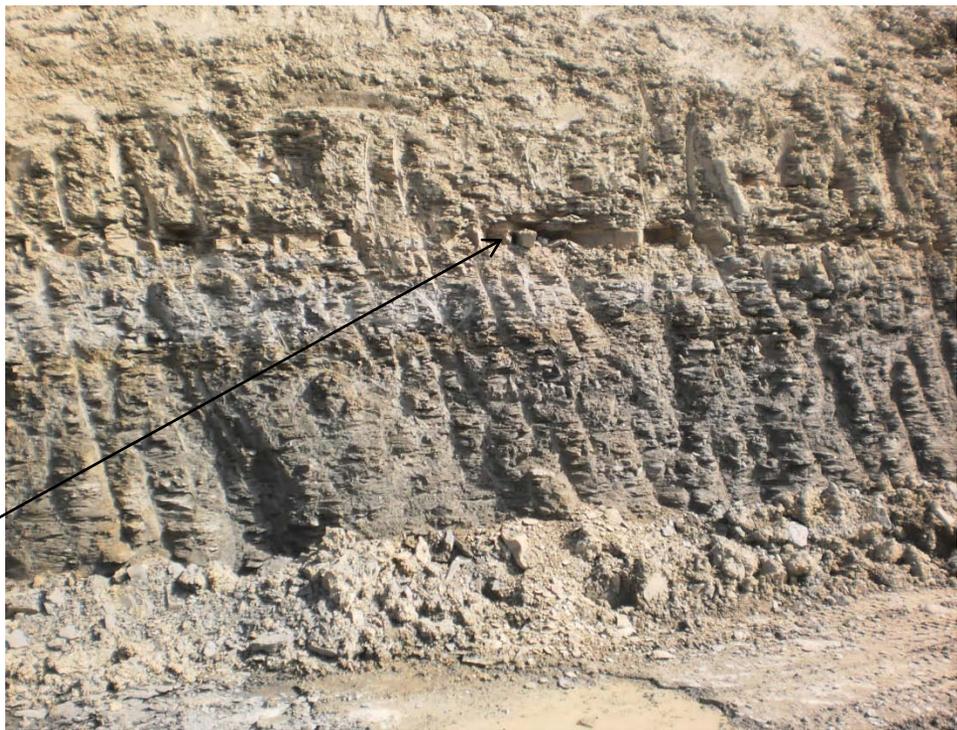
PLATE 3

Ongoing physical weathering processes (rain, ice, sun, freeze/thaw, and wind) will continue to degrade the rock faces over time. In general, weathering processes often exploit existing weaknesses in the rock mass such as fractures or joints, resulting in the break down of the rock mass which can eventually result in rock falls. The exposed rock faces in the shale are particularly susceptible to ice jacking due to freeze thaw in the winter months and wetting and drying cycles over the remainder of the year. Raveling in the shale generally results in small pieces of rock (up to about 0.1 m in size) falling from the face; however, the harder limestone/siltstone layers often result in small unstable blocks or slabs (up to approximately 0.2 m across and 0.1 m thick) on the face which eventually fall when the supporting shale below ravel and spalls.

Harder Layer
Resulting in Unstable
Slabs

Typical Cut Face Showing Ravelling Failures and Slabs in the Harder Interbedded Layers

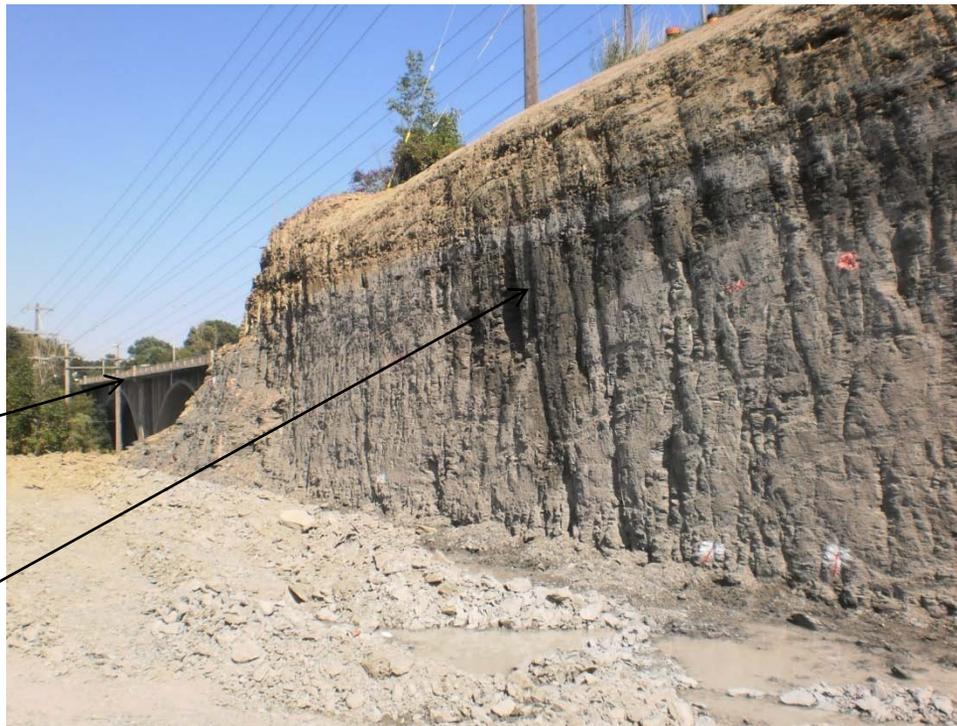
Groundwater seepage was noted along the south rock cut face at a number of locations (refer to Plate 3). The seepage appears to originate along a bedding plane joint located about 1.5 m to 2 m below the bedrock surface. The rock face was noted to be damp below the bedding plane at the time of the inspection; however, no running water was noted. No significant seepage was noted along the north rock cut face at the time of the inspection.

Seepage from
Bedding Plane and
Damp Rock Face
Below

View of South Rock Face Showing Groundwater Seepage

- There is a concern that groundwater seepage directed along the 300 mm wide drainage strips may freeze during the winter months and may cause the shotcrete covering the strips to crack and spall from the face. For this reason the drainage strips are not recommended, unless the Contractor can adequately address this issue in his design submissions. Drainholes on a regular pattern in accordance with SP299S08 (i.e. 3.0 m long, 25 mm minimum diameter drain holes at 3.0 m centres, inclined approximately 10 degrees above the horizontal and lined with slotted PVC pipe, conforming to ASTM D1784) are recommended. Drainholes (or drainage strips if accepted) should be laid out to intersect the bedding plane on the south rock face which is the source of the groundwater seepage,

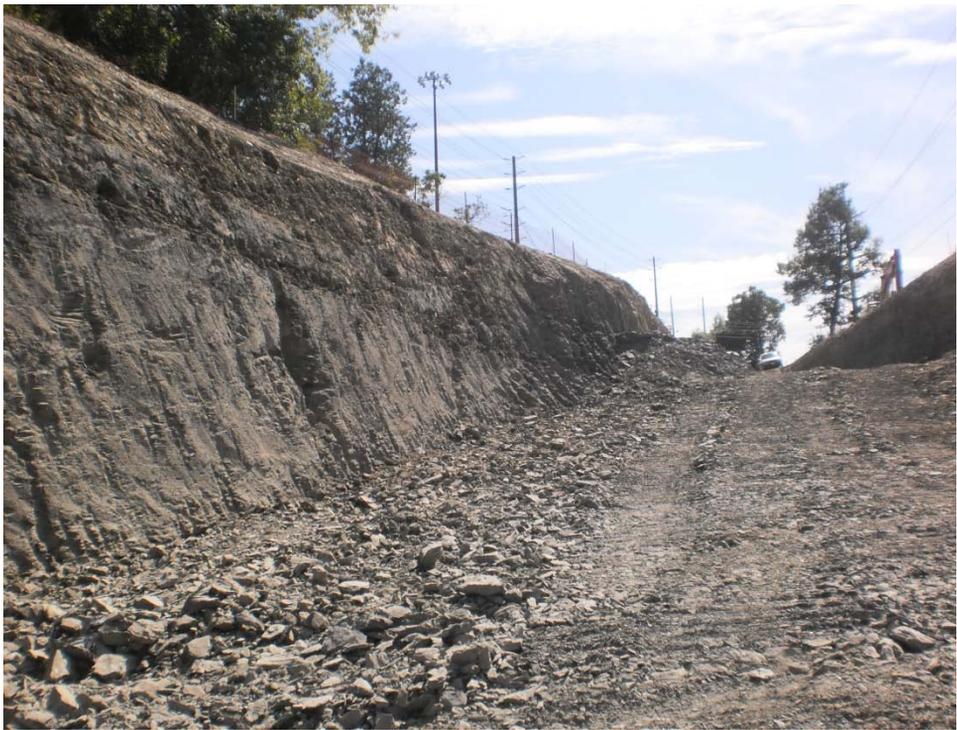
PLATE 4

View of South Rock Cut Looking West Showing Deep Weathered Zone

- The shotcrete thickness is in accordance with SP299S08 and is considered adequate,
- Given the rough and irregular nature of the rockface it will be difficult to contour the mesh closely to the face and as a result additional shotcrete thickness will be required in many areas in order to adequately cover the mesh,
- The rock bolts (diameter, length and spacing) are considered adequate. It is important that they are installed at 15 degrees downward as shown on the drawings in order to cross the bedding planes in the rock,
- Some longer rock bolts (up to 3 m long) may be required in areas of the south rock cut where the zone of weathered rock extends down about 3 m from the crest to within 2 m of the base of the rock cut (Plate 4). These bolts should be spaced at 1.8 m centre to centre,

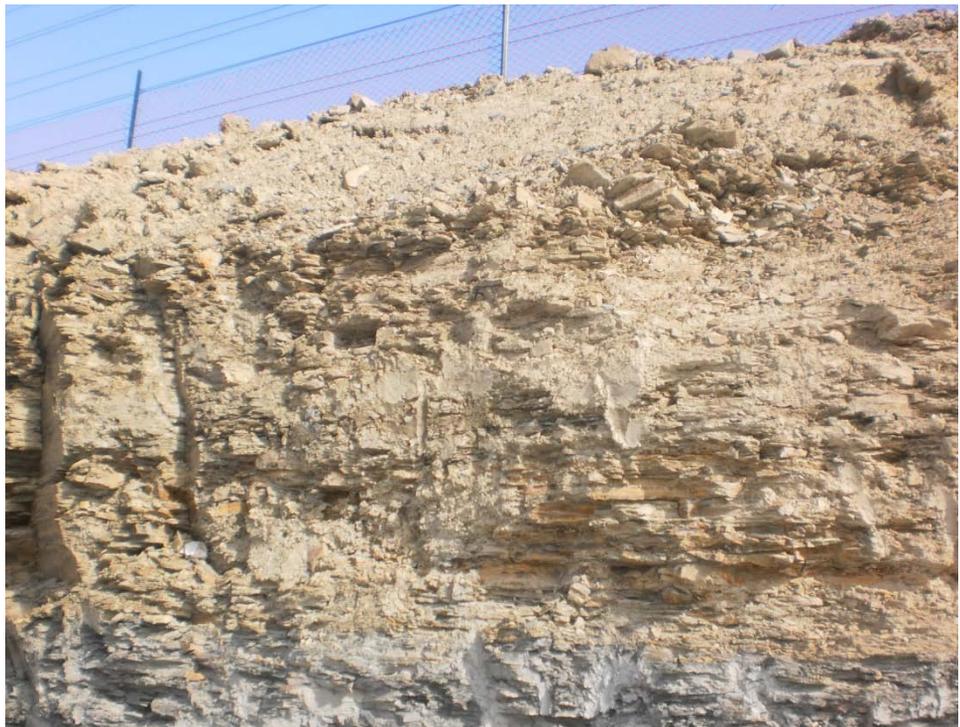
Deeper Weathered Zone on South Rock Cut
