**FOUNDATION INVESTIGATION AND DESIGN REPORT
REMEDIAL MEASURES FOR
SOUTH EMBANKMENT SLOPE INSTABILITIES
HIGHWAY 140/CNR OVERPASS
AGREEMENT No. 2013-E-0051
G.W.P. 2044-13-00, GEOCRES No. 30L14-58**

File No. 11-14-4076
January 09, 2015
Terraprobe Inc.

**REMEDIAL MEASURES FOR
SOUTH APPROACH EMBANKMENT SLOPE INSTABILITIES
HIGHWAY 140/CNR OVERPASS
PORT COLBORNE, ONTARIO
AGREEMENT No. 2013-E-0051, G.W.P. 2044-13-00
GEOCRES No. 30L14-58**

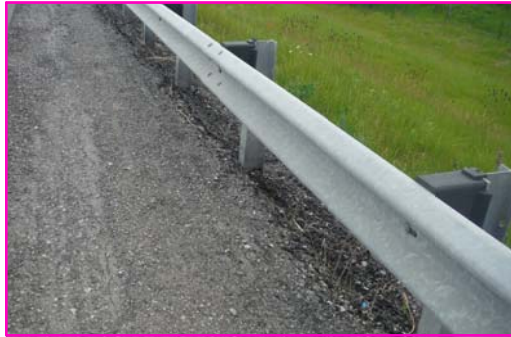
Crack along slope crest on the west side of Hwy 140 along south embankment looking south.

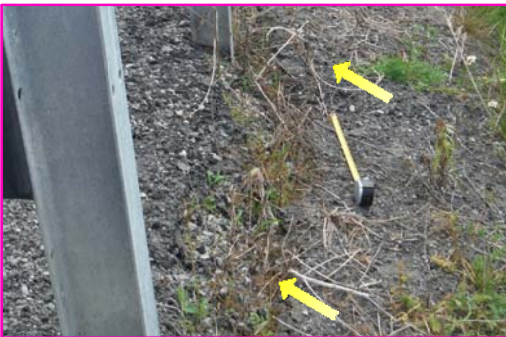
Close-up view of crack along slope crest on the west side of south embankment.

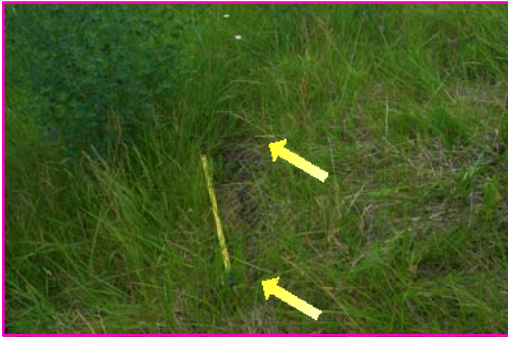
Cracks near the toe of mid-height berm on the west slope of south embankment.

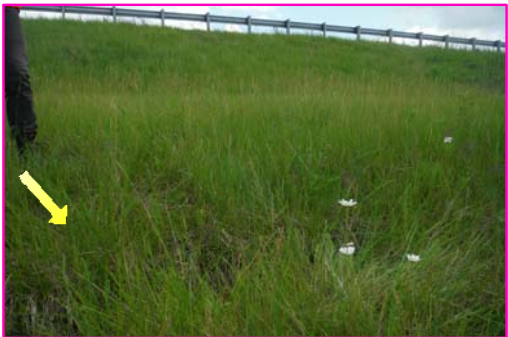
General view of mid-height berm showing crack location.

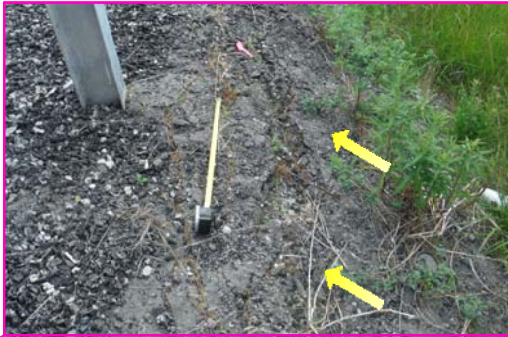
Crack along slope crest about 1 m west of guide rail on the west side of south embankment.

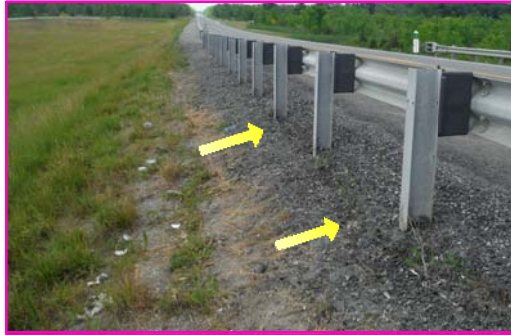
Crack along slope crest running parallel to and on the east side of the guide rail.

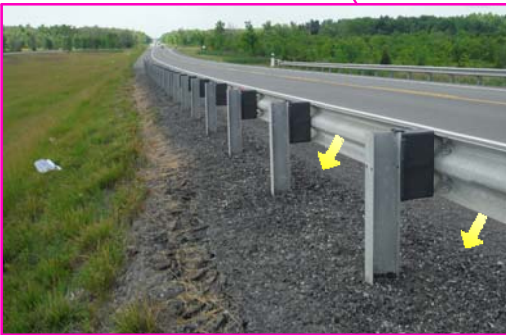
Crack along slope crest running parallel to and on the west side of the guide rail.

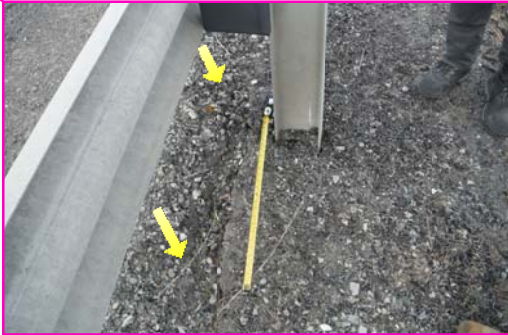
Close-up view of crack at the slope crest at approximately Sta. 15+375.

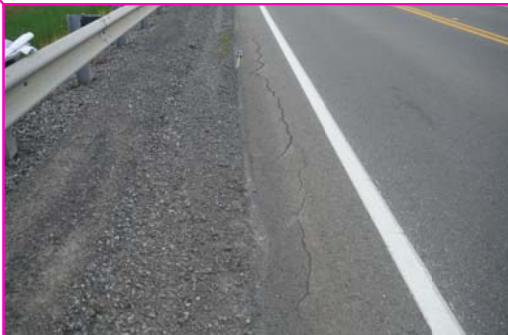
Crack on the partially paved shoulder on the east side of south embankment looking south, located about 1.5 m west of guide rail.

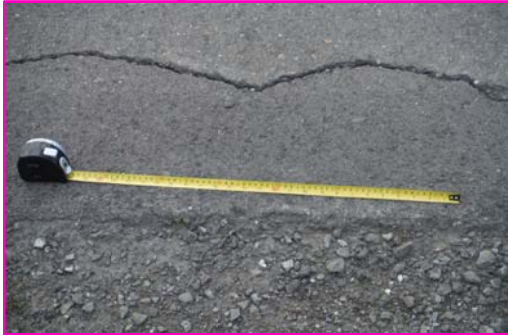
Closer view of crack on the partially paved shoulder on the east side of south embankment at approximately Sta. 15+470.

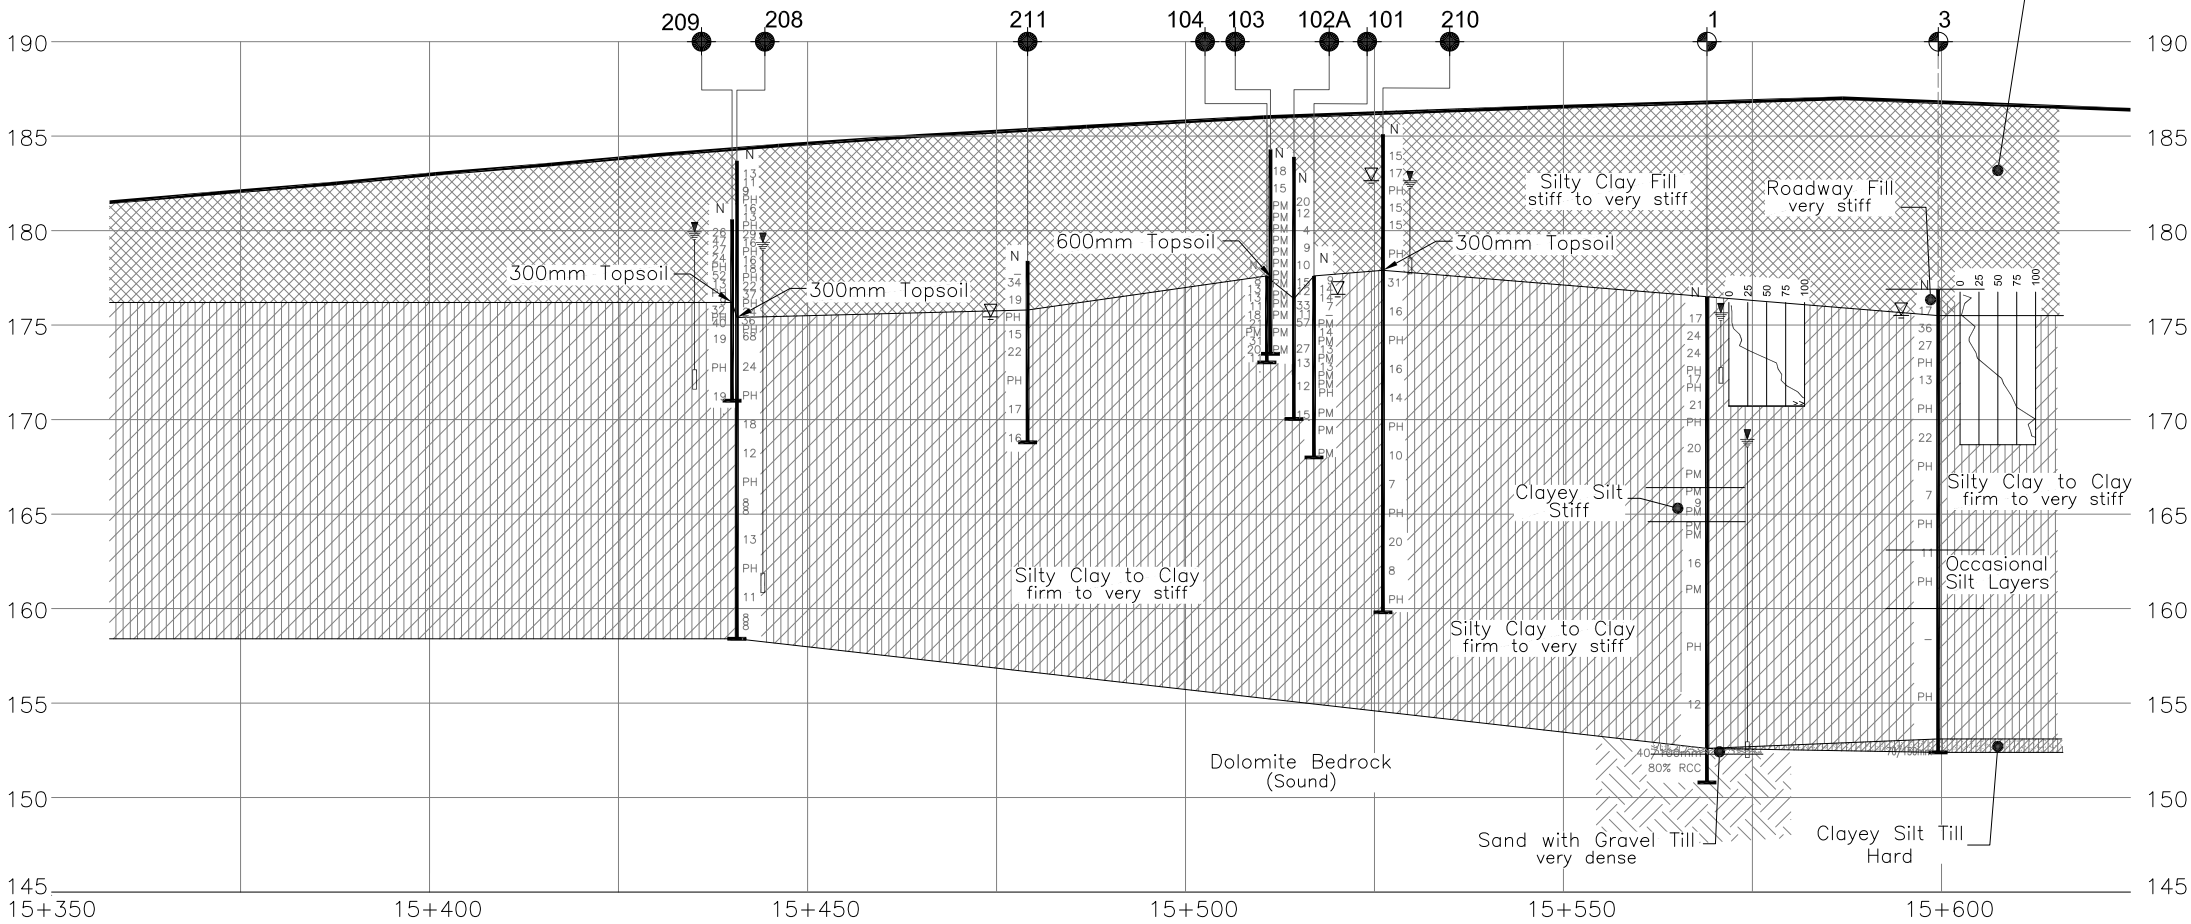
Refer to sheets 2 & 10 of Contract 98-116.
Embankment Repaired by benching with Granular A.
From Sta. 15+410 to Sta. 15+620 (East Slope)
From Sta. 15+500 to Sta. 15+615 (West Slope)
