DATE February 27, 2014**PROJECT No.** 12-1121-0193-1330**TO** Brad Craig, P.Eng.
Dillon Consulting Limited**FROM** Kevin Nelson, P.Eng.
Fin Heffernan, P.Eng.**EMAIL** Kevin_Nelson@golder.com
Fin_Heffernan@golder.com

**PRELIMINARY FOUNDATION INVESTIGATION (DESKTOP STUDY)
REHABILITATION OF NORTHUMBERLAND ROAD 26 UNDERPASS AT HIGHWAY 401
NORTH OF BRIGHTON, ONTARIO
W.P. 4051-11-01
GEOCRES 31C-224**

PART A – PRELIMINARY FOUNDATION INVESTIGATION (DESKTOP STUDY)

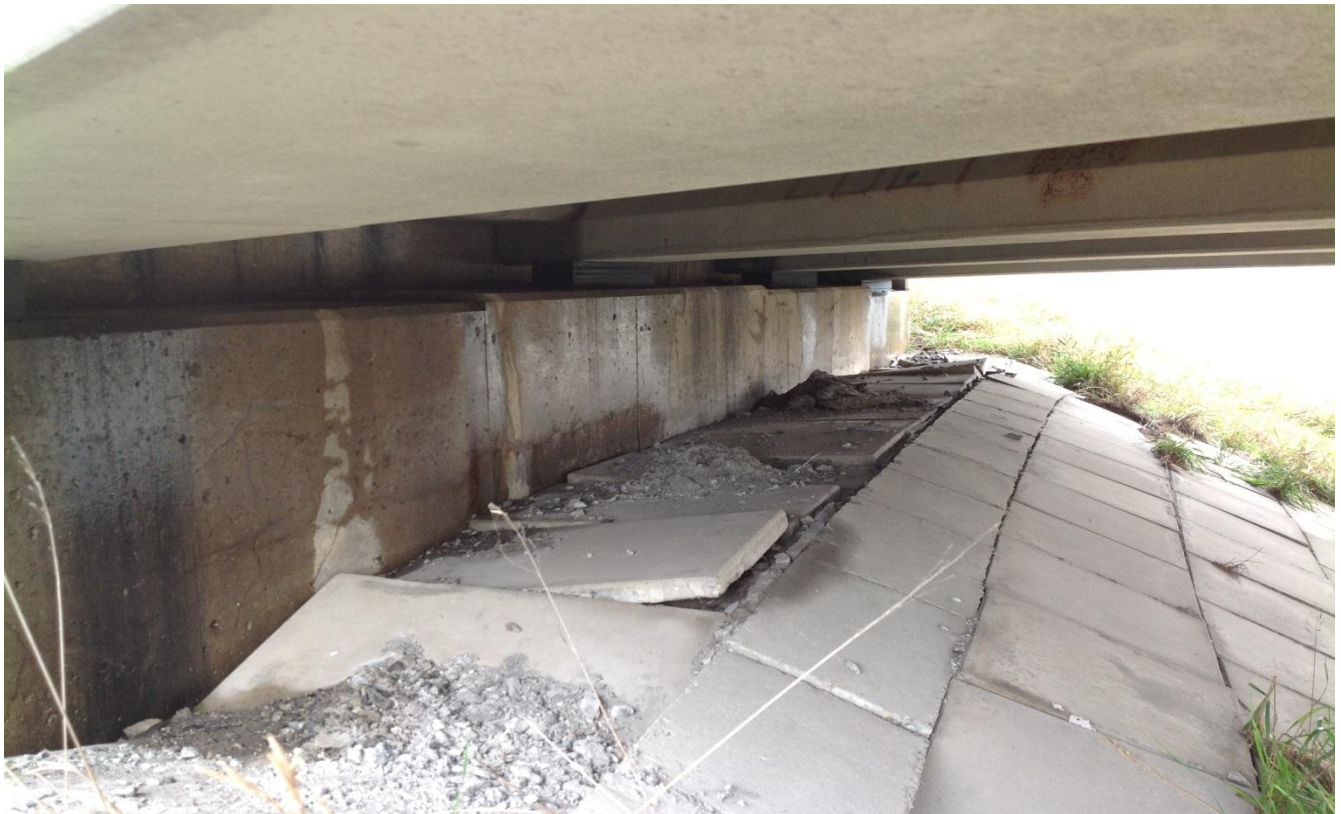
Significant movement of, and damage to, the concrete slope paving erosion protection (e.g., buckling of slab panels, broken panels present at toe of slope, settlement and potential loss of ground beneath the panels near the south abutment etc.) present on the slope faces beneath the bridge abutments was noted during the site visit. In addition, gaps/voids were noted beneath the panels near the front edges of the abutments suggesting that some material may have been lost in these areas; this may have been a result of localized excavations as there were small piles of soil above some of the panels in this area as shown in the photo below.

Deformation of the existing concrete embankment slope face protection panels, including buckling, sliding and cracking, was noted during the site reconnaissance. In addition, gaps beneath the panels near the front edges of the abutments suggest that some material appears to have been lost in this area; these gaps may have been a result of excavations in these areas.

Ongoing deterioration of the slope face protection could eventually impact the performance of the perched abutment footings. Therefore, it is recommended that slope protection measures be reinstated; the new slope face protection should be designed and constructed in accordance with the details provided on MTO Standard Drawing SS116-10 (Details of Concrete Slope Paving).
