## FOUNDATION INVESTIGATION AND DESIGN REPORT

**STABILIZATION OF HIGHWAY 71 EMBANKMENT AT  
KAKABIKITCIWAN LAKE, NESTOR FALLS, ONTARIO  
ASSIGNMENT 6011-E-0039  
WORK ORDER NUMBER 2013-11005**

**GEOCRES NO.:** 52F-40

**Report Number:** 12-1191-0005/2100

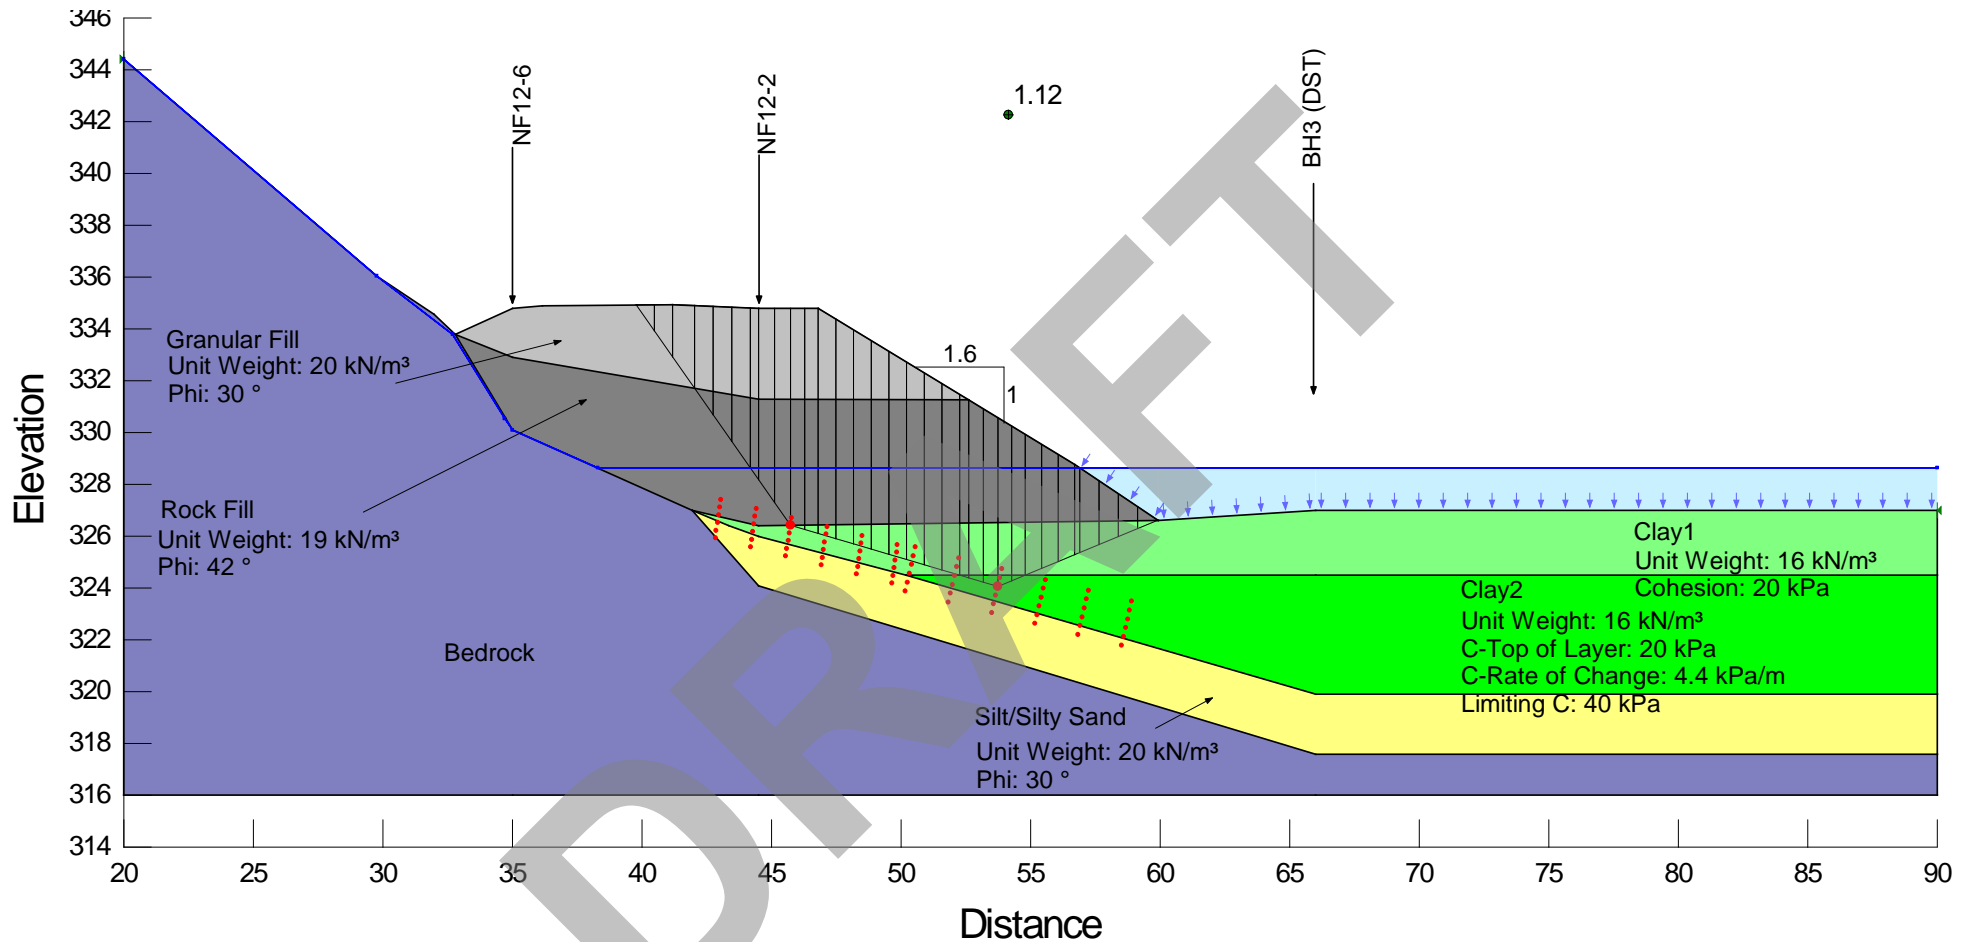
Figure 2A

Since the movement of the embankment has been ongoing over approximately the last 60 years, but a catastrophic failure has not occurred, the calculated FoS of slightly above 1.0 for the chosen parameters, model stratigraphy and slope geometry "makes sense" and it is considered realistic since the failure mechanism is likely a slow creeping movement.

FoS = 1.12

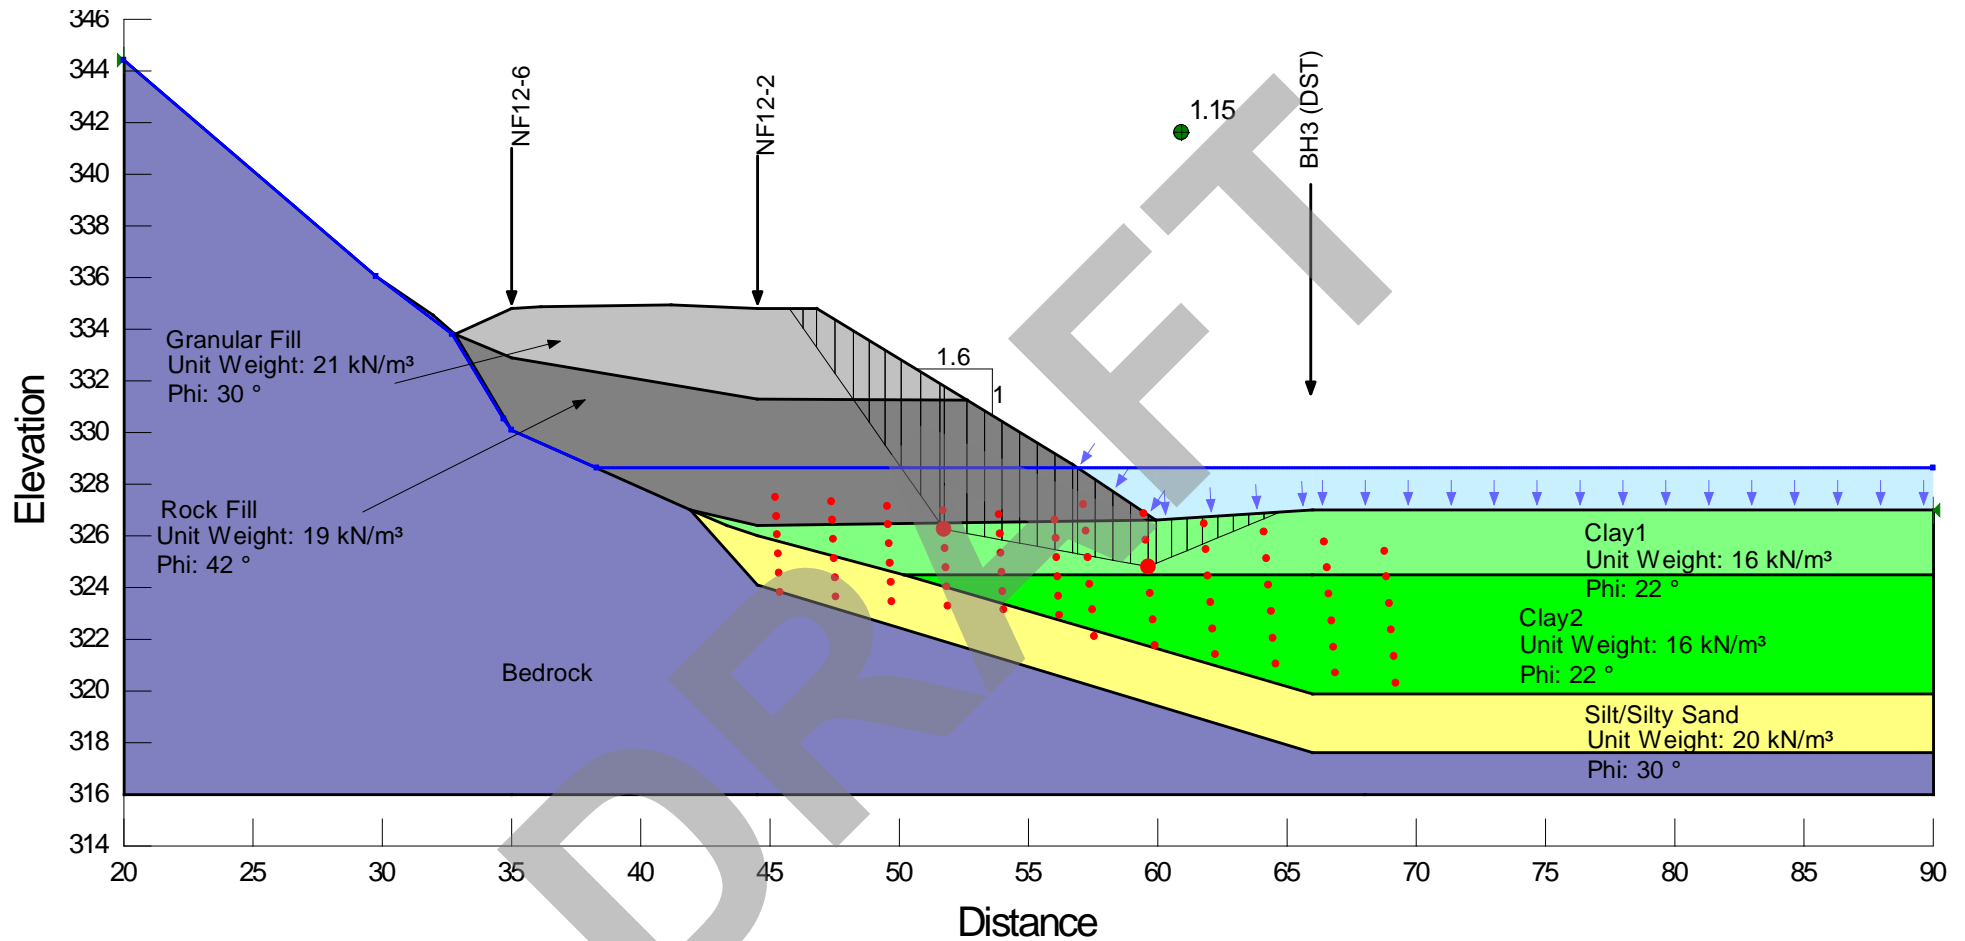
Figure 2B

FoS = 1.15

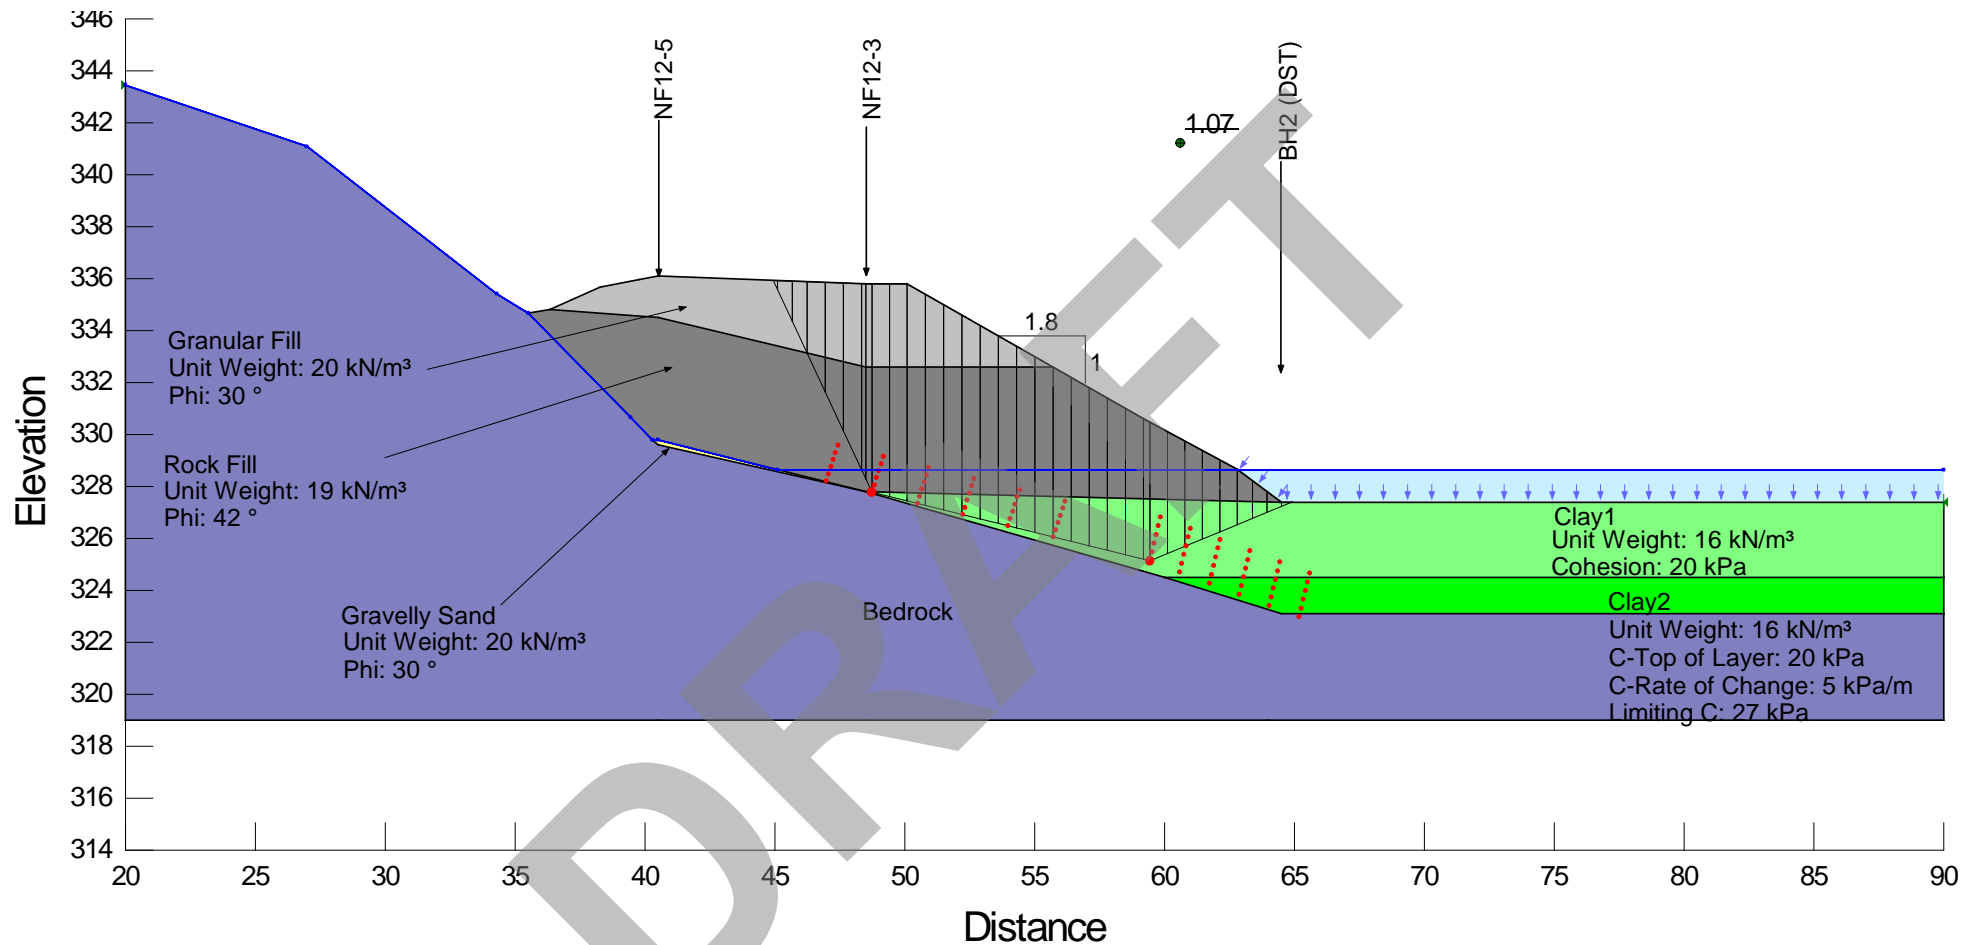
Figure 3A

FoS = 1.07

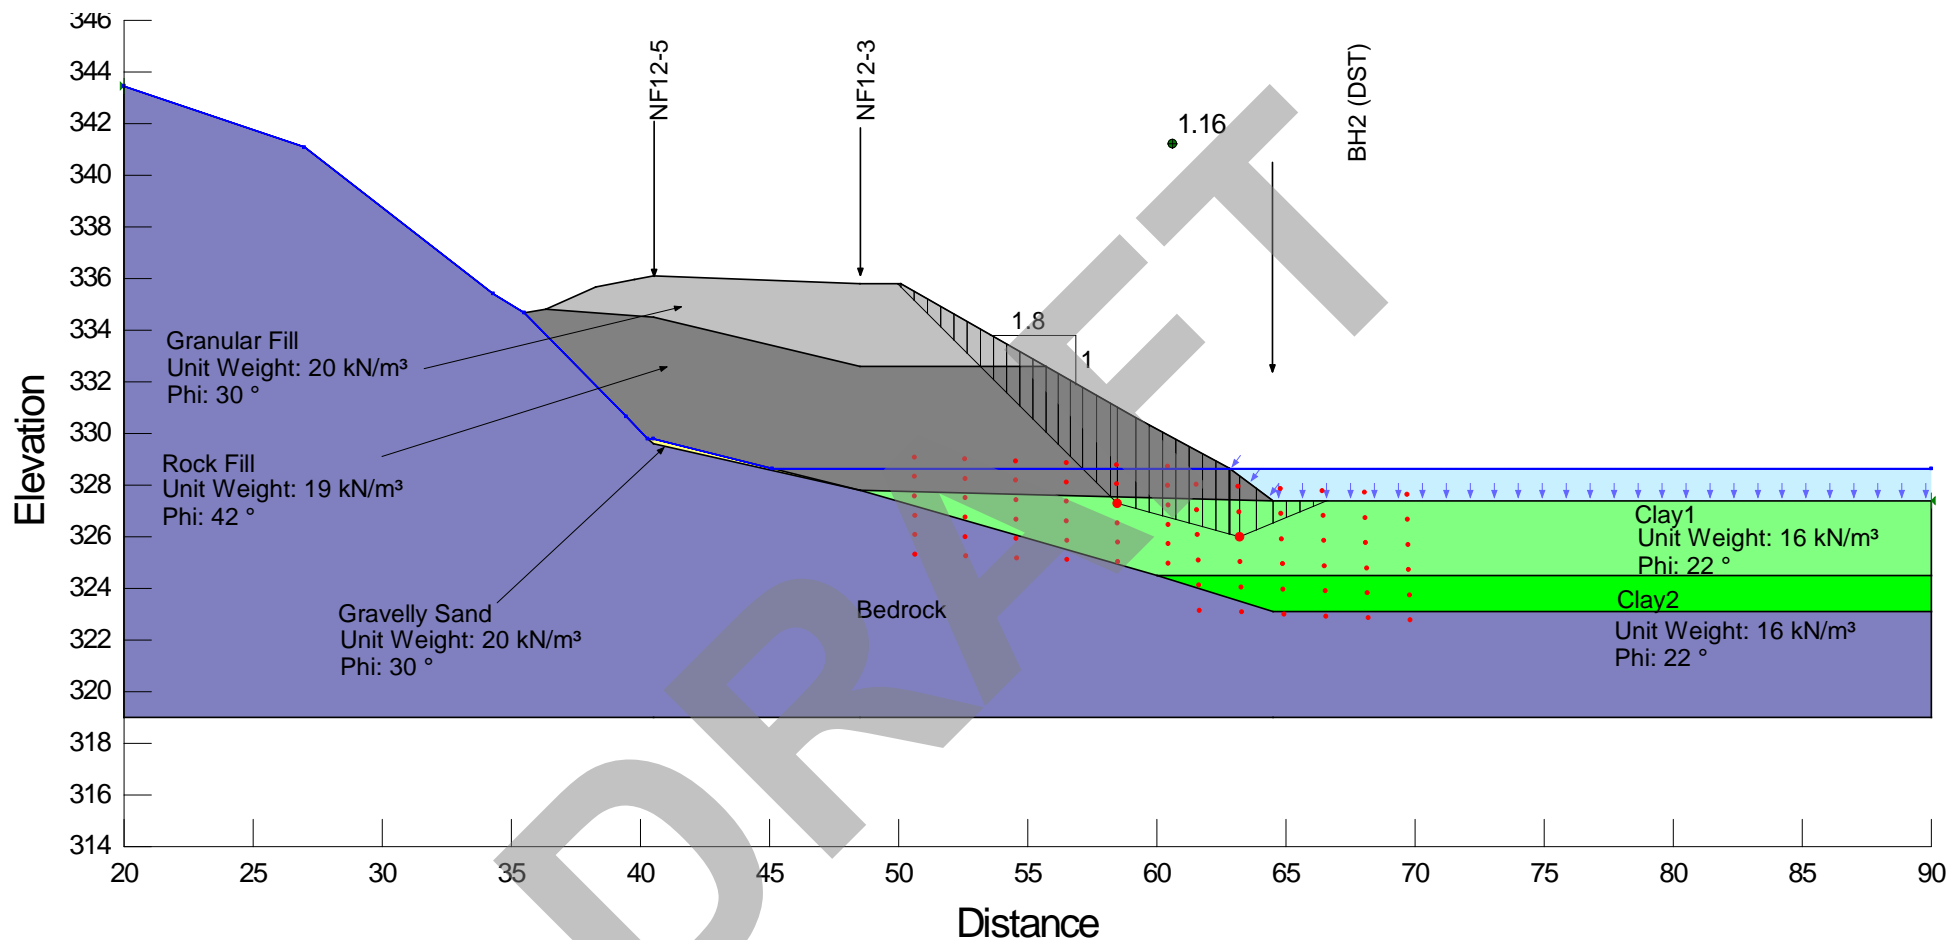
Figure 3B

FoS = 1.16

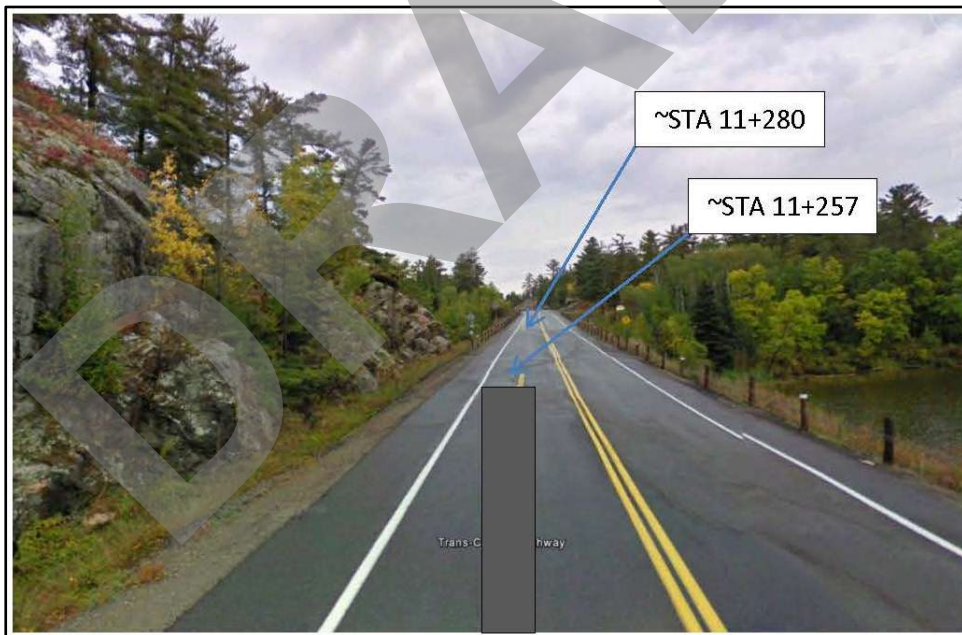
Photo 2: Embankment distress section looking north (courtesy of Google - 2009).

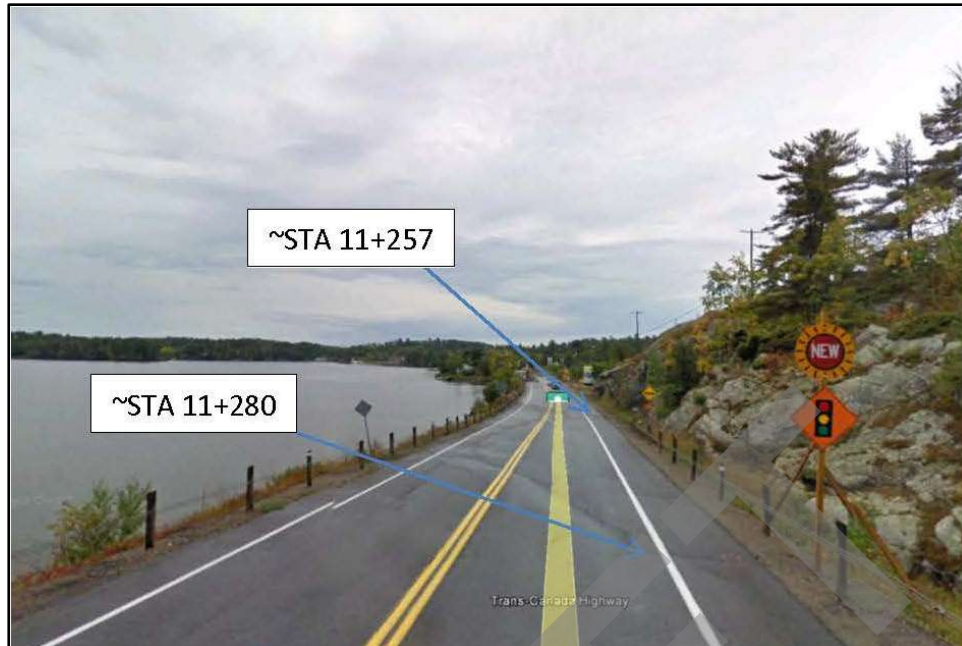
Photo 3: Embankment distress section looking south (courtesy of Google – 2009)

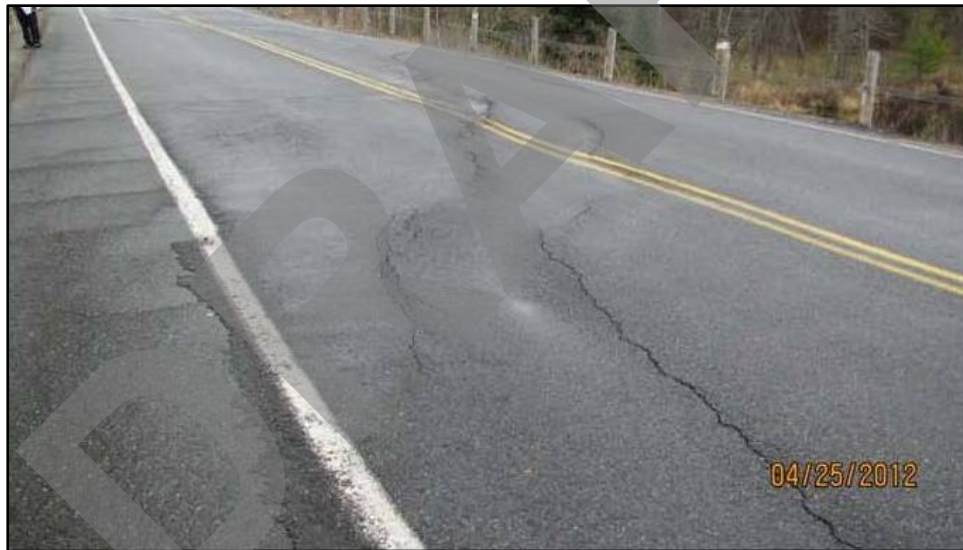
Photo 4: Cracking April 2012 (provided by MTO).

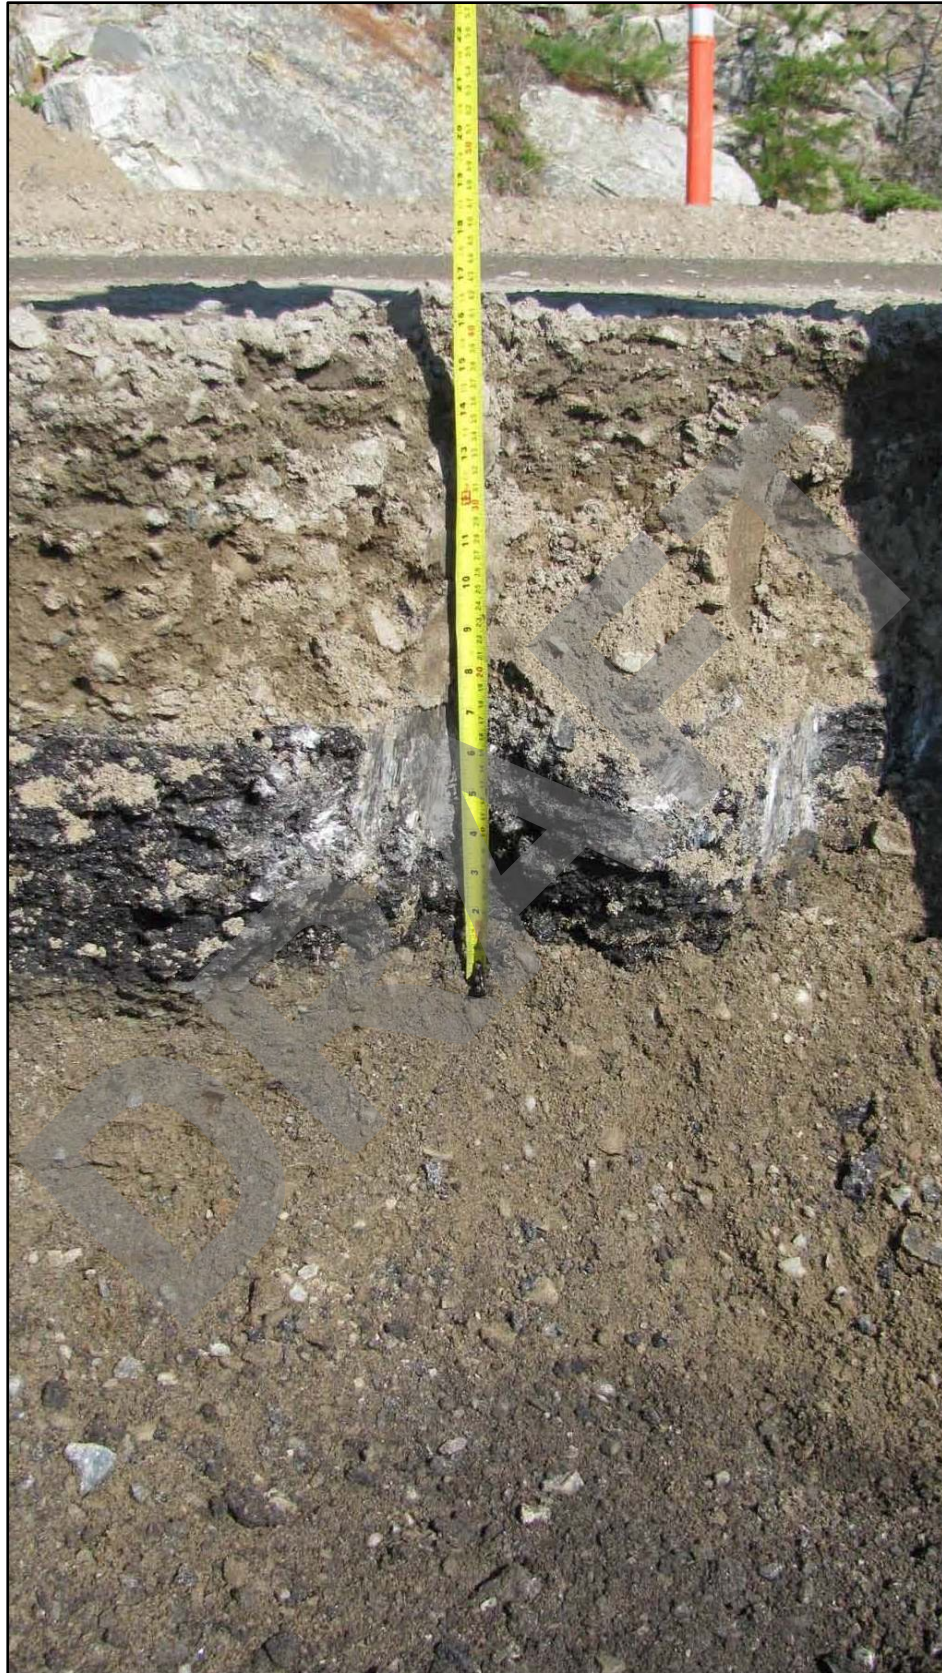
Photo 5: Pavement repair – note eight inches (200 mm) of fill over previous asphalt pavement (June 2012 by MTO).

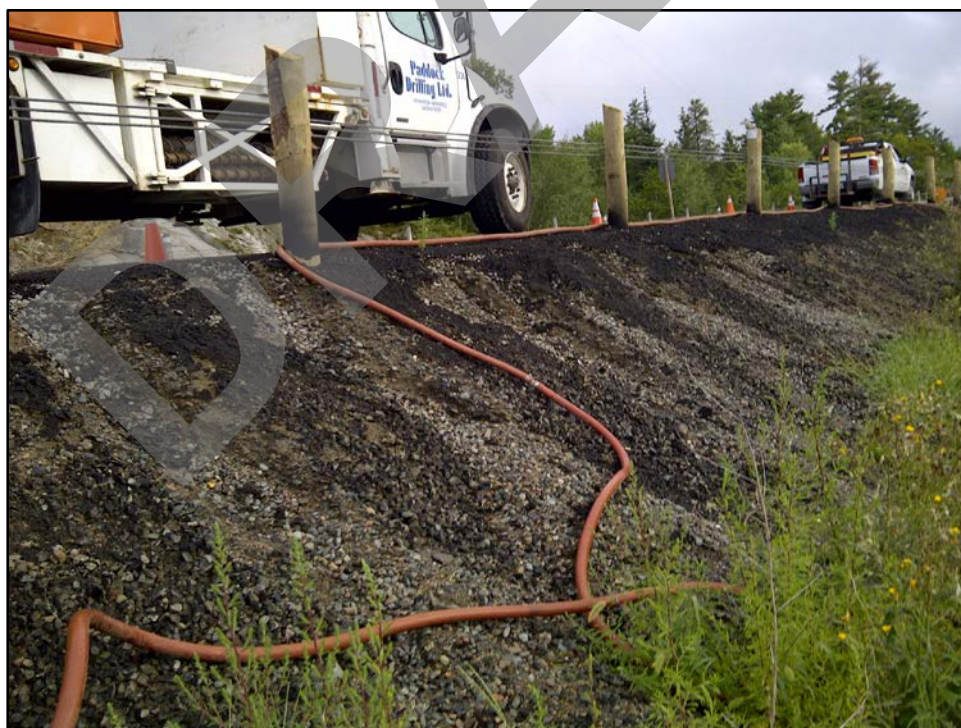
Another potential contributing factor to distress, albeit less likely than other factors, is the observation of the evidence of erosion of the east side slope in the upper granular fill material, as well as the presence of large rock fill fragments observed on the surface of the slope and encountered during the borehole drilling, suggesting that the portion of the embankment comprised of rock fill contains large sizes of rock and voids between the rock pieces. Further, the core recovery within the rock fill, ranging from 0 per cent to 50 per cent in places, suggests that there are voids within the rock fill mass that may or may not be filled with granular fill material. Therefore, it is possible that a portion of the ongoing movement could be attributed to infiltration or migration of fines from the overlying granular fill into the rock fill voids. However, the location of the cracking, as manifested at the top of the embankment/pavement, and the ongoing nature of the cracking (over many years) are not consistent with loss of fines as a contributing factor to the instability.

Photo 7: Erosion of East slope by surface water runoff (August 2012).

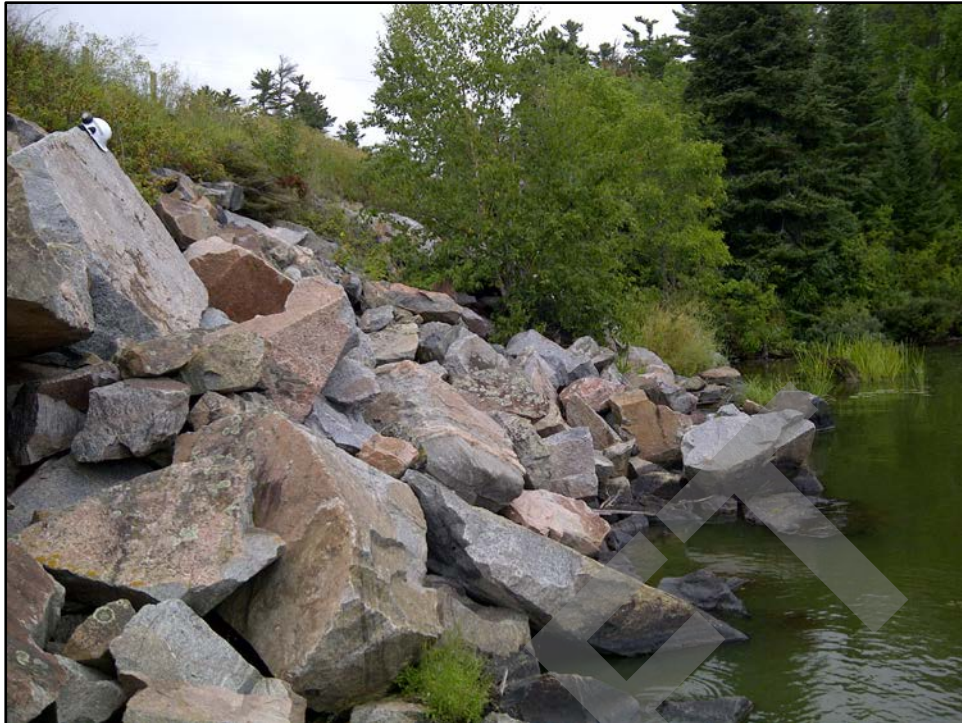
Photo 8: Large rock fill along toe of east slope (August 2012).

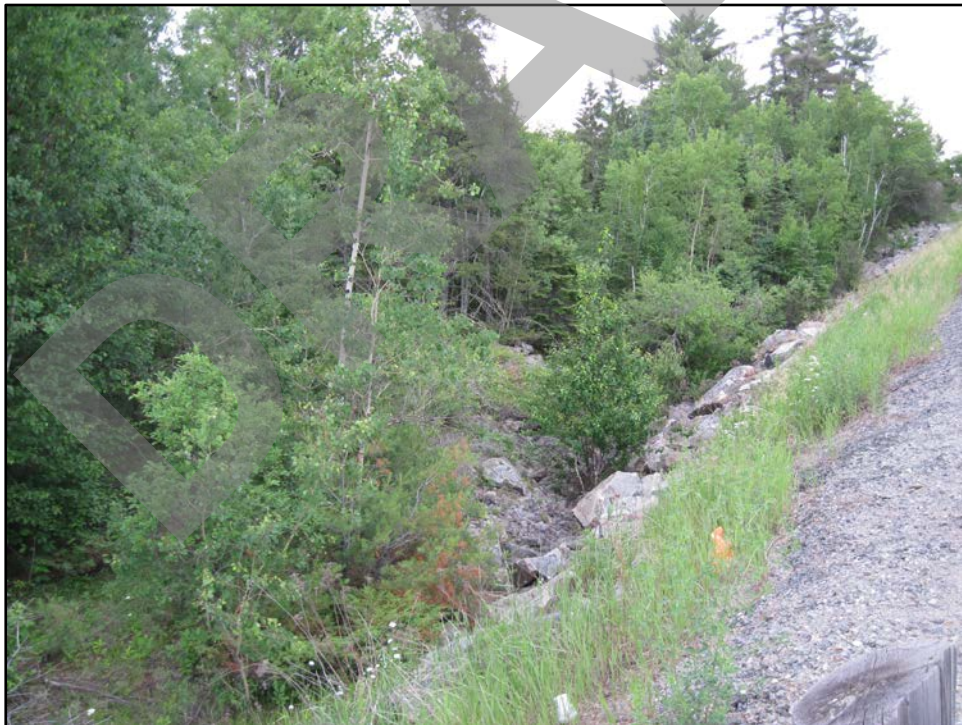
The presence of a topographic low area (i.e. “valley” or “ditch”) to the northwest of the roadway section exhibiting distress may be a contributing condition to the roadway instability albeit it is not considered to be the major contributing factor to the instability based on the observed deformation at the top of the embankment. Since the adjacent lake water level does not fluctuate appreciably, it is possible that during periods of precipitation, the water level in the “valley/ditch” rises and drains through the embankment, possibly along the base of rock fill and interface with the clay deposit, where it is present. We understand that there are no recorded measurements of the magnitude of vertical or lateral movement of this roadway section nor is there any information on the rate of movement, or if the rate of movement varies during lake water level fluctuations or rainfall events. Observations and actual measurements over time coupled with anecdotal observations of how the northwest “valley” and ditch system is functioning during storm events, could help in narrowing down the cause(s) of the local distress.

Photo 9: Valley adjacent to west toe of embankment looking north.
