FOUNDATION INVESTIGATION AND DESIGN REPORT

Culvert Rehabilitation, Site No. 19-669/C
Station 23+000, Highway 402
Contract 3 Structure Replacements and Rehabilitation
GWP 3045-11-00
Ministry of Transportation, West Region

Report Number: 12-1132-0163-3000-R02

FOUNDATION INVESTIGATION AND DESIGN REPORT CULVERT REHABILITATION, SITE 19-669/C, HIGHWAY 402

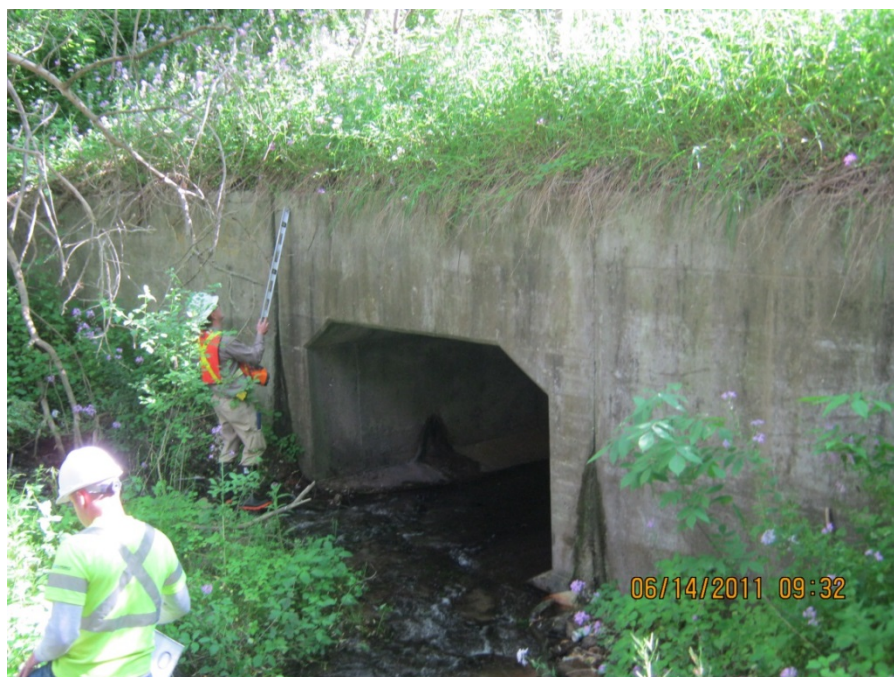
Photograph 1: East elevation (inlet) of Culvert Site 19-669/C. (Courtesy MTO)

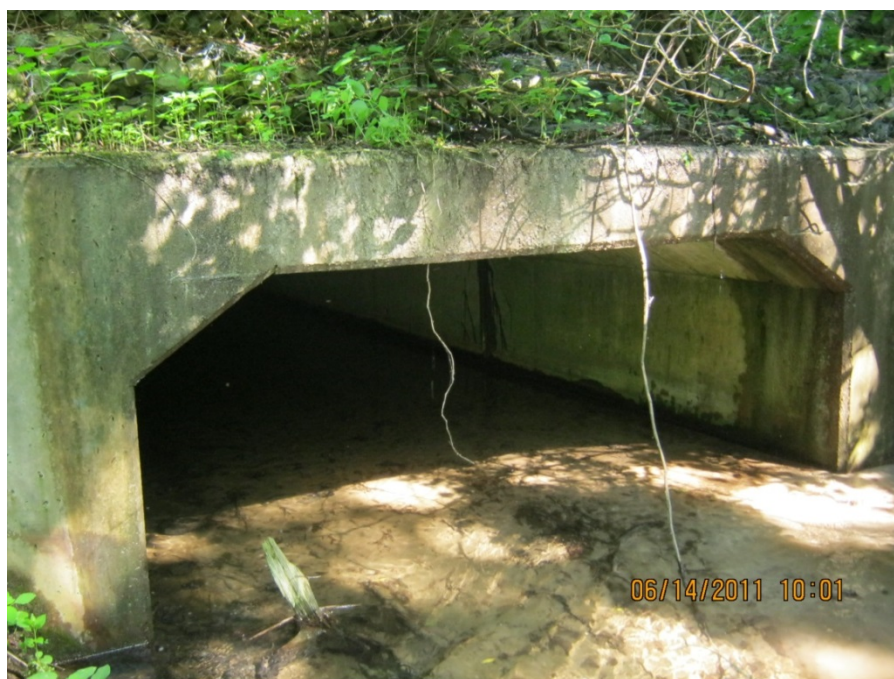
Photograph 2: West elevation (outlet). (Courtesy MTO)

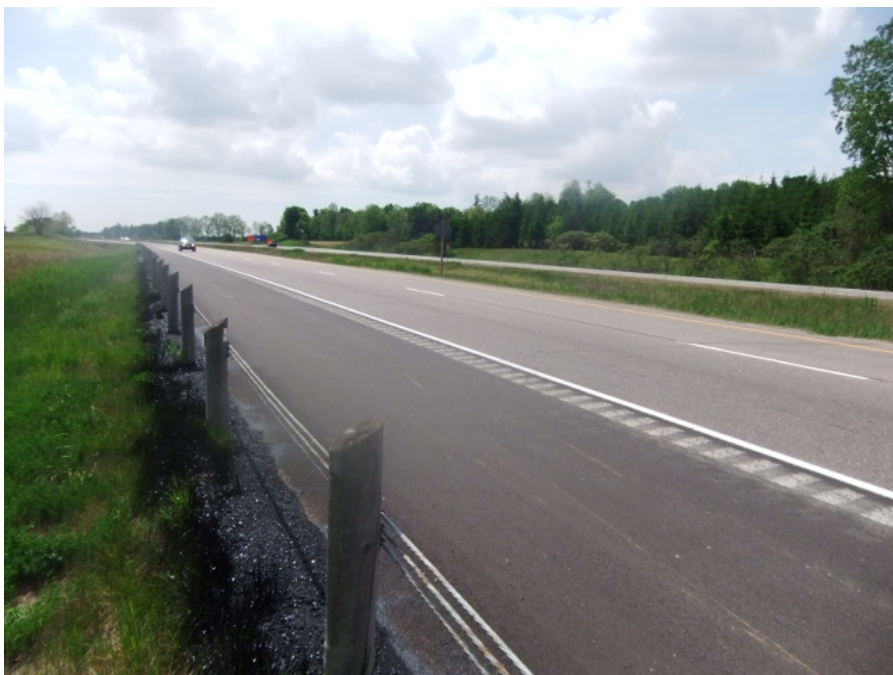
Photograph 3: Westbound Lanes of Highway 402 looking south from Culvert Site 19-669/C.

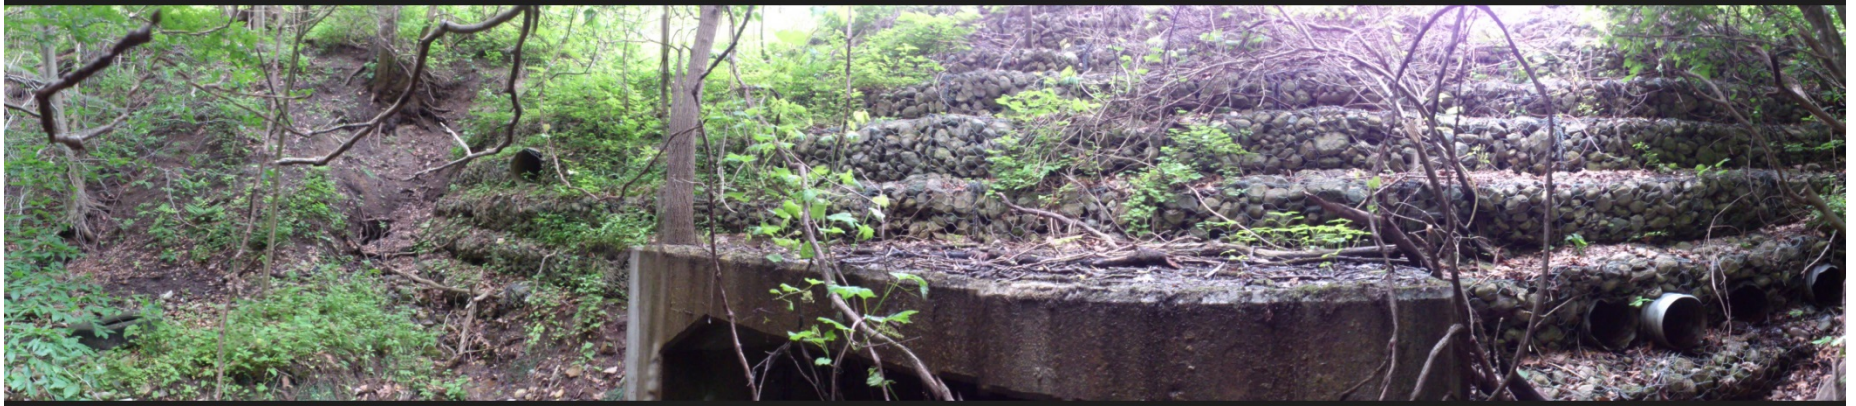
The gabions were found to be in relatively good condition. Rusted and broken wires and minor deformations of the wall, typically in the form of bulging and sagging of the baskets above the culvert, were observed. The gabion wall was covered with small shrubs and some woody vegetation has established within the gabions, most notably to the left of the box culvert as shown in Photograph 5. No voids within the baskets were noted; however voids may be present which were either not visible at the exposed surface of the gabion baskets or were obscured by vegetation. No evidence of gabion wall instability was noted; however an erosion channel relatively bare of vegetation was observed along the embankment slope to the left of the gabion wall (see Photographs 4 and 6). This area may also be used as a deer trail since footprints and droppings were observed and a deer was trying to approach the waterway during the site visit. A small sinkhole or possible animal burrow was observed behind the wall at the southwest corner of the wall. Approximately 3 metres vertically above the wall was a larger sinkhole containing a near-vertical CSP (see Photographs 7 and 8). The approximate observed locations of the sink holes are shown in plan on Drawing 1. With the exception of these sinkholes, no subsidence was observed along the top of the gabion wall. Although evidence of scour was observed at the outlet on the left side of the culvert near the toe of the embankment slope (see Photograph 9), the channel is stable downstream of the box culvert (see Photograph 10).

Golder Associates has assessed the gabion retaining wall as stable based on the visual assessment only. The minor deformations of the wall are attributed to settlement or movement of the gabion fill material due to corrosion of the basket wires. A computational stability check of the gabion wall was not carried out since the exact configuration of the gabion baskets was not known and design or as-built drawings are not available. However, a global stability analysis of the slope and gabion system was carried out using SLOPE/W Version 7.23, a limiting equilibrium slope stability software produced by GEO-SLOPE International, Ltd. The results indicate that the slope is stable with a Factor of Safety greater than 1.3.

Photograph 4: Panorama view of gabion wall looking upstream towards outlet (June 11, 2015).

Stantec has indicated that rehabilitation of the gabion retaining wall will primarily consist of localized grouting, addition/replacement of wires and/or replacement of baskets. Gabion wall repair works shall be carried out in accordance with Ontario Provincial Standard Specification (OPSS) 512.

During rehabilitation, any baskets which contain significant voids should be repacked or replaced depending on the condition of the wires. When replacing baskets which are in direct contact with the retained fill, the area should be inspected to confirm the presence and condition of a filter fabric/geotextile. If it is absent or damaged, the filter fabric at the rear of the wall should be replaced with non-woven geotextile conforming to OPSS 1860. A minimum overlap of 0.3 metres should be maintained between adjacent pieces of geotextile. Geotextile placed along the top course shall be adequately anchored. Bulging of the face of new or repacked baskets may be minimized through the installation of stiffeners after each lift has been placed.

Apart from repairs/replacement of corroded baskets or replacement of baskets where required, rehabilitation works should include remediation of the two sinkhole areas, removal of all woody vegetation growing within the baskets and implementation of erosion protection measures along the left side of the gabion wall, including the outlet area. The sinkhole immediately behind the rear of the wall should be filled with lean concrete. However, the larger sinkhole may likely have developed due to collapse of soil surrounding the CSP due to corrosion. If this CSP is no longer needed, it should be filled with lean concrete. Otherwise, it should be replaced, slip-lined or repaired. Large woody vegetation growing through the gabions should be removed and the wires repaired and stone replaced, as required. The slope along the right (southern) side of the retaining wall should be regraded and erosion protection installed.

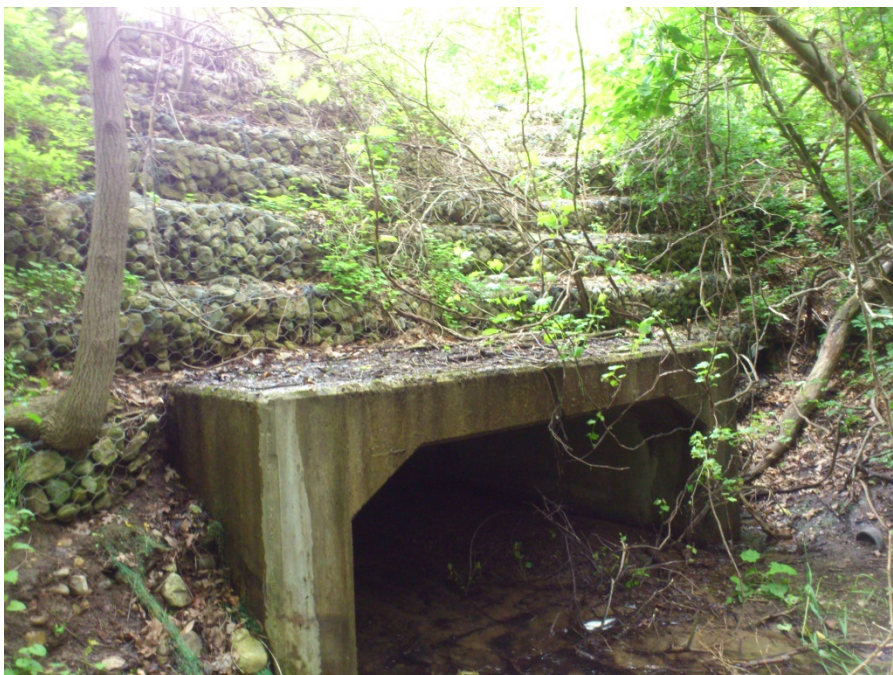
Photograph 5: Looking north at outlet of box culvert. Small drainage culvert in bottom right (June 11, 2015).

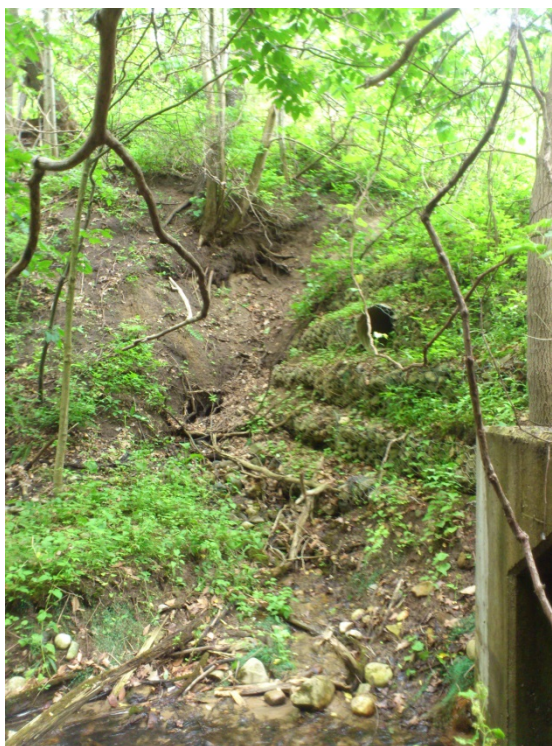
Photograph 6: Looking south at erosion channel adjacent to south edge of gabion wall (June 11, 2015).

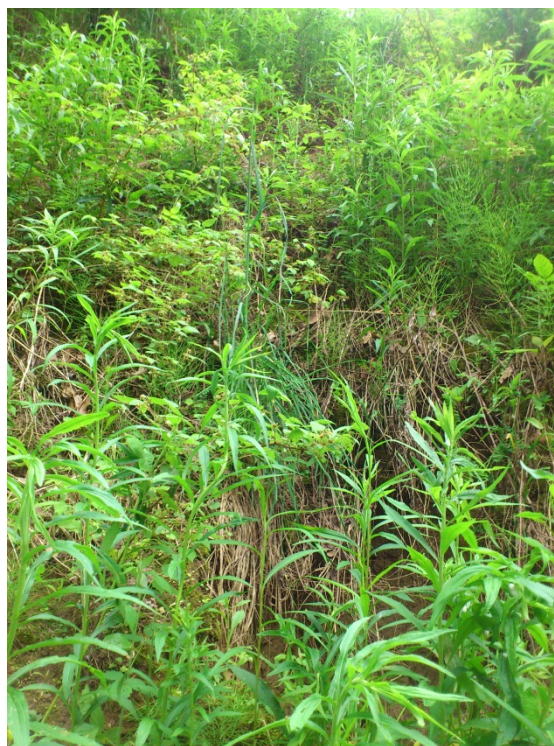
Photograph 8: Looking south at embankment slope approximately 3 metres above gabion retaining wall. The sinkhole with the CSP is visible in the lower part of the photo (June 11, 2015).

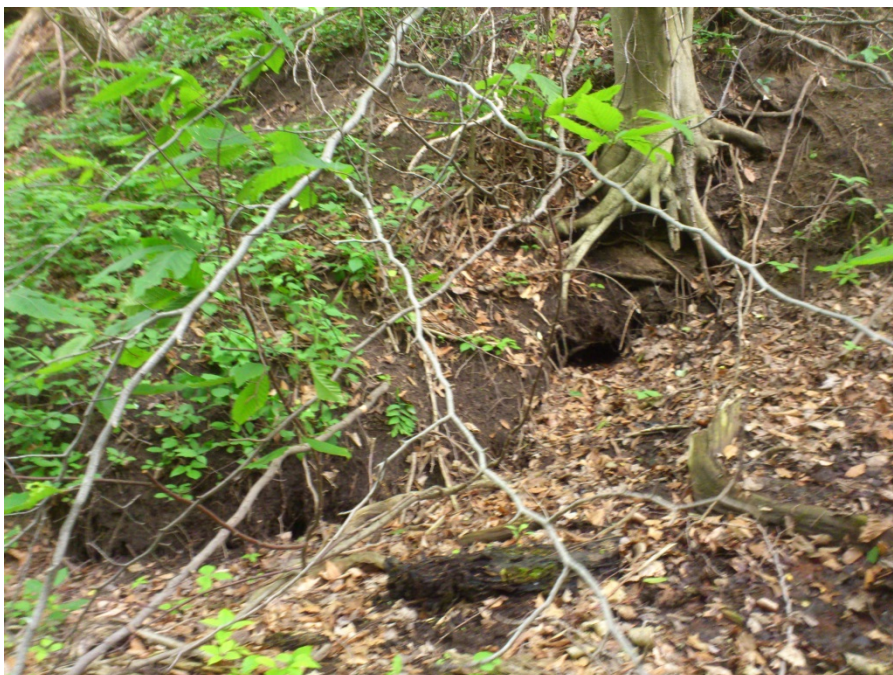
Photograph 9: Scour area near inlet, looking south towards right bank (June 11, 2015).

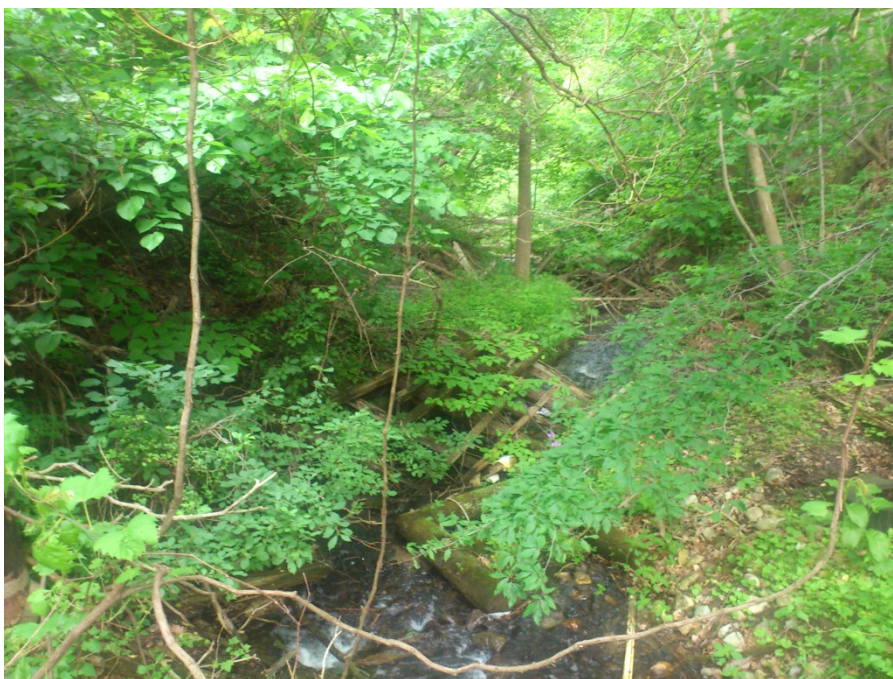
Photograph 10: Looking southeast and downstream of outlet (June 11, 2015).
