FOUNDATION INVESTIGATION AND DESIGN REPORT

North Saugeen River Culvert Rehabilitation
Site No. 8-342/C, Highway 6, Williamsford
Contract 4 Structure Replacements and Rehabilitation
GWP 3042-11-00
Ministry of Transportation, Ontario - West Region

Report Number: 12-1132-0163-4000-R02

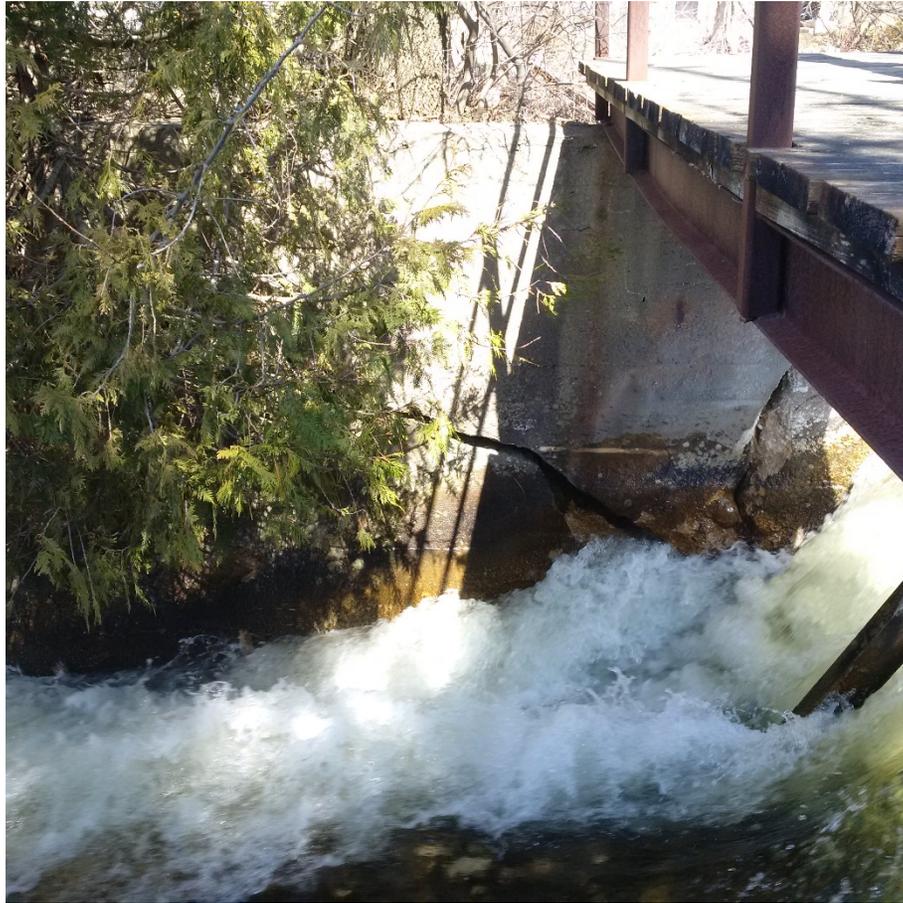
A very wide crack was noted in the north wall of the spillway at the north culvert. This crack and major spalling of the concrete walls was also noted in the 2006, 2008 and 2010 OBMS inspection reports. These cracks should be repaired.

Photograph 5: Note significant cracking of north wall of spillway at inlet of north culvert.

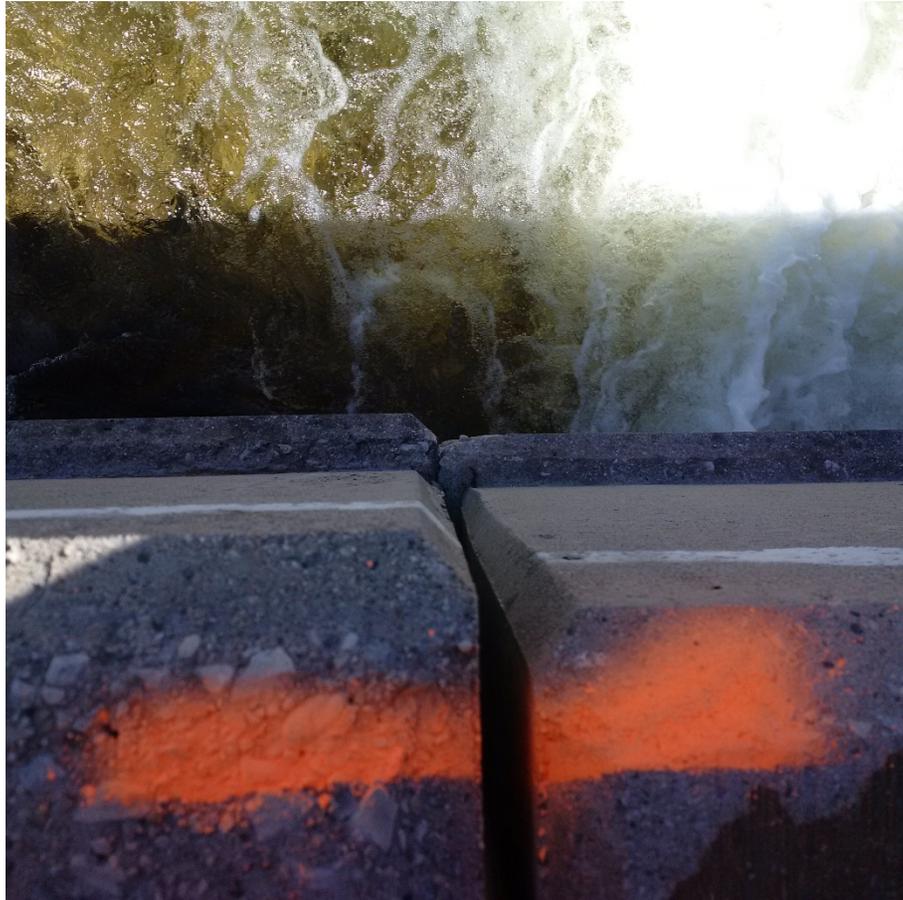
The Ontario Bridge Management System (OBMS) inspection report dated June 2006 noted an outward leaning of Retaining Wall 'B' by about 15 millimetres. OBMS inspections dated August 2008 and 2010 noted an outward leaning of approximately 20 millimetres at the north end and 15 millimetres at the south end. Settlement of the adjacent sidewalk has also been recorded since 2002. The 2006, 2008 and 2010 OBMS inspection reports noted 25 millimetres of settlement of the sidewalk adjacent to Retaining Wall 'B'. The settlement and outward leaning of about 25 millimetres was also observed at the time the field work was carried out for this report. The settlement of the sidewalk is likely attributable to the outward rotation of the retaining wall. Based on the borehole drilled adjacent to the settled sidewalk, our other nearby boreholes and our analysis of the retaining wall, it is considered likely that the retaining wall was not originally designed to accommodate elevated water table conditions such as those caused by flooding conditions. Based on our analysis, the factor of safety for resisting overturning when the groundwater level is at or just below Highway 6 pavement surface is about 1.1 and 1.3 for the north and south end, respectively. If the groundwater level in the analysis is lowered by about one metre (to about elevation 321 metres), the factor of safety is about 1.8. Generally, a factor of safety of at least 2.0 is desirable when designing

for overturning resistance. The Factor of Safety with respect to sliding reduces to approximately 1.1 when the groundwater level is near the top of the wall with the downstream water level near elevation 319.1 metres. It is likely that the retaining wall performed adequately until such time that elevated groundwater levels occurred during a flooding event, at which point movement likely would have first occurred. Additional possible causes for the rotation are listed below.

- Poor quality backfill behind the wall. Variable amounts of silt, topsoil, organics and wood pieces were encountered in the boreholes. These materials may have a lower angle of friction than contemplated during design which would result in an increase in active earth pressures.
- Inhibited drainage. Although the backfill is generally free draining, silty zones were noted. Also, there is some concern about the drain/weep hole detailing as discussed in Section 6.2. A significant buildup of hydraulic pressures, even in the short-term, behind the wall decreases the factor of safety against overturning and sliding.
- Scour. During the flood conditions, scour of the soil below the retaining wall footings can take place.

Photograph 6: Note retaining wall movement at south elevation (outlet) of Culvert Site 8-342/C.

Alternatives 5 and 6 are costly and will require interruption of traffic and in-water work to implement. Given that Retaining Wall 'B' is in relatively good condition and rotation of the wall is considered minor, these two options will not be discussed further. Alternatives 1 to 4 are considered to be the most practical and economically feasible for consideration for Detailed Design. Alternative 3 can be implemented on its own or in combination with Options 1 and 2. A comparison of these four alternatives is presented in Table I. Costs are relative and are in comparison to the lowest cost alternative, Option 4. The risk rating is relative to the risk associated with Option 4 and considers the potential for continued rotation of Retaining Wall 'B'. Based on the provided information, it is understood that Option 3 will be implemented, along with replacement of the sidewalk adjacent to Retaining Wall 'B'.

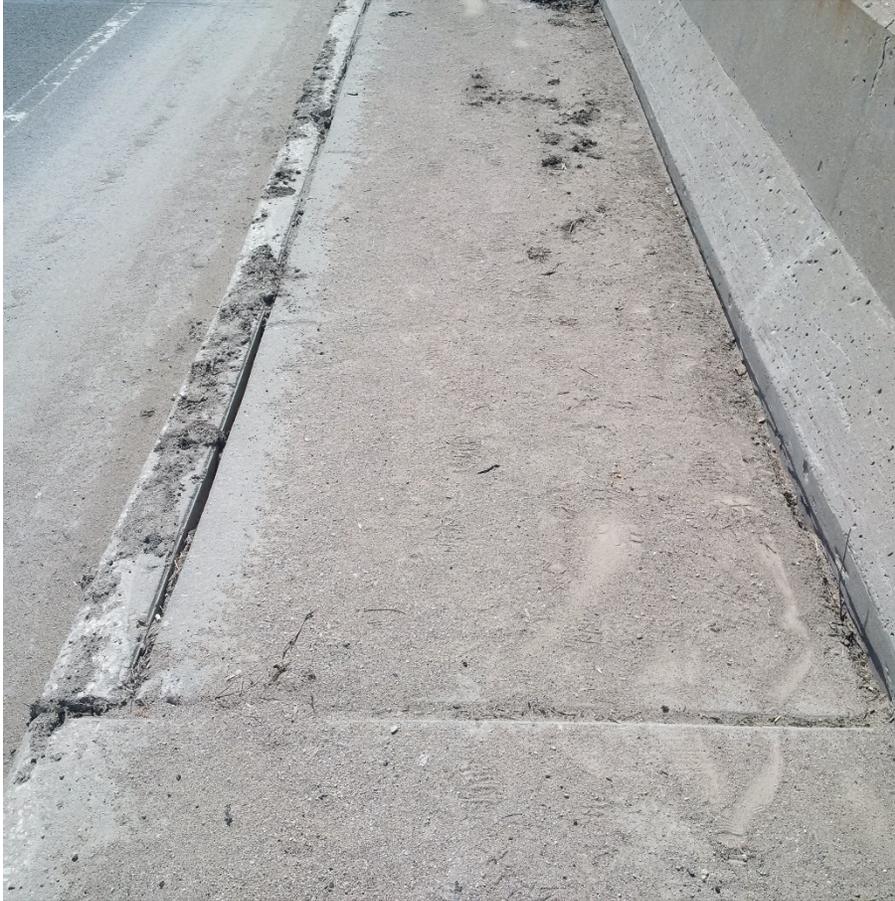
Review of the 2006, 2008 and 2010 OBMS inspection reports revealed that no additional settlement occurred in the sidewalk area adjacent to Retaining Wall 'B' during the period 2006 to 2010. Similarly, additional rotation of the wall did not appear to occur during this period. Based on the observations made during our 2016 field investigation, the wall has rotated outward some 5 millimetres in the last six years. Our analyses have indicated that Retaining Wall 'B' is stable during normal water levels but achieves marginal stability for overturning and sliding during flood conditions if the weirs of the Mill Pond Dam are overtopped and the water level increases within the backfill to within 1 metre of the pavement surface. The water level and marginally stable condition may remain for some time after the flood waters subside.

Photograph 7: Note settlement of west sidewalk at Culvert Site 8-342/C.
