FOUNDATION TECHNICAL MEMORANDUM

**MEDWAY CREEK BRANCH BRIDGE (ST. JOHN'S)
MTO WEST REGION 59 STRUCTURE REHABILITATIONS
HIGHWAY 4, SITE 19-162, CONTRACT 5
GWP 3062-11-00
GEOGRAPHIC TOWNSHIP OF LONDON
MIDDLESEX COUNTY, ONTARIO**

PML Ref.: 13KF006F-M1
Index No.: 219TMEM
Geocres No.: 40P03-002
June 17, 2015

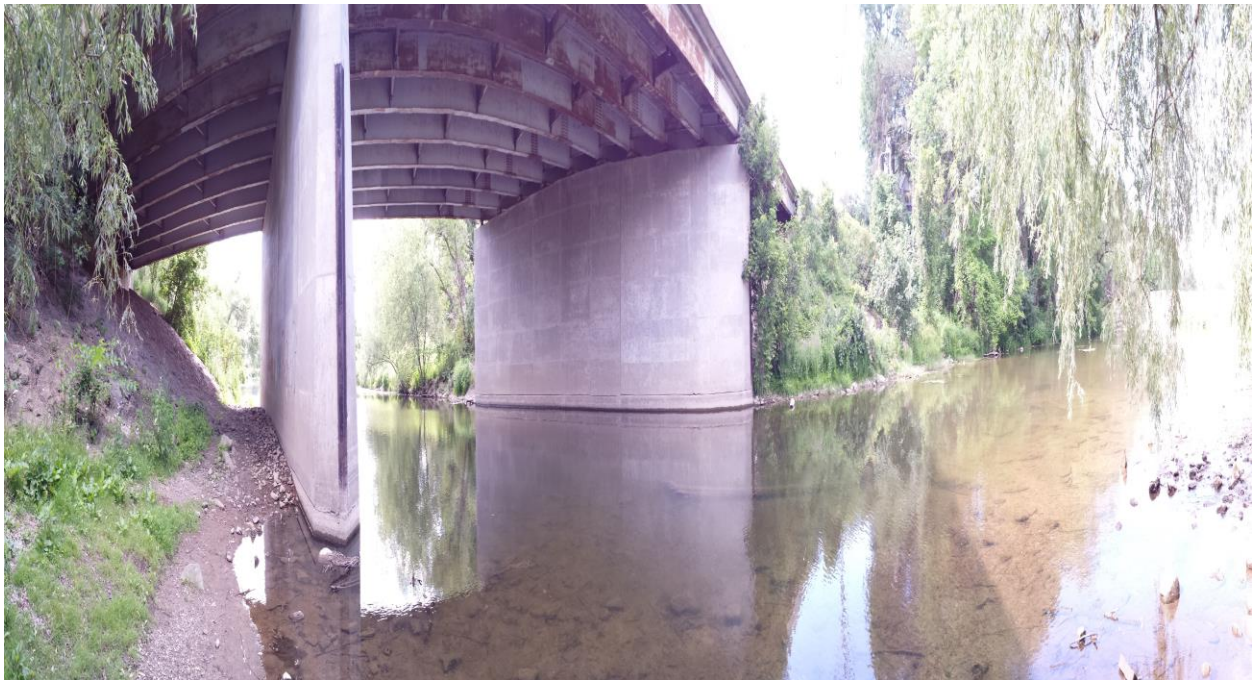
Photographs 1, 6 and 7 show the bridge structure from various corners at the site location. The west and east slopes adjacent to north and south abutments were partially vegetated with strands of trees and bushes. However, evidence of erosion activity on the slope faces and toes was also observed (Photographs 2, 6, 9 and 12), particularly the east slope adjacent to the south abutment (Photograph 12). No obvious major cracks, except for minor surface cracks were observed on the north and south piers (Photographs 3 and 10). Further, erosion activity was also observed on the front slope faces at the abutments (Photographs 4, 5 and 8). It was observed that the rip-rap stones were present at the bottom of the slopes adjacent to of the piers (Photographs 5 and 11).

Photograph 1: Looking west at the bridge structure from the southeast corner. Slight erosion was observed on the slope face and the exposed earth adjacent to the south pier. (July 24, 2014)

The slope faces in front of the abutments and adjacent slopes should be rehabilitated with rock protection, rip-rap or equivalent materials to mitigate erosion and scouring effects. The aggregate materials should conform to OPSS.PROV 1004 and the construction of the rock protection, rip-rap or equivalent should conform to OPSS 511.

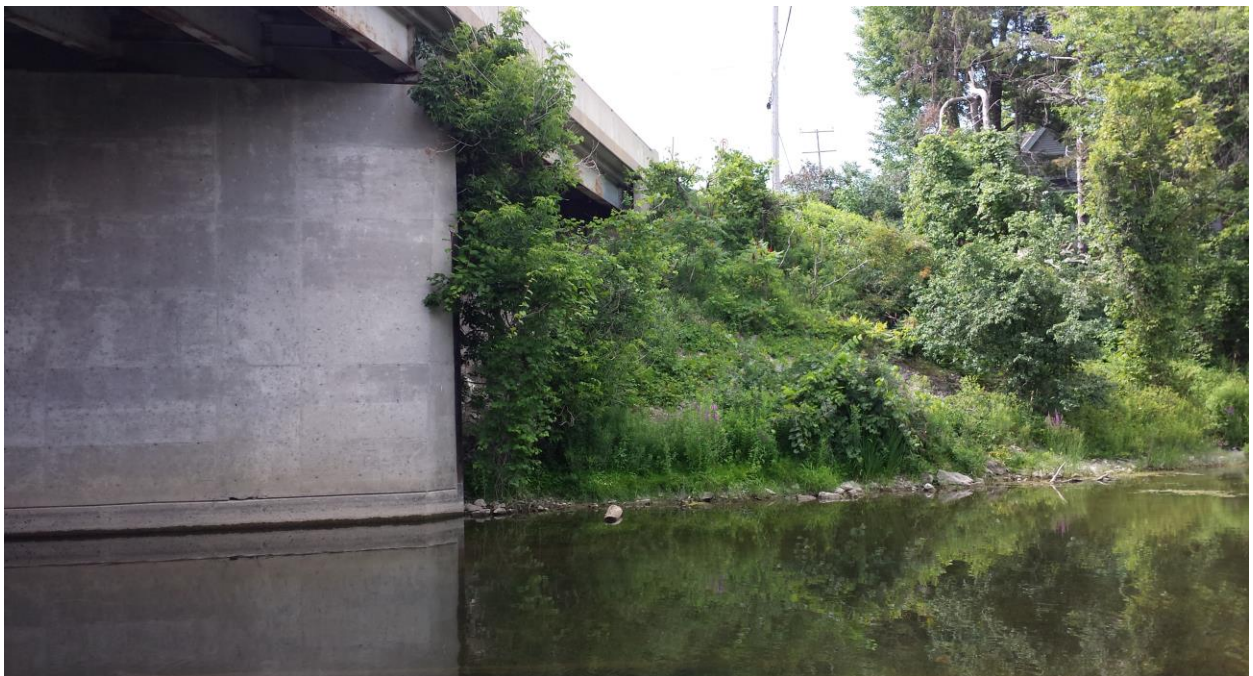
Photograph 2: Looking north from the east side of the bridge. The northeast slope was covered with bushes. Slight erosion of the slope face and scouring of the slope toe adjacent to the abutment was observed. (July 24, 2014)

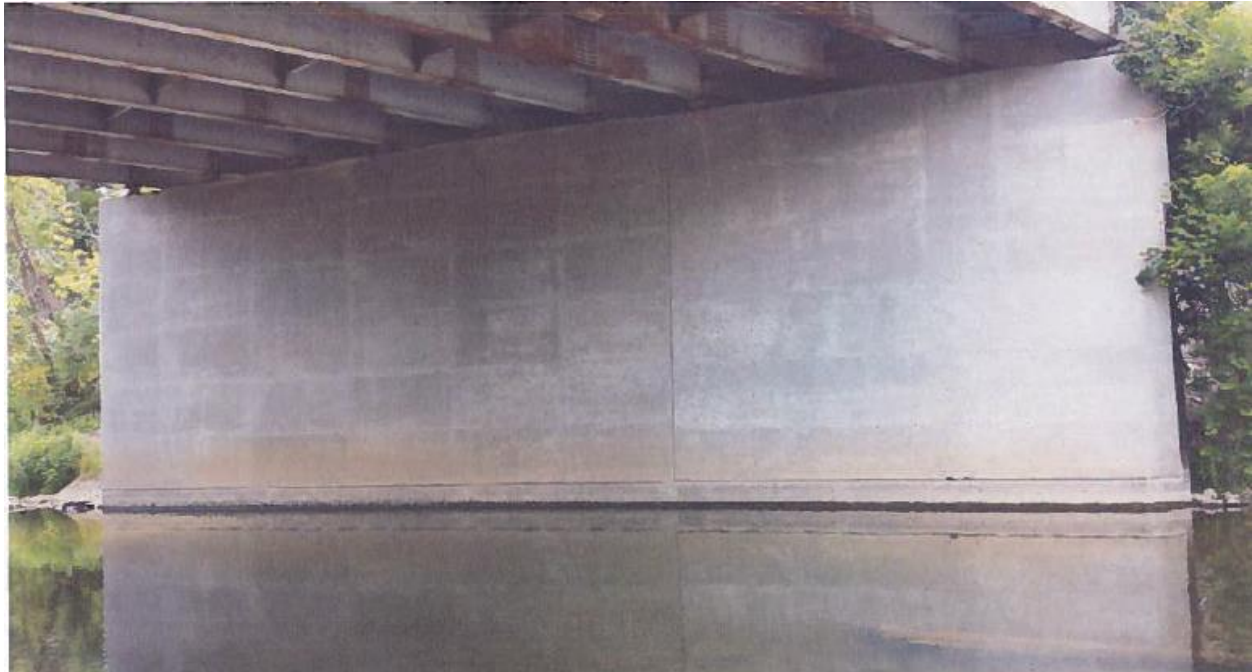
Photograph 3: Looking north at the north pier wall from the southeast corner. No obvious cracks were observed on the concrete pier. Scouring effect below the water could not be established during the site reconnaissance. (July 24, 2014)

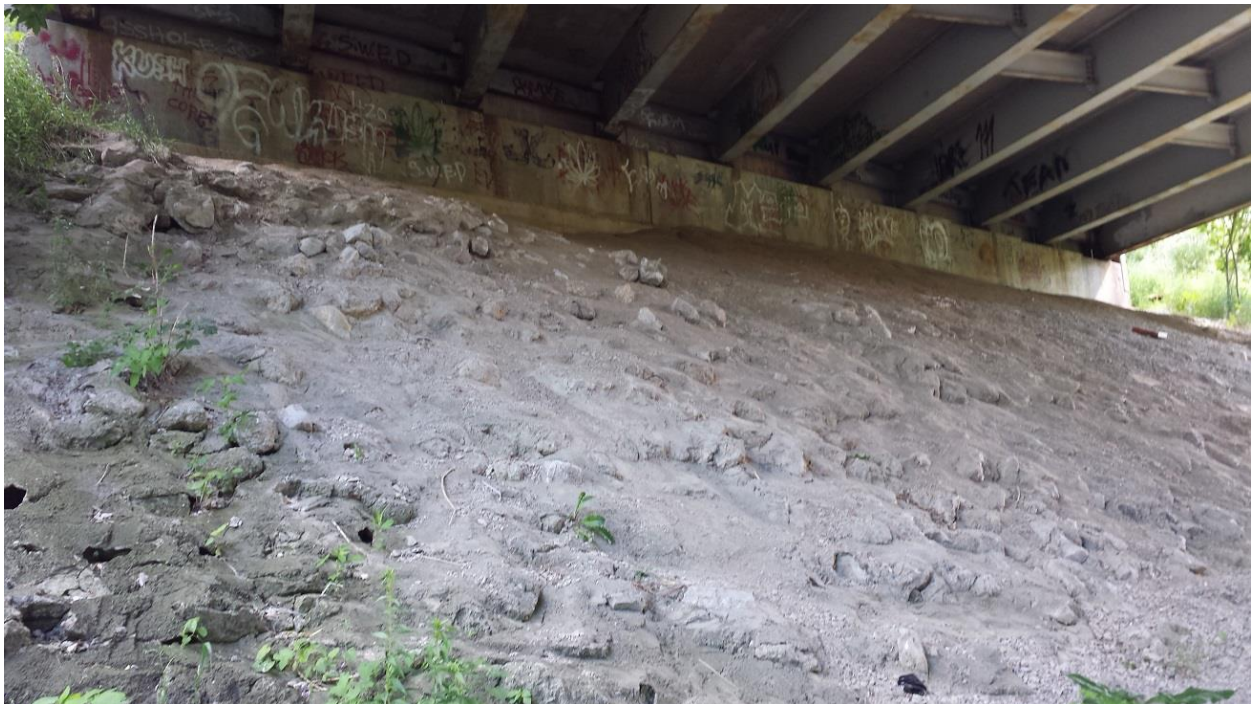
Photograph 4: Looking south at the slope face in front of the south abutment. Effects of erosion were observed on the slope face. (July 24, 2014)

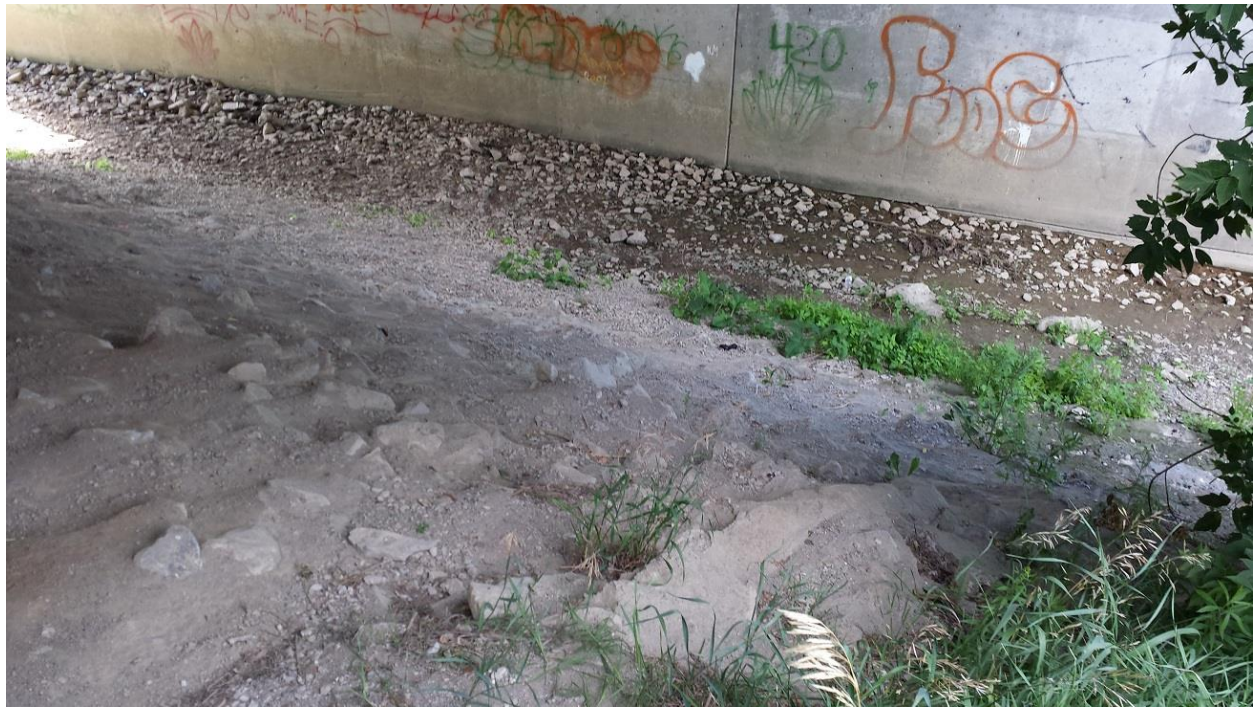
Photograph 5: Looking down at the slope face in front of the south abutment. Effects of erosion were observed on the slope face and the exposed earth in front of the south pier. There were no obvious cracks on the pier wall. (July 24, 2014)

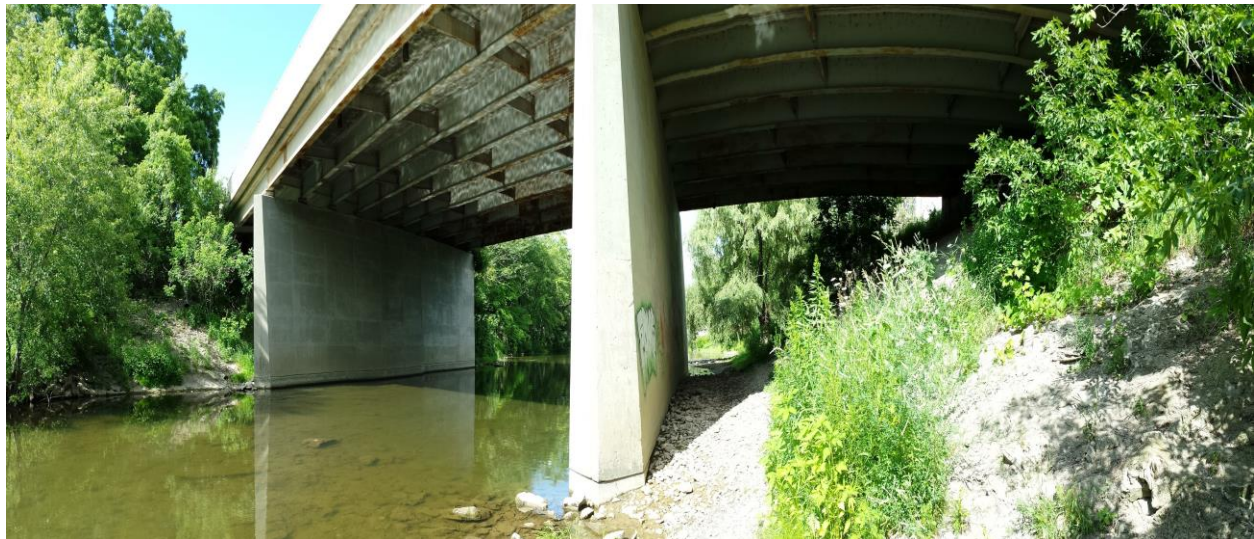
Photograph 6: Looking east at the bridge structure from the southwest corner. Erosion of exposed earth was evident on the slope face and adjacent to the south pier. (July 24, 2014)

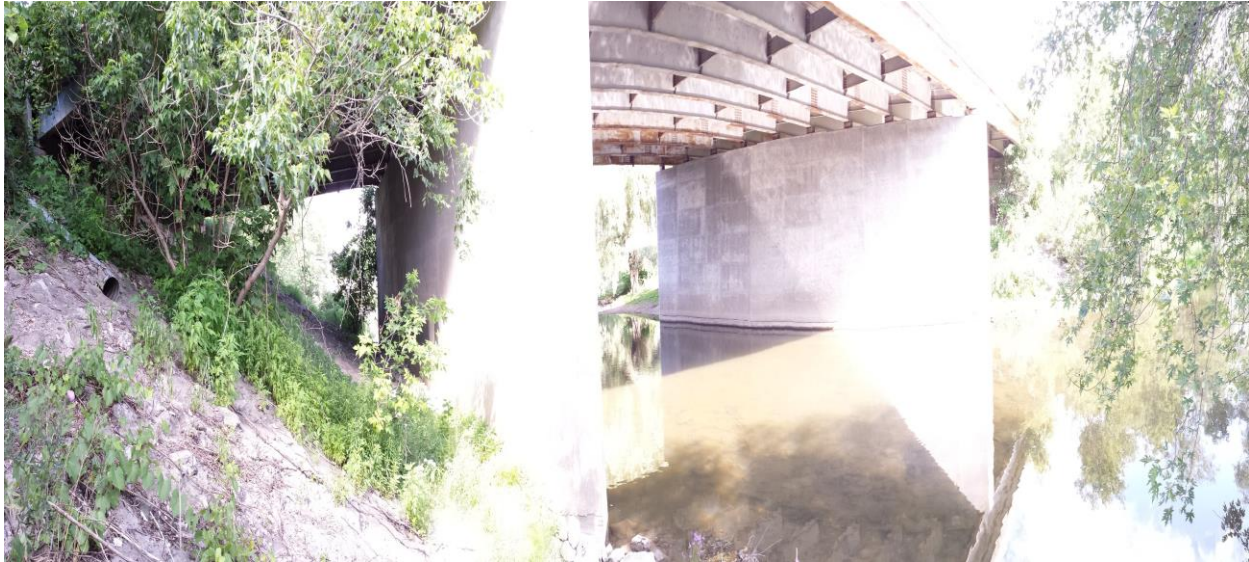
Photograph 7: Looking east at the bridge structure from the northwest corner. Erosion of exposed earth was evident on the slope face and adjacent to the north pier. (July 24, 2014)

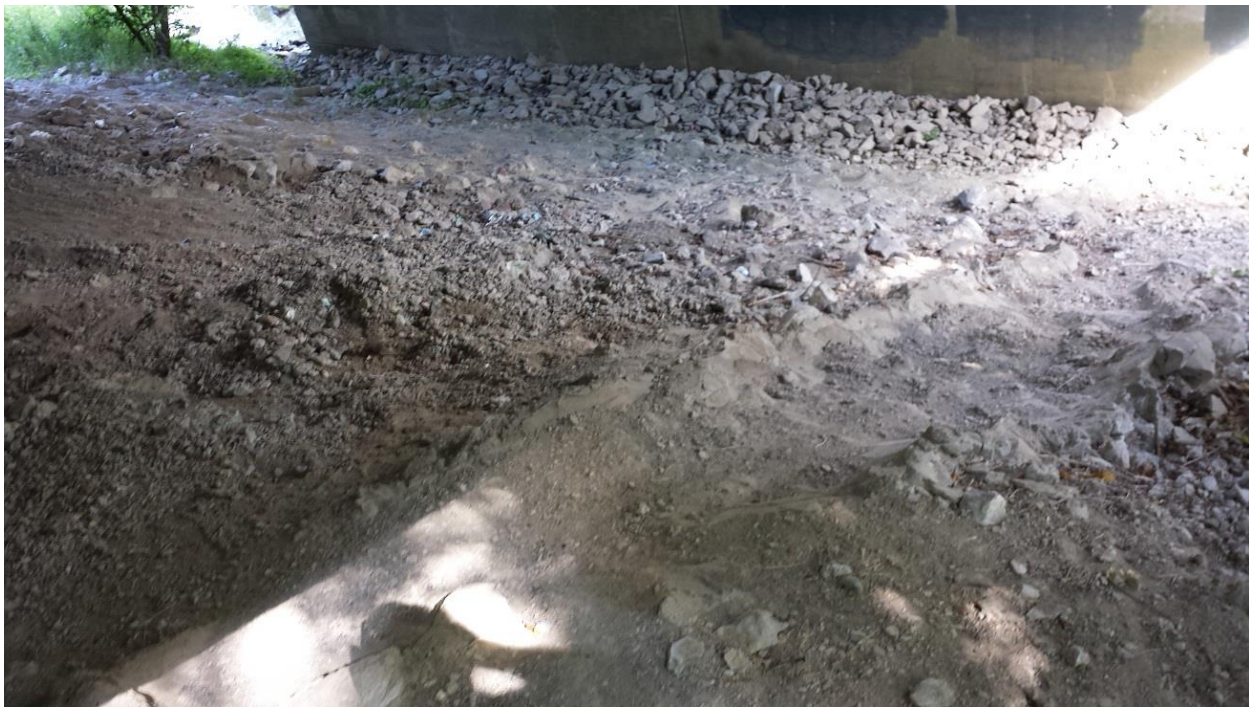
Photograph 8: Looking down at the slope face in front of the north abutment. Effects of erosion were observed on the slope face and the exposed earth in front of the north pier. The rip-rap stones gathered at the bottom of the slope probably due to erosion activity of the slope face. There were no obvious cracks on the pier wall. (July 24, 2014)

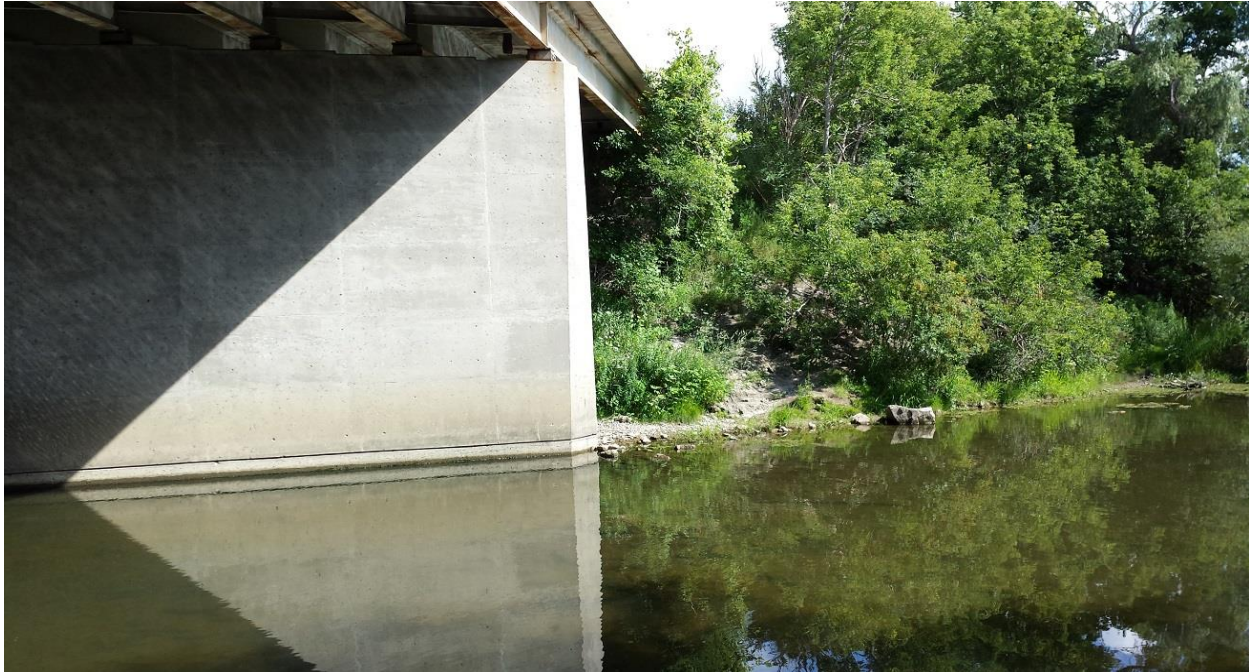
Photograph 9: Looking south from the west side of the bridge. The west slope adjacent to the south abutment was covered with bushes. Erosion of the slope face and scouring of the slope toe adjacent to the south abutment was observed. (July 24, 2014)

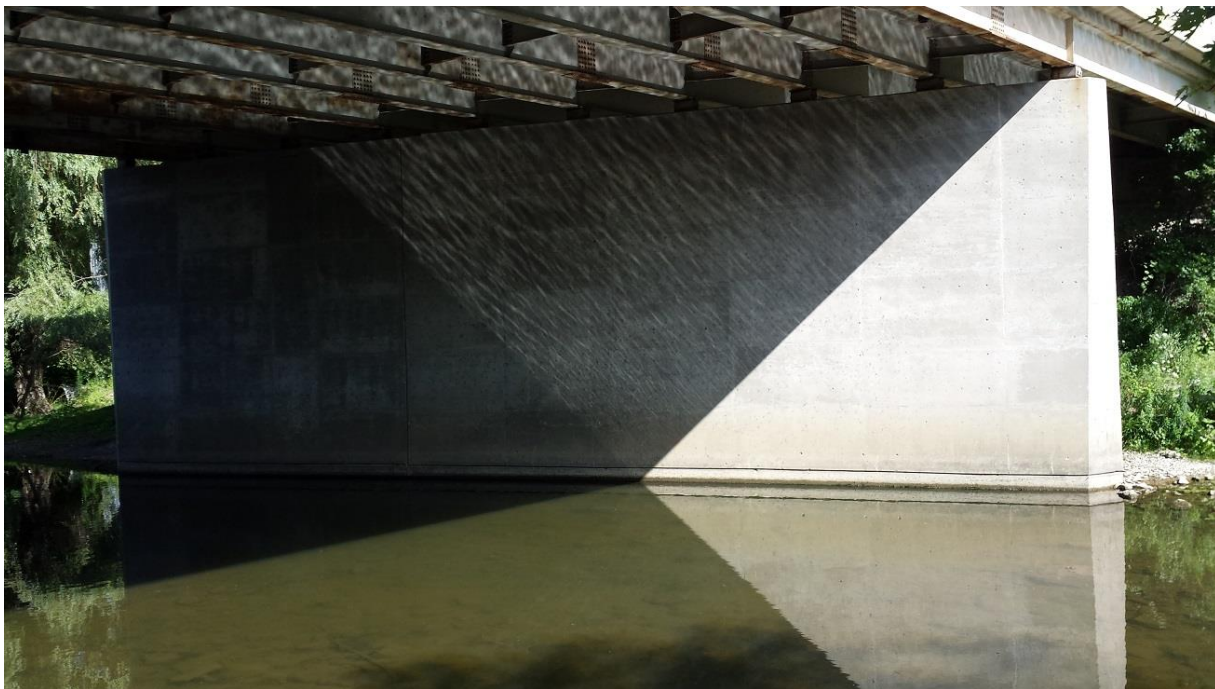
Photograph 10: Looking south at the south pier wall from the northwest corner. No obvious cracks were observed on the concrete pier. Scouring effect below the water could not be established during the site reconnaissance. (July 24, 2014)

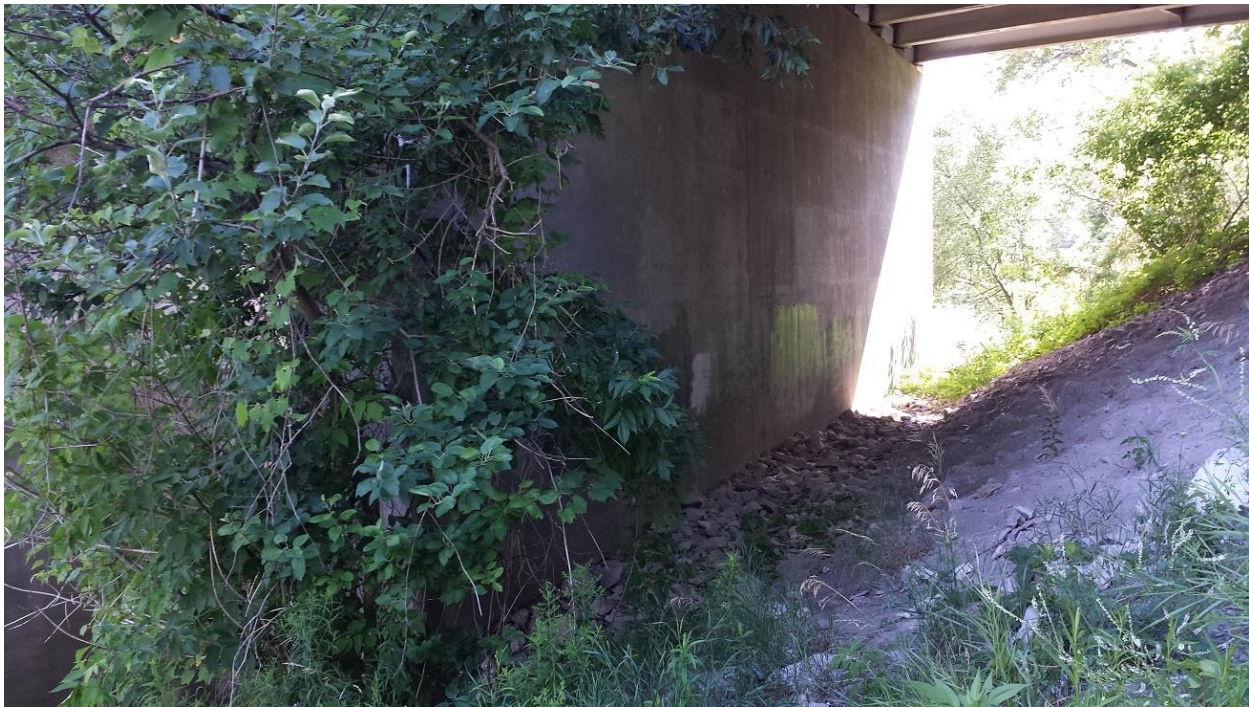
Photograph 11: Looking west at the north pier structure from the northeast corner. Rip-rap stones gathered at the bottom of the slope in front of the pier. No obvious cracks were observed on the pier. (July 24, 2014)

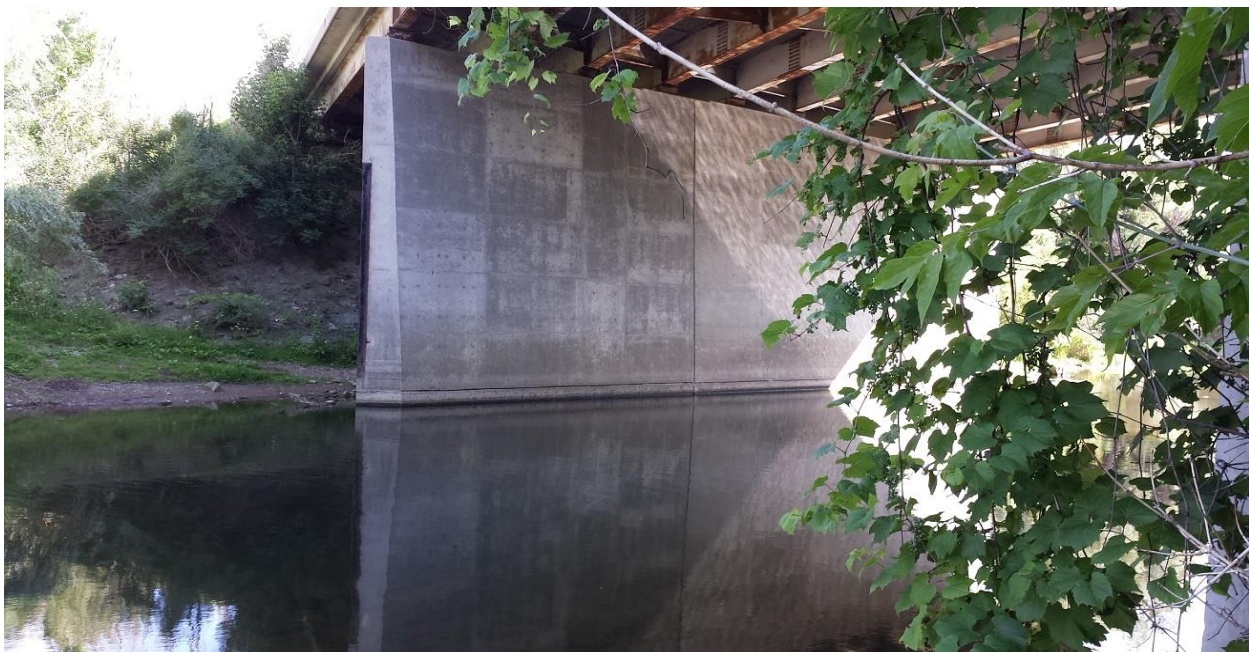
Photograph 12: Looking south from the east side of the bridge. The east slope adjacent to the south abutment was greatly affected by erosion activity. (July 24, 2014)
