FOUNDATION TECHNICAL MEMORANDUM

**MEDWAY CREEK BRANCH BRIDGE
MTO WEST REGION 59 STRUCTURE REHABILITATIONS
HIGHWAY 4, SITE 19-161, CONTRACT 5
GWP 3062-11-00
GEOGRAPHIC TOWNSHIP OF LONDON
MIDDLESEX COUNTY, ONTARIO**

PML Ref.: 13KF006F-M2
Index No.: 221TMEM
Geocres No.: 40P03-004
June 17, 2015

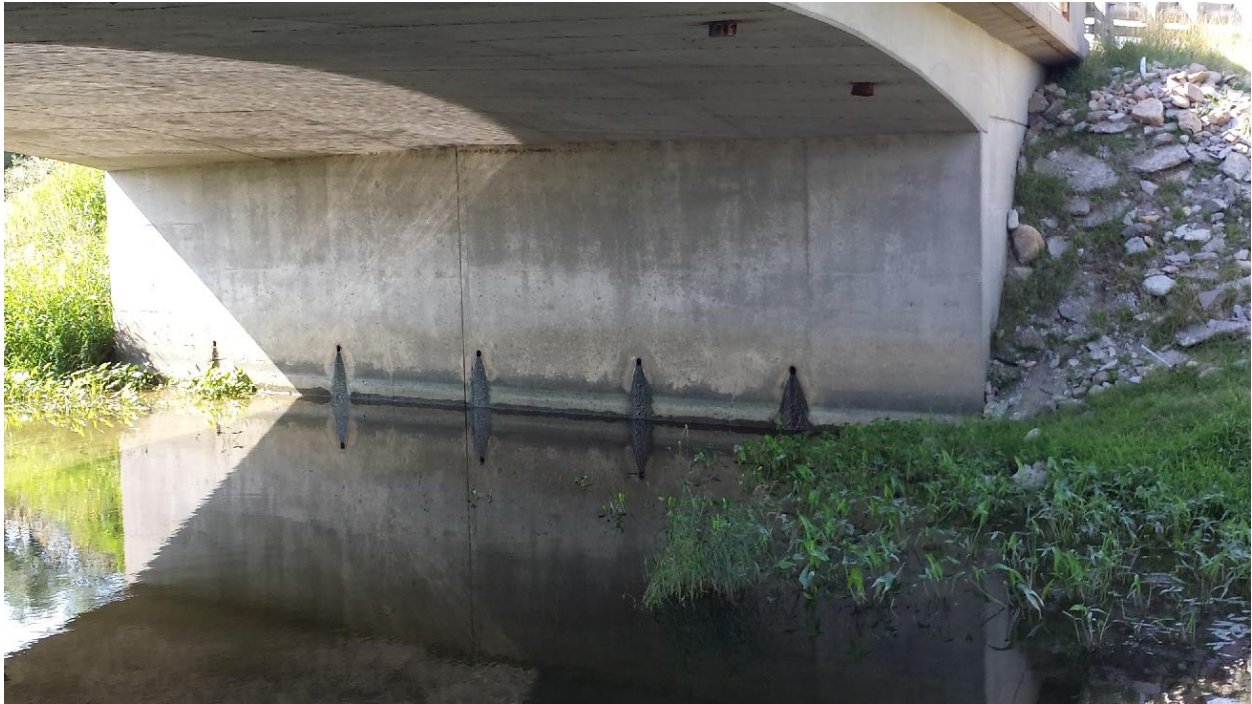
The north and south abutment walls had no obvious cracks except for minor surface cracks (Photographs 1 and 4). The weep holes in the abutment walls were open and wet, indicating that they are functioning satisfactorily. Rip-rap protection was observed on the east slope adjacent to the north abutment to prevent further erosion of the slope surface (Photograph 2). The west slope face adjacent to the north abutment was vegetated. However, previous construction debris was dumped on the slope face (Photograph 3). The slopes adjacent to the south abutment were generally vegetated with rip-rap protection placed on areas of the slope faces and toes to prevent further erosion and scour of the earth soil material (Photographs 5 and 6).

Photograph 1: Looking north at the north abutment. No obvious cracks were observed on abutment wall except some surficial cracks. Weep holes observed in the abutment wall were open and wet. (July 24, 2014)

Further, it is suggested that the weep holes out of the abutment walls should be maintained and cleaned at a regular basis to prevent any clogging of the holes. Regular maintenance of the weep holes will keep the water flowing from behind the abutment walls and will mitigate hydrostatic pressure to build-up behind the abutment walls.

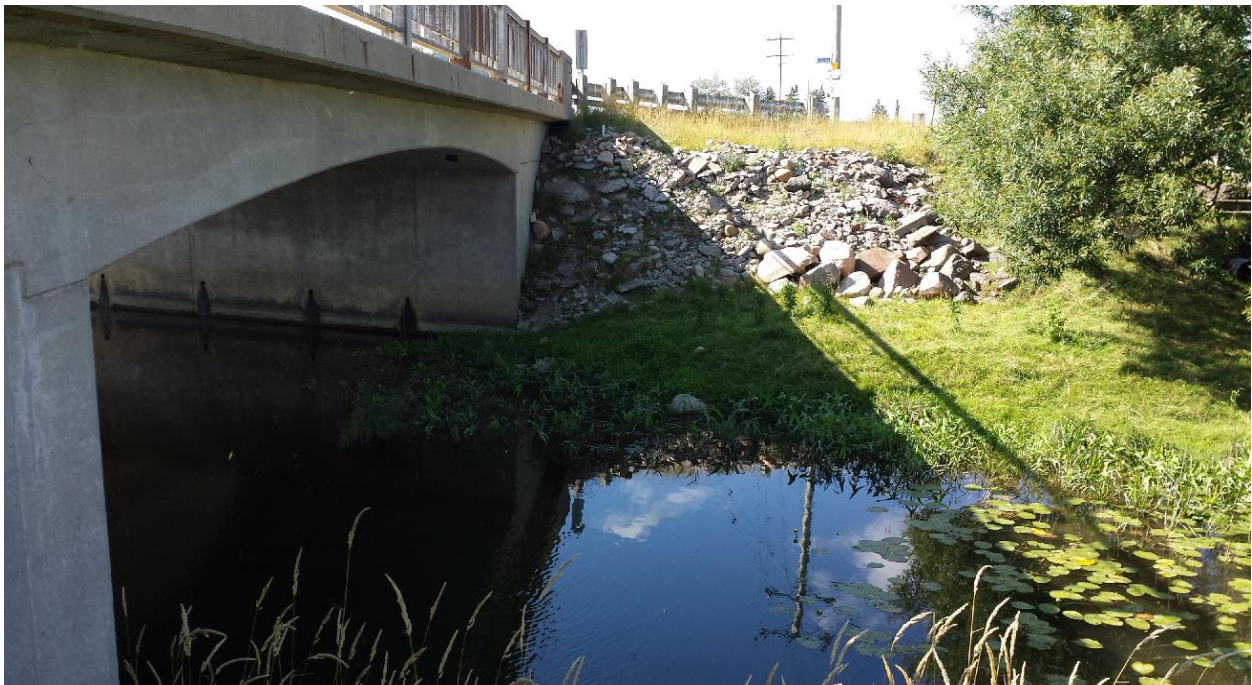
Photograph 2: Looking north at the east slope adjacent to the north abutment. Rip-rap protection was observed on the slope face to prevent further erosion of the exposed earth. (July 24, 2014)

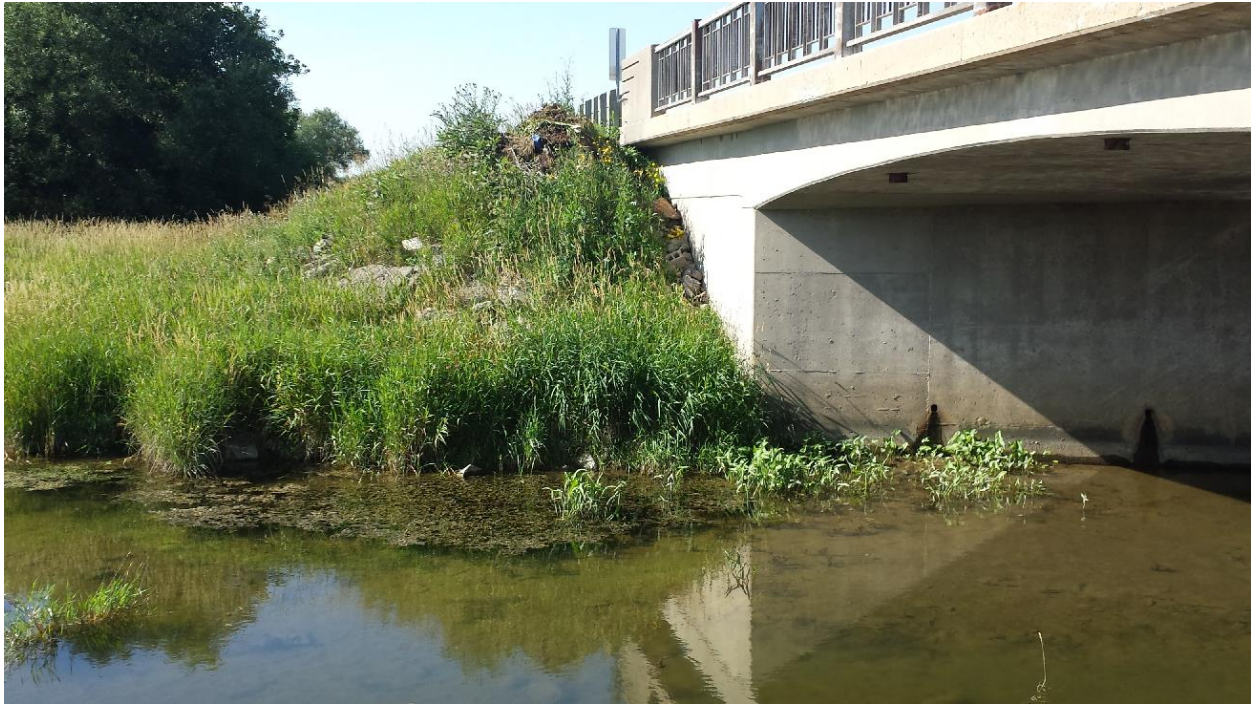
Photograph 3: Looking north at the west slope adjacent to the north abutment. The slope face was vegetated. However, previous construction debris was observed on the slope face. (July 24, 2014)

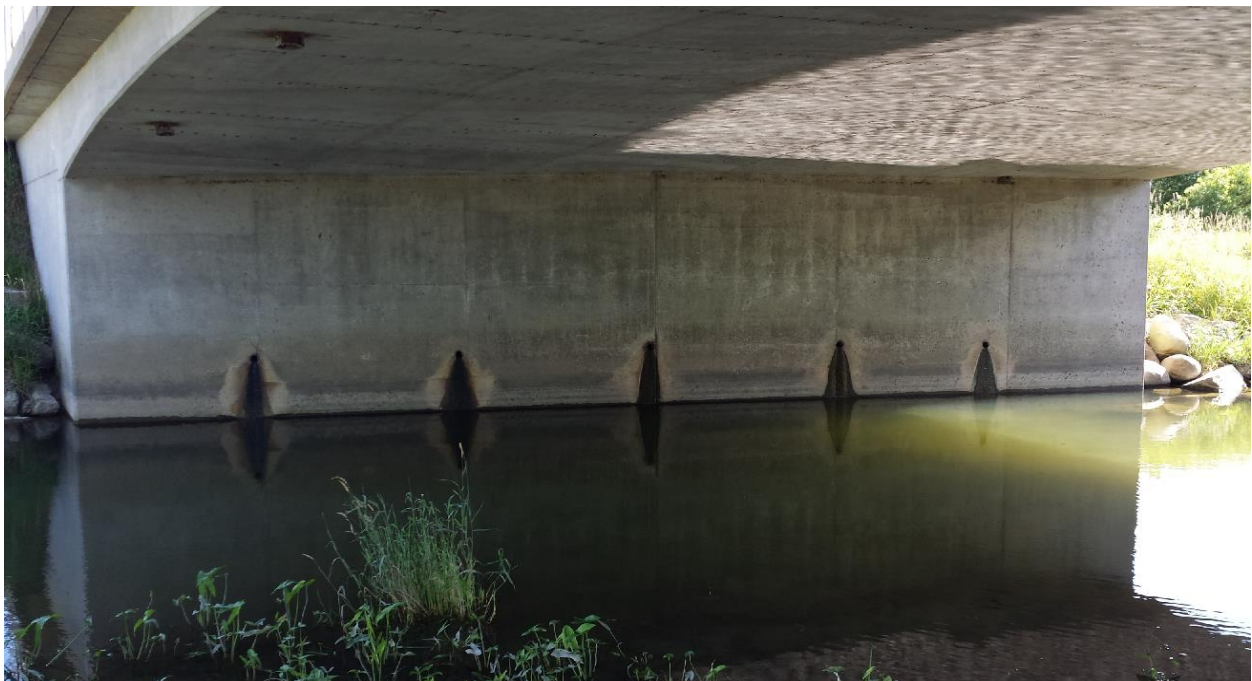
Photograph 4: Looking at the south abutment from the northeast corner of the bridge. No obvious cracks were observed on the abutment wall, except some surficial cracks. Weep holes in the abutment wall were open and wet. (July 24, 2014)

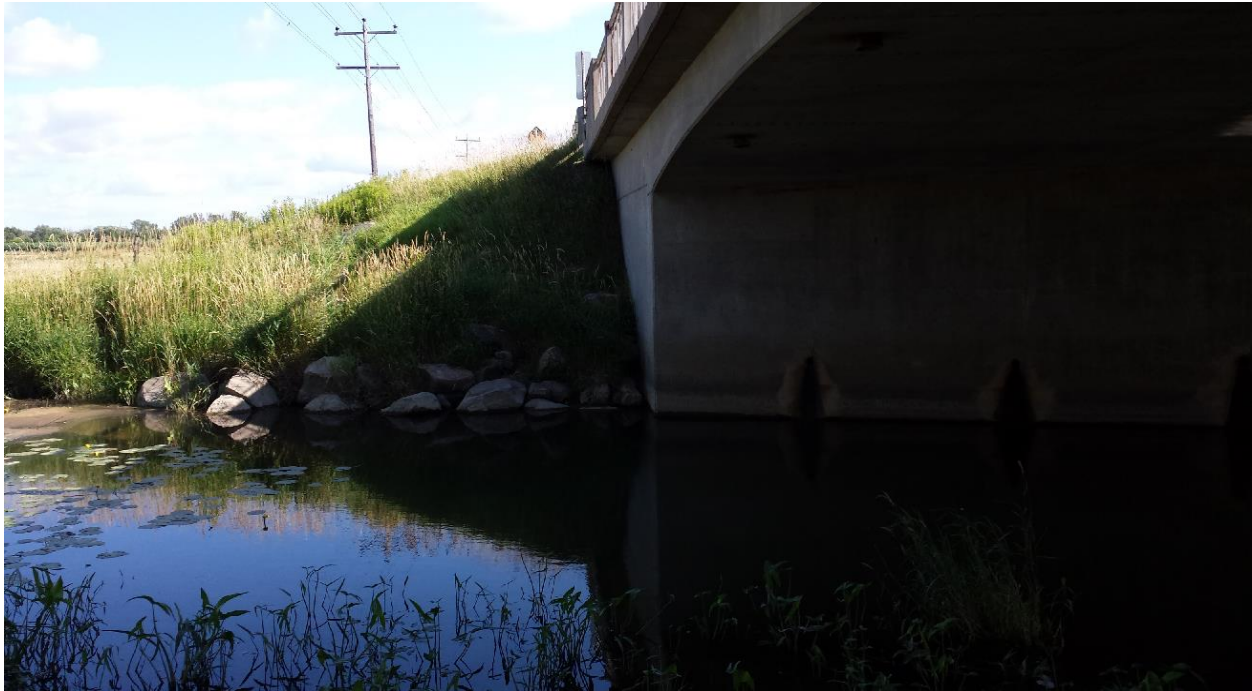
Photograph 5: Looking south at the east slope adjacent to the south abutment. The slope face was vegetated. Rip-rap was observed at the toe of the slope. (July 24, 2014)

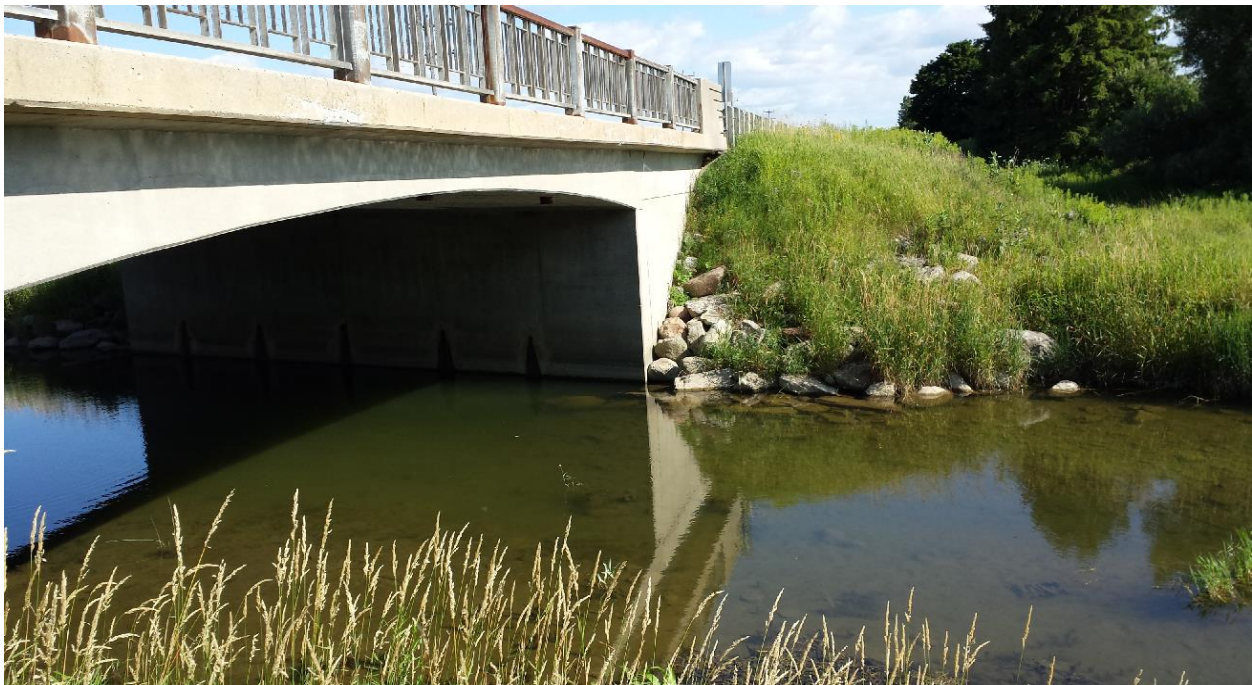
Photograph 6: Looking south at the west slope adjacent to the south abutment. The slope face observed was vegetated with rip-rap placed on the face and at the toe of the slope to prevent erosion and scour of the exposed earth. (July 24, 2014)
