DRAFT FOUNDATION INVESTIGATION AND DESIGN REPORT

Rock Slope Inspection - Segment 11 Highway 33 from Adolphustown to Collins Bay (Kingston) Agreement No. 4014-E-0012 Assignment No. 14

Report Number: 1413191-#14-3

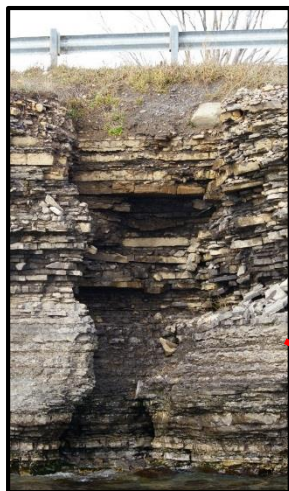
Undercutting of the rock face

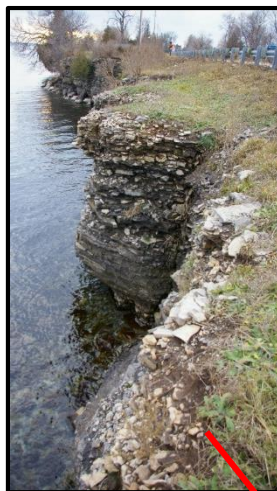
Irregular crest line

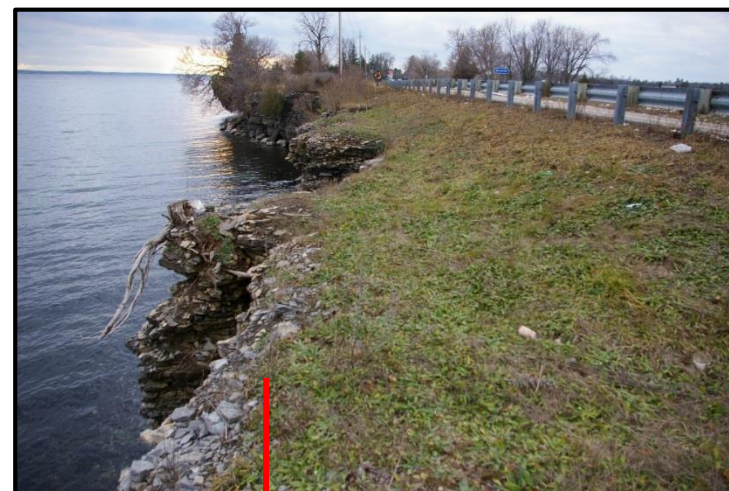
Irregular crest line

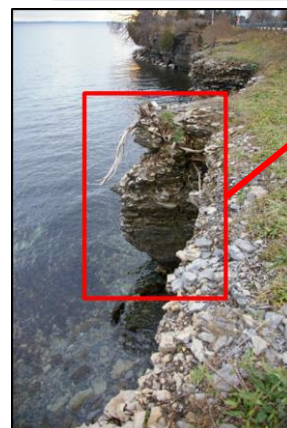
Undercutting of the rock face

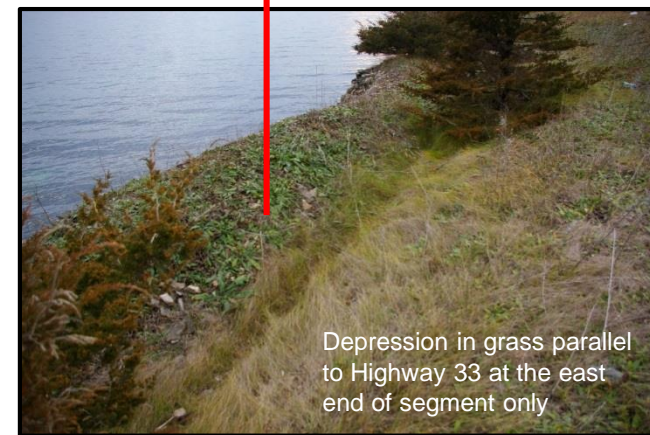
Depression in grass parallel to Highway 33 at the east end of segment only

Crest of eroded rock face is about 2.4 m from the guardrail of Highway 33.

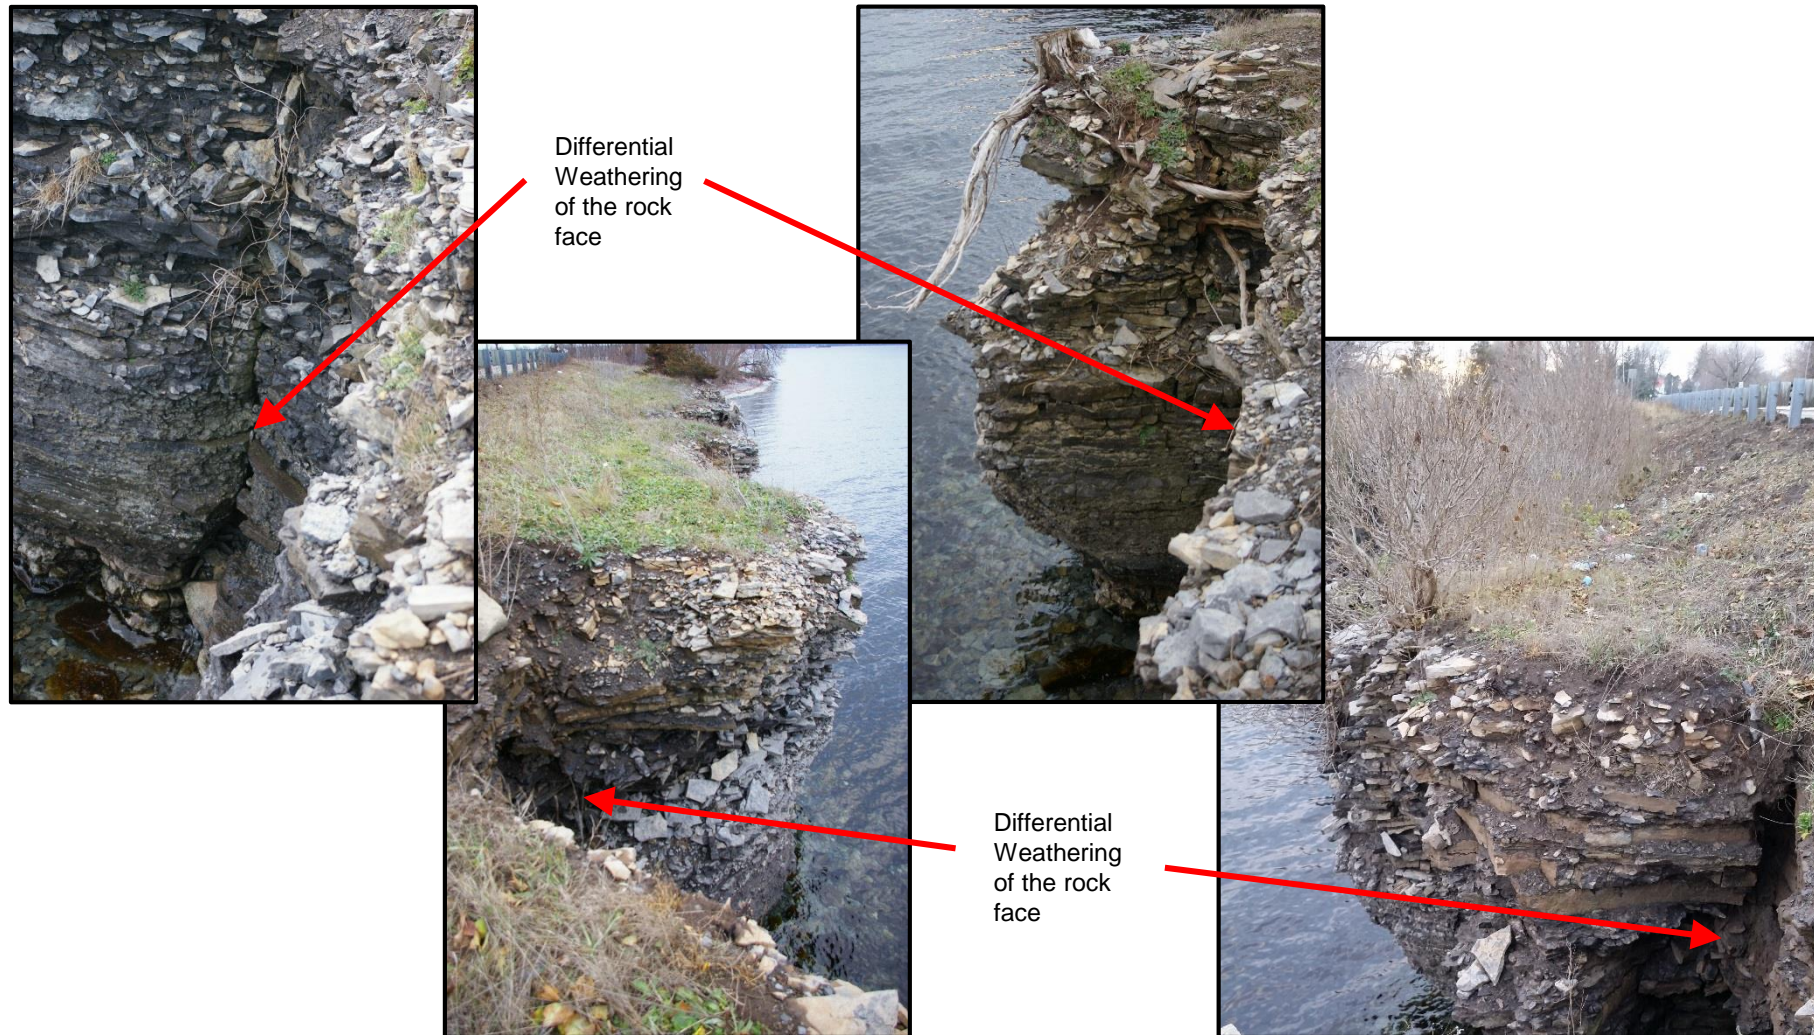
Details of Differential Weathering of Rock Face

The rock mass consists of a slightly weathered, very thinly to thinly bedded, grey limestone interbedded with fissile shale (refer to Figure 4). The bedding is approximately horizontal and the rock mass is very blocky and fractured which contributes to the rate of erosion of the rock slope. Some of the developing erosion areas and open fractures at surface would indicate that there is likely a sub-vertical joint set oriented approximately east-west or about 080° and a second sub-vertical joint set oriented approximately north-south.

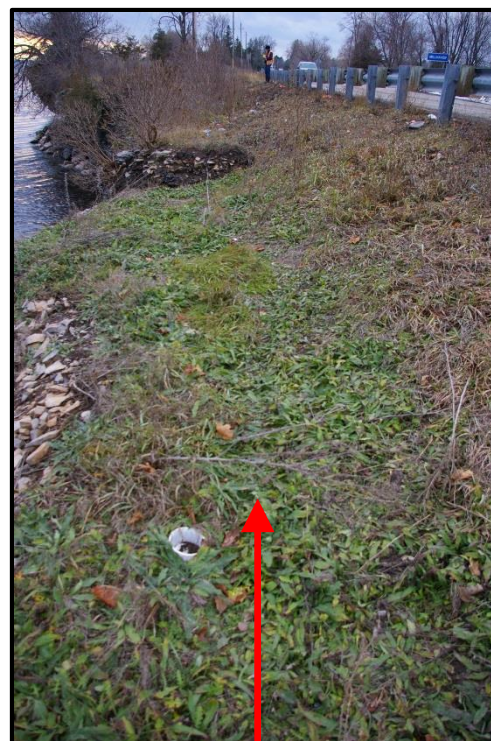
Possible
Vertical
Discontinuity

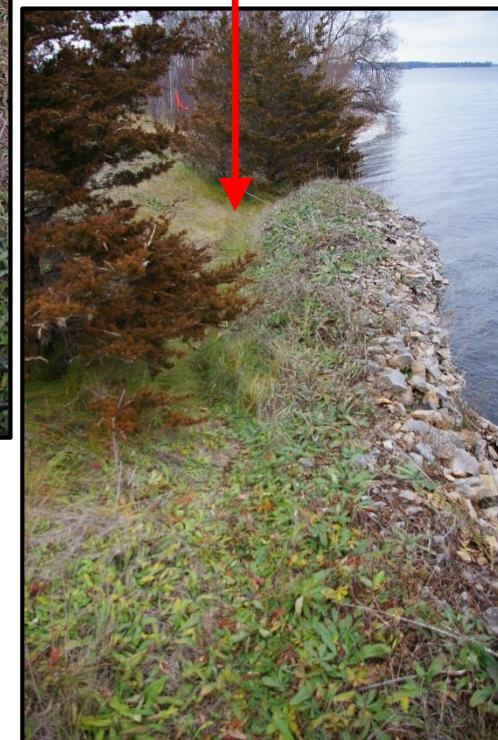
Possible
Vertical
Discontinuity

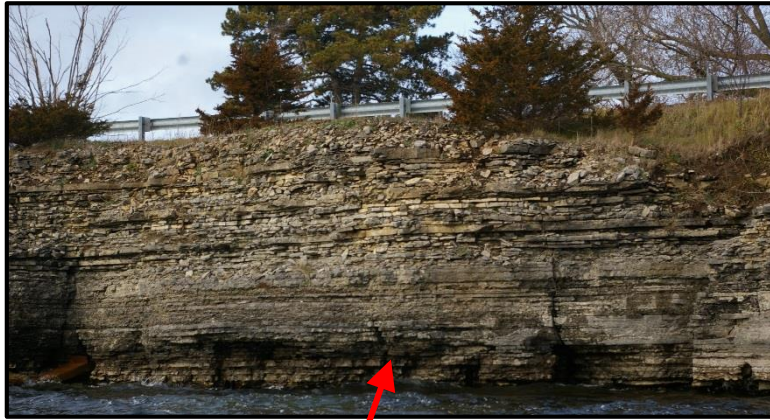
Differential Weathering
of the Rock Face
Resulting in Overhangs

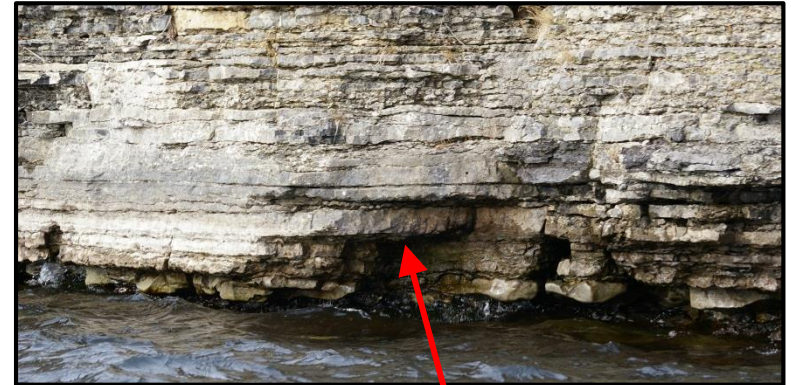
Differential Weathering
of the Rock Face
Resulting in Overhangs

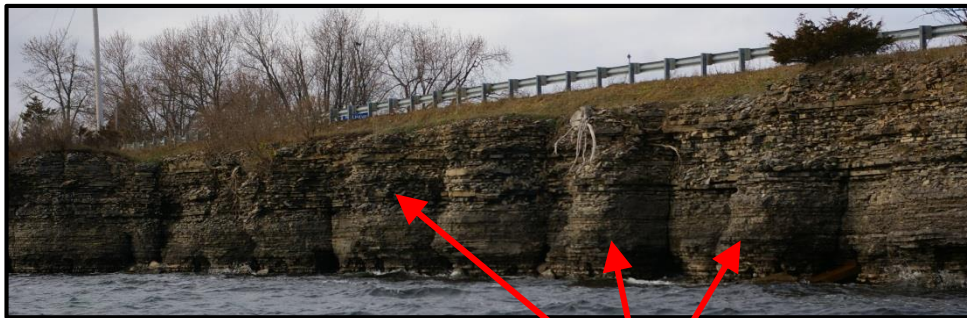
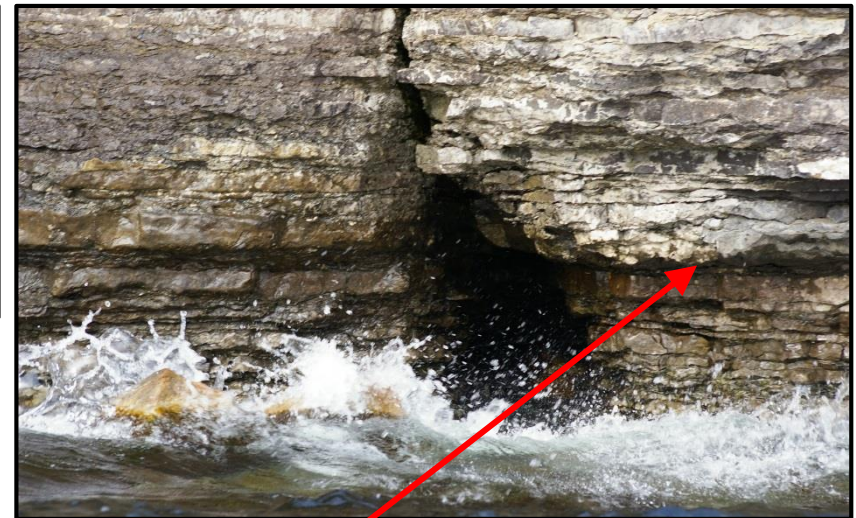
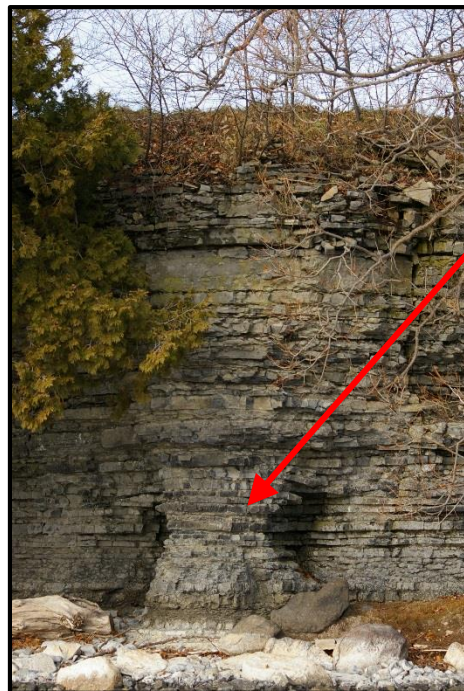
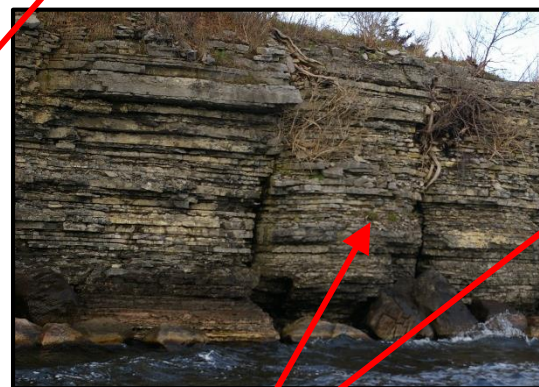
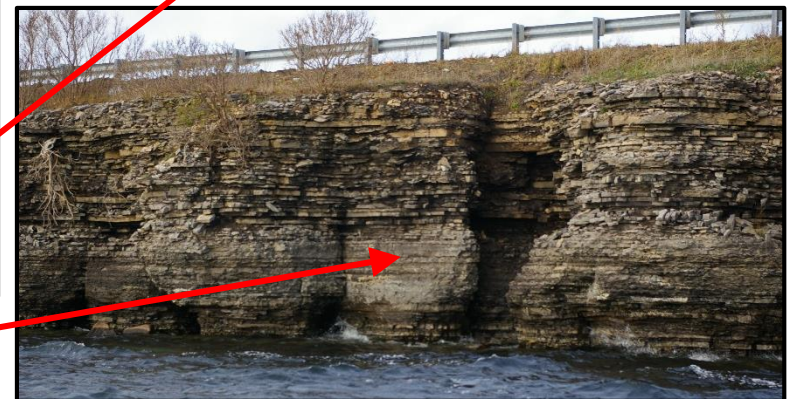
Caves and Pillars due to Differential Erosion of Rock Face

Rock Pillars
