**FOUNDATION INVESTIGATION AND DESIGN REPORT
HIGH FILL APPROACH AND
RAMP EMBANKMENT SETTLEMENT
HIGHWAY 77 / 401 INTERCHANGE
TOWN OF LAKESHORE, ESSEX COUNTY
G.W.P. 3072-12-00**

GEOCRES No. 40J2-133

**Report
to
Ministry of Transportation Ontario**

January 18, 2016
File: 15-64-35

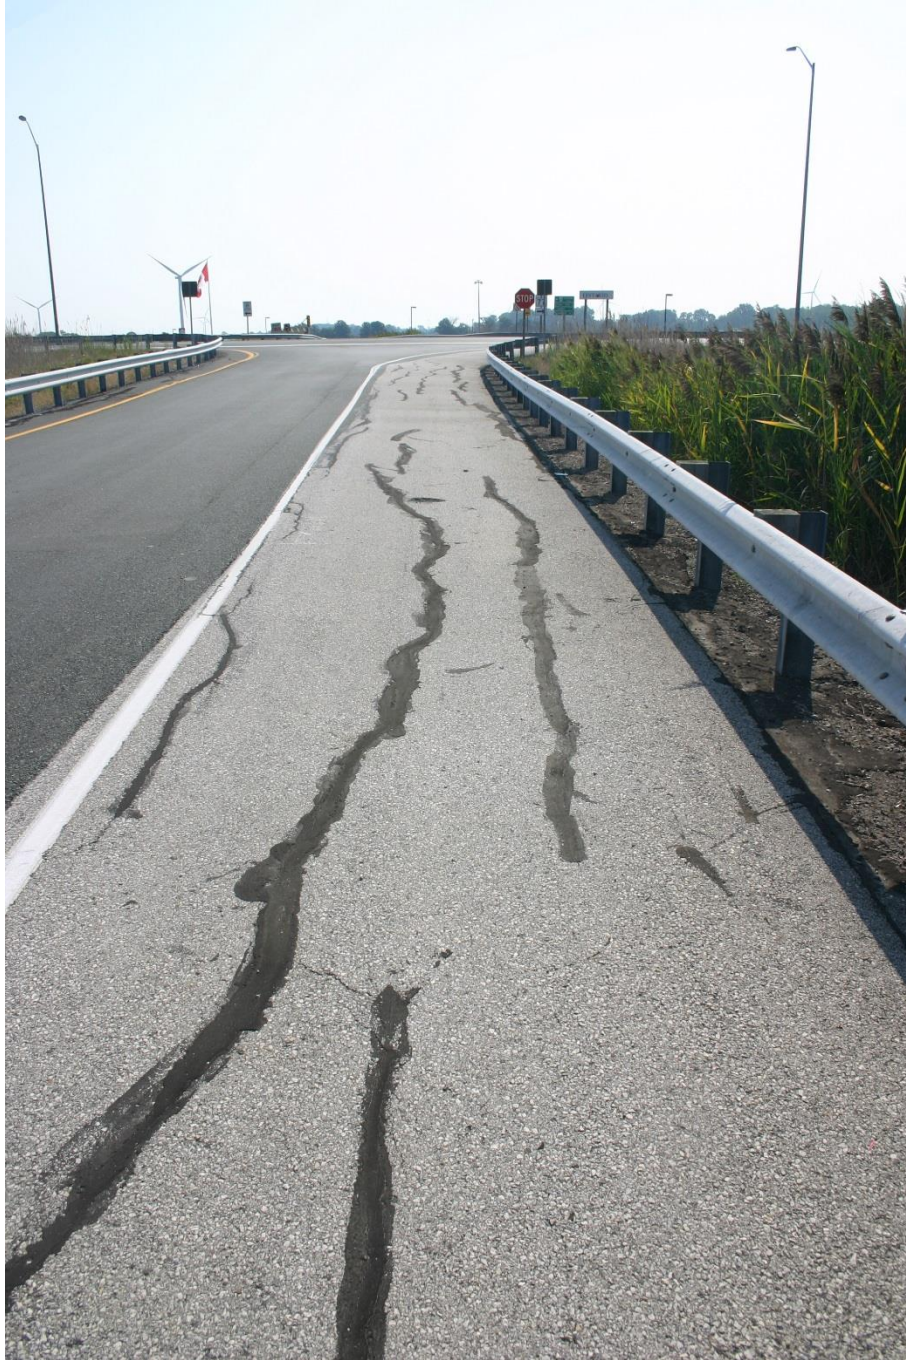
Along the W-N/S Ramp to the west of Highway 77, tension cracks that had reportedly been observed previously at the crest of the embankment above the culvert have been filled with asphalt. Since the time of the last patching of the cracks, it is understood that neither new significant cracks have appeared, nor have the previous cracks opened further. The most severe deformation and cracking were observed above the 72-inch diameter concrete culvert that runs below the ramp embankment. Near the north crest of the embankment, the tension cracks extended about 22 m west and about 18 m east of the culvert centreline. Near the south crest of the embankment, the tension cracks extended over a similar length. Less severe cracking extended for about 100 m west of the culvert centreline. From a foundation engineering standpoint, the 72-inch diameter concrete culvert was visually inspected and the culvert grade appeared to be straight and there was no visual evidence of distortion and/or differential settlement of the culvert at the time of the site visit.

Looking east at south shoulder of eastbound off-ramp from Highway 401 to Highway 77
(August 17, 2015)

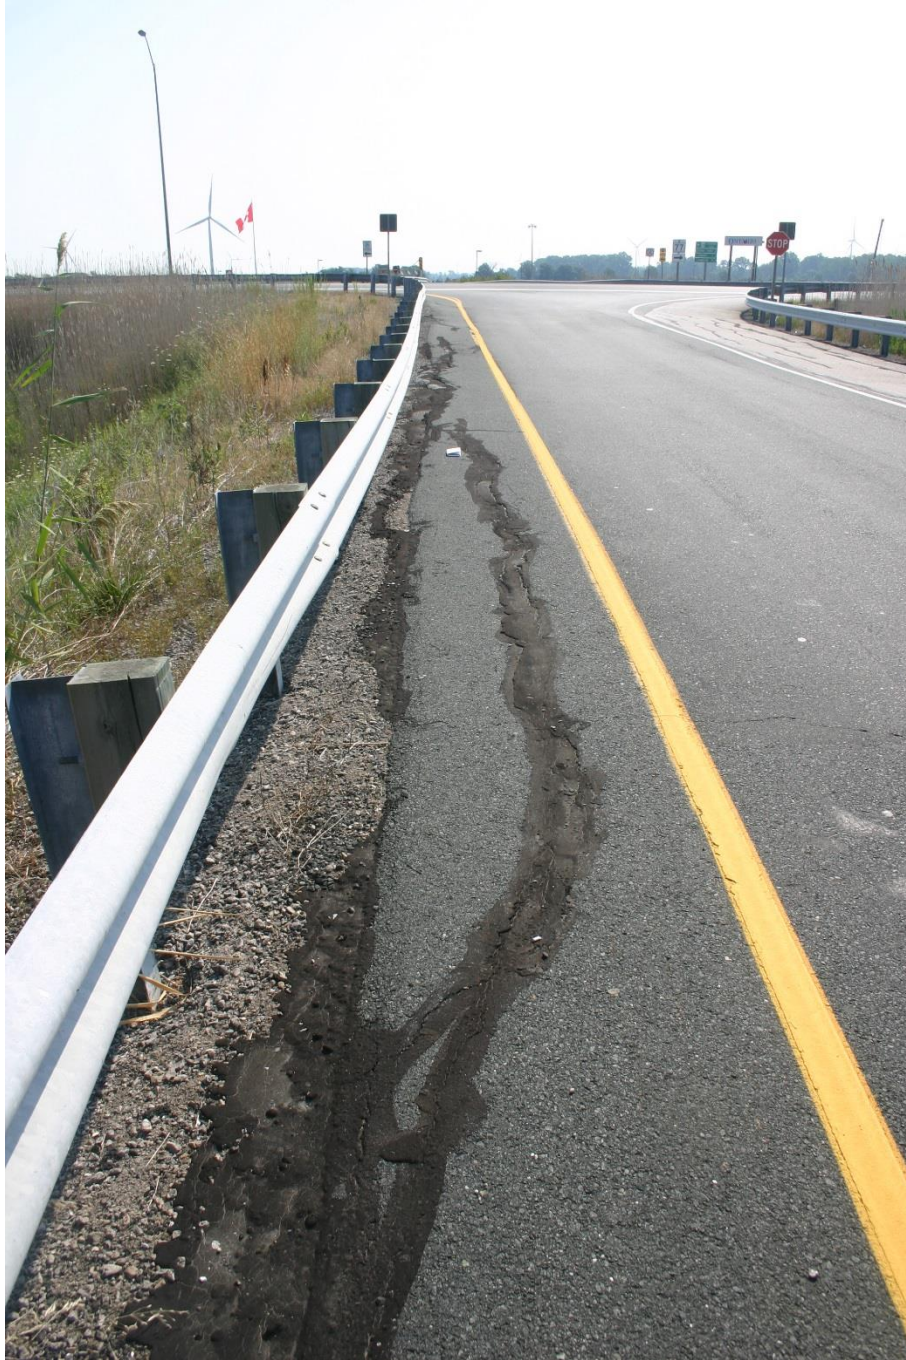
Looking east at north shoulder of eastbound off-ramp from Highway 401 to Highway 77
(August 17, 2015)

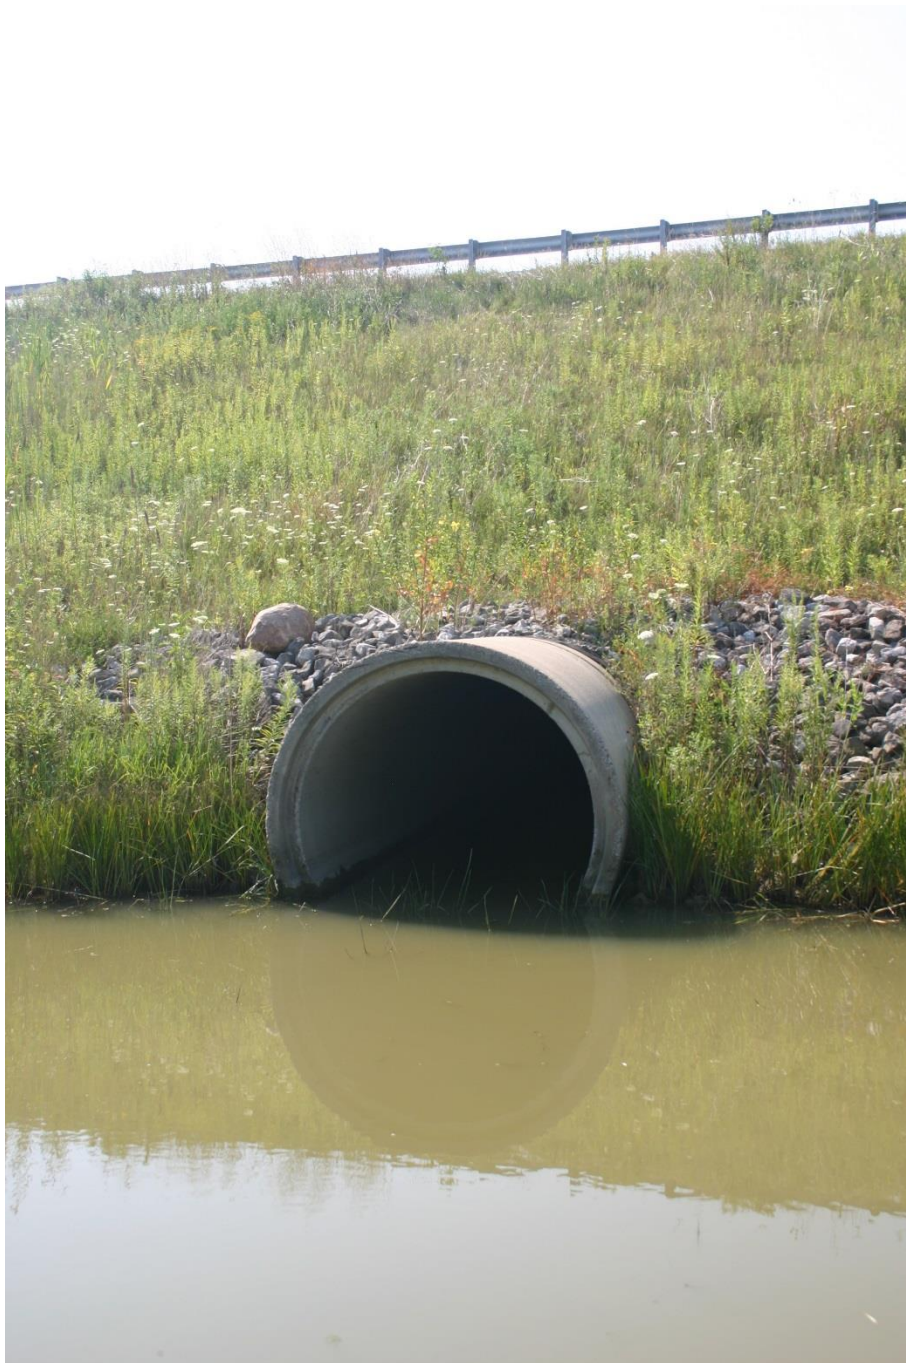
Since culverts underlie Areas A and B, it is possible that some of the observed surficial settlement is attributed to culvert settlement. Since there is no visual evidence of distortion and/or differential settlement, any culvert settlement that might have occurred was likely uniform along the culvert alignment. It is also anticipated that such settlement, if present, has completed over the years.

Looking south at north end of culvert below eastbound off-ramp from Highway 401 to Highway 77
(August 17, 2015)

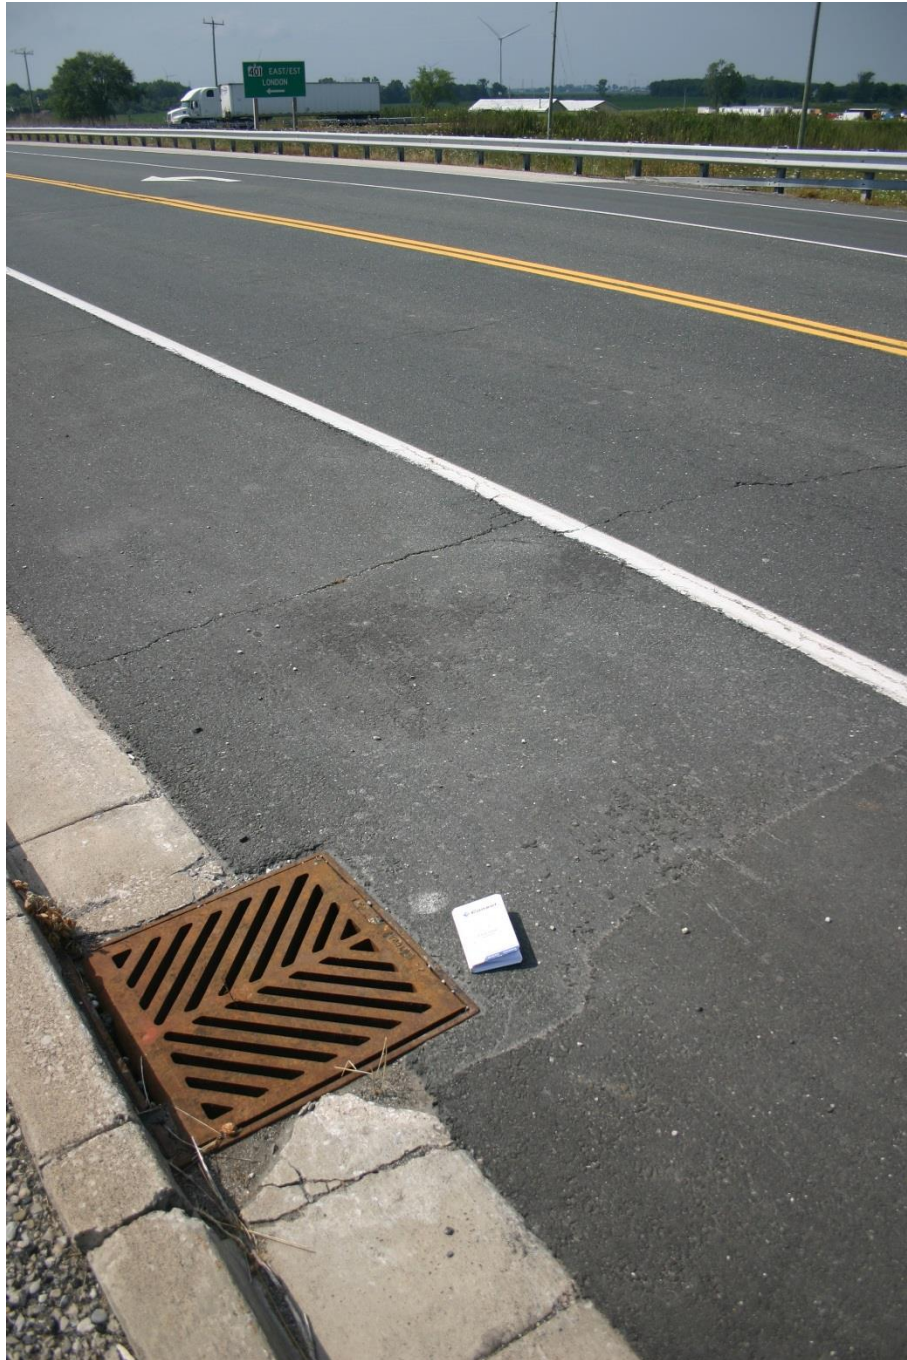
settlement. Further to the north, a second section of pavement (Area C) appeared to have been repaired over two 16 m long lengths. While the timing of the repairs is not known, there was no visual evidence at the time of the site visit of significant further embankment settlement since completion of the repairs.

Looking south at boundary of patches at south abutment along Highway 77
(August 17, 2015)

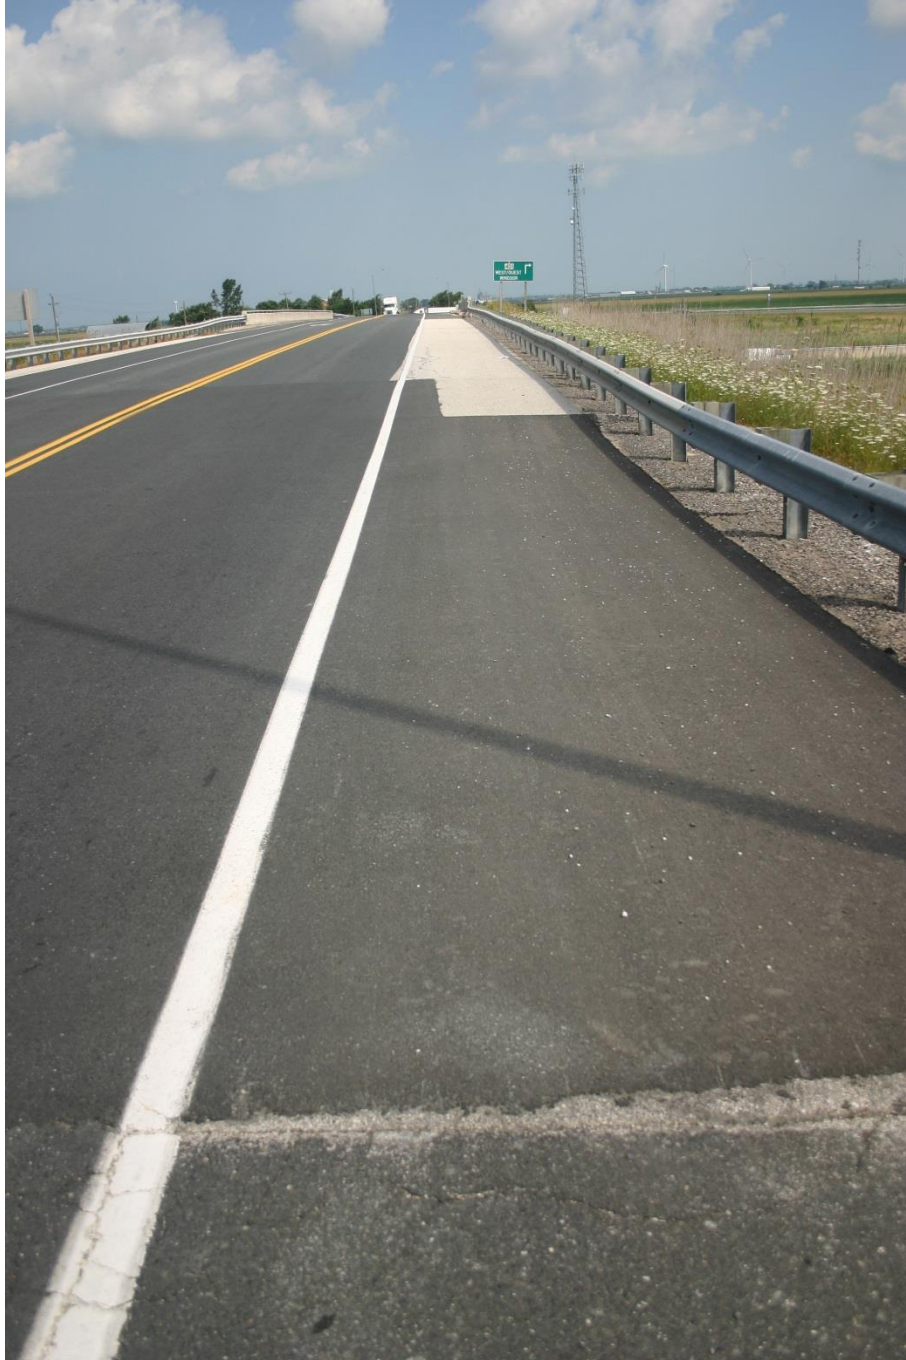
Along the south approach, there are two sections of pavement patching/overlay north of the W-N/S Ramp. The first patch section (Area B) is approximately 19 m long and is located above, and centred over, a 36-inch diameter concrete culvert that runs below the approach embankment. From a foundation engineering standpoint, this culvert was also visually inspected and showed no evidence of distortion and/or differential

Looking north at patch above 36 inch diameter concrete culvert along Highway 77
(August 17, 2015)

- full width of ramp (transverse).
- Area B – from 10 m north to 10 m south of 36-inch diameter culvert centreline (longitudinal)
 - full width of south approach (transverse).
- Area C – 20 m long north to south to include two repaired cracks (longitudinal)
 - full width of south approach (transverse).

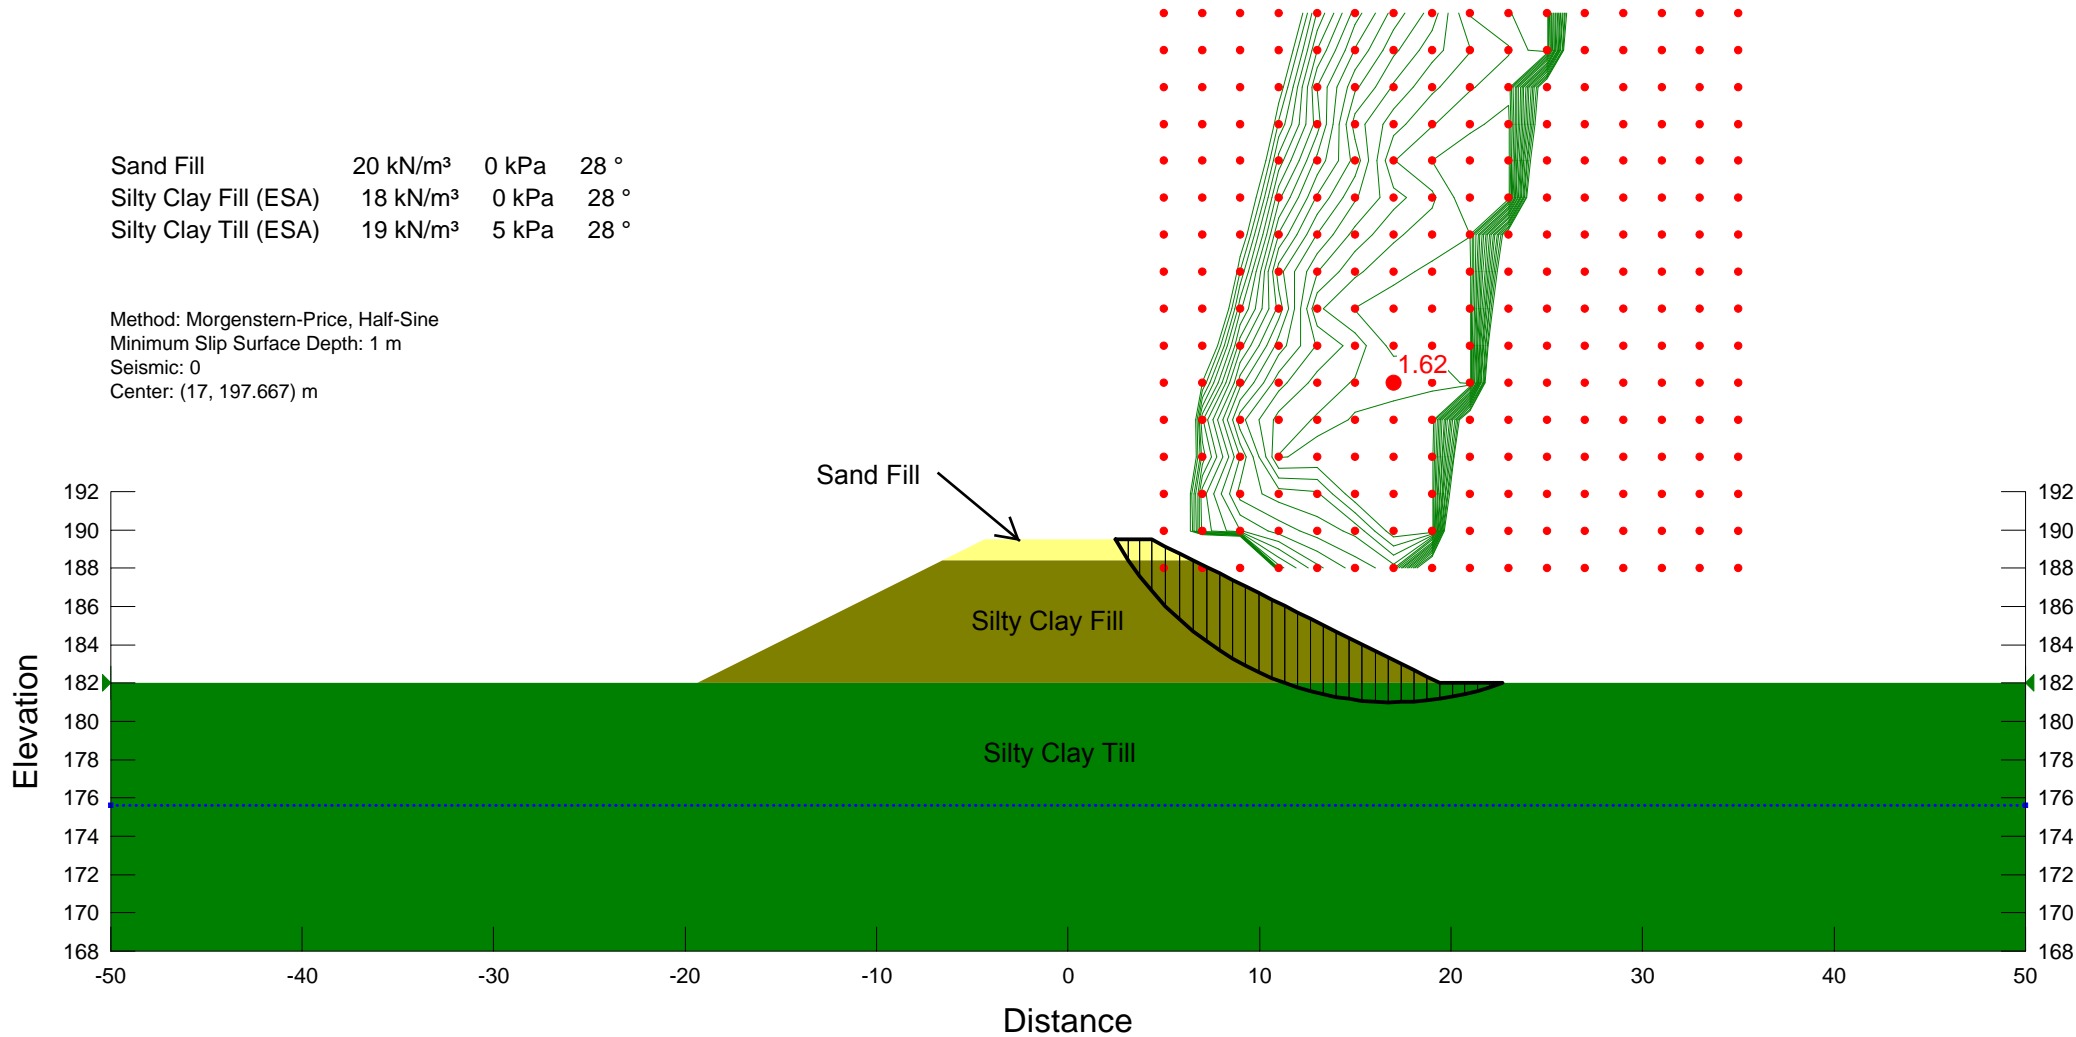
The above results indicate that the long-term conditions generally satisfy the minimum Factor of Safety (F.S.) of 1.5 acceptable to MTO. Figures E1 to E3 in Appendix E provide graphical presentations of the results summarized above.

Based on these results, our site observations and background information from MTO, global stability is not considered to be a contributing factor to the reported embankment distress and pavement cracking.

GLOBAL STABILITY – SECTION B-B (ESA) HIGH FILL APPROACH AND RAMP EMBANKMENT SETTLEMENT HIGHWAY 77 / 401 INTERCHANGE

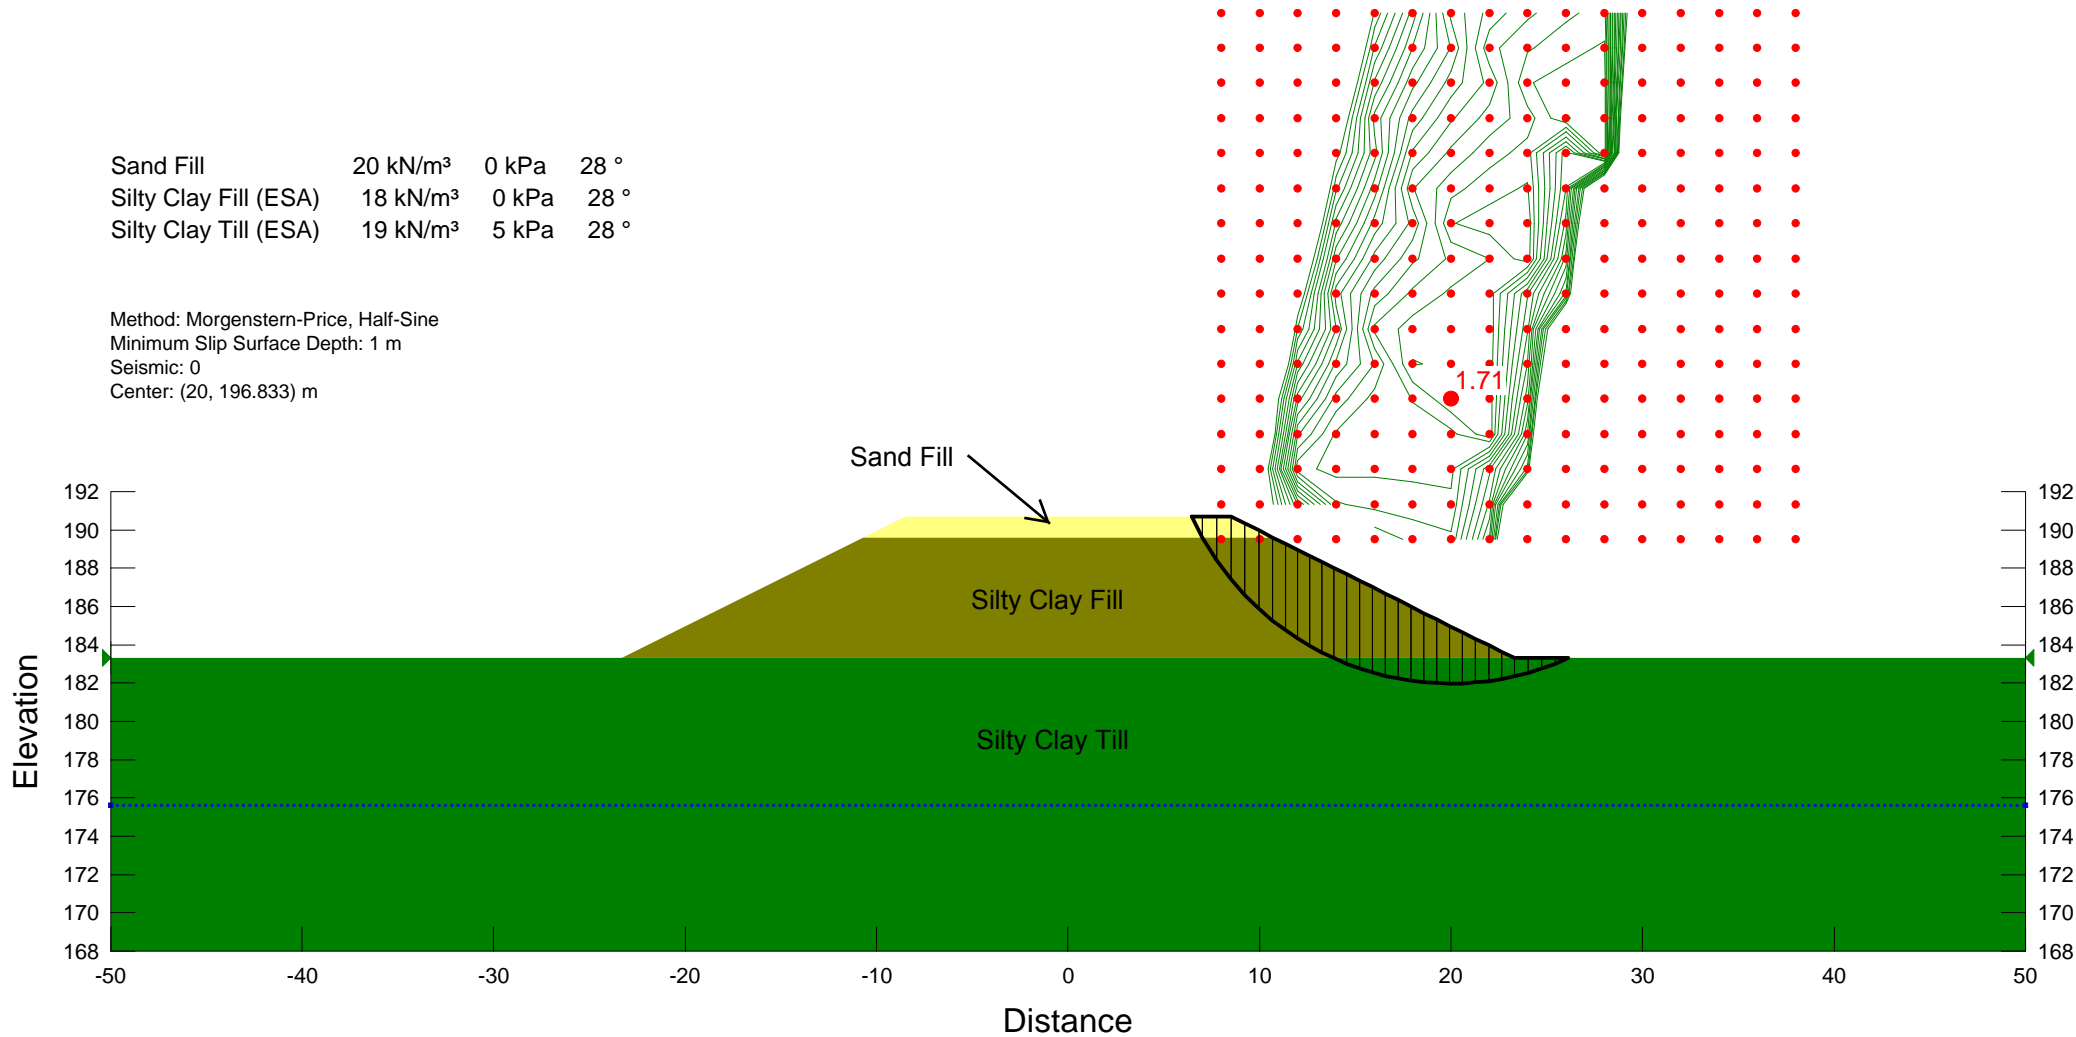
FIGURE E2

GLOBAL STABILITY – SECTION C-C (ESA) HIGH FILL APPROACH AND RAMP EMBANKMENT SETTLEMENT HIGHWAY 77 / 401 INTERCHANGE
