FOUNDATION INVESTIGATION REPORT

HIGHWAY 9, TEESWATER RIVER BRIDGE REHABILITATION

(SITE No. 2-256)

Report Number: 1534424-5002C-R01

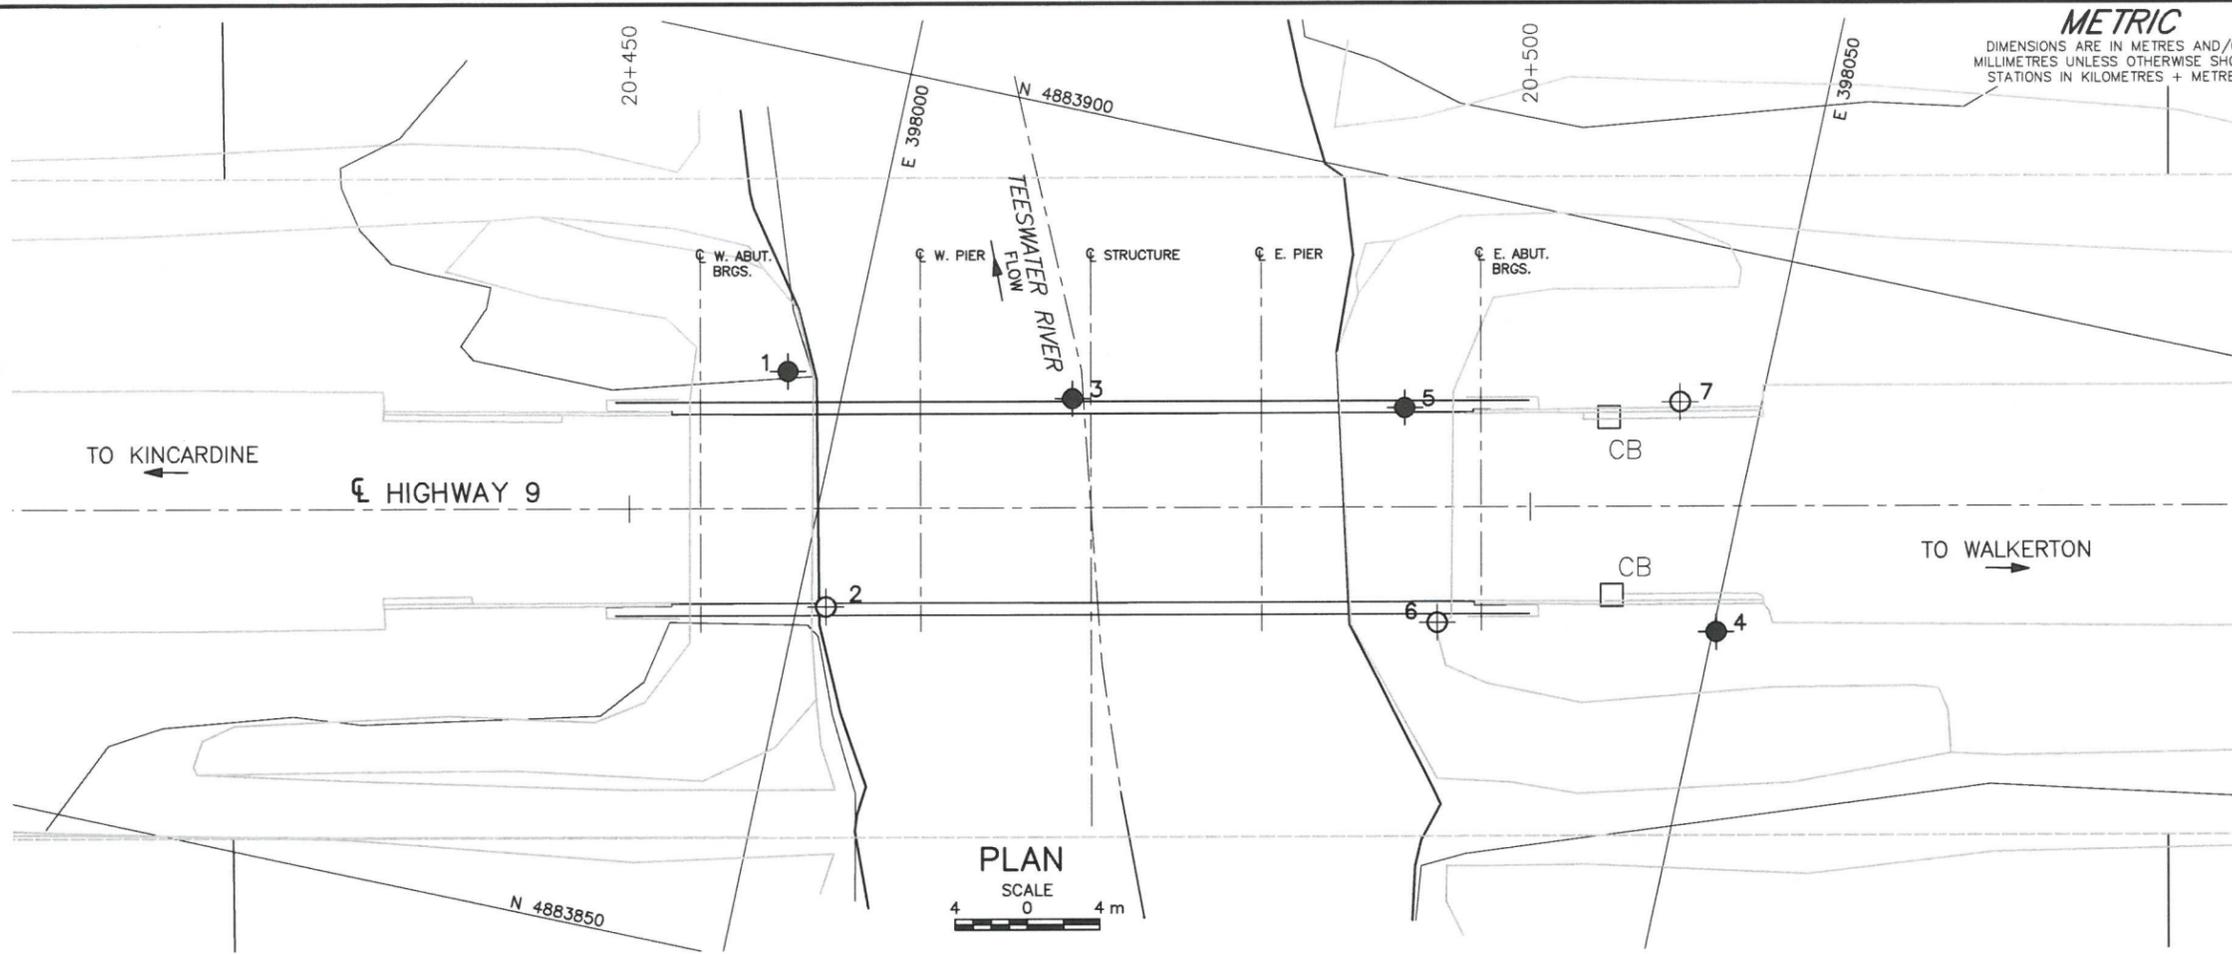
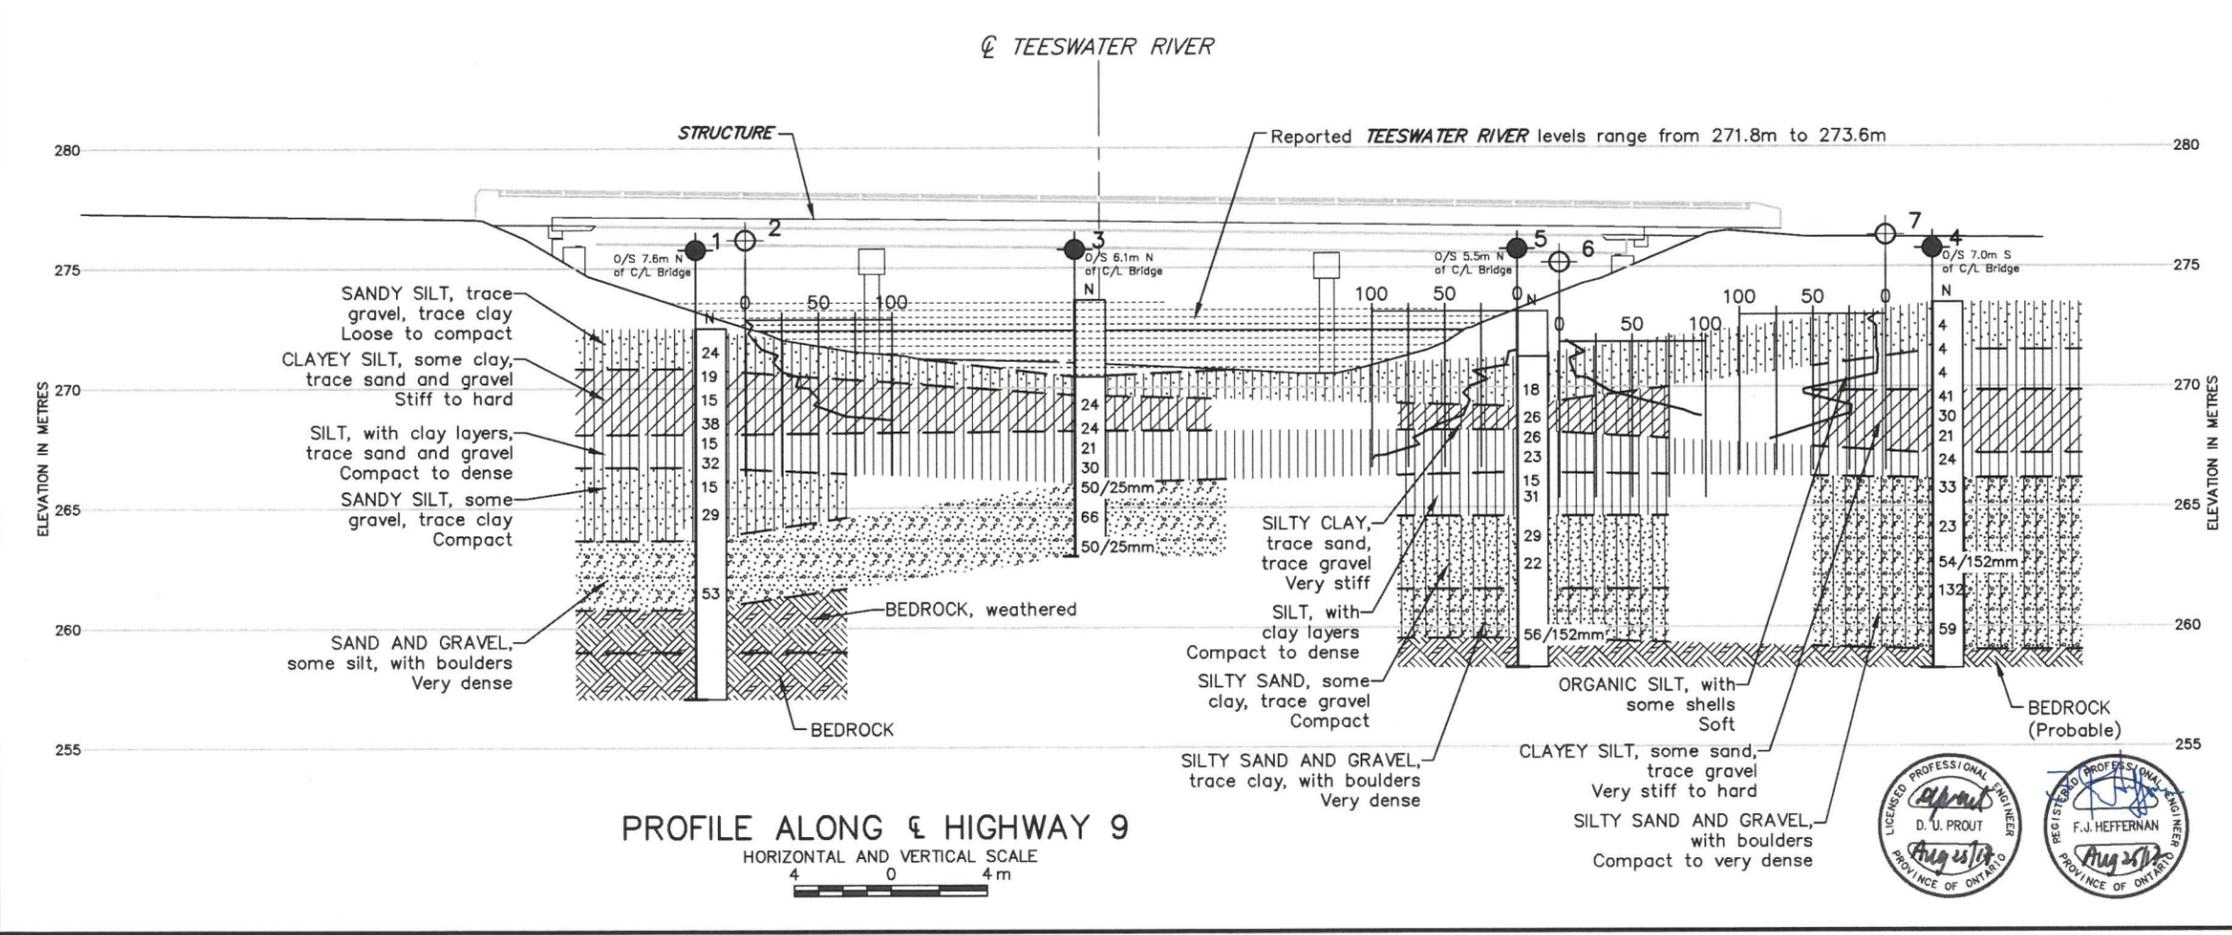
CONT No. WP No. 3025-14-00
 TEESWATER RIVER BRIDGE
 STRUCTURE REHABILITATION
 BOREHOLE LOCATIONS AND SOIL STRATA

A layer of sandy silt was found at ground surface or formed the river substrate at boreholes 1, 3, 4 and 5. The thickness of the sandy silt stratum varied between 0.8 and 2.1 metres. The sandy silt was very loose to compact with standard penetration test (SPT) N values ranging from 4 to 24 blows per 0.3 metres. The sandy silt is of low plasticity based on a single sample with liquid and plastic limits of 39 and 36 per cent, respectively.

Organic silt was encountered at elevation 271.5 metres in borehole 4 below the sandy silt deposit. The organic silt layer was about 1.7 metres thick and had SPT N values of 4 blows per 0.3 metres. The organic silt had water contents of 77 and 95 per cent.

Layers of clayey silt and/or silty clay were encountered beneath the sandy silt in boreholes 1, 3 to 5 and beneath the organic silt in borehole 4. These cohesive soils were encountered between elevation 269.2 and 271.5 metres and were 1.8 to 3.7 metres thick. The very stiff to hard cohesive soils had SPT N values of 15 to 41 blows per 0.3 metres and water contents of about 13 to 18 per cent. The cohesive deposits are of low to intermediate plasticity based on liquid limits of 18 to 38 per cent and plastic limits of 13 to 20 per cent.

Granular deposits, ranging in gradation from silt to sand and gravel, were encountered in boreholes 1 and 3 to 5 beneath the clayey silt from elevation 266.2 and 269.7 metres. The thickness of the granular layers ranged from about 6.9 to 7.3 metres thick.

Borehole 3 was terminated in a sand and gravel layer after exploring it for about 3.1 metres. The granular deposits had SPT N values of 15 to over 100 blows per 0.3 metres. The sand and gravel deposits below approximate elevation 263.7 metres were very dense while the overlying silt to silty sand deposits were loose to dense. Boulders were noted in the sand and gravel deposits. Water contents ranged between 8 to 25 per cent with silt layers having water contents of 21 per cent and above. The silt deposits contain clay layers and are of low plasticity based on liquid limits of 25 and 27 per cent and plastic limits of 19 and 20 per cent.

Limestone bedrock was encountered beneath the sand and gravel layer in borehole 1 at elevation 260.8 metres or a depth of 11.7 metres. Borehole 1 was terminated in the bedrock after it was cored to a depth of 3.7 metres below the bedrock surface. The bedrock in borehole 1 was described as weathered from elevation 259.0 to 260.8 metres, and sound from elevation 257.0 to 259.0 metres. Boreholes 4 and 5 were terminated in inferred bedrock at elevations 259.0 and 259.5 metres after penetrating the rock for 0.8 and 1.2 metres, respectively.

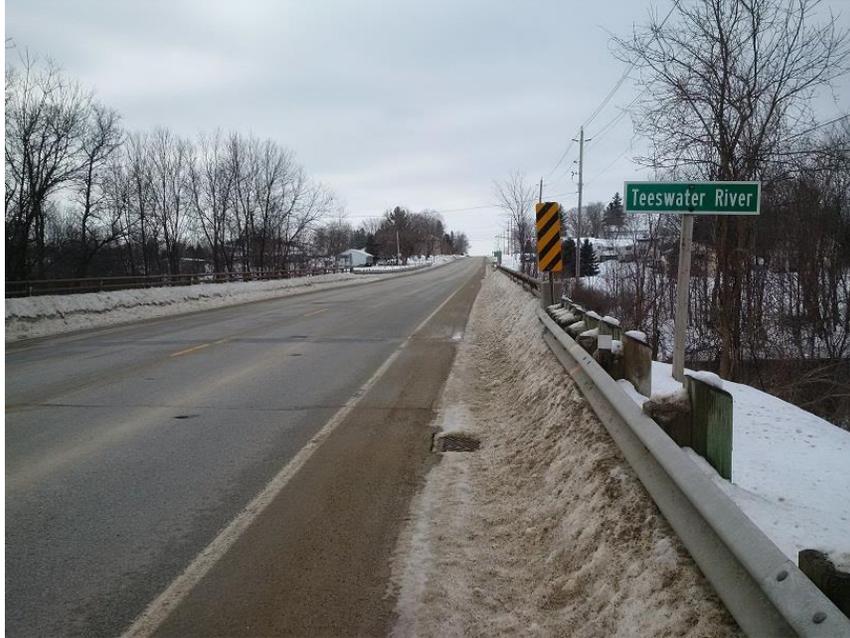
Photograph 1: East end of bridge, looking west.

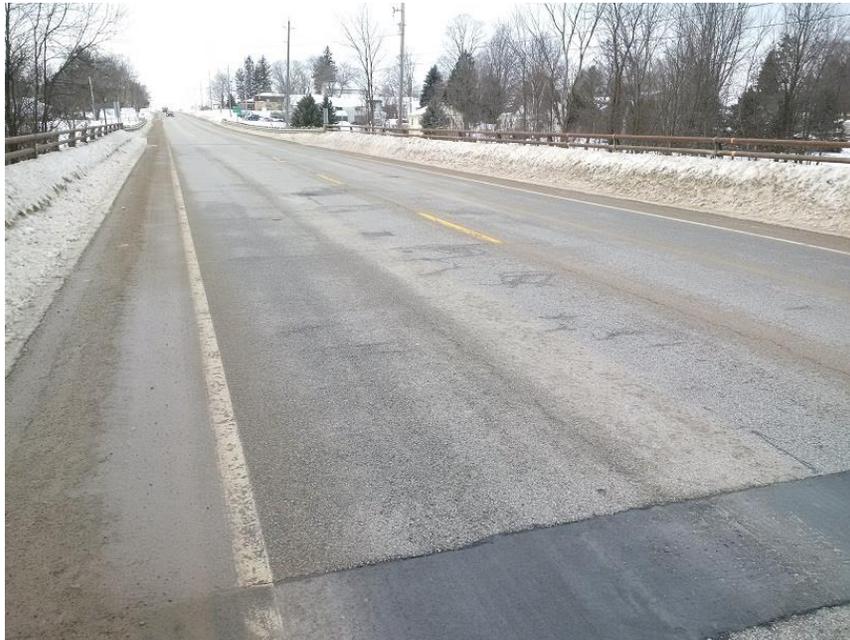
Photograph 2: East end of bridge, looking west.

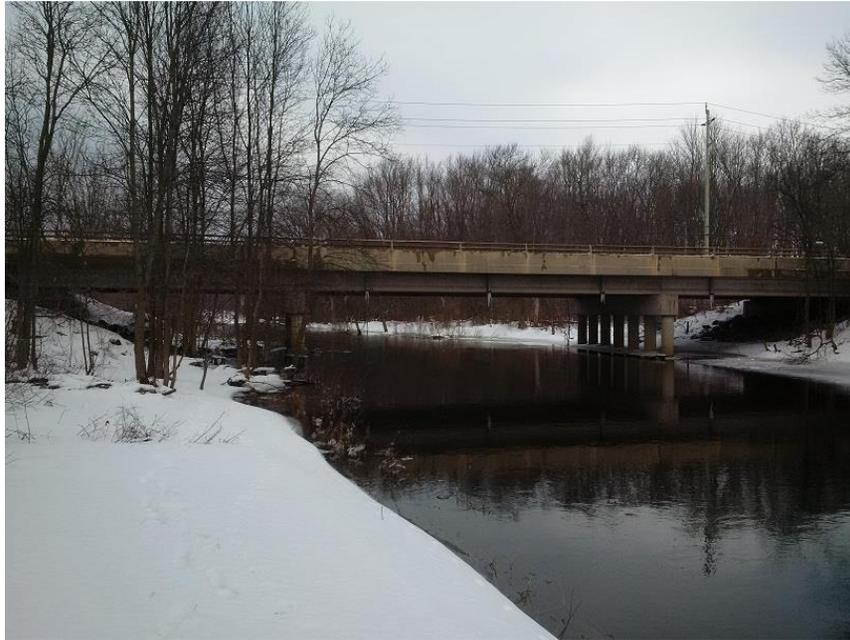
Photograph 3: South elevation.

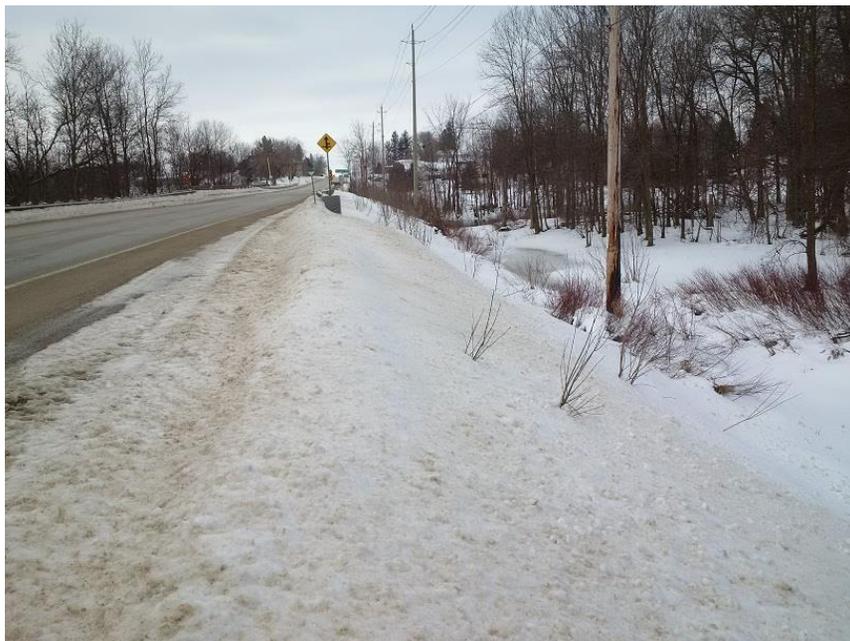
Photograph 4: Embankment sideslope in northeast quadrant.

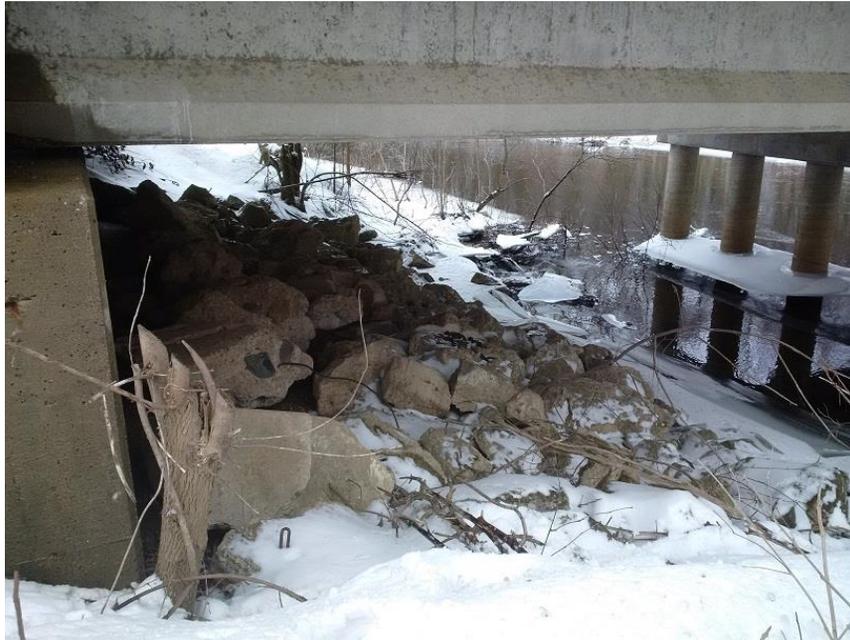
Photograph 5: West abutment, looking north.

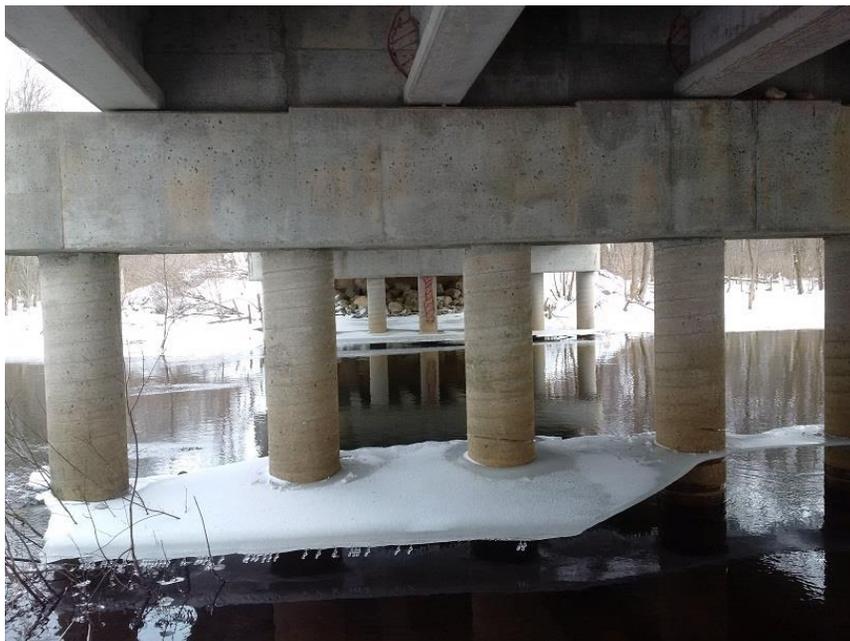
Photograph 6: Looking east under bridge.

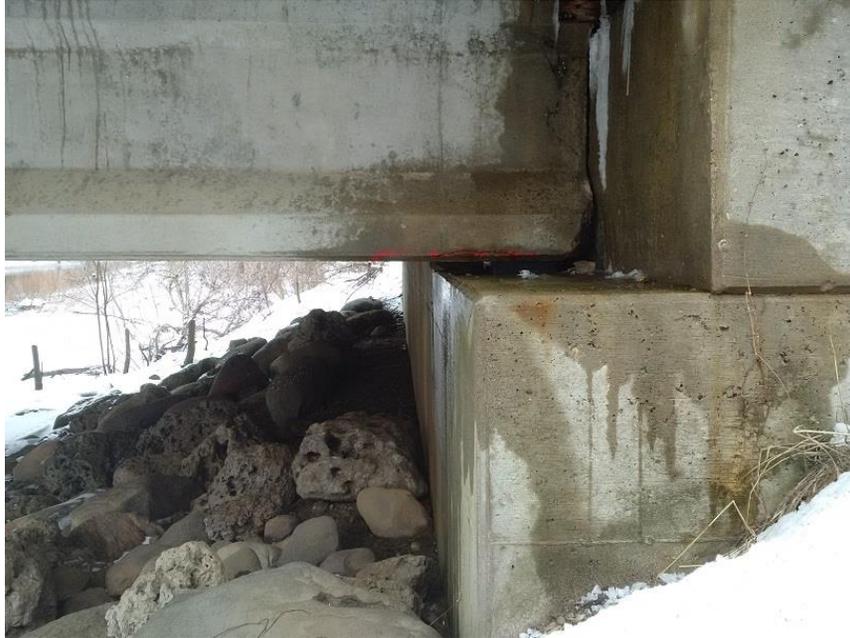
Photograph 7: East abutment, looking north.

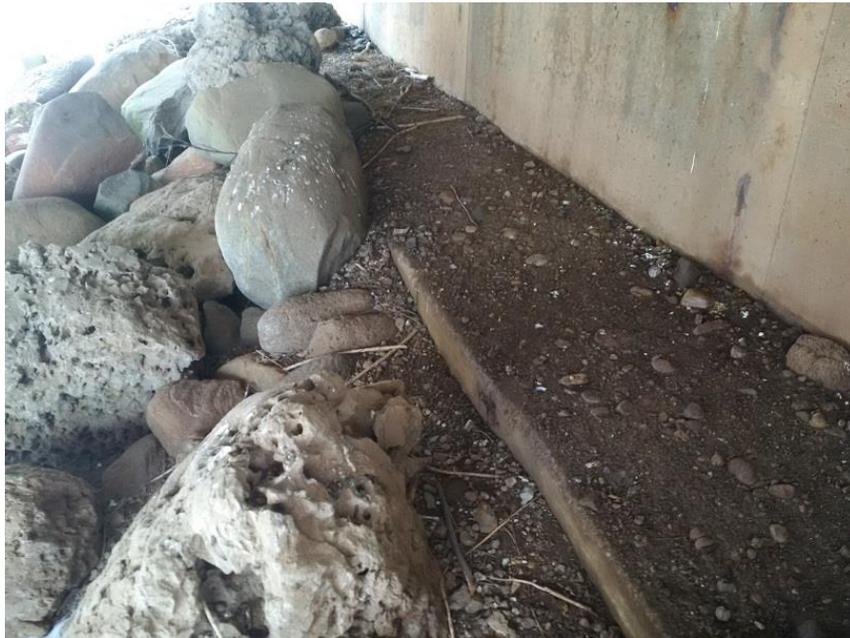
Photograph 8: Partially exposed pile cap at east abutment.
