**TECHNICAL MEMORANDUM  
For  
HIGHWAY 6/21  
EMBANKMENT INVESTIGATIONS (PART A)  
SPRINGMOUNT TO OWEN SOUND AREA, ONTARIO  
GWP 3068-12-00 AND 3071-14-00**

PML Ref.: 15KF036A  
Index No.: 011TM  
Geocres No.: 41A-237  
January 12, 2016

For  
Highway 6/21  
Embankment Investigations (PART A)  
Springmount to Owen Sound Area, Ontario  
GWP 3068-12-00 and 3071-14-00

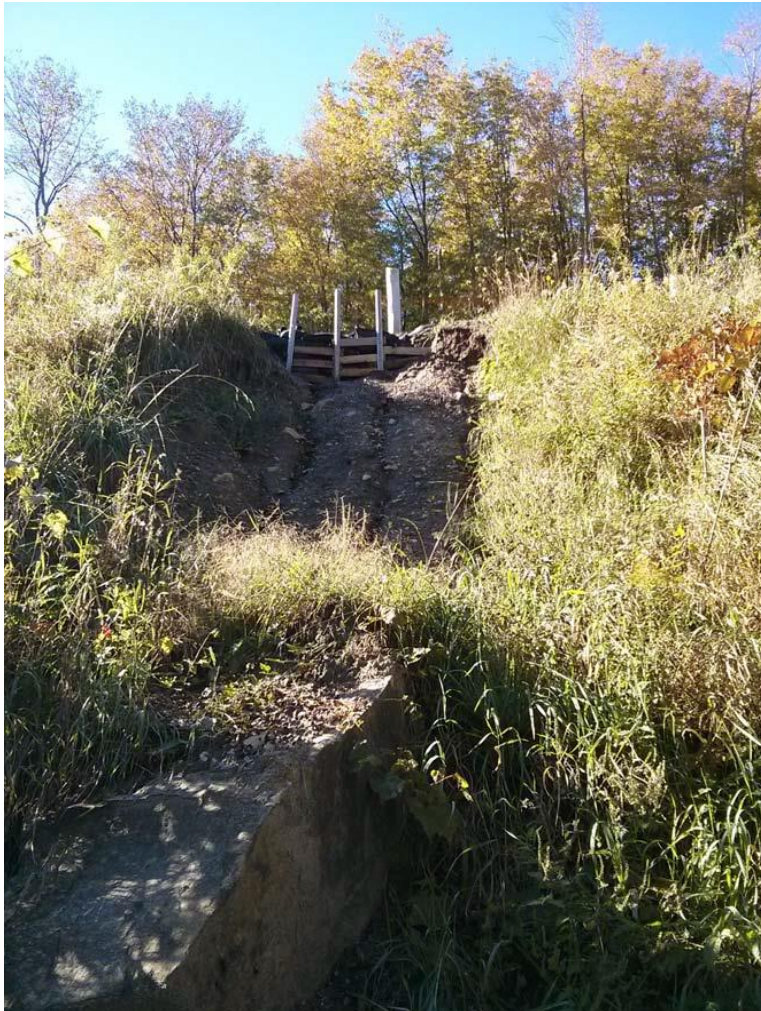
These types of instabilities are the result of the marginally stable 1.7H:1V slope geometry for earth fills exacerbated by uncontrolled surficial runoff. They are typified by surficial gullying, as illustrated

in the photos of the previous slope instability in the report referenced in Section 2, and can potentially evolve into deep gullies that could destabilize the embankment and create a safety risk for the travelling public. Although the extent of gully erosion is currently limited to areas where there is uncontrolled surface drainage down the slopes, this type of erosion can extend to other areas depending on the locations where erosion from uncontrolled surface drainage occurs. Consequently, the remediation should address the entire north slope of the Highway 6/21 embankment between 420 m and 570 m east of the intersection of Highway 6/21 and County Road 18 rather than individual localized instabilities.

**Photo 4** (from previous report): Looking Southward (toward Highway) from north toe of slope showing erosion gullies and soil deposition along slope failure on north side of highway. (2013)

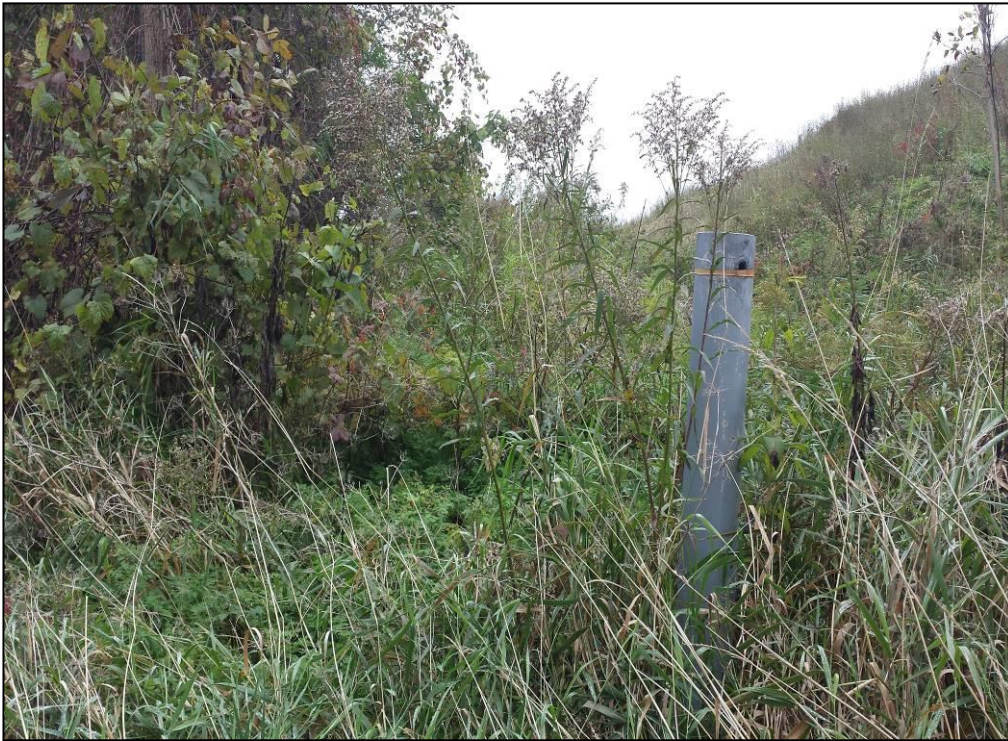
**Area 1** was identified at approximate Sta. 21+830 to Sta. 21+930 as a possible 100 m long location of instability by MTO personnel during the site reconnaissance. However, no significant signs of slope instability were identified in this area (refer to photographs 1 to 3 in Appendix C).

**Photograph 1:** Area 1 - Looking northwest from the location of existing CSP culvert. Heavily vegetated slope and stand of trees are visible. (October 6, 2015)

No significant signs of slope instability were identified in Area 1 at the time of the investigation despite on-site consultation with MTO district staff. Although rehabilitation is not required at this area, it is recommended that periodic inspection of the site should be conducted by MTO personnel to confirm that the conditions have not changed.

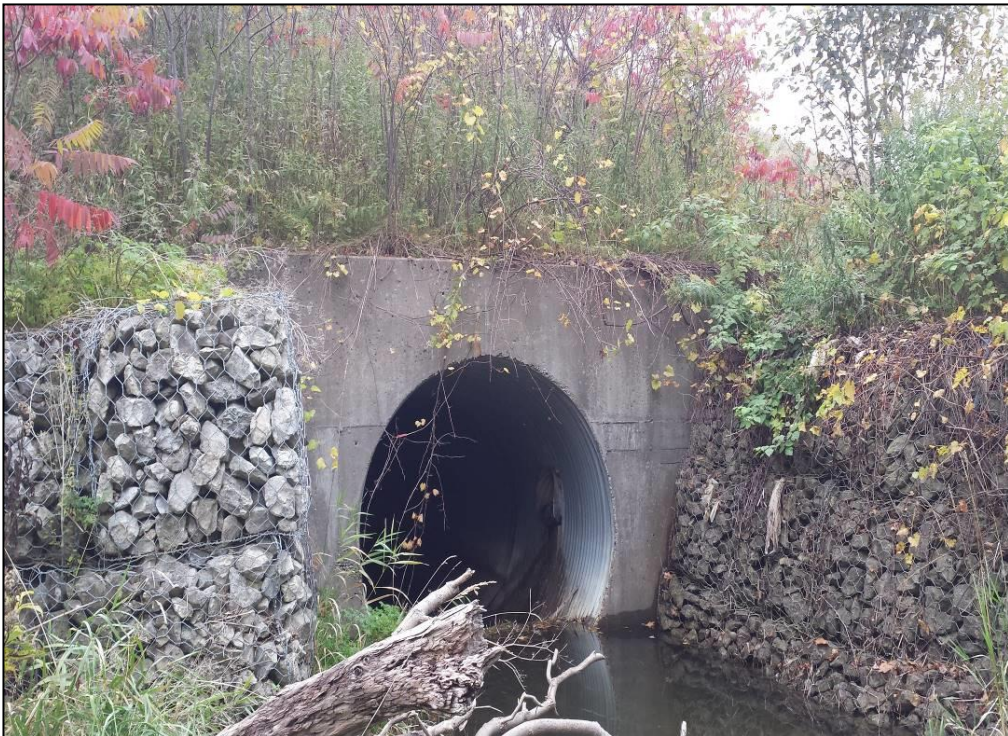
During the site reconnaissance of Area 1, it is noted that a CSP culvert is located at approximate Sta. 21+930 and carries the water from south to north direction into the Pottawatomi River. The highway embankments at westbound and eastbound lanes were heavily vegetated with grasses, bushes and trees and were sloped at approximately 1.7H:1V. The adjacent areas at the culvert inlet were covered with rip-rap. No obvious major cracks were observed on the shoulder of west and eastbound lanes, except some surficial cracks.

**Photograph 2:** Area 1 - Looking north at the location of existing CSP culvert. The culvert inlet and rip-rap protection is visible. (October 6, 2015)

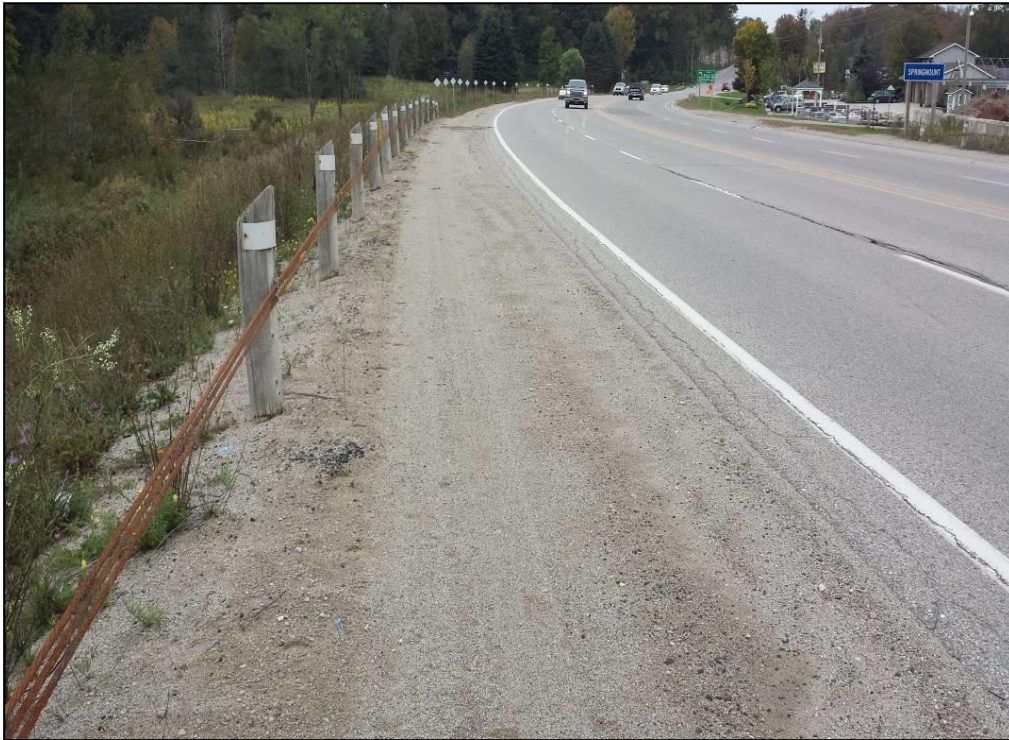
**Photograph 3:** Area 1 - Looking west from the Hwy 6/21 eastbound lane shoulder at approximate location of the existing CSP culvert. Minor surficial cracks are visible along the shoulder. (October 6, 2015)

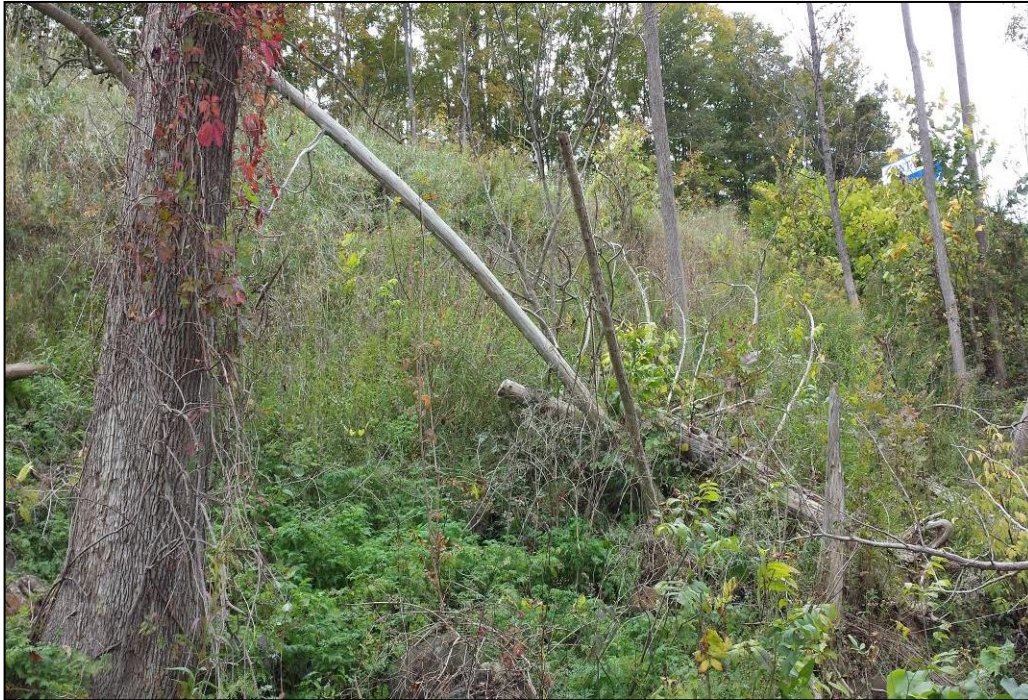
**Photograph 4:** Area 2 - Looking up from bottom of the slope. Heavily vegetation and trees are visible. (October 6, 2015)

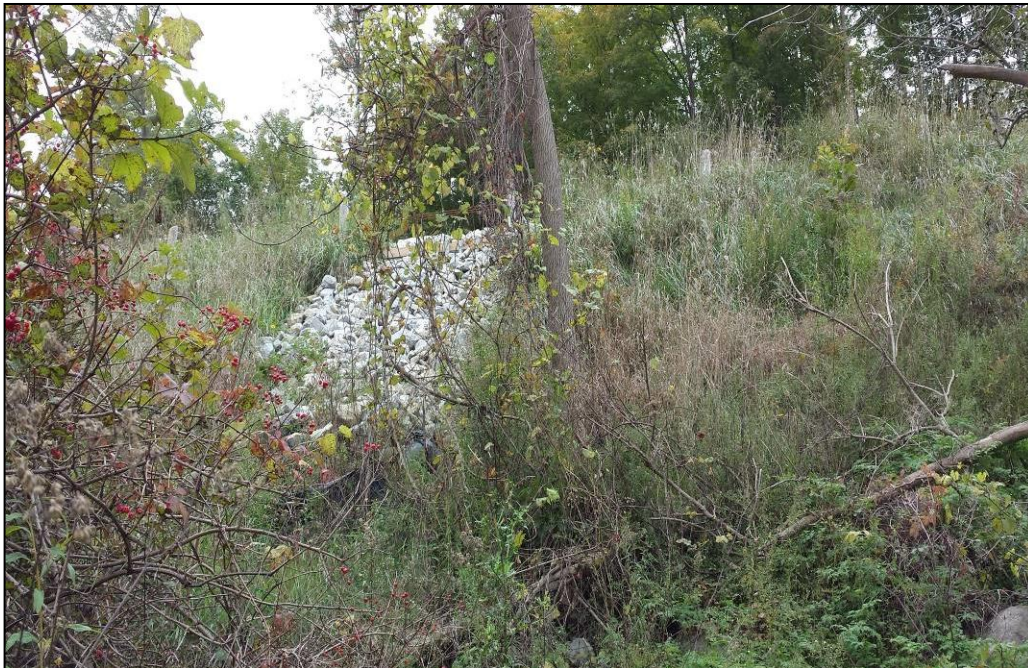
The ground beyond the paved areas of the highway is heavily vegetated and consists of grasses, bushes and stands of trees. Previous remedial treatments for a major surficial slope instability were observed at about 450 m east (Approximate Sta. 21+350) of the Highway 6/21 and County Road 18 intersection. Other minor surficial slope instabilities were noted at approximately 425 and 515 m east of the intersection (approximate Sta. 21+330 and 21+420), but were considered to be of minor significance as evidenced by the continuity of vegetation cover.

**Photograph 5:** Area 2 - Looking up from bottom of the slope. Heavily vegetation and the rock protection remediation at the previous slope failure are visible. (October 6, 2015)

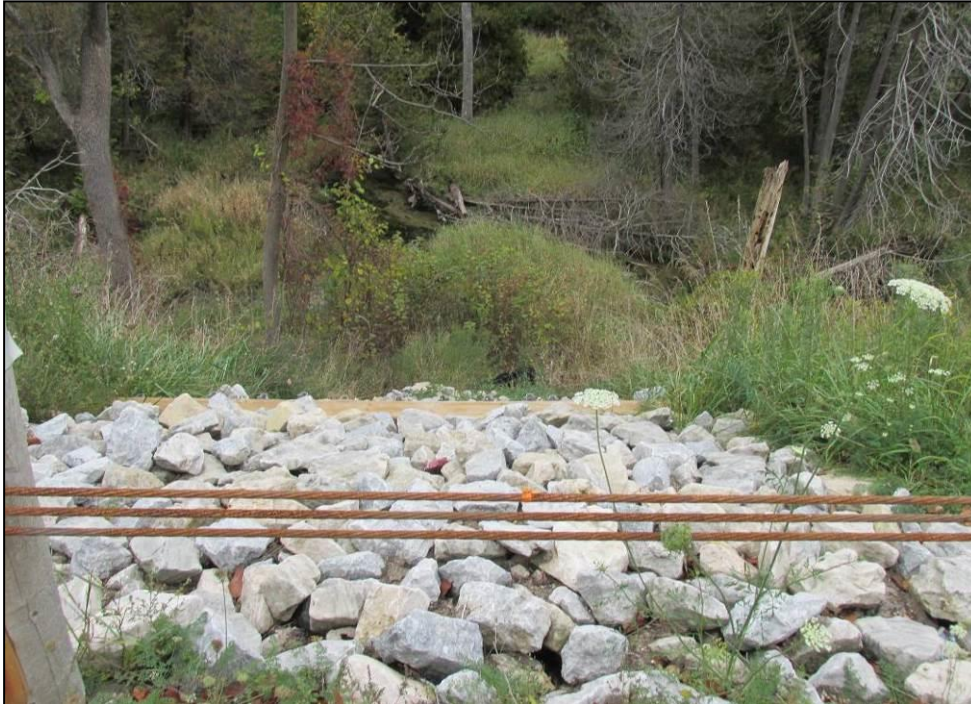
**Photograph 6:** Area 2 - Looking down from top of the slope. Previous remedial measure for the surficial slope instability. (October 6, 2015)

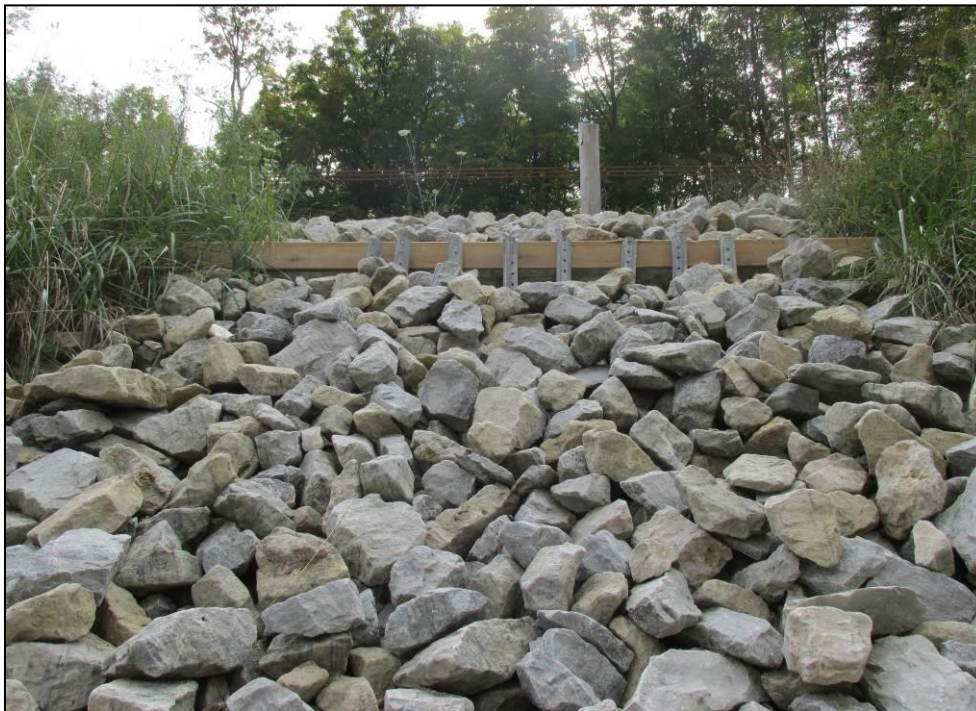
**Photograph 7:** Area 2 - Looking up from toe of the slope. Previous remedial measure for the surficial slope instability and partial timber cribbing is visible (October 6, 2015)

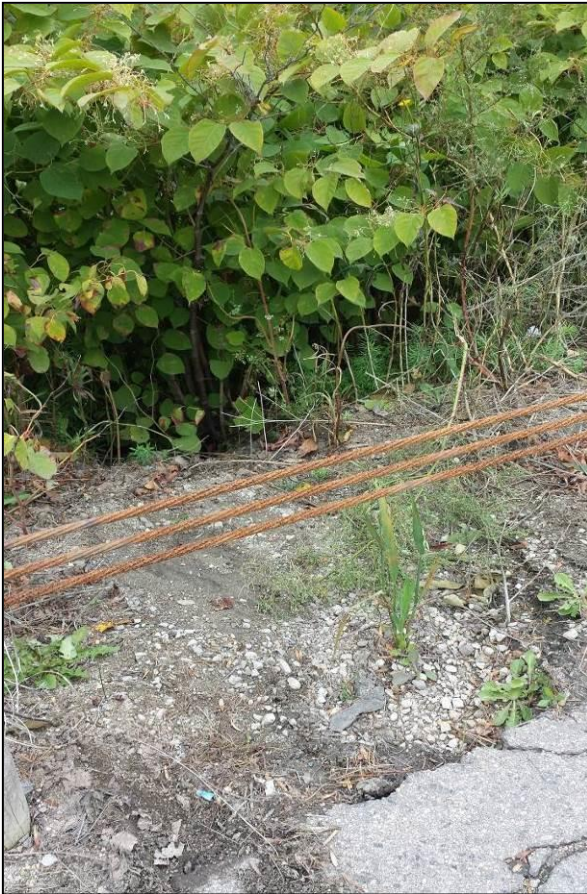
Pavement distress consisting of minor cracking was observed along the westbound lane shoulder of the highway. These distresses have been caused by uncontrolled surficial drainage resulting in minor erosion and loss of support and confinement for the pavement and shoulder materials.

**Photograph 8:** Area 2 – Surficial erosion on the westbound lane shoulder. (October 6, 2015)

1. Bi-weekly inspection of the site by MTO personnel to confirm that the condition of the north side embankment slope and the pavement, shoulders and guardrails along the north side embankment have not changed. A brief inspection report should be prepared and filed. The appropriate MTO personnel should be alerted immediately if changes are observed.
2. Install asphalt curb and gutter along north side of embankment on the highway side of the existing guardrail (so as not to disturb the existing guardrail). The curb and gutter should provide a swale with minimum 100 mm confinement on the north side and discharge into the existing armoured channel located 450 m east of the centreline of the intersection of Highway 6/21 and County Road 18.

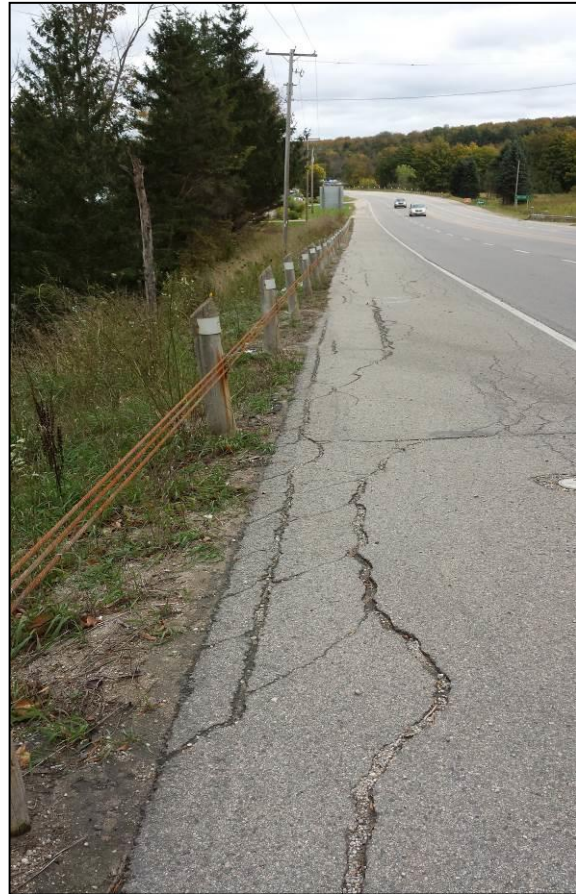
**Photograph 9:** Area 2 – Looking west from the location of the previous slope failure. Pavement distress and cracking along the westbound lane shoulder. (October 6, 2015)
