**Preliminary Foundation Investigation  
Report  
Ormond Street Overpass  
Replacement - Site No. 16X-0123/B0**

Highway 401 Rehabilitation  
Brockville, ON

Prepared for:  
Ministry of Transportation Ontario

February 2023

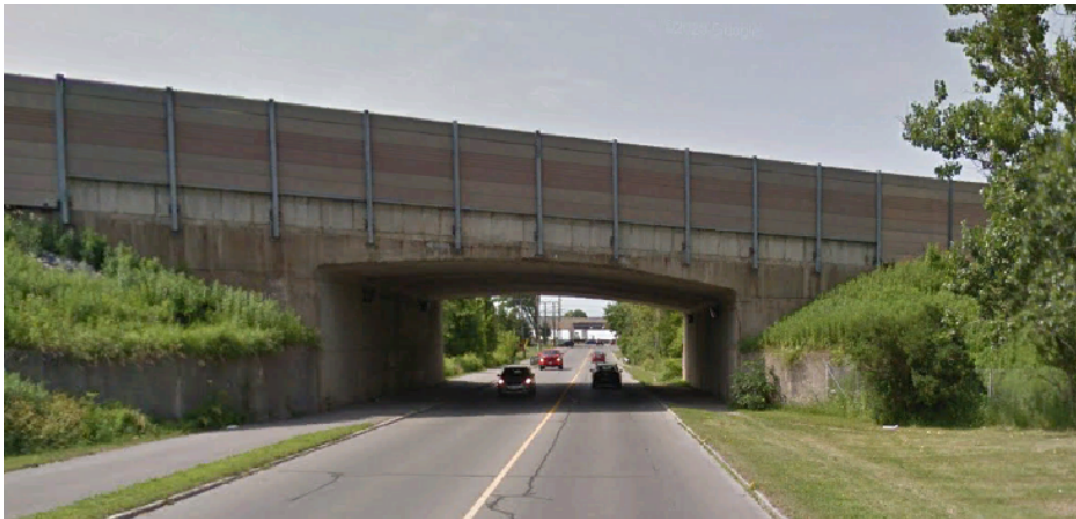
The existing bridge is a single-span, rigid frame structure constructed in 1958 (Contract 57-165). The overpass structure has a width of approximately 29 m and carries four lanes of traffic over Ormond Street. Curved retaining walls are present adjacent to the abutments in all four quadrants of the bridge. A photo of the bridge looking towards the north is provided below.

- No visible signs of settlement or deformation of the existing bridge structure were noted.
- The bridge soffit exhibits areas of delamination and spalls with exposed rebar, especially near the fascia, and there are narrow to wide vertical cracks in the abutment walls.
- The asphalt on the bridge surface displayed only minor cracking (one longitudinal crack/joint running down the centerline of the EBL and occasional transverse cracks).
- No signs of embankment settlement or significant instability were observed.

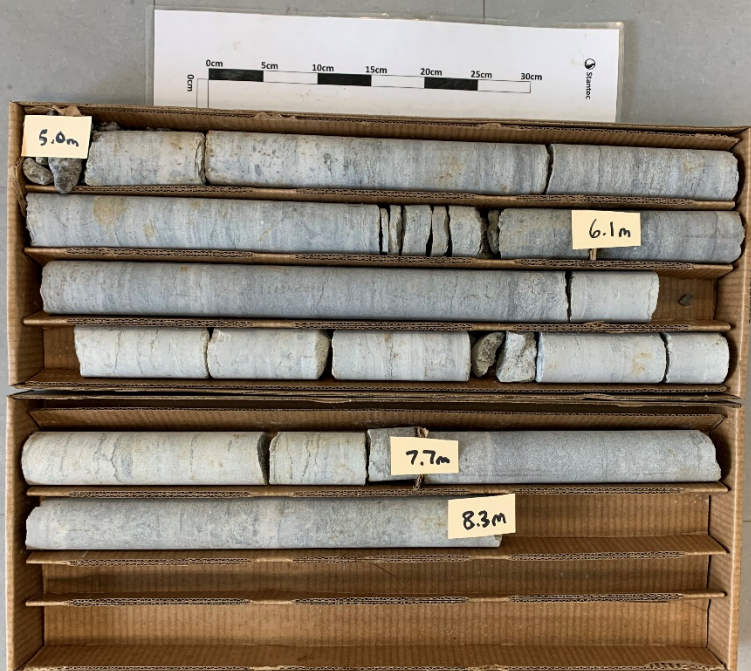
Rock Core Photo No.: 1

Borehole: BC21-1

Depth: 5.0 m to 8.3 m

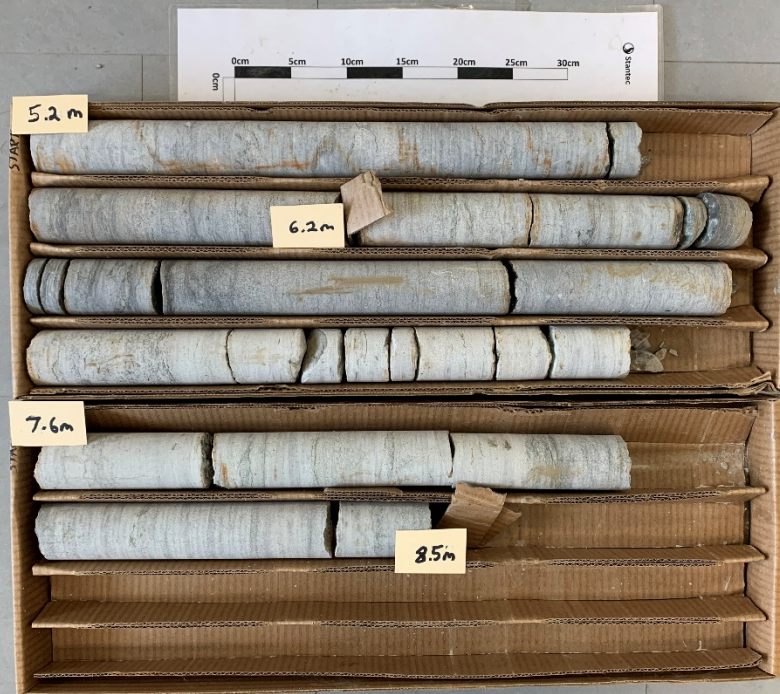
Rock Core Photo No.: 1

Borehole: OS21-1

Depth: 5.2 m to 8.5 m
