Geotechnical Assessment of Shotcrete on Access Road Rock Cuts

QEW Widening from West of Mississauga Road to West of Hurontario Street, Mississauga, Ministry of Transportation, Ontario, GWP 2002-13-00

1662333-4

July 20, 2018

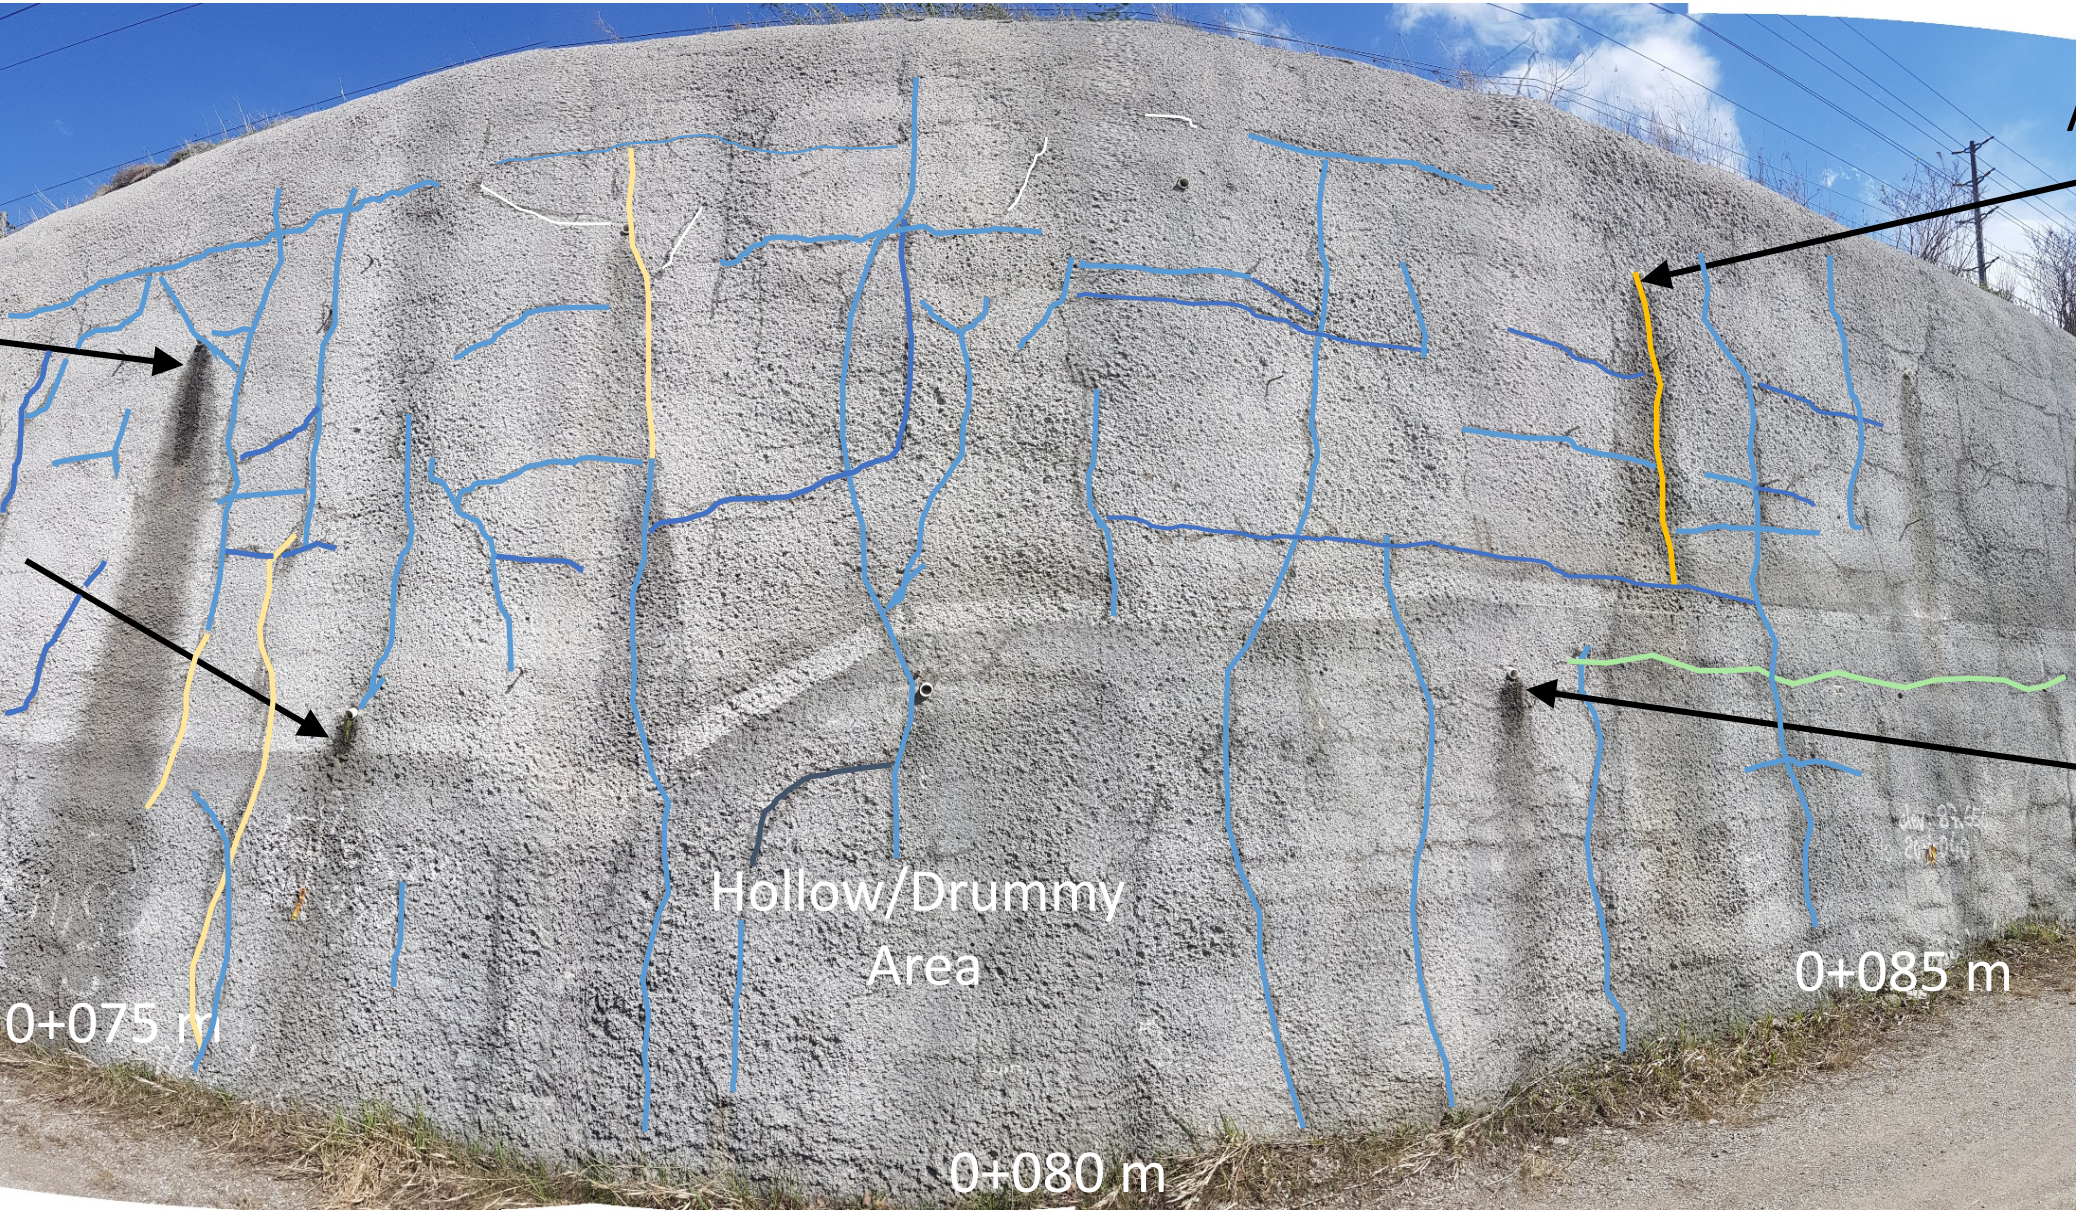
Active drain

Hollow/Drummy
Area

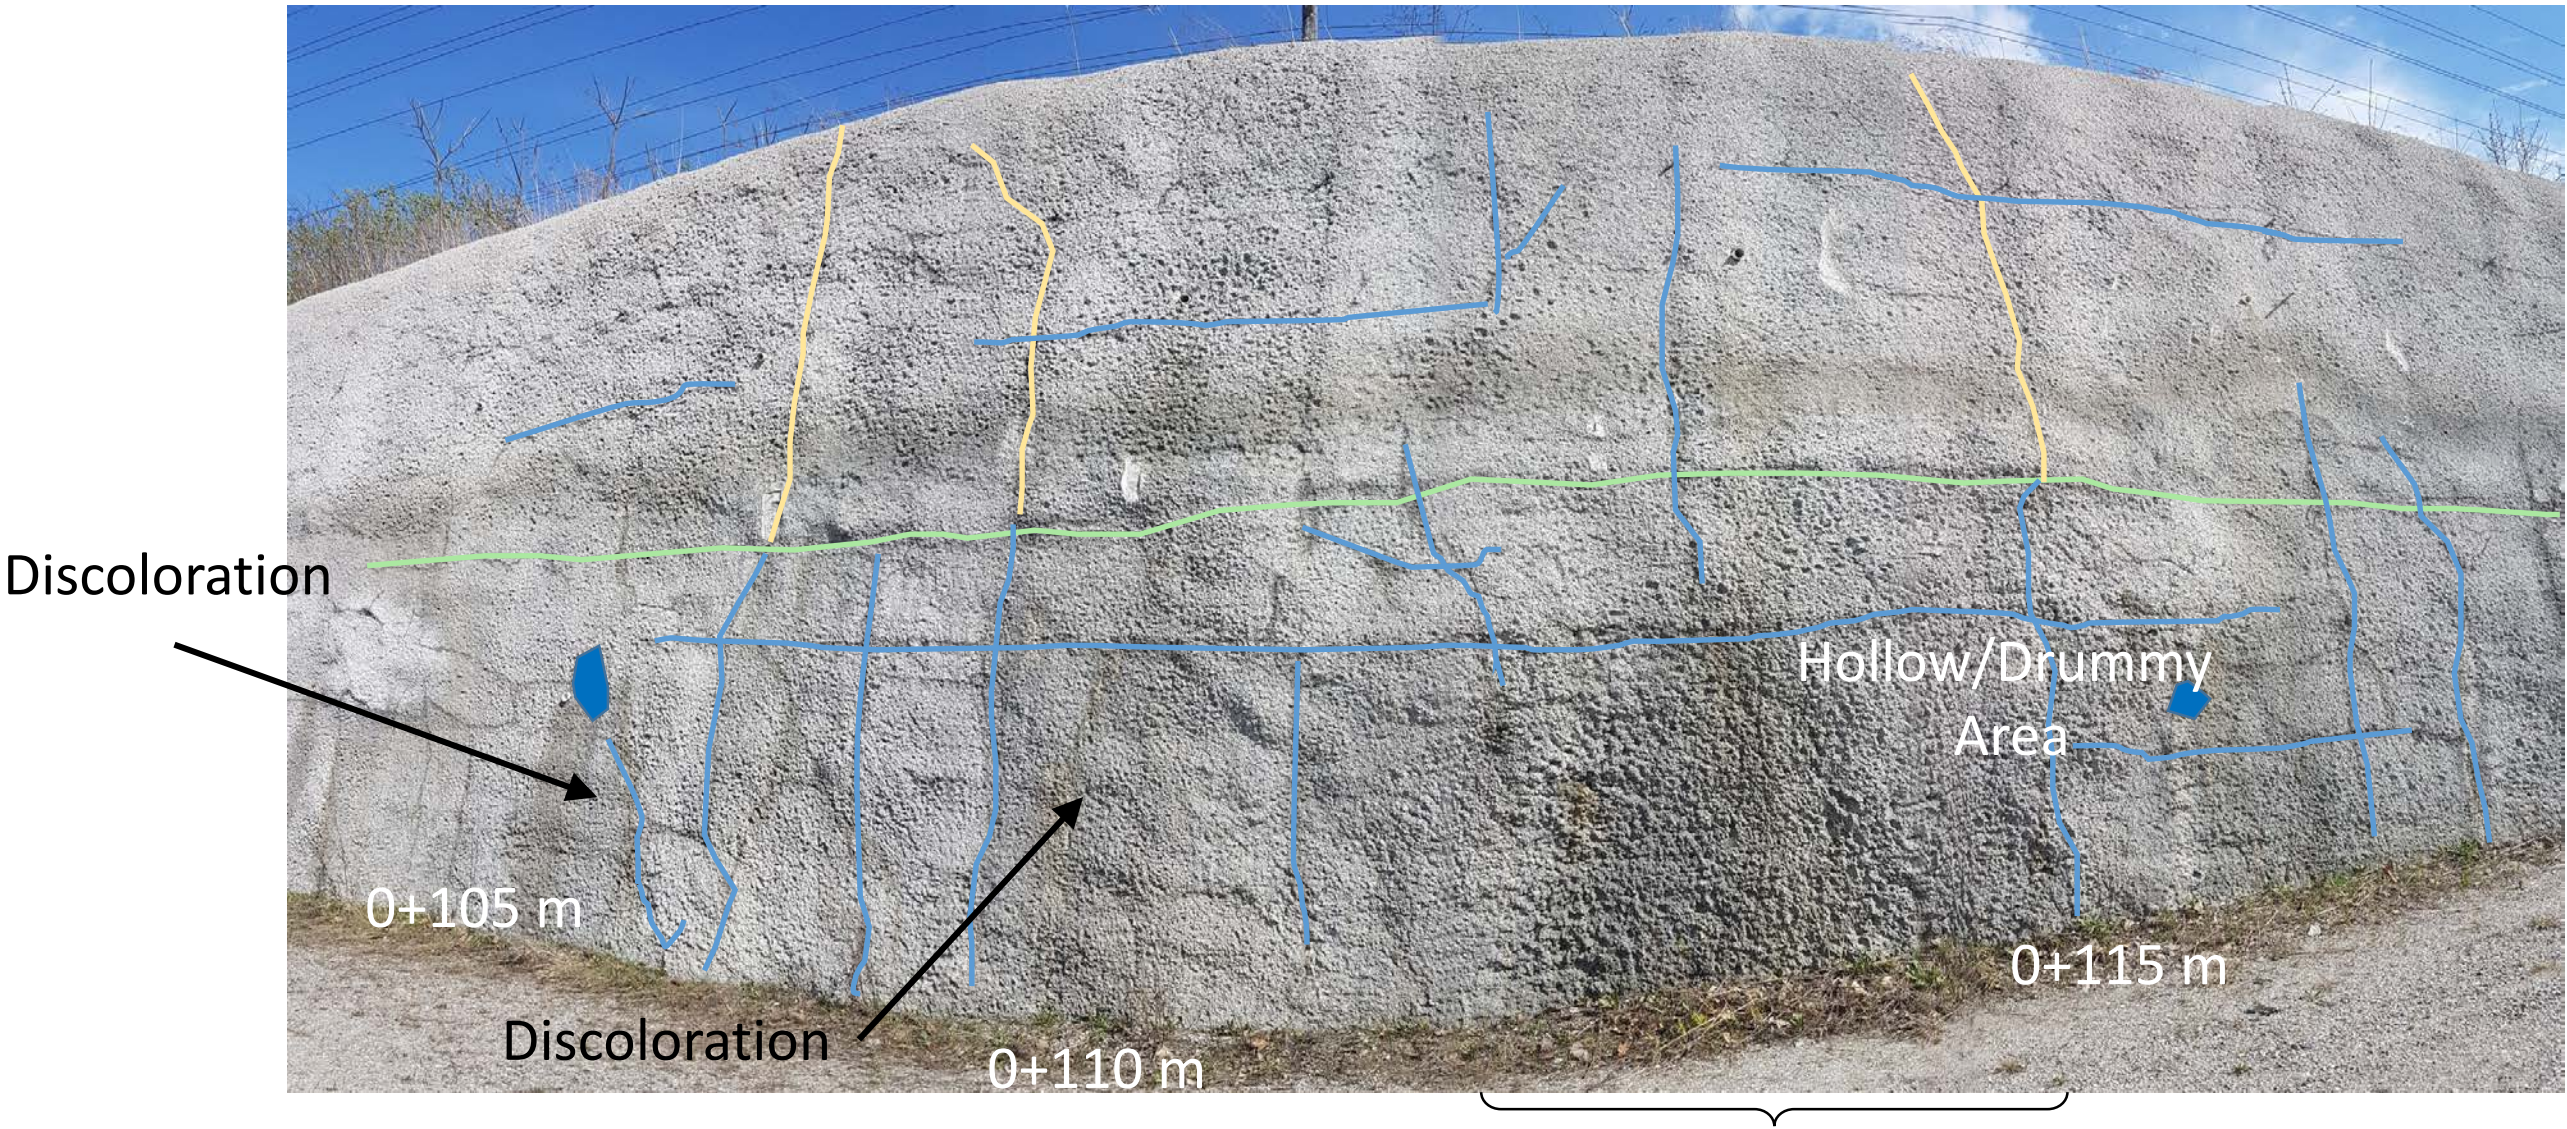
FIGURE 10

Some horizontal fractures, healed to 1 mm aperture, 1-3 m in length

Eroded face, possible seepage from crack above

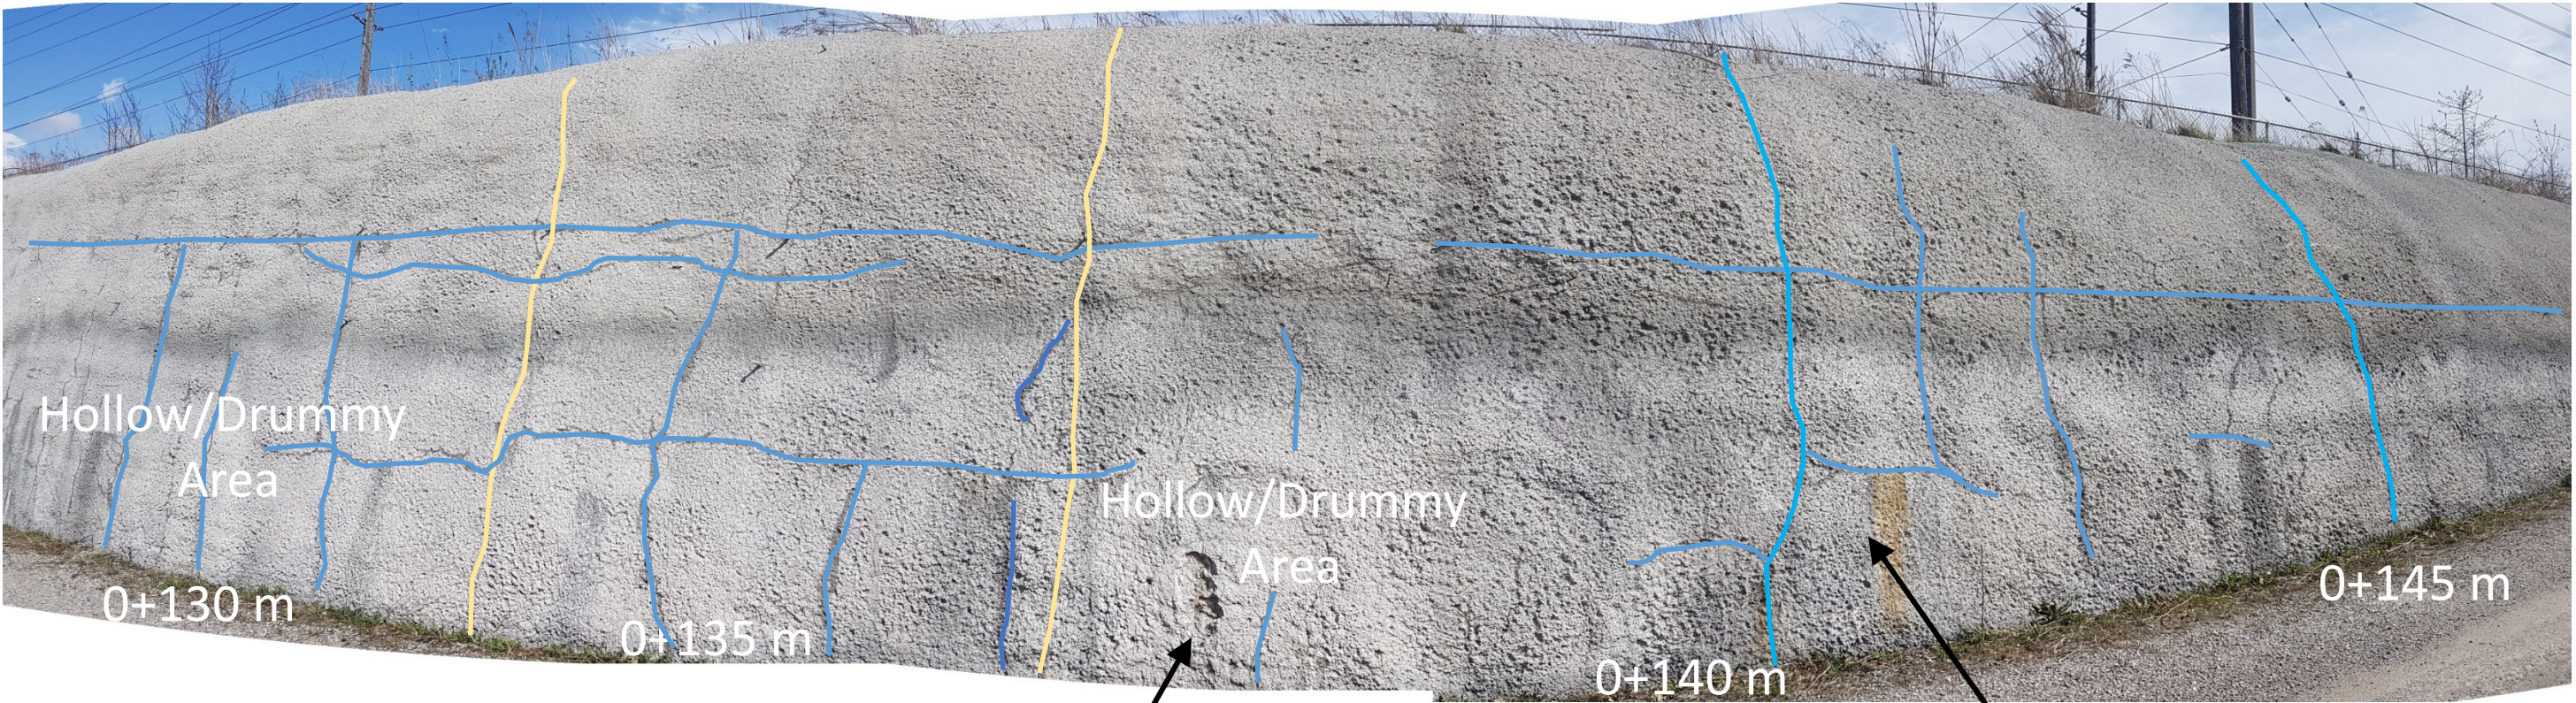
FIGURE 12

Delaminated/spalled zone,
exposing wire mesh underneath
shotcrete

Discoloration, oxidation from
seeping crack

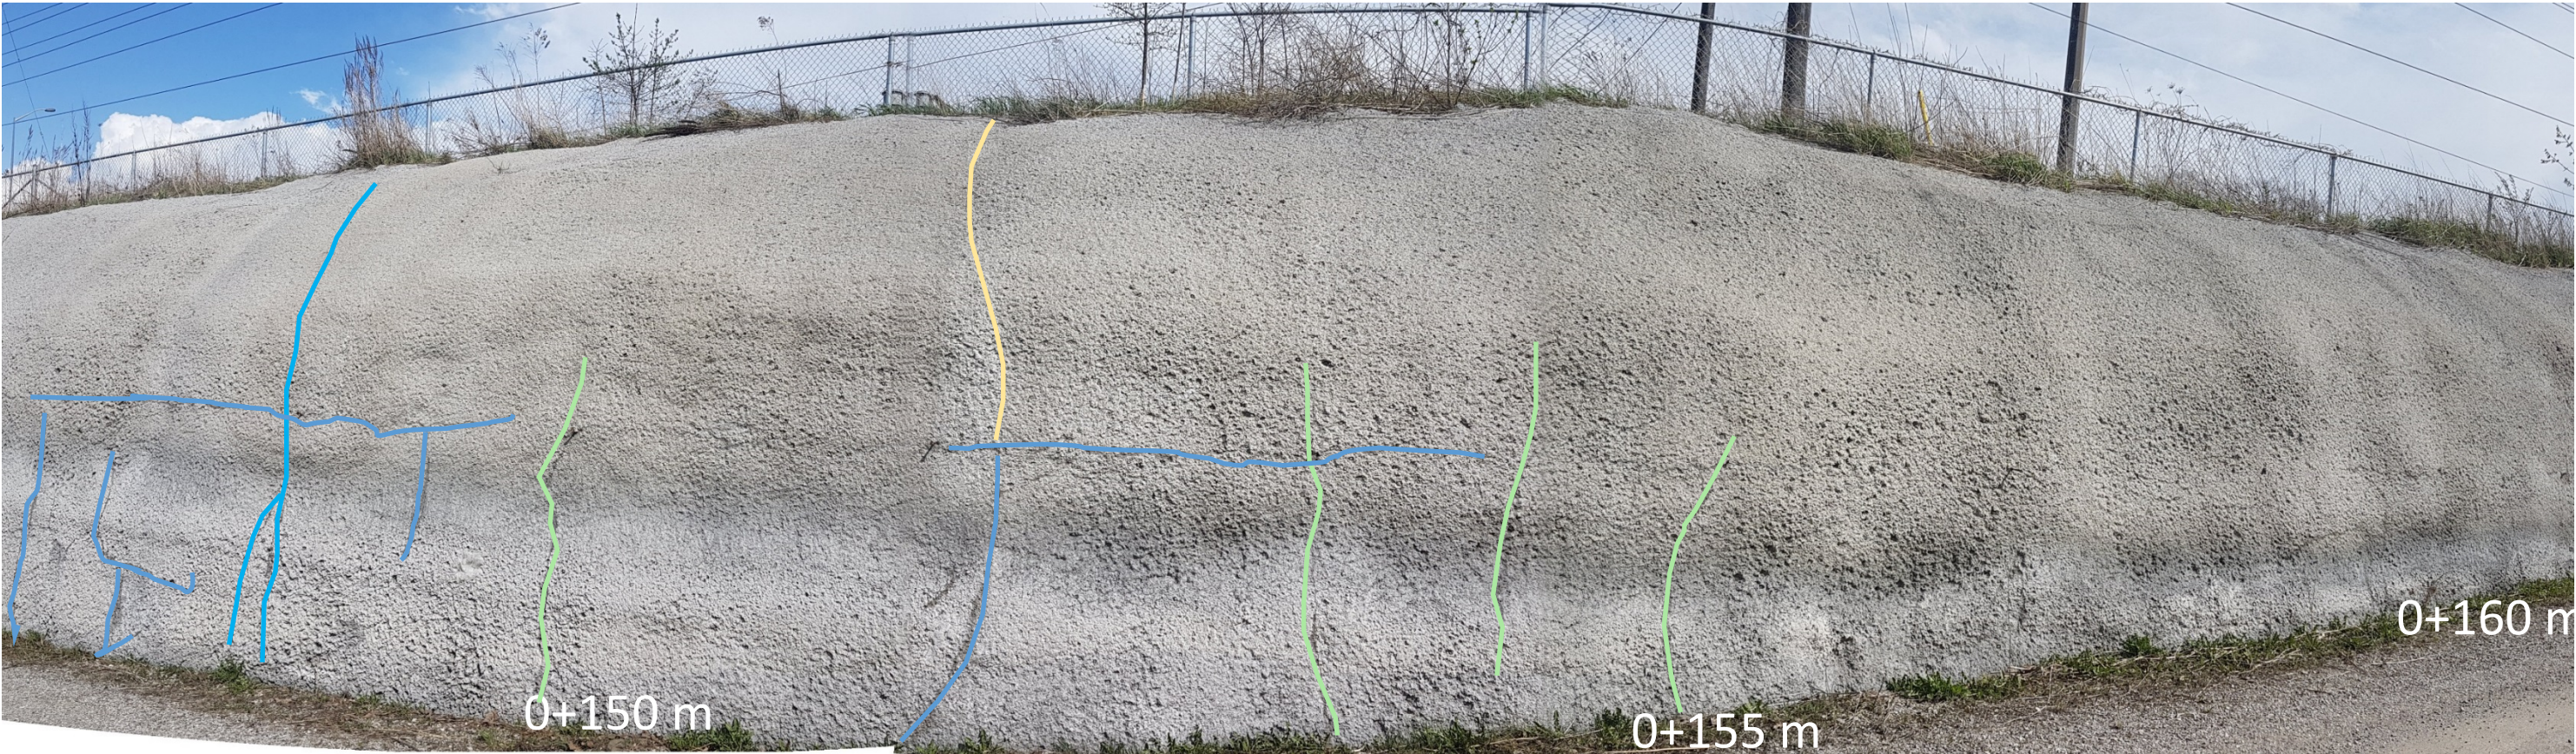
FIGURE 13

All other features mapped beyond Chainage 0+160m were very similar.
Vertical features were <1 mm aperture, minor seepage, <1 m length.
Horizontal features were <1 mm aperture, minor seepage, 2-3 m length.

Eroded face, possible surface runoff

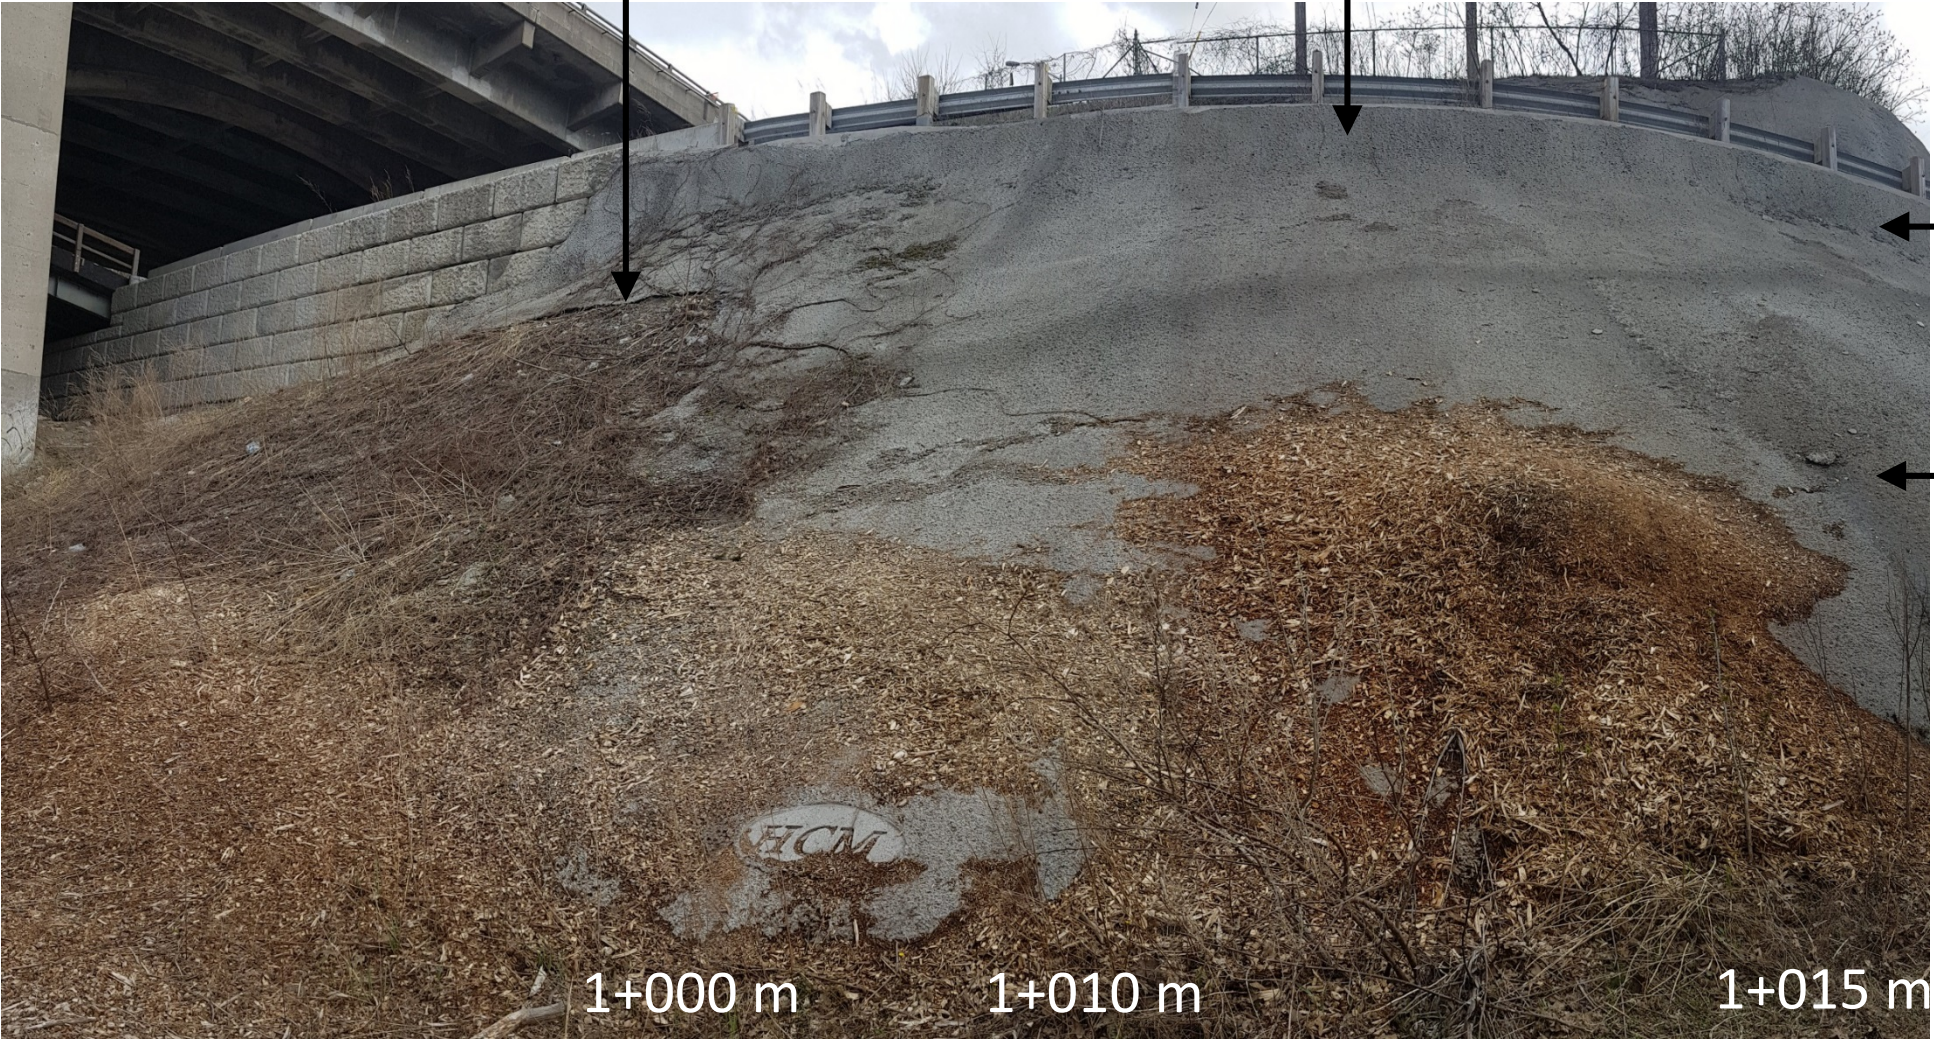
Shotcrete lip, vegetation growing underneath

Small vertical cracks

Rock debris
from road

Eroded surface
from surface
runoff

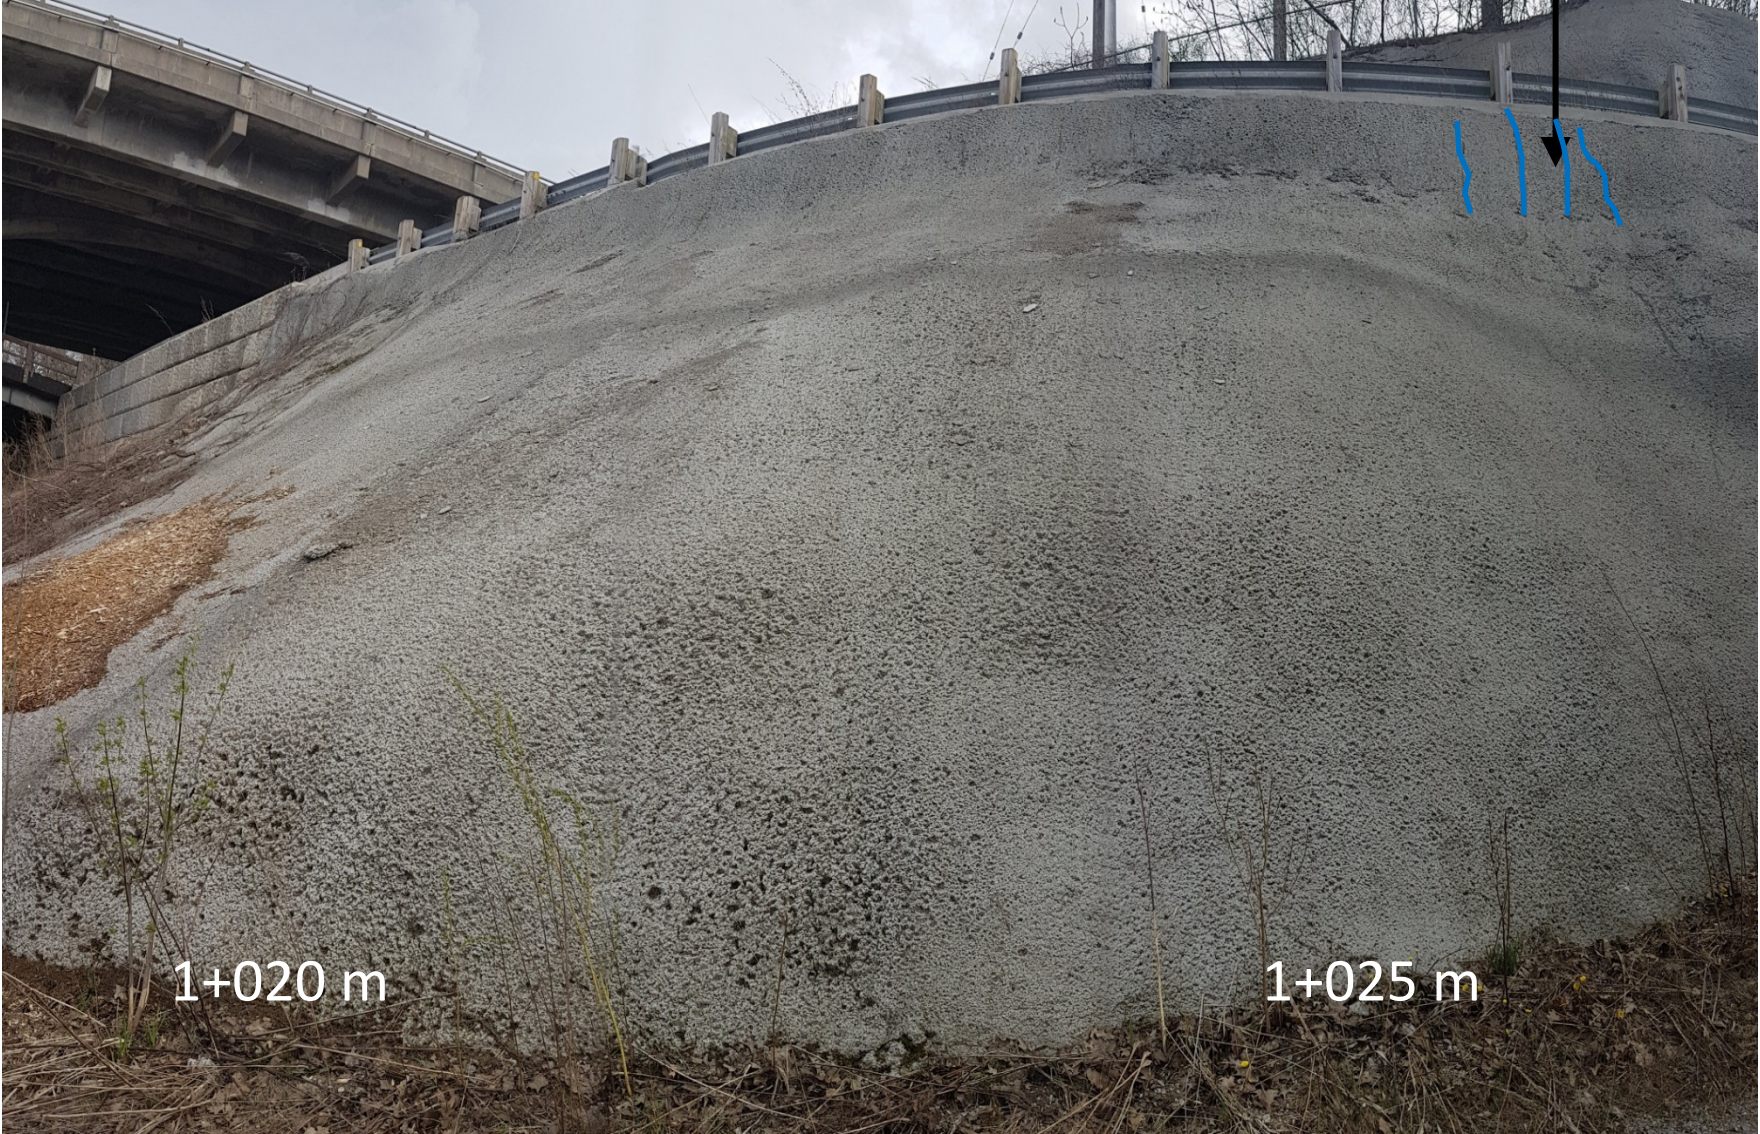
FIGURE 15

Small vertical cracks

Eroded/dissolved face, possible surface runoff

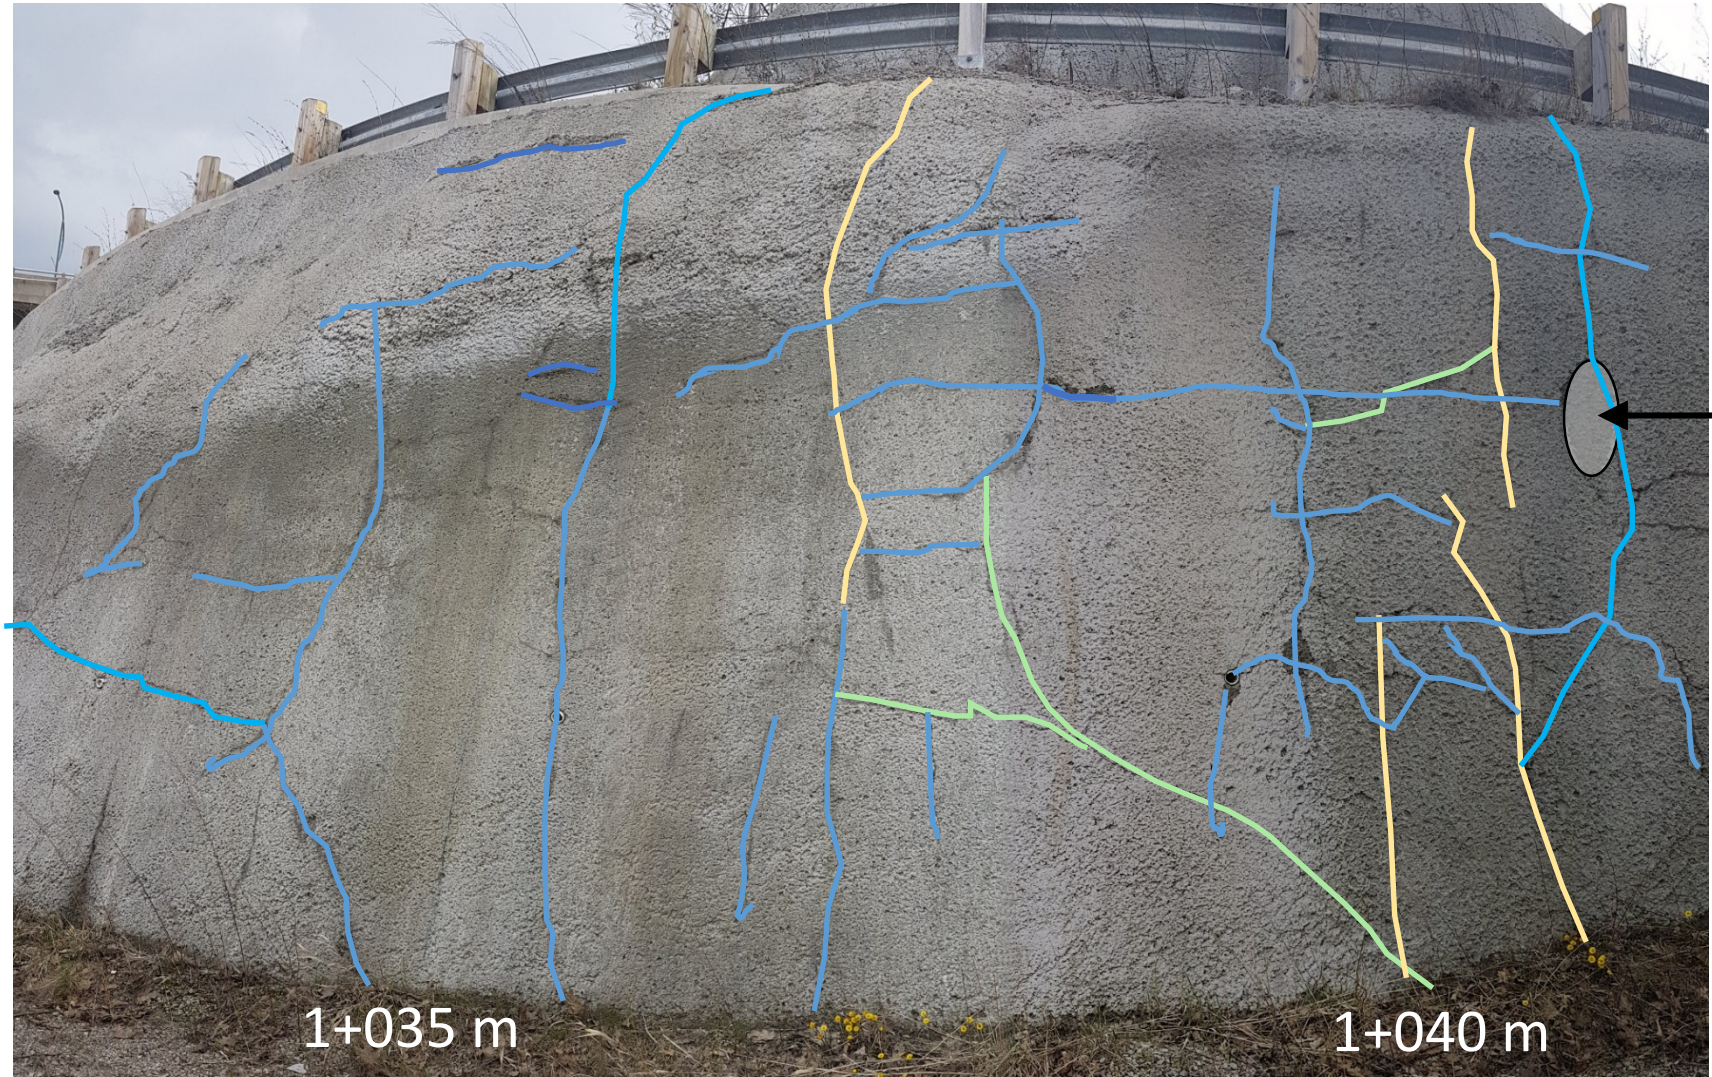
FIGURE 17

Seepage
source
not
visible

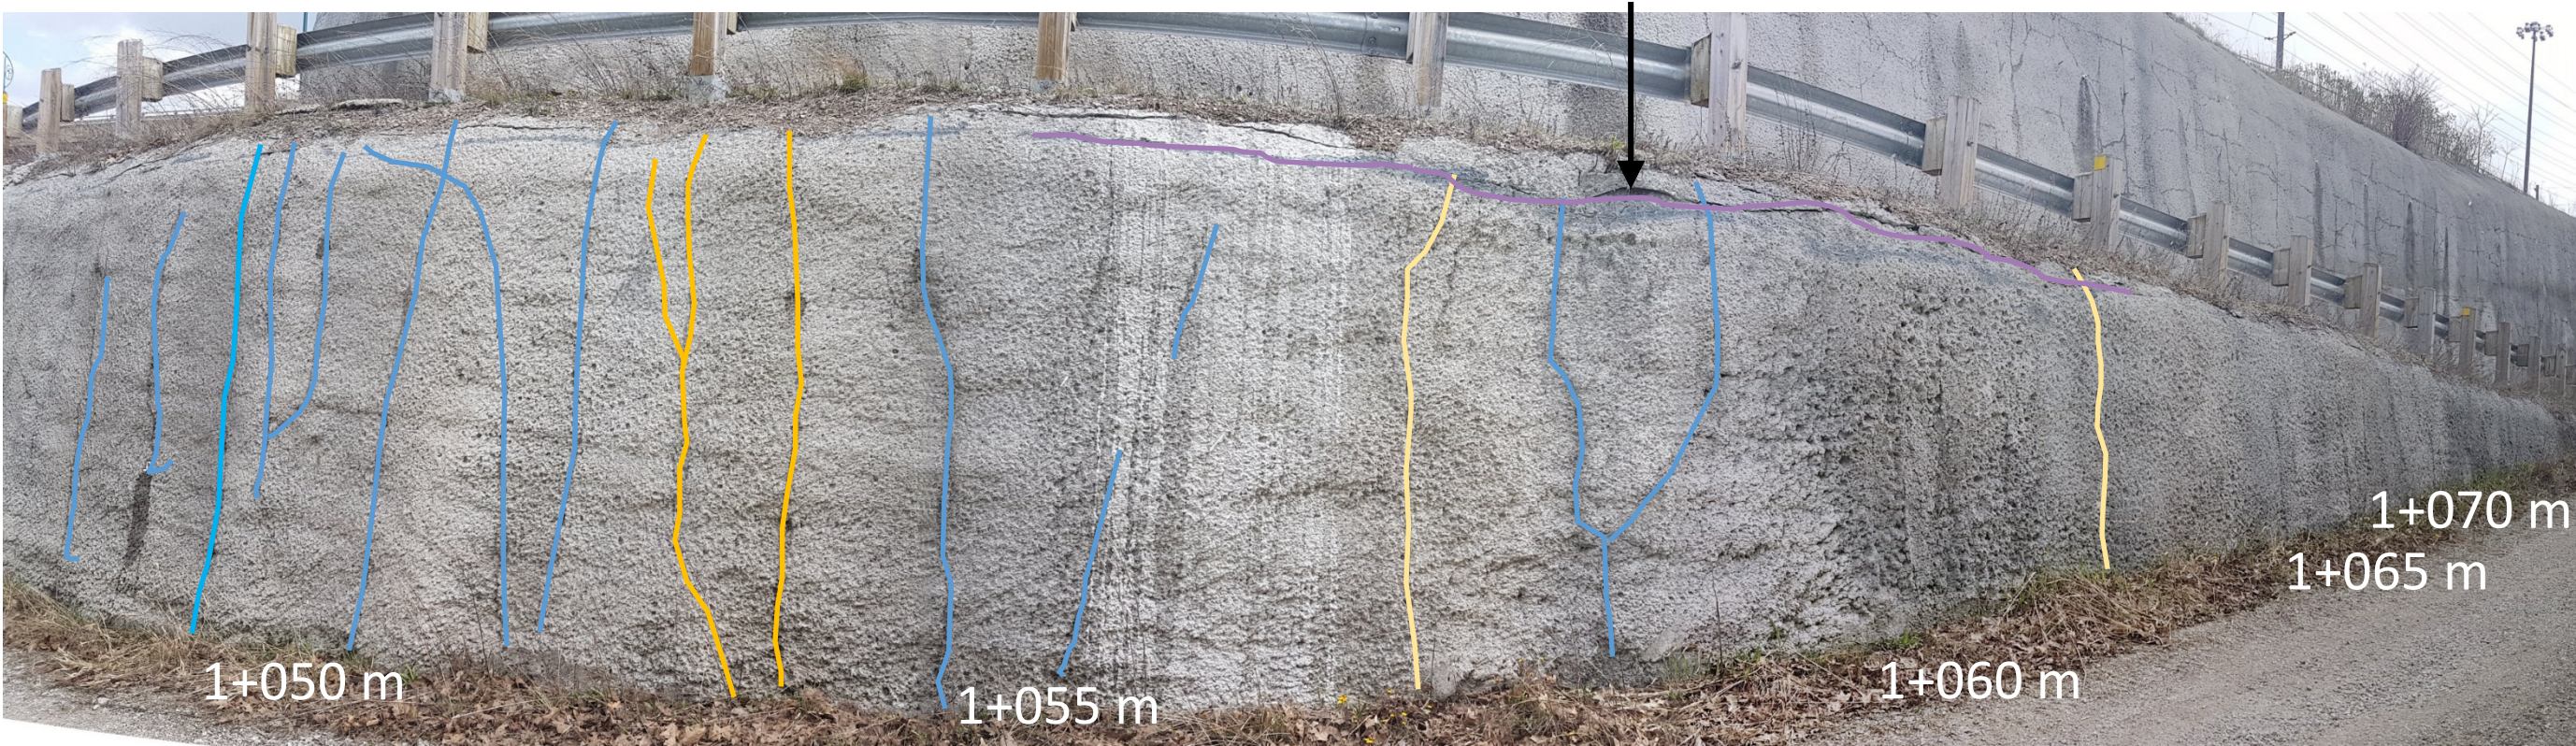
FIGURE 19

Major overhanging horizontal joint, top layer of shotcrete hanging over vertical wall, open, dry, 1-5 mm

Surface runoff from below gravel layer at top

Eroded/pitted large seeps, discolouration on healed joints

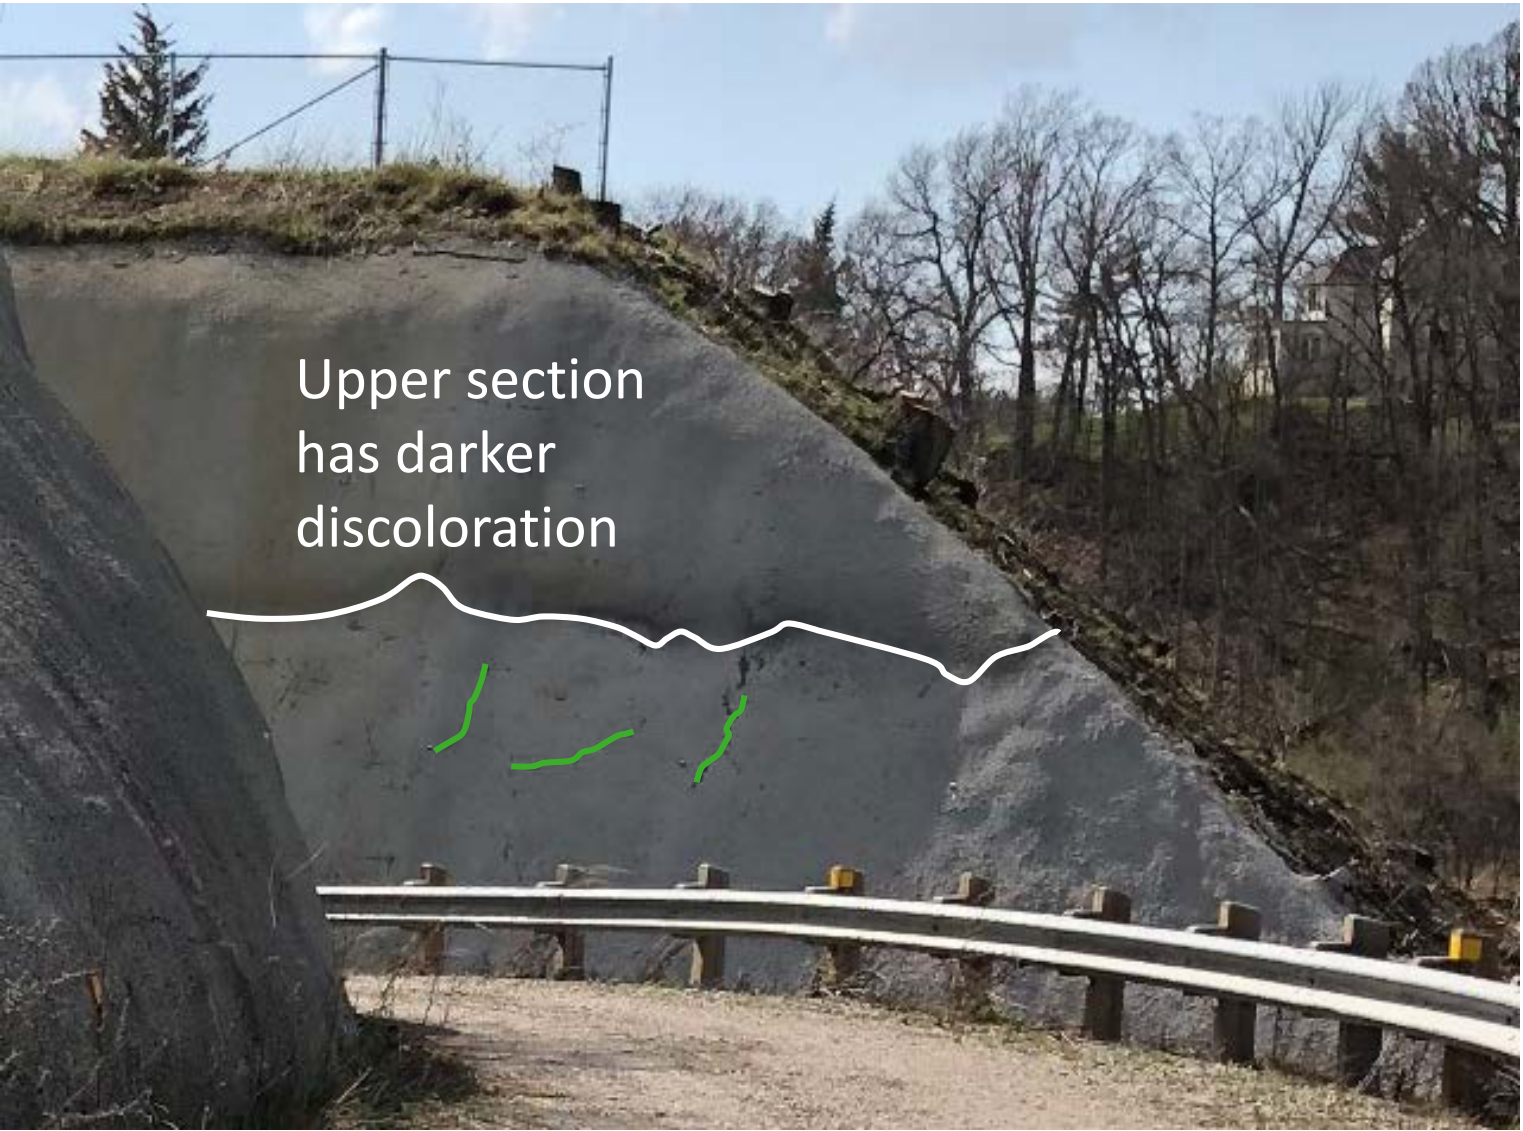
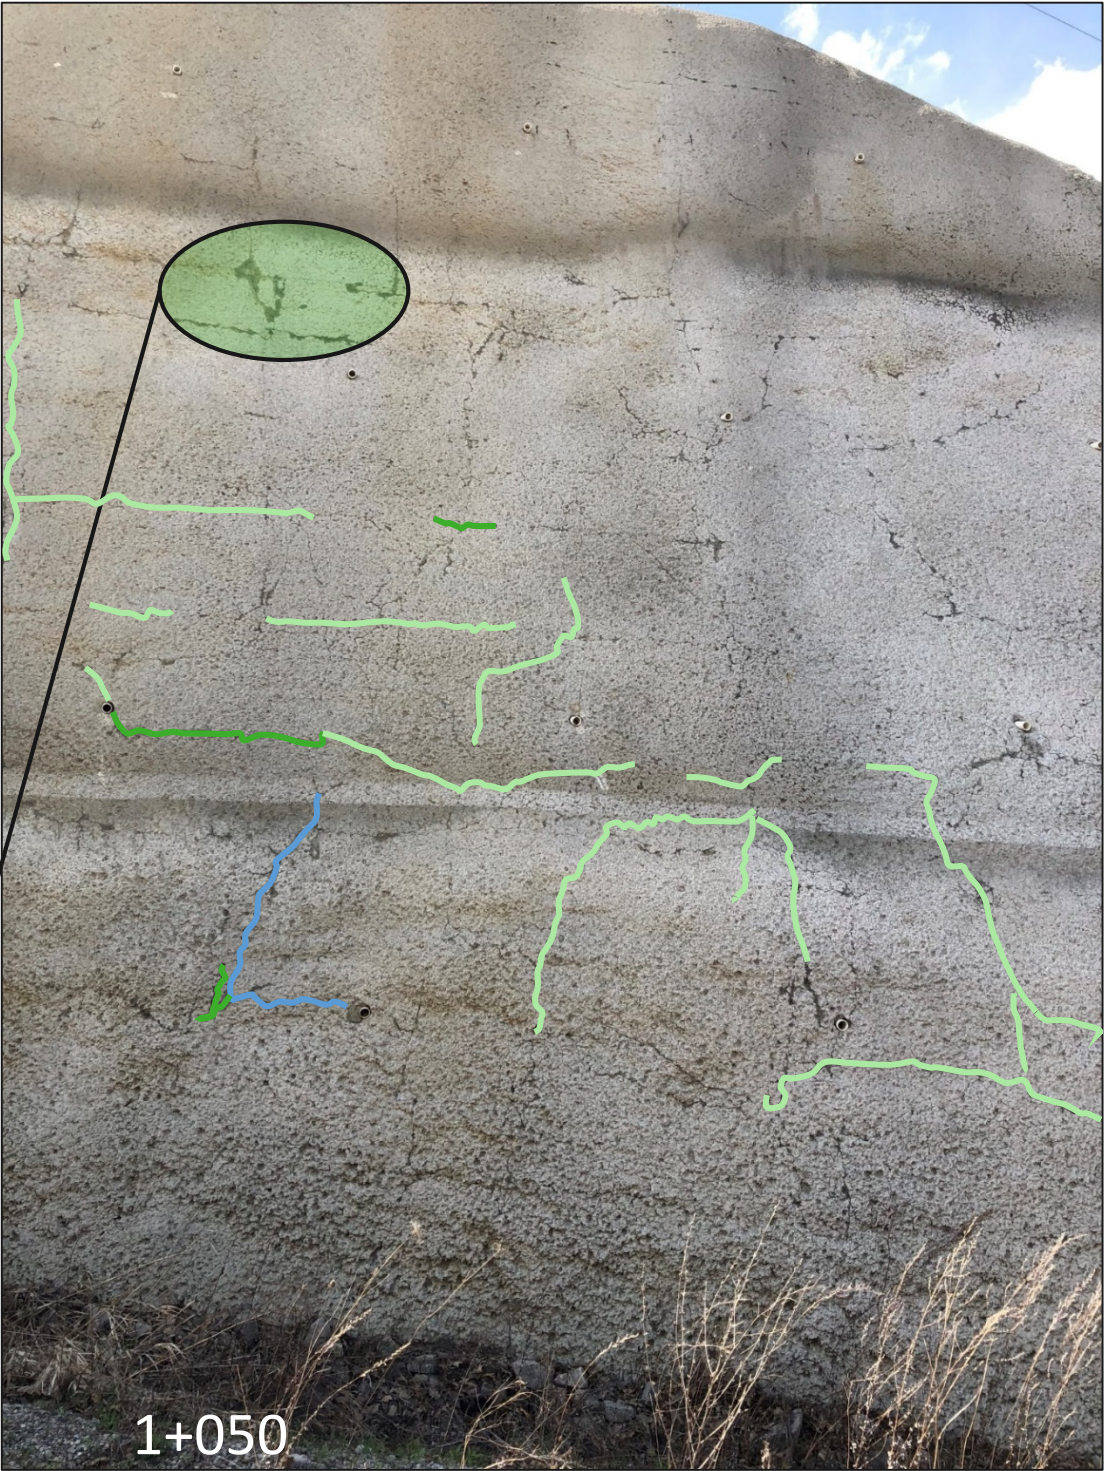
FIGURE 20

Seepage from
intersecting
vertical and
horizontal
fractures
