Geotechnical Assessment of Shotcrete on Access Road Rock Cuts

QEW Widening from West of Mississauga Road to West of Hurontario Street, Mississauga, Ministry of Transportation, Ontario, GWP 2002-13-00

1662333-4

July 20, 2018

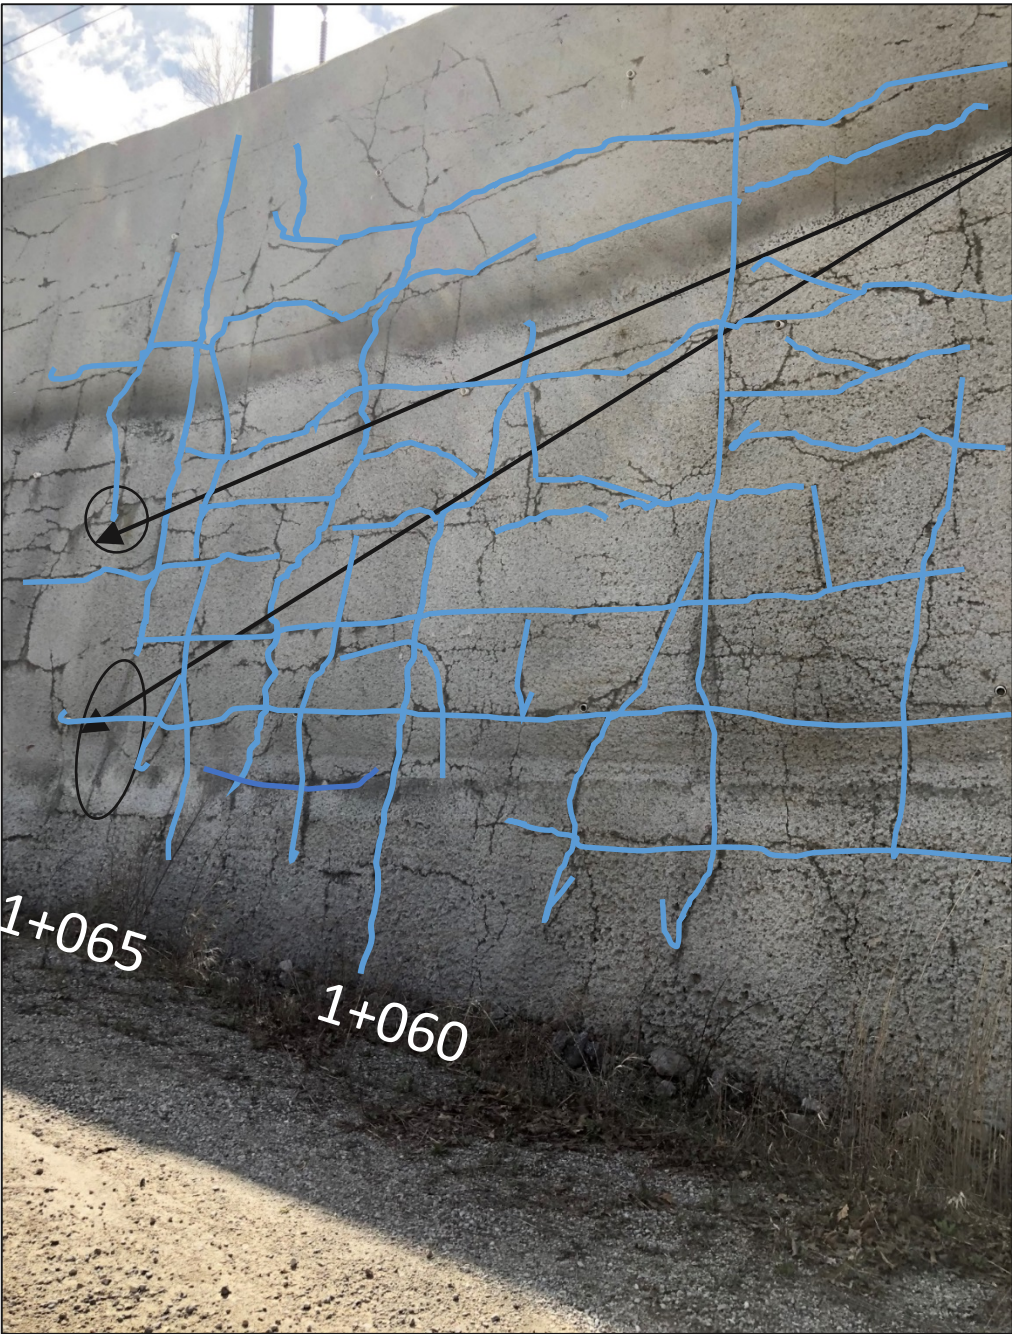
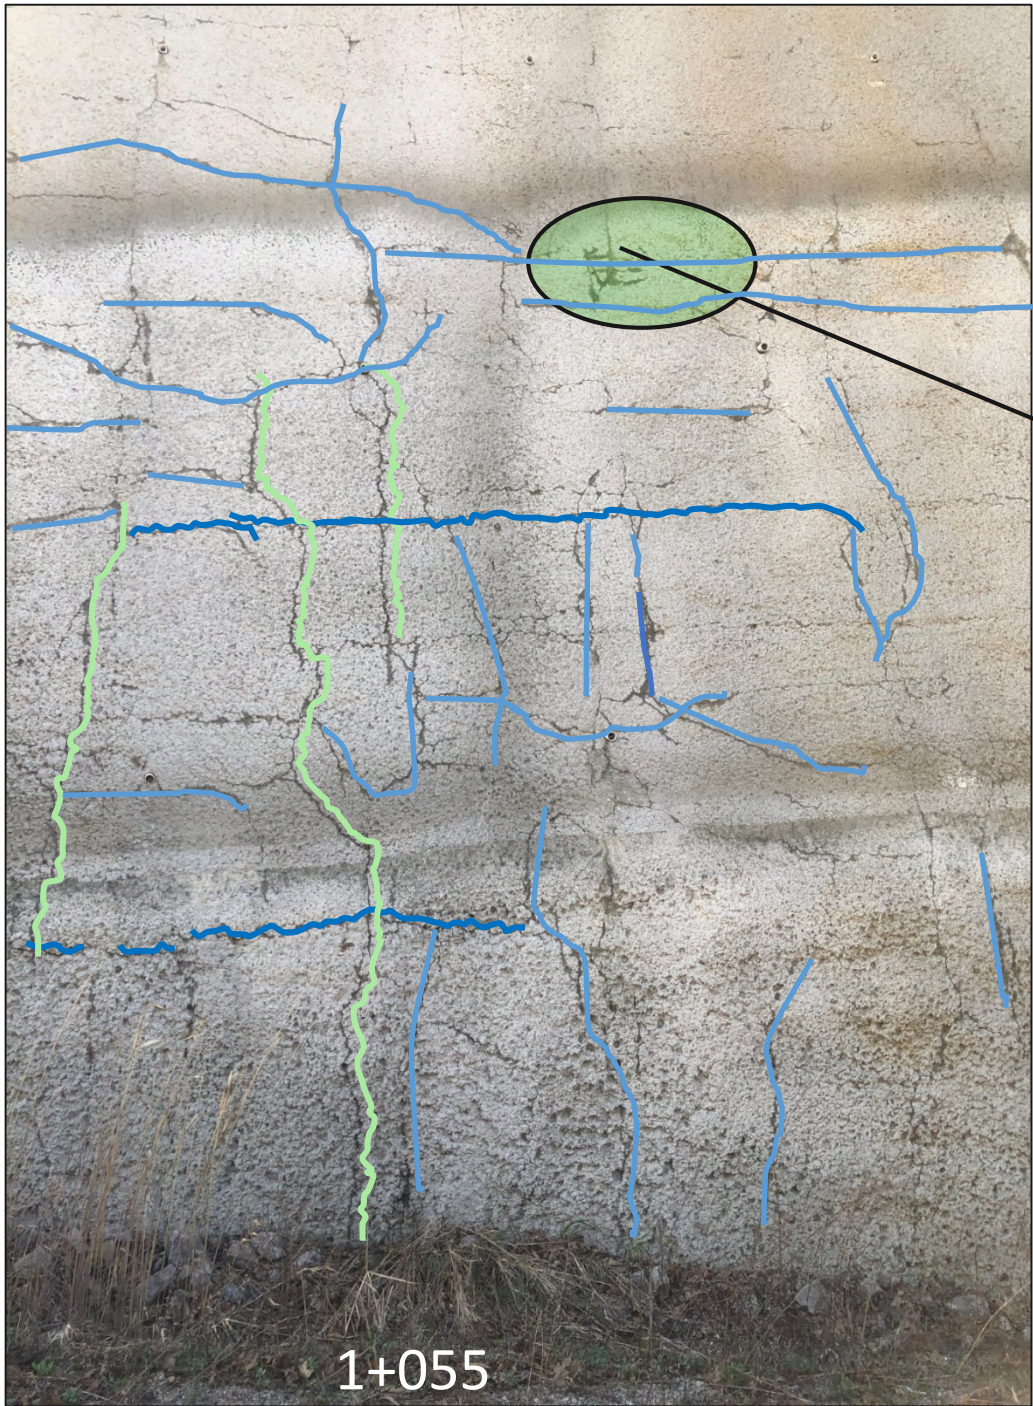
FIGURE 21

Zone of
Greenish-brown
discoloration

Base of the
shotcrete
has a
'pitted'
texture due
to erosion

Minor seepage at
Intersection of
vertical and
horizontal
fractures, 1-2 mm
apertures.

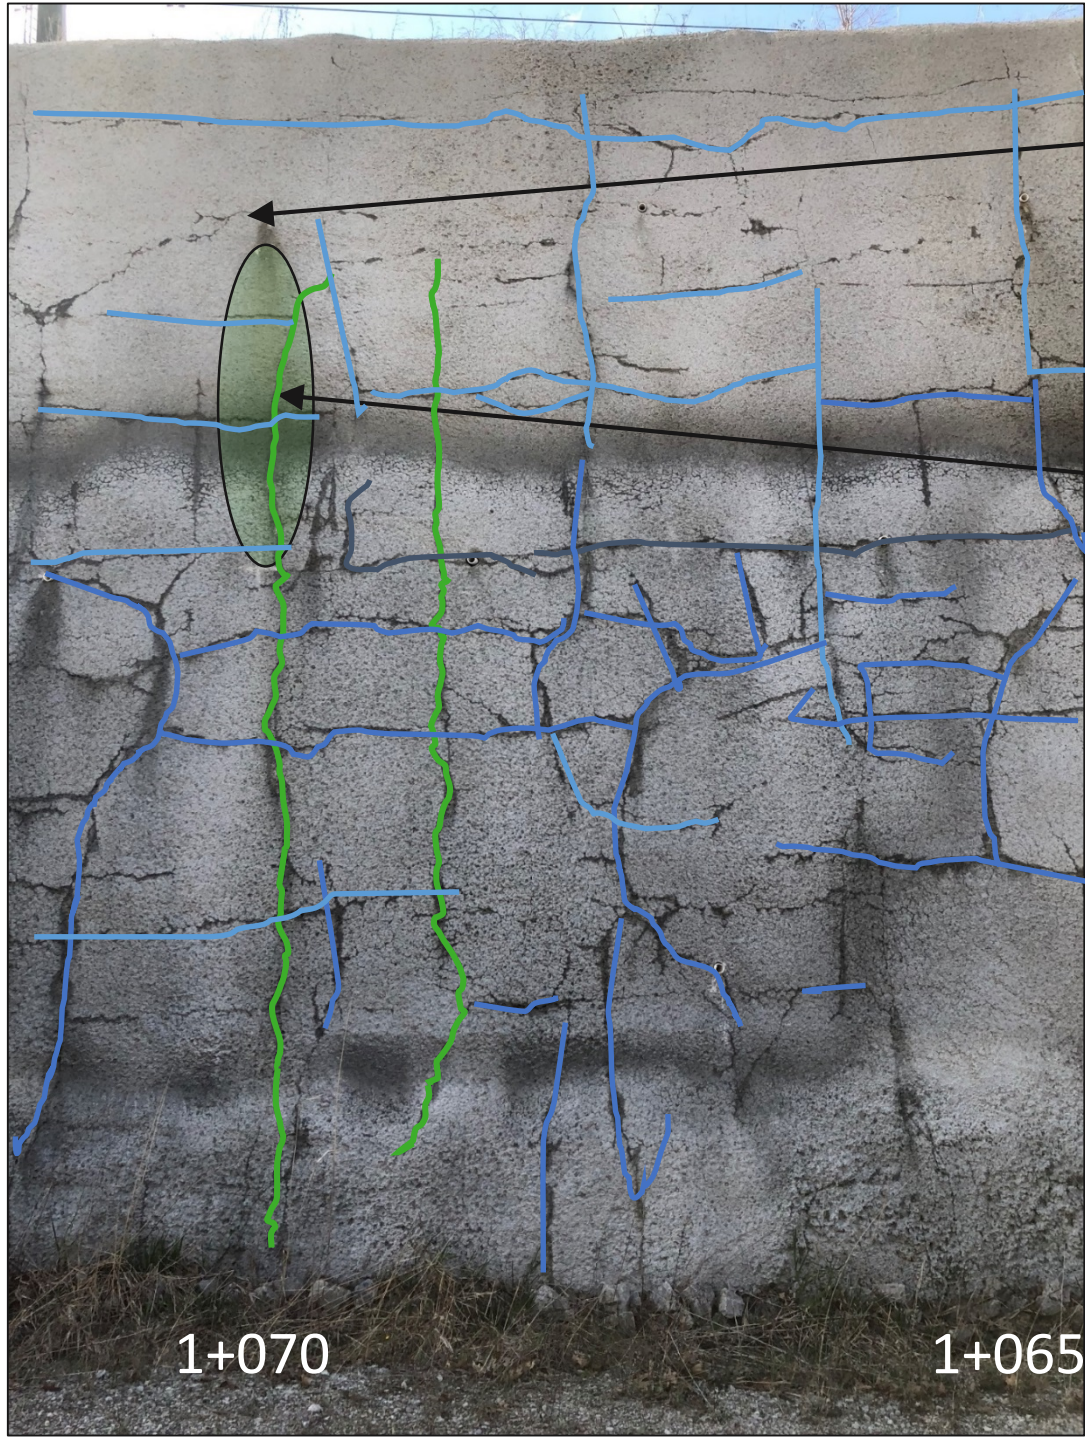
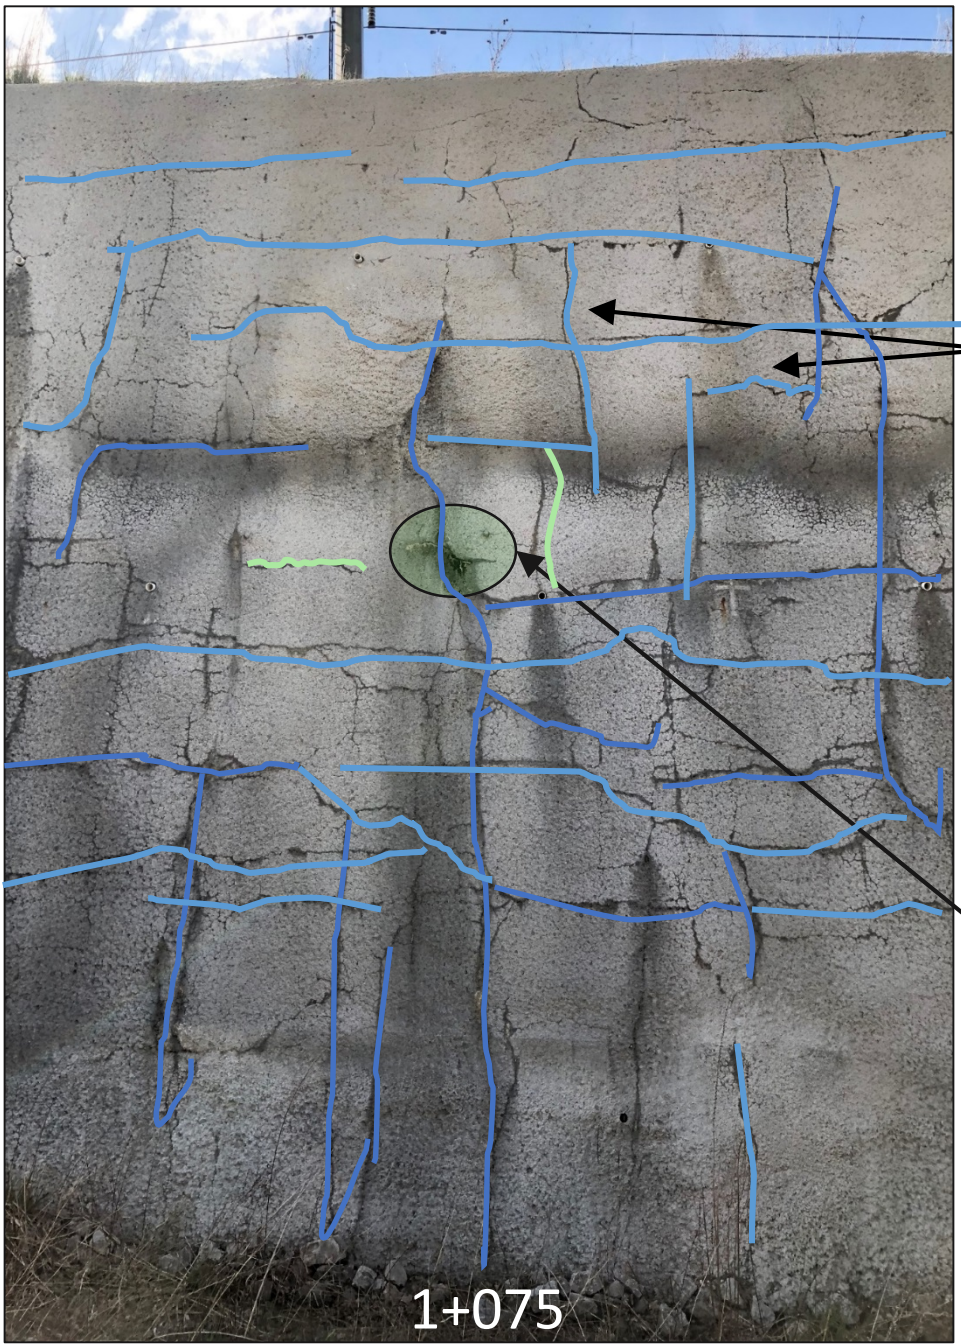
FIGURE 22

Active drainpipe

Yellow-brown discoloration along drainage path

Shotcrete has 'pitted' texture due to erosion

Various discontinuous horizontal/vertical healed fractures, some seepage, 0.5 m-3 m length

Active seepage from healed fracture junction.

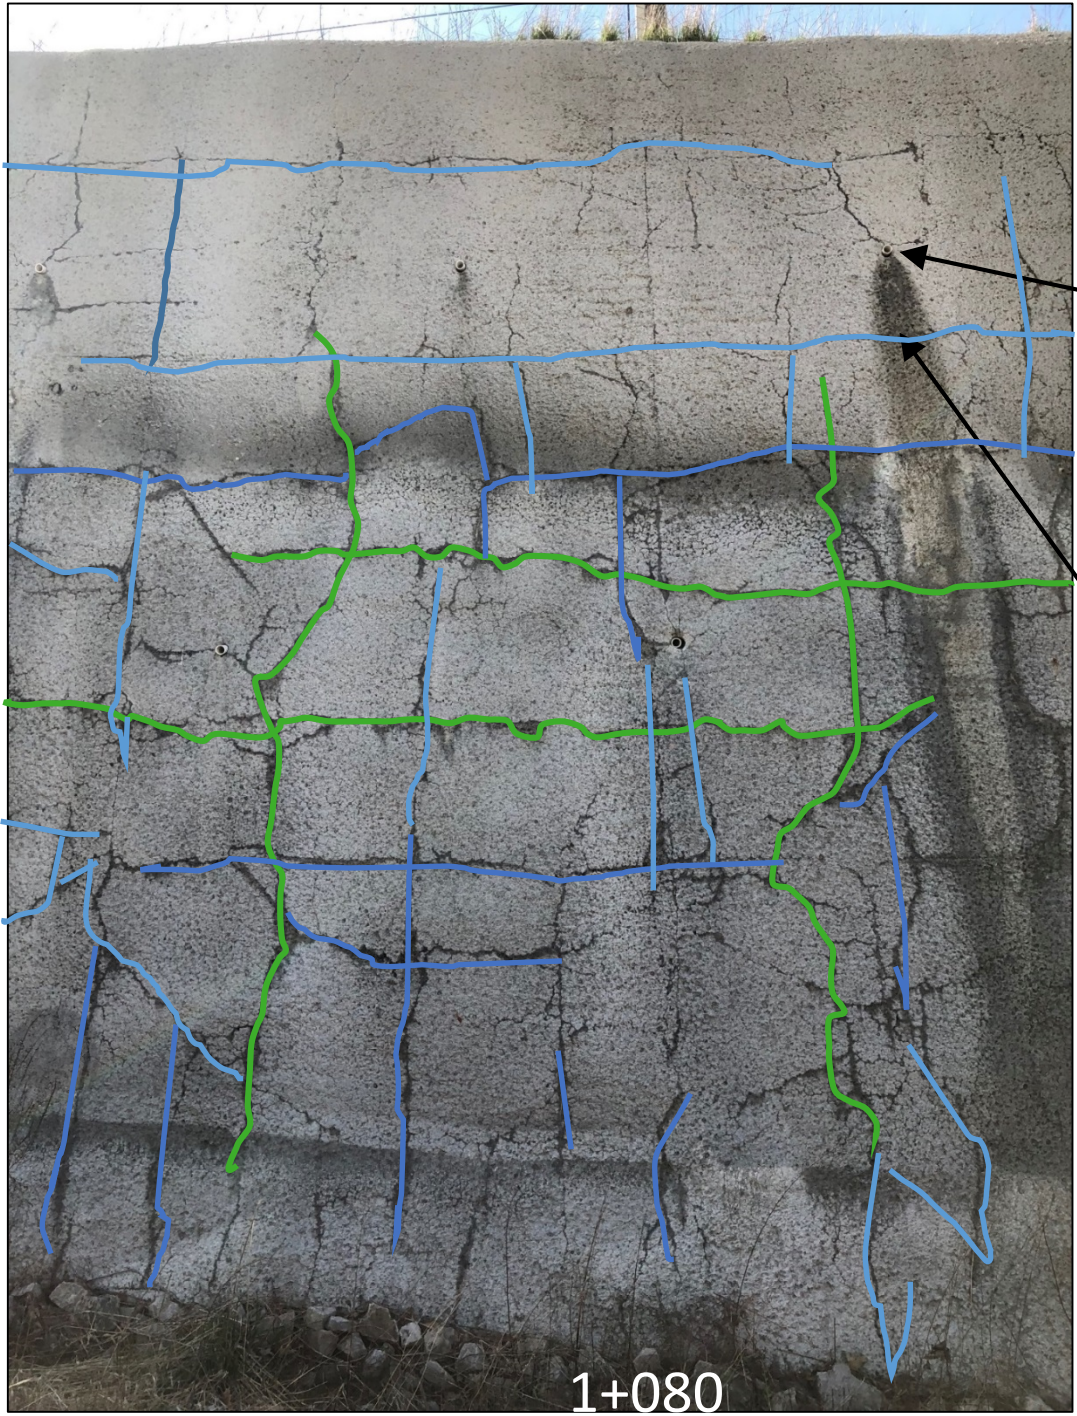
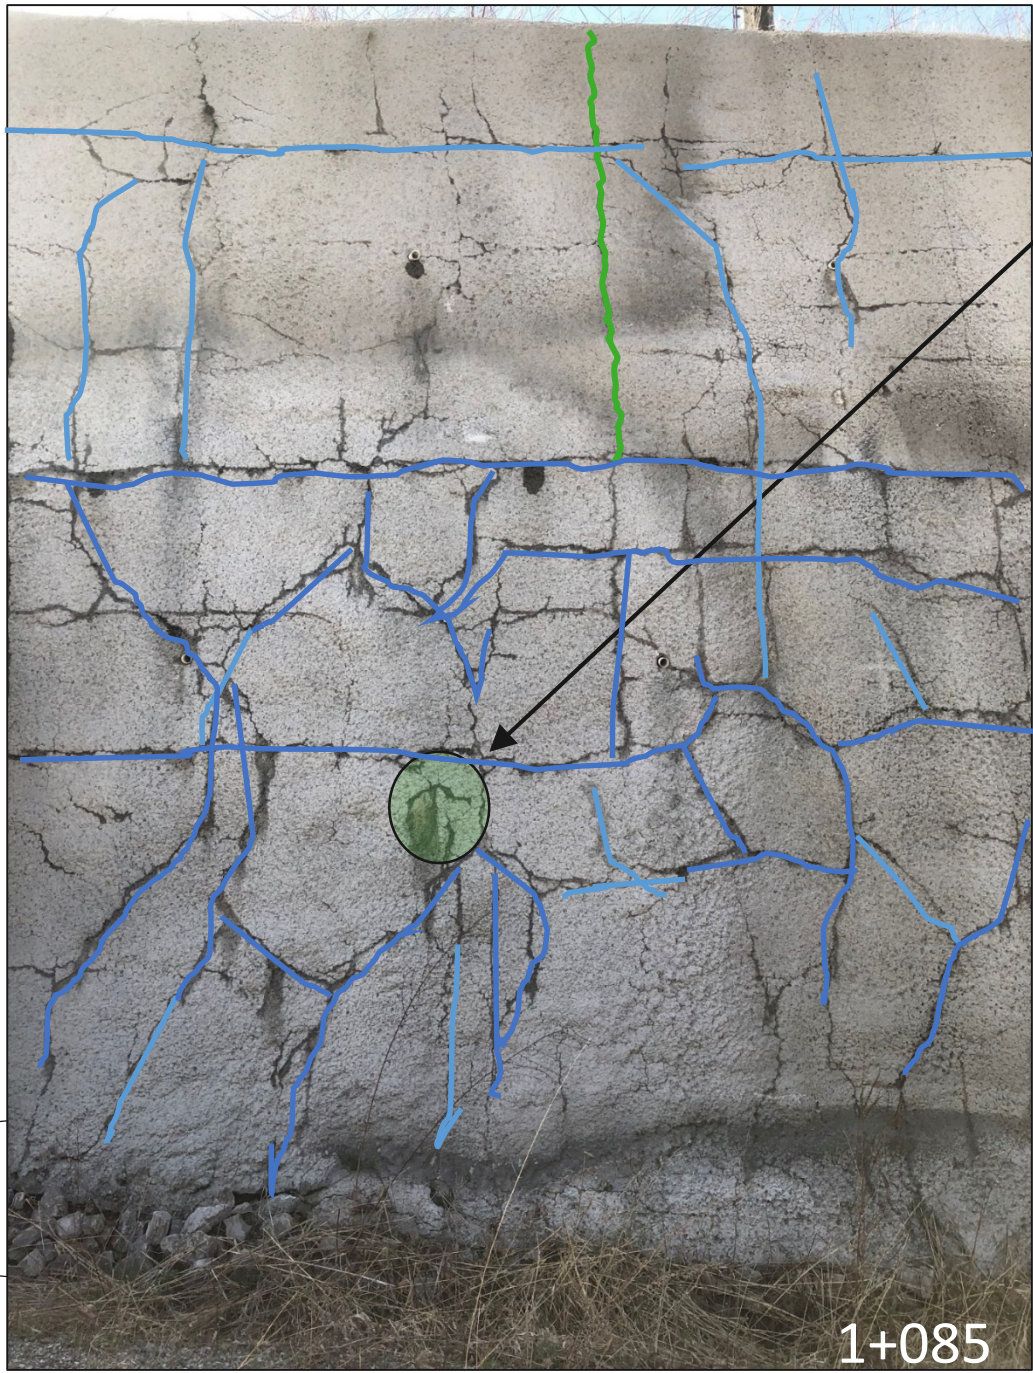
FIGURE 23

Overall: Various vertical/horizontal fractures, some seepage, 0.5 m – 4 m length

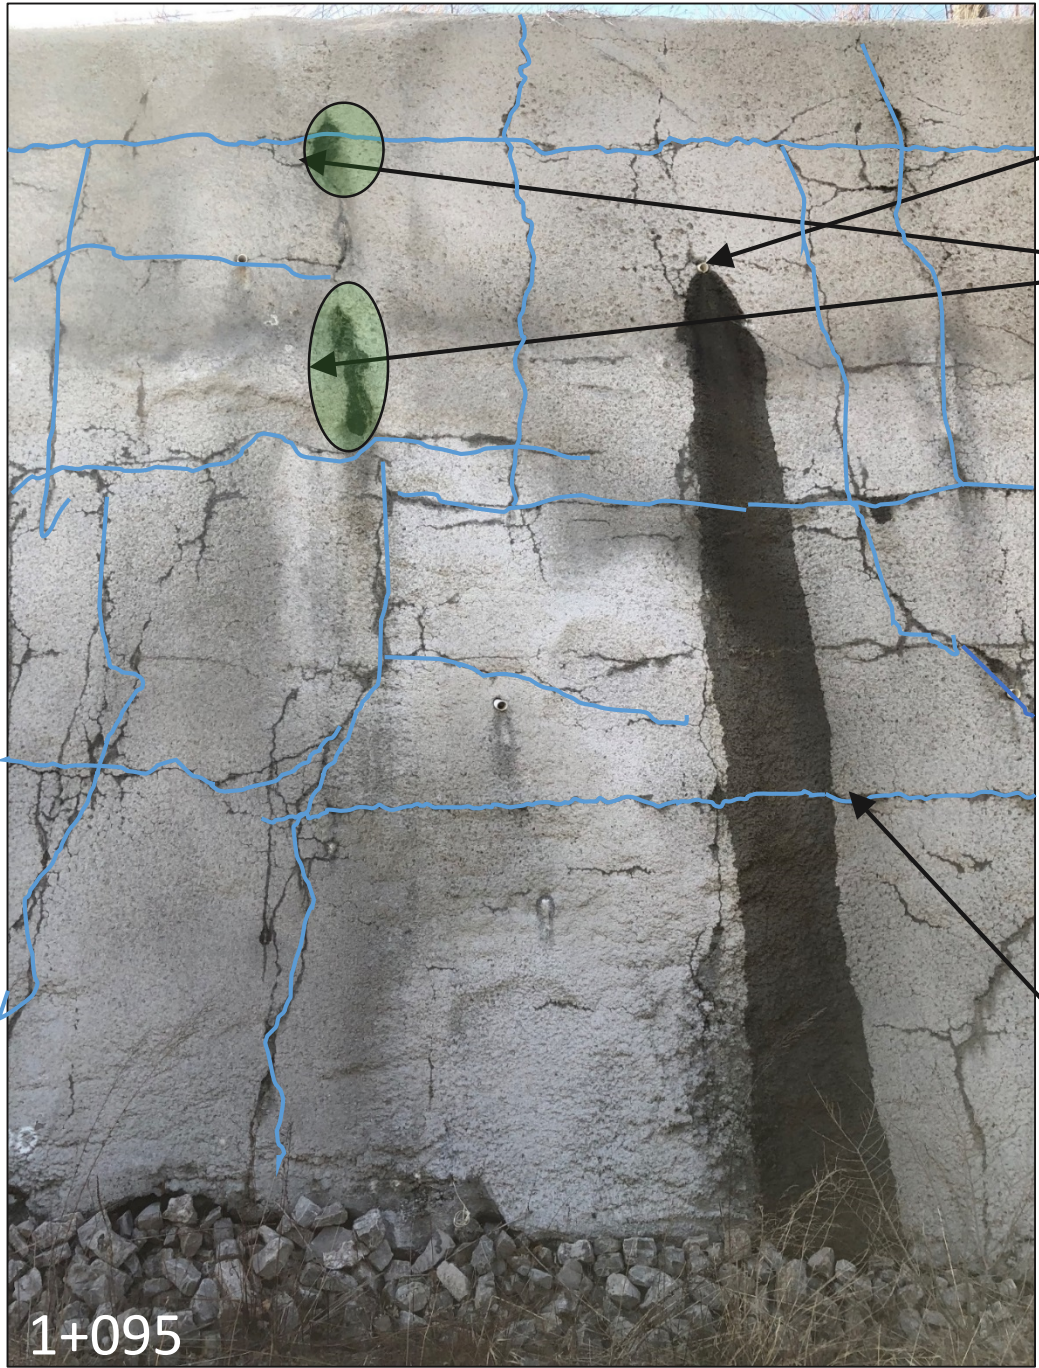
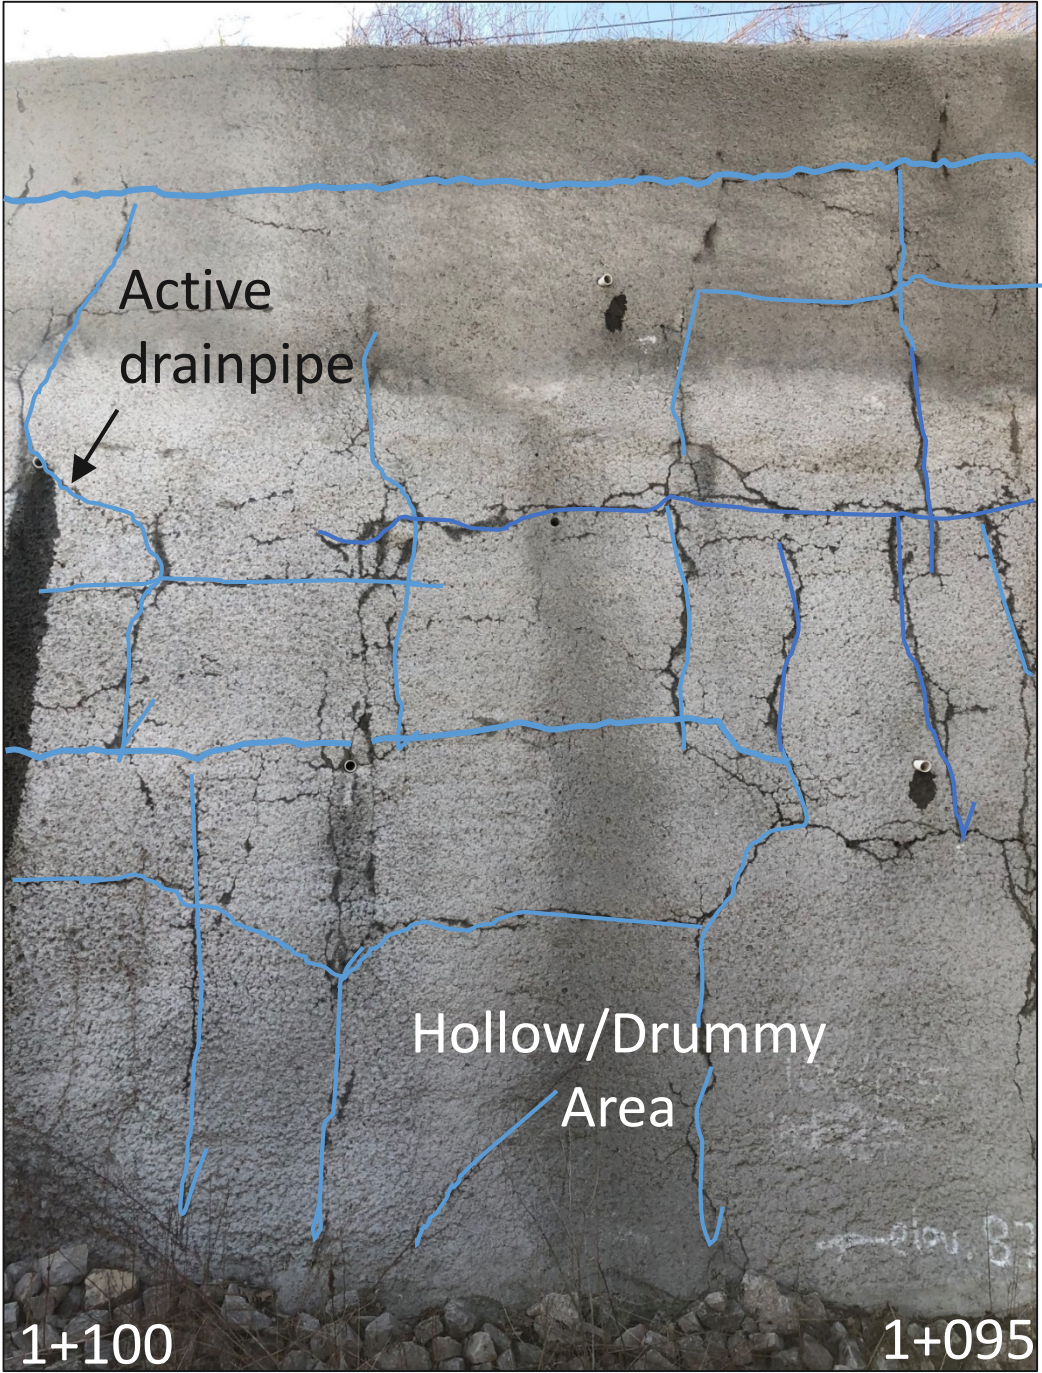
FIGURE 24

Active
drainpipe

Dark
brown/black
discoloration
from seepage
at healed
fracture.

Light grey
discoloration
along drainage
path

~5 m
long
fracture

Overall: various
vertical/horizontal healed
fractures, minor to some
seepage, 0.5 m – 4 m length

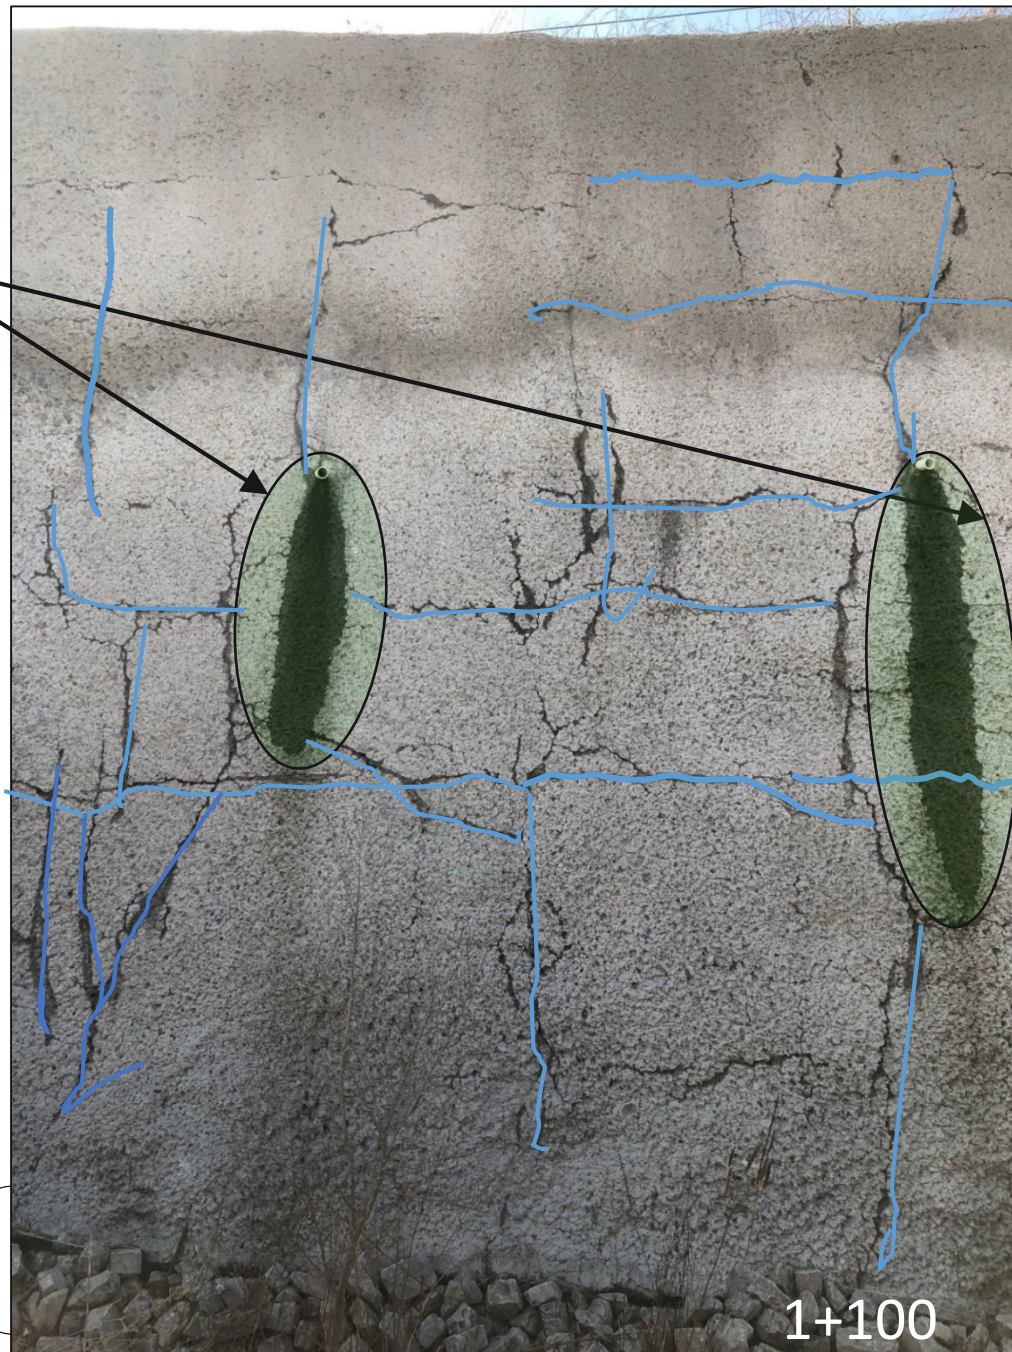
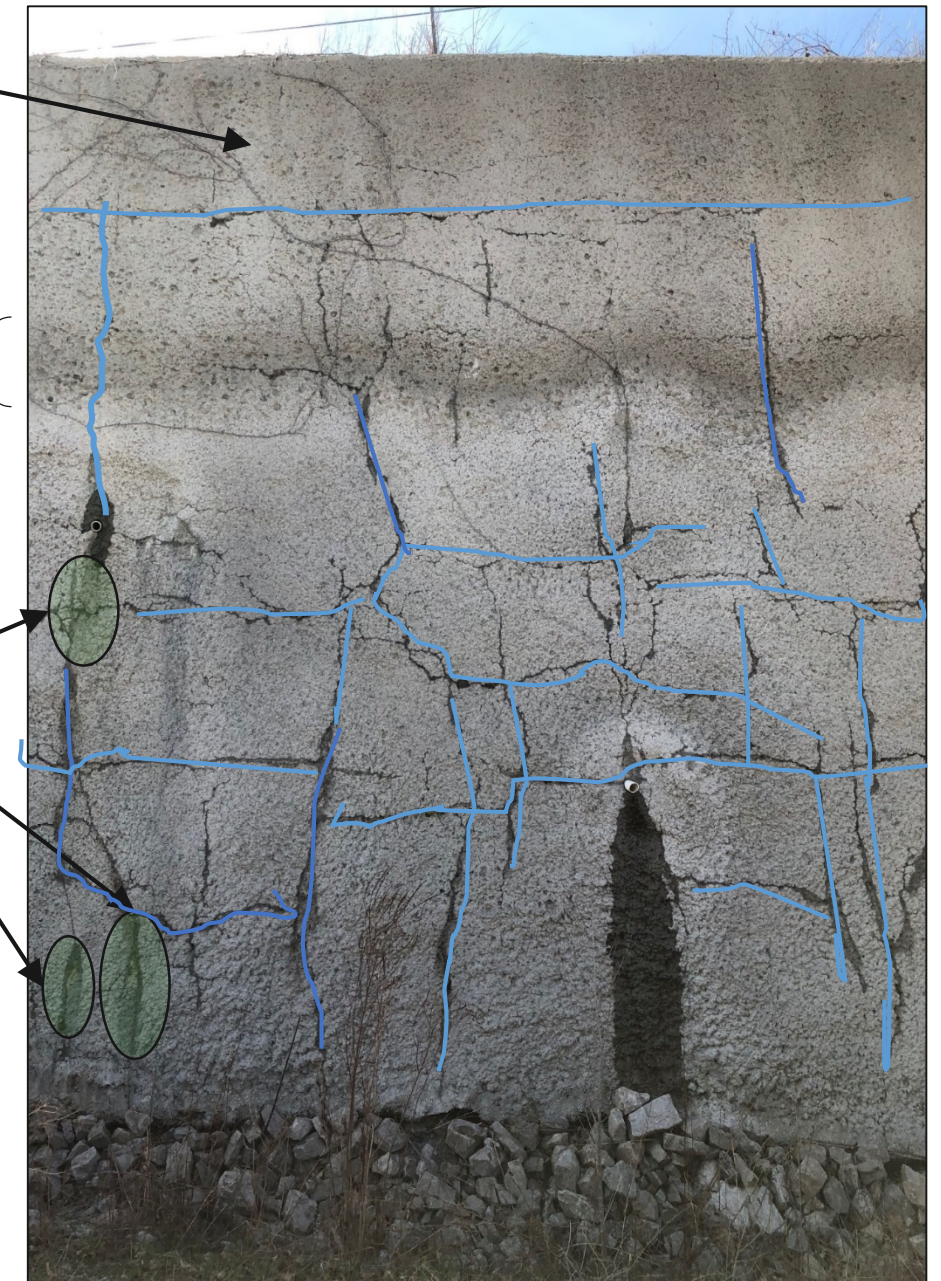
FIGURE 25

Active drainage pipes. Dark grey/brown discoloration.

Base of shotcrete exposed

Shotcrete eroded from water causing 'pitted' texture.

Light grey discoloration from drainage

Overall: Various healed vertical/horizontal fractures. Minor seepage. 0.5 m – 4 m length fractures

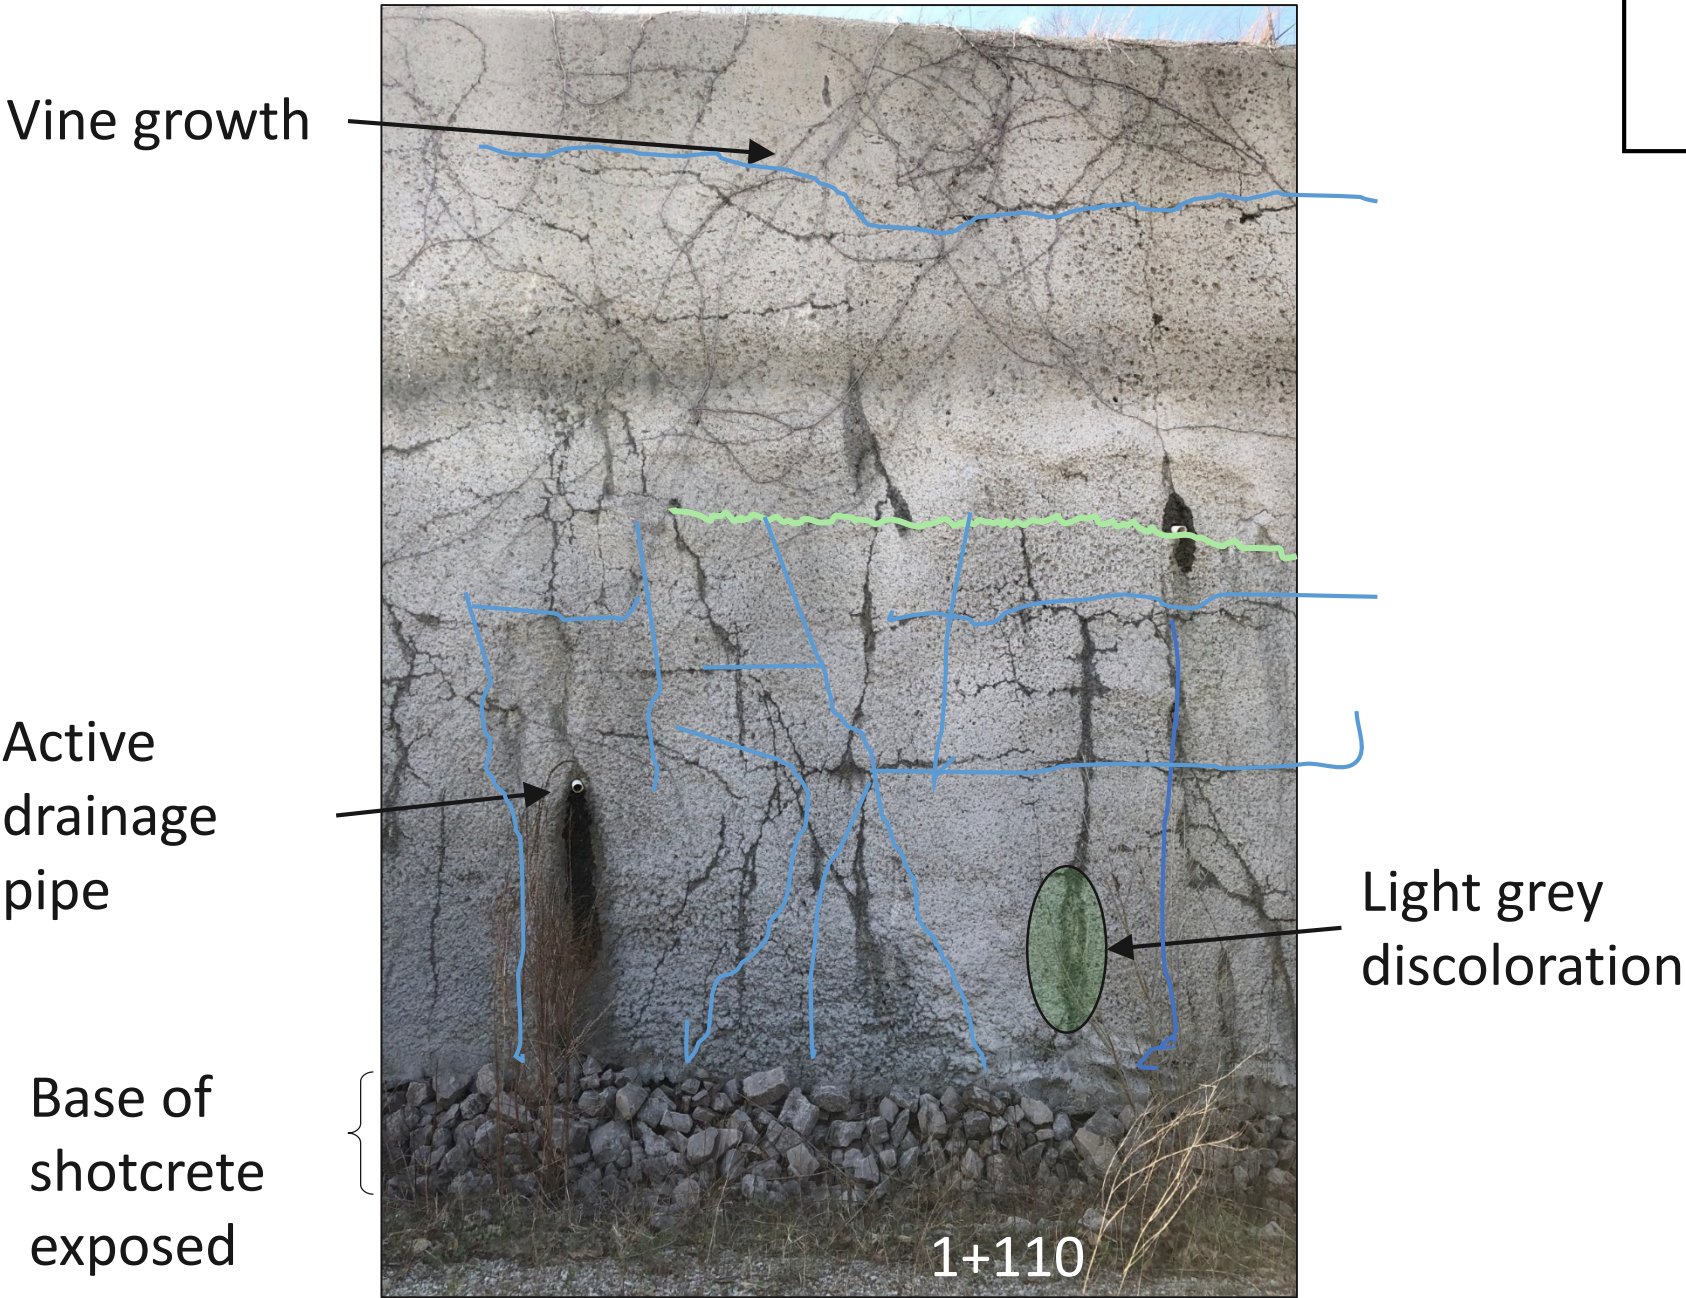
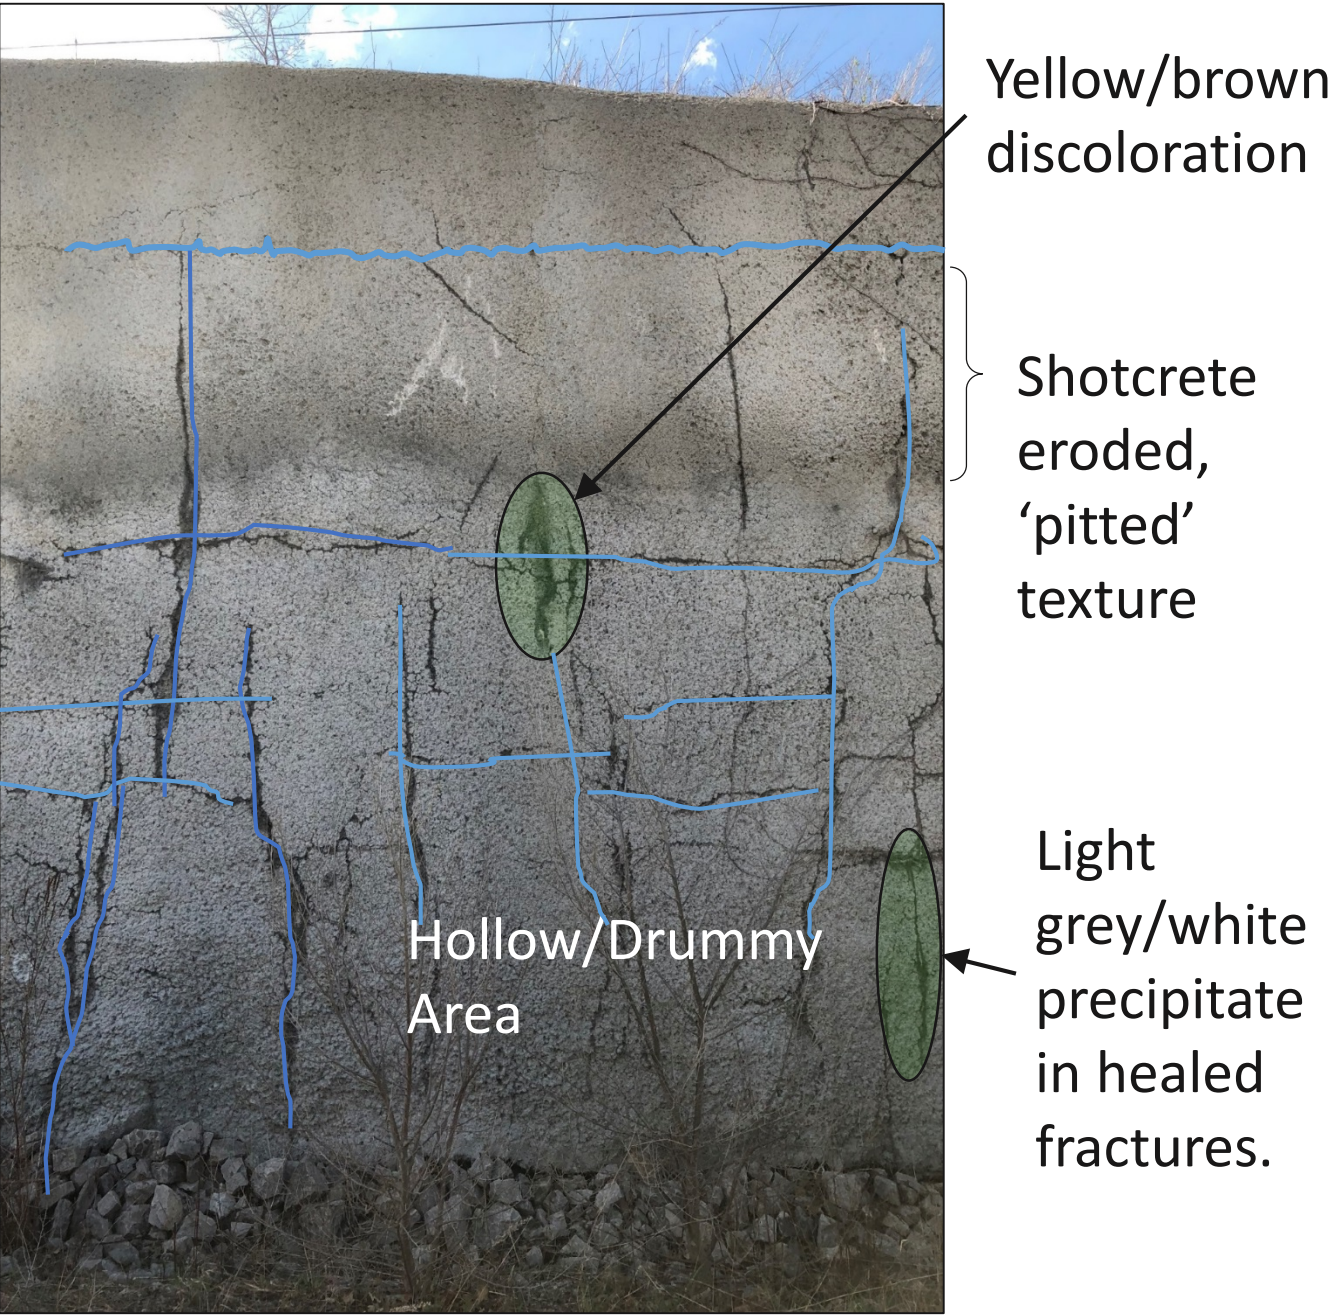
FIGURE 26

Overall: Various vertical/horizontal healed fractures. 0.5 m -3 m length. Minor seepage.

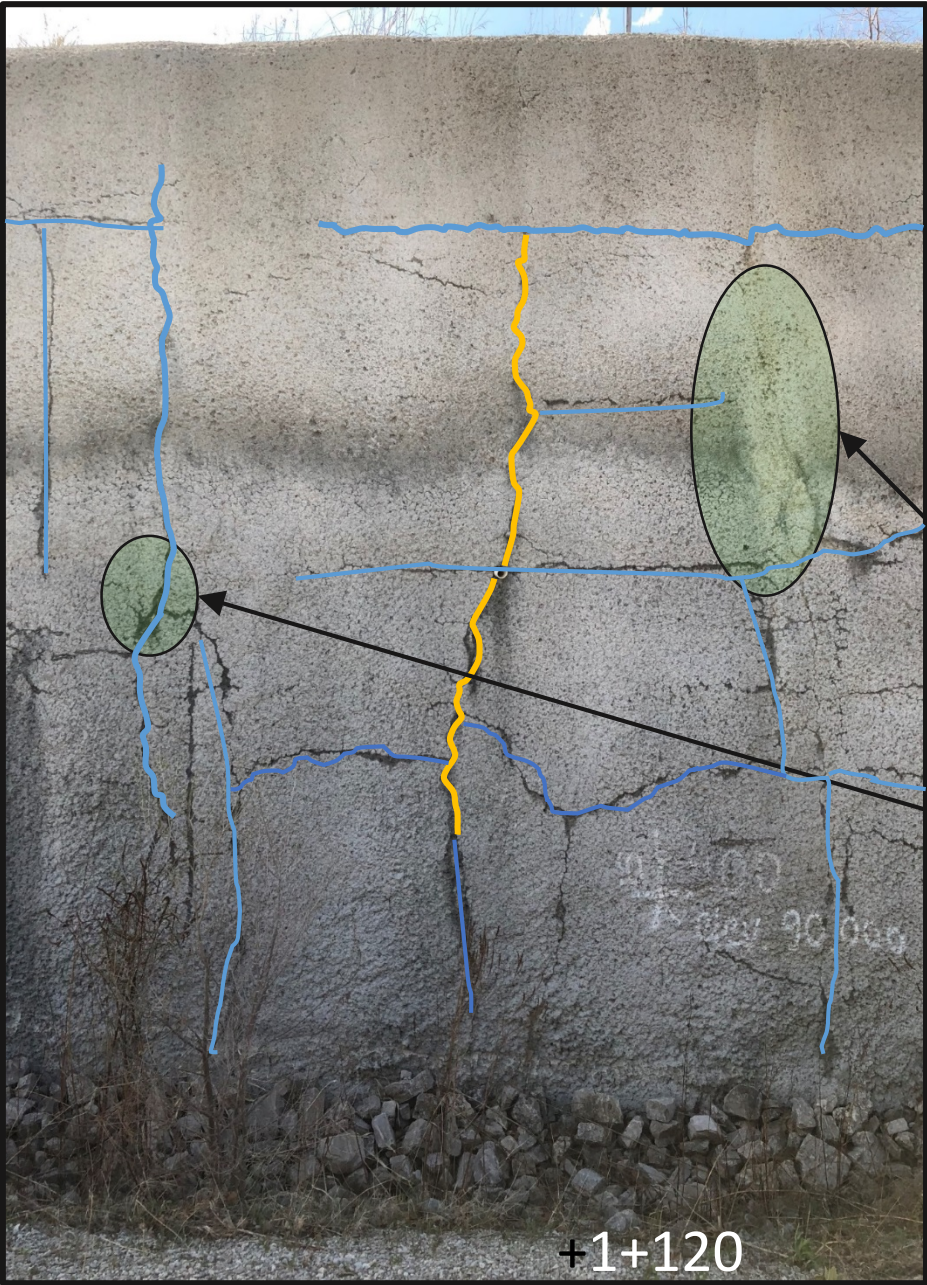
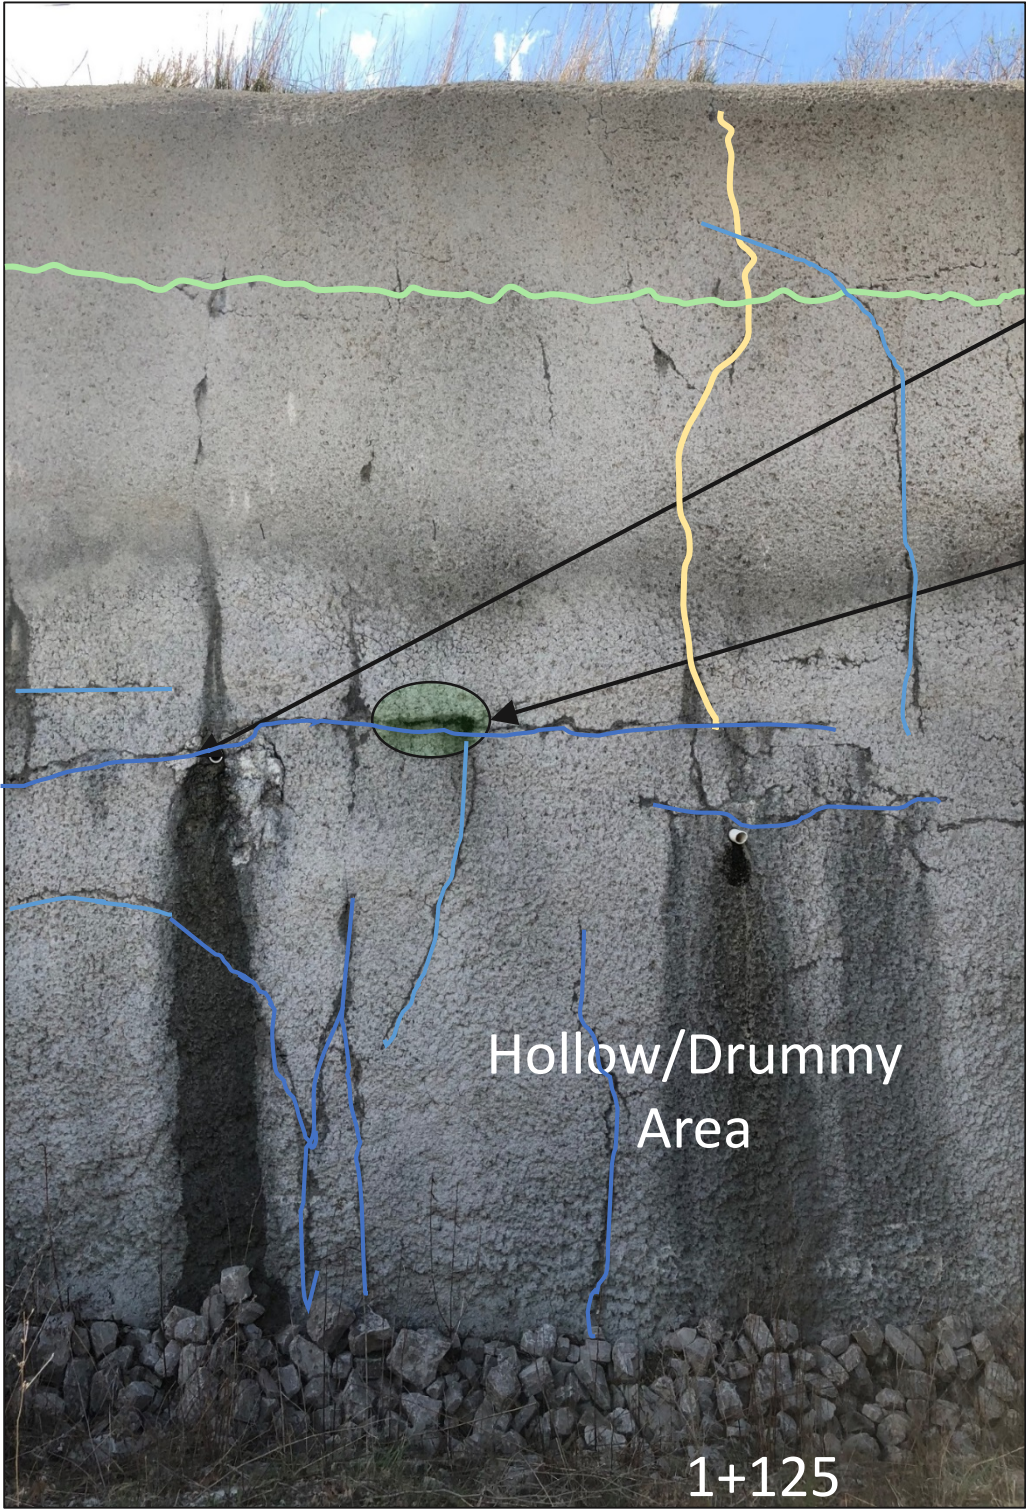
FIGURE 27

Continuous healed horizontal fracture (1+105 to 1+150)

Light grey discoloration

White precipitate in fracture

Active drainage pipes

Lichen growth

Overall: Various horizontal/vertical healed fractures. Minor seepage. 0.25 m -3 m length.
