Geotechnical Assessment of Shotcrete on Access Road Rock Cuts

QEW Widening from West of Mississauga Road to West of Hurontario Street, Mississauga, Ministry of Transportation, Ontario, GWP 2002-13-00

1662333-4

July 20, 2018

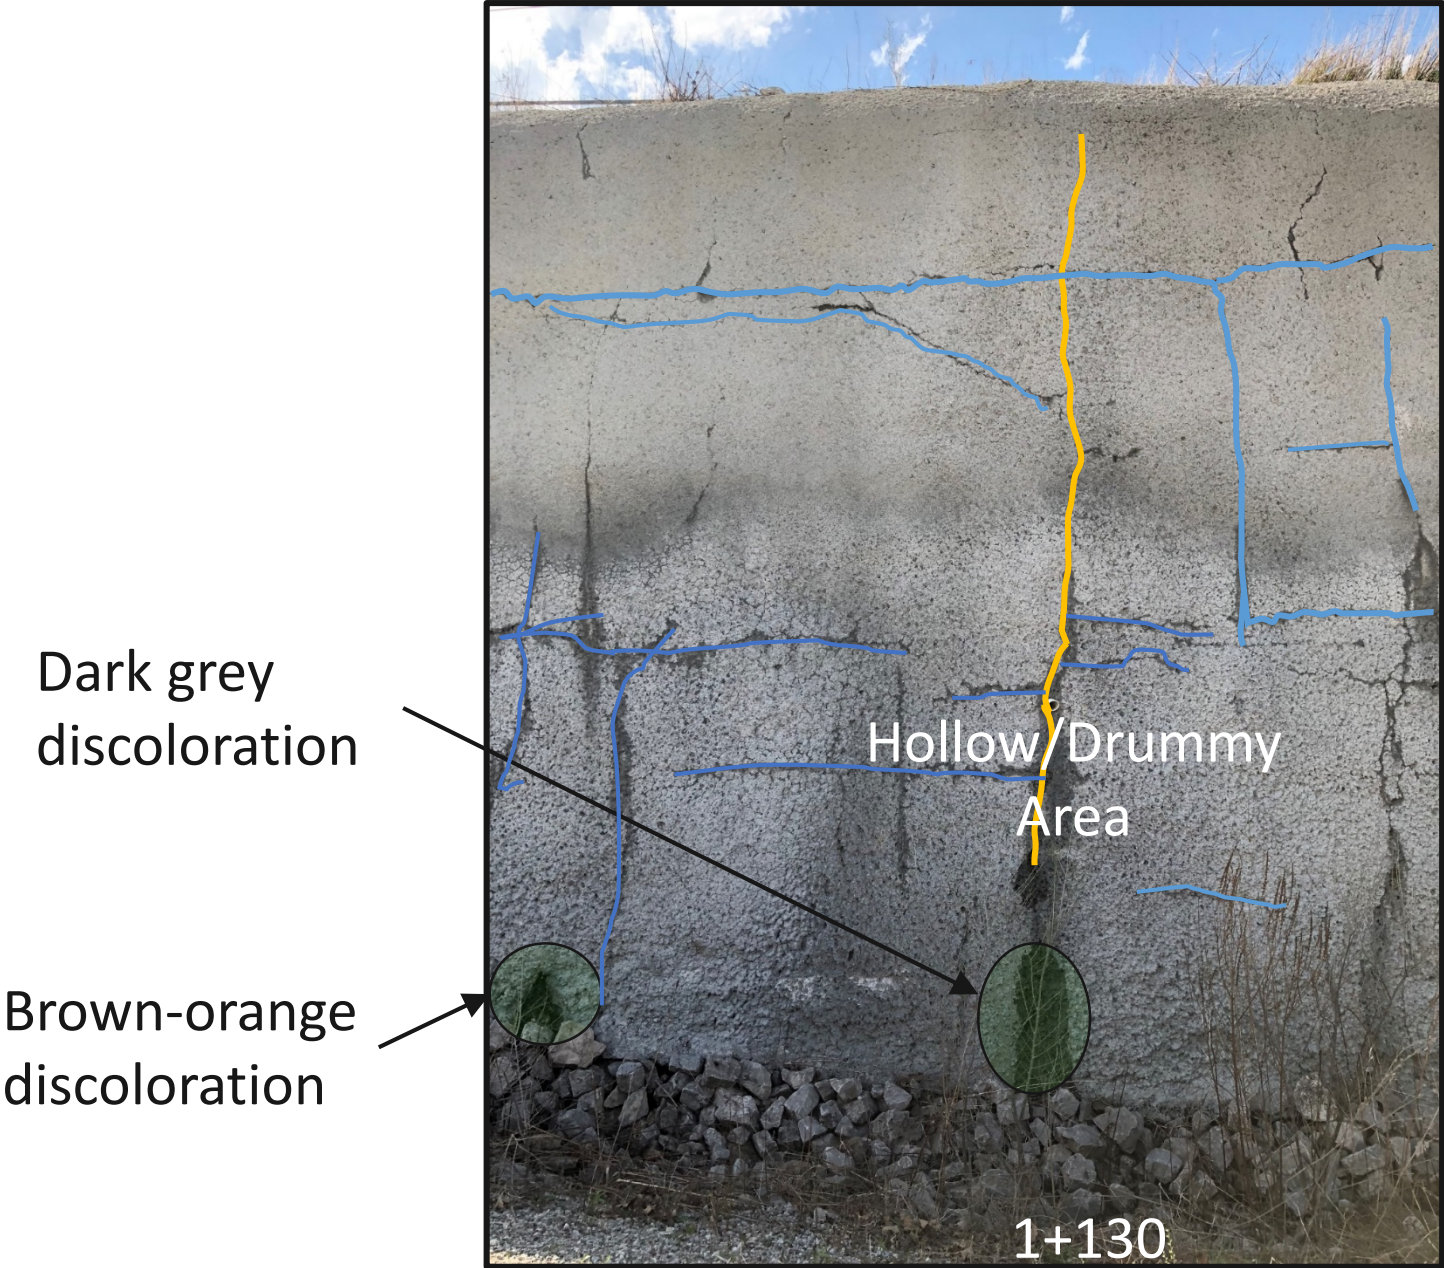
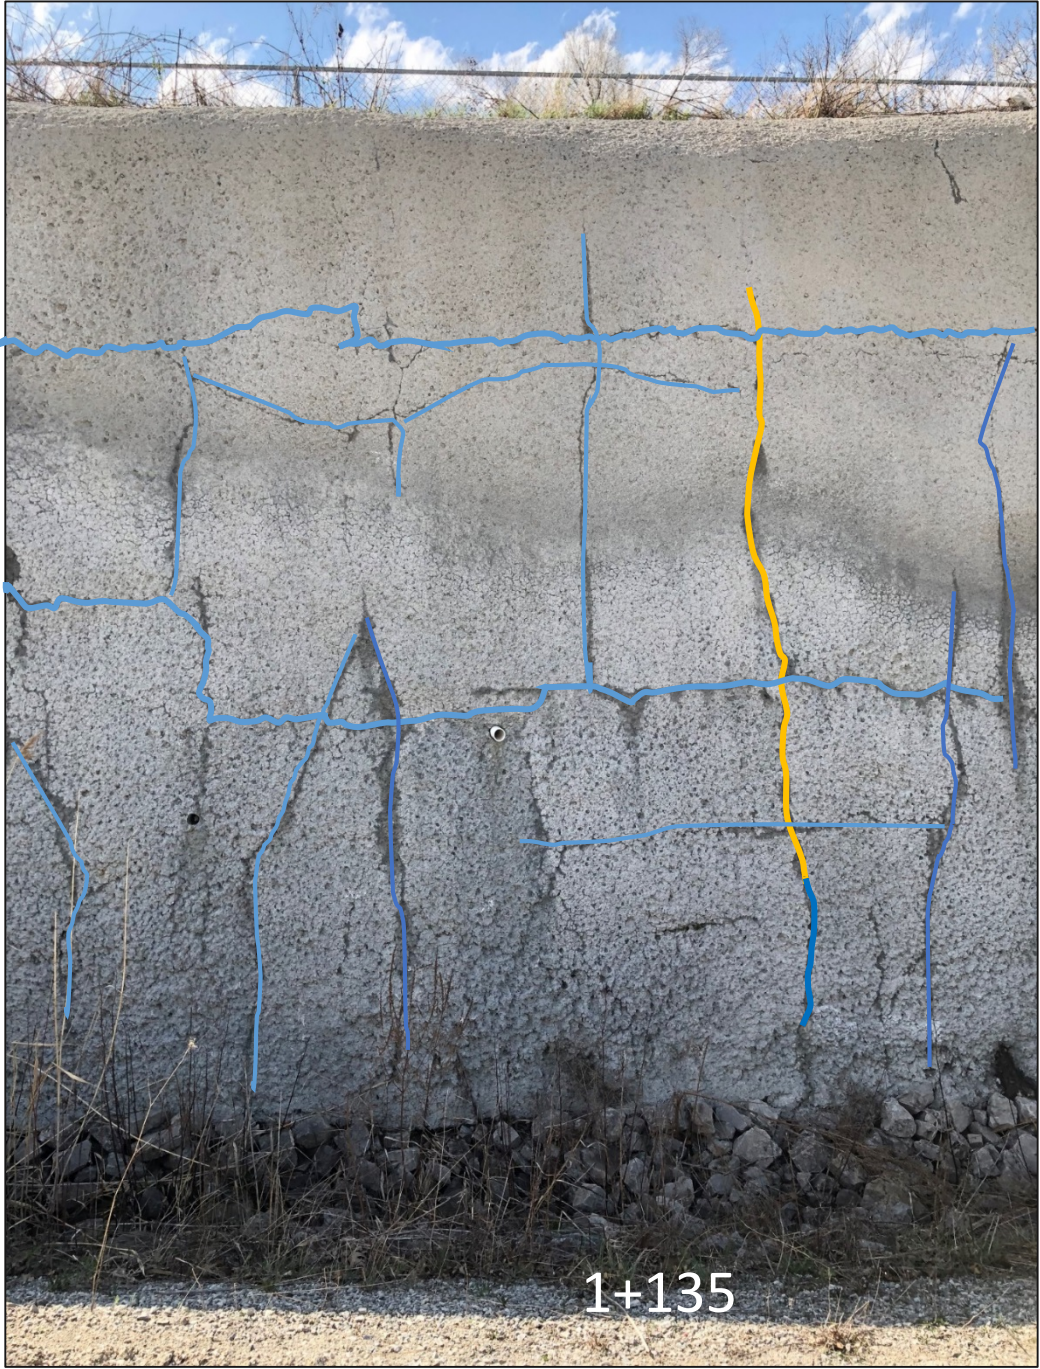
FIGURE 28

Overall: Various healed horizontal/vertical fractures. Minor seepage. 0.5 m-3 m in length. Shotcrete in good condition.

Shotcrete base exposed at some points.

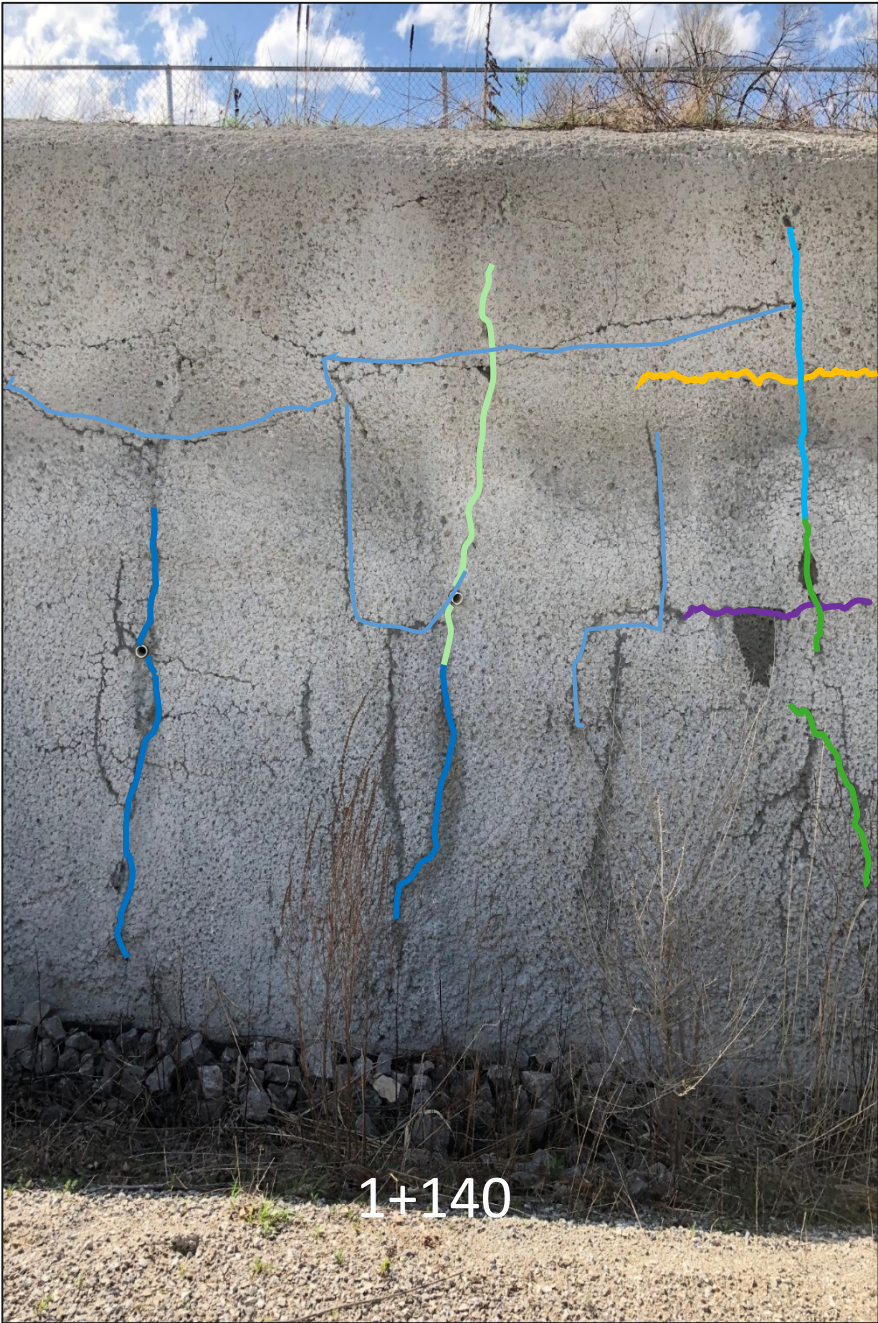
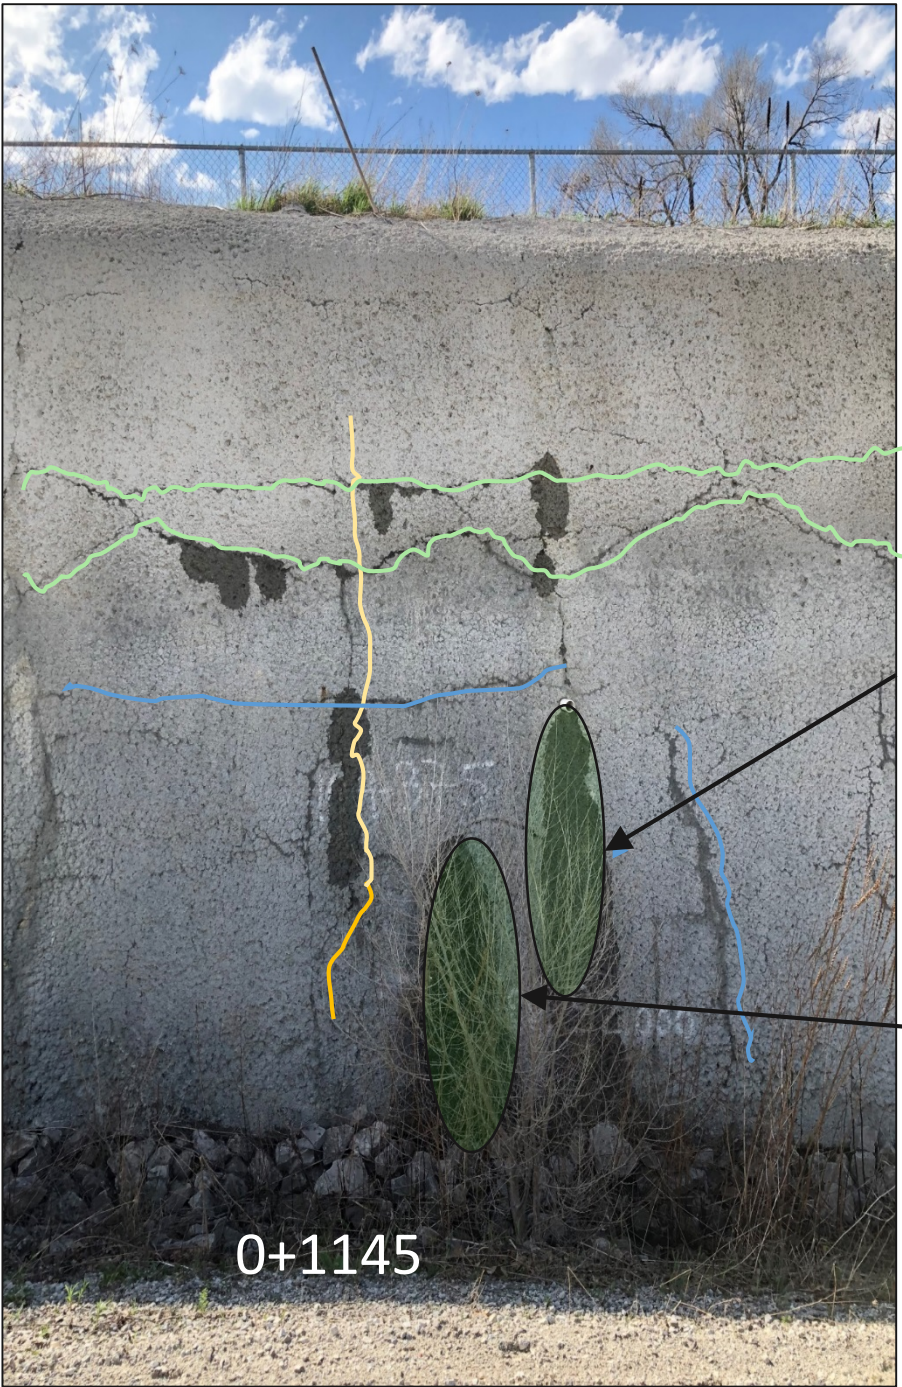
FIGURE 29

'Pitted' texture

Dry during field assessment on (May 9th)

Major seepage and discoloration

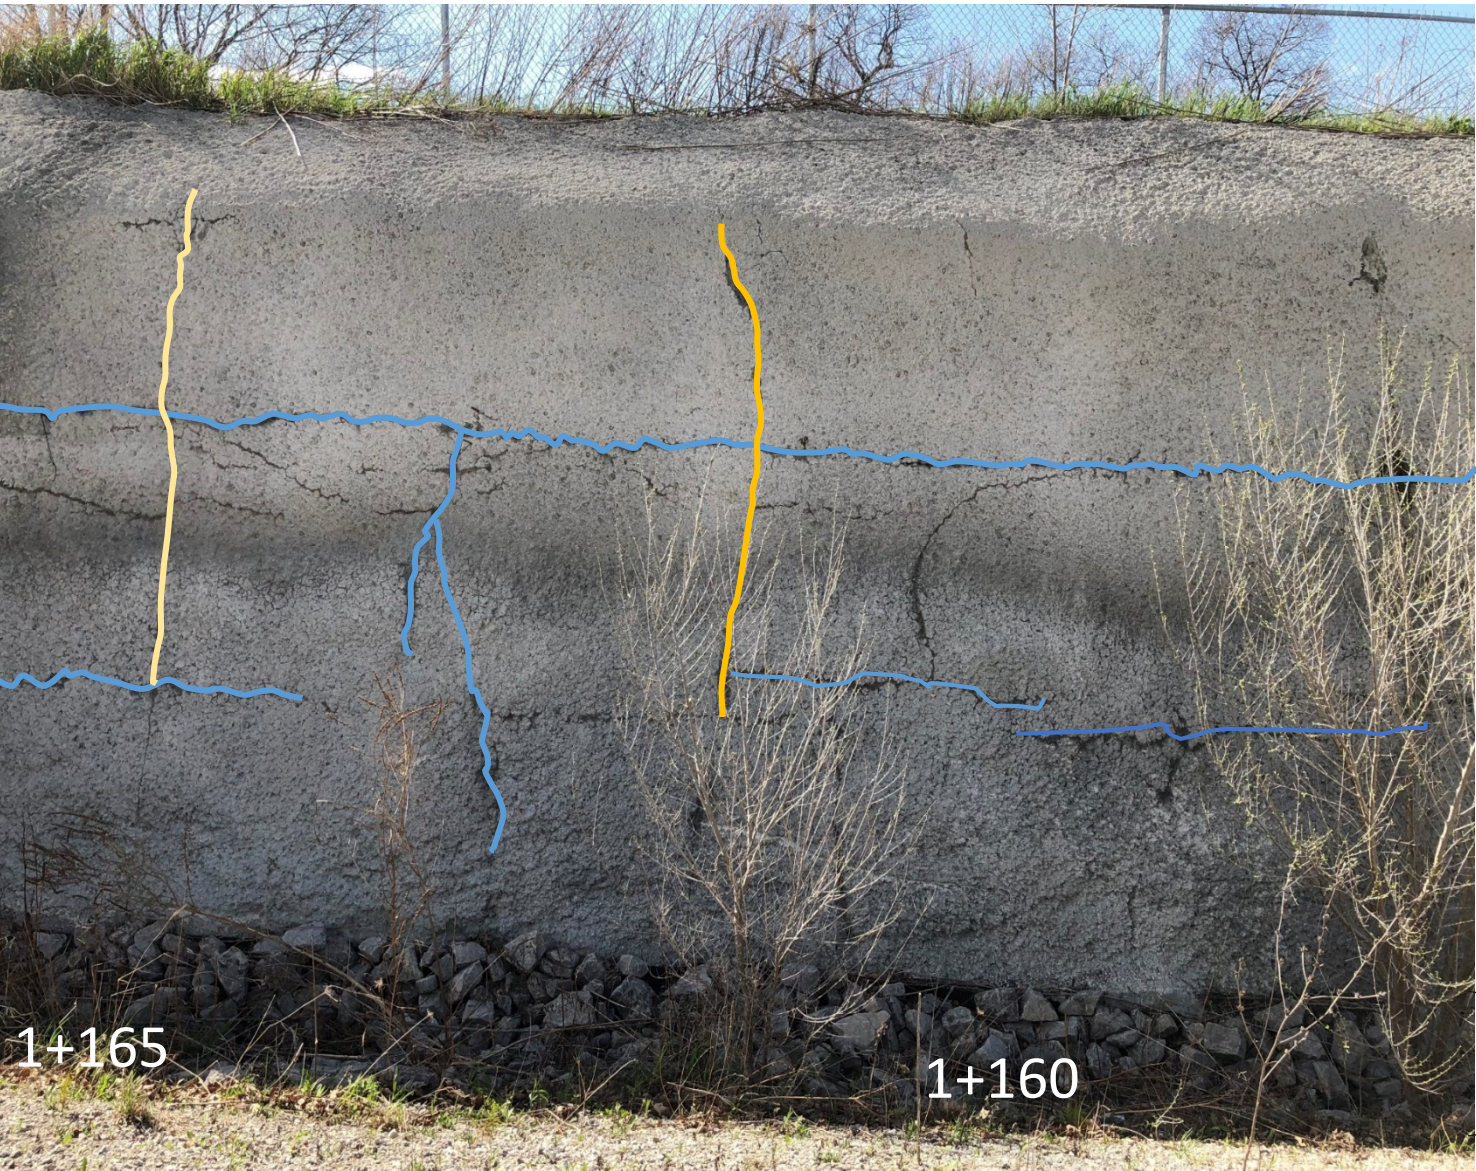
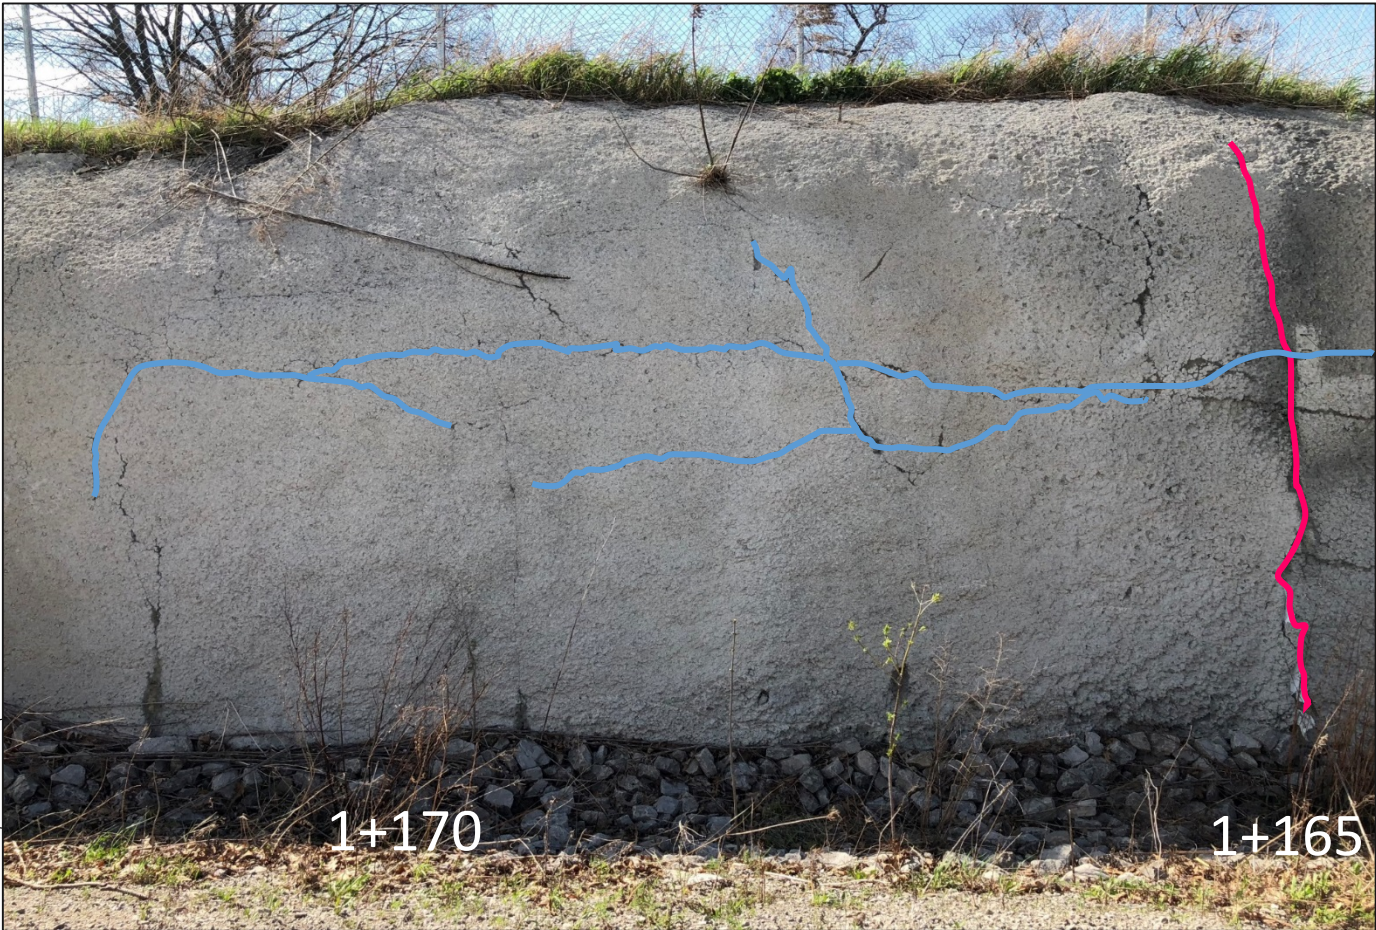
FIGURE 31

Mesh at
bottom of
shotcrete

Black mesh at
base of
shotcrete
