# Geotechnical Assessment of Shotcrete on Access Road Rock Cuts

*QEW Widening from West of Mississauga Road to West of Hurontario Street, Mississauga, Ministry of Transportation, Ontario, GWP 2002-13-00*

**Golder Associates Ltd.**

July 20, 2018

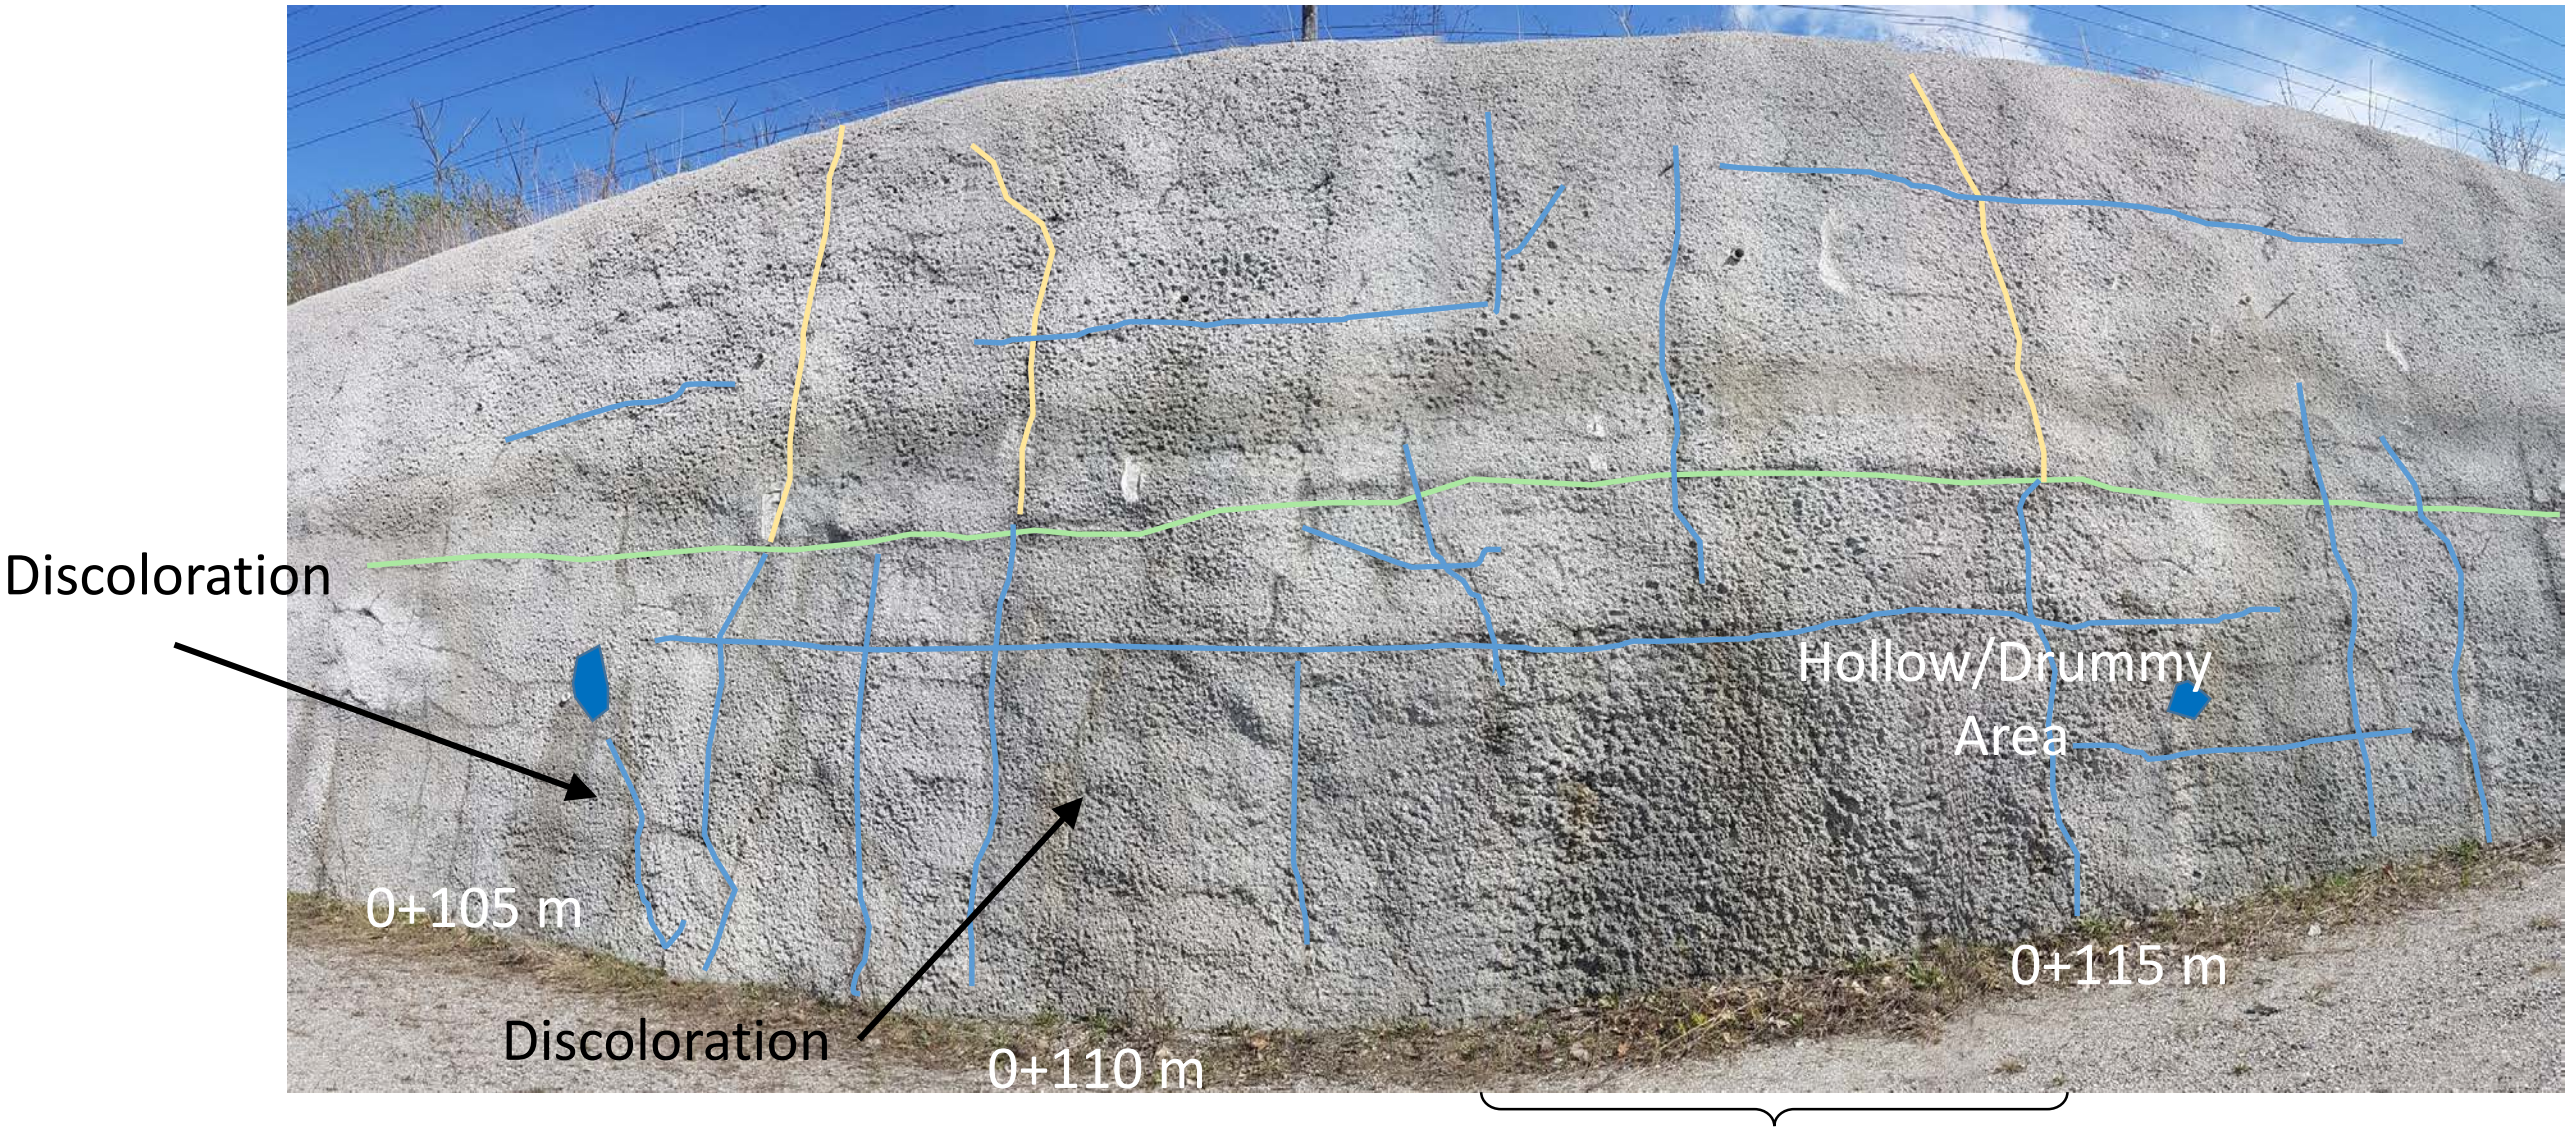
**FIGURE 10**

Some horizontal fractures, healed to 1 mm aperture, 1-3 m in length

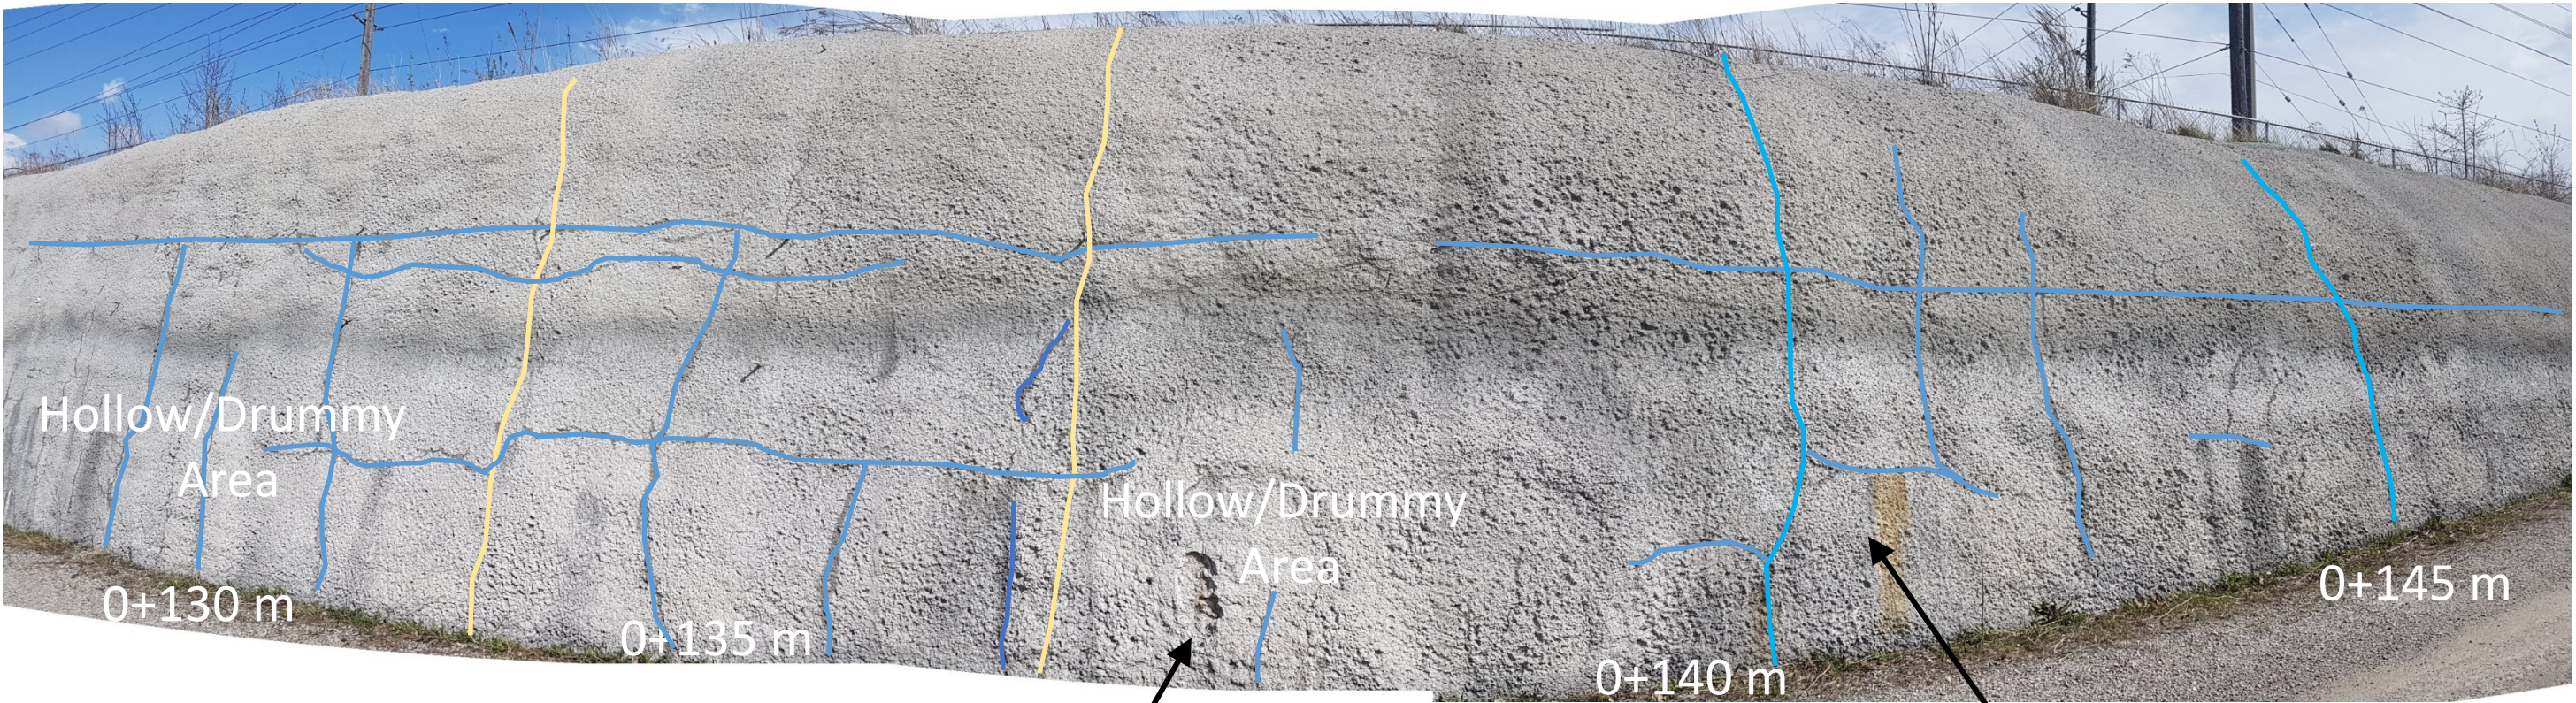
**FIGURE 12**

Delaminated/spalled zone,  
exposing wire mesh underneath  
shotcrete

Discoloration, oxidation from  
seeping crack

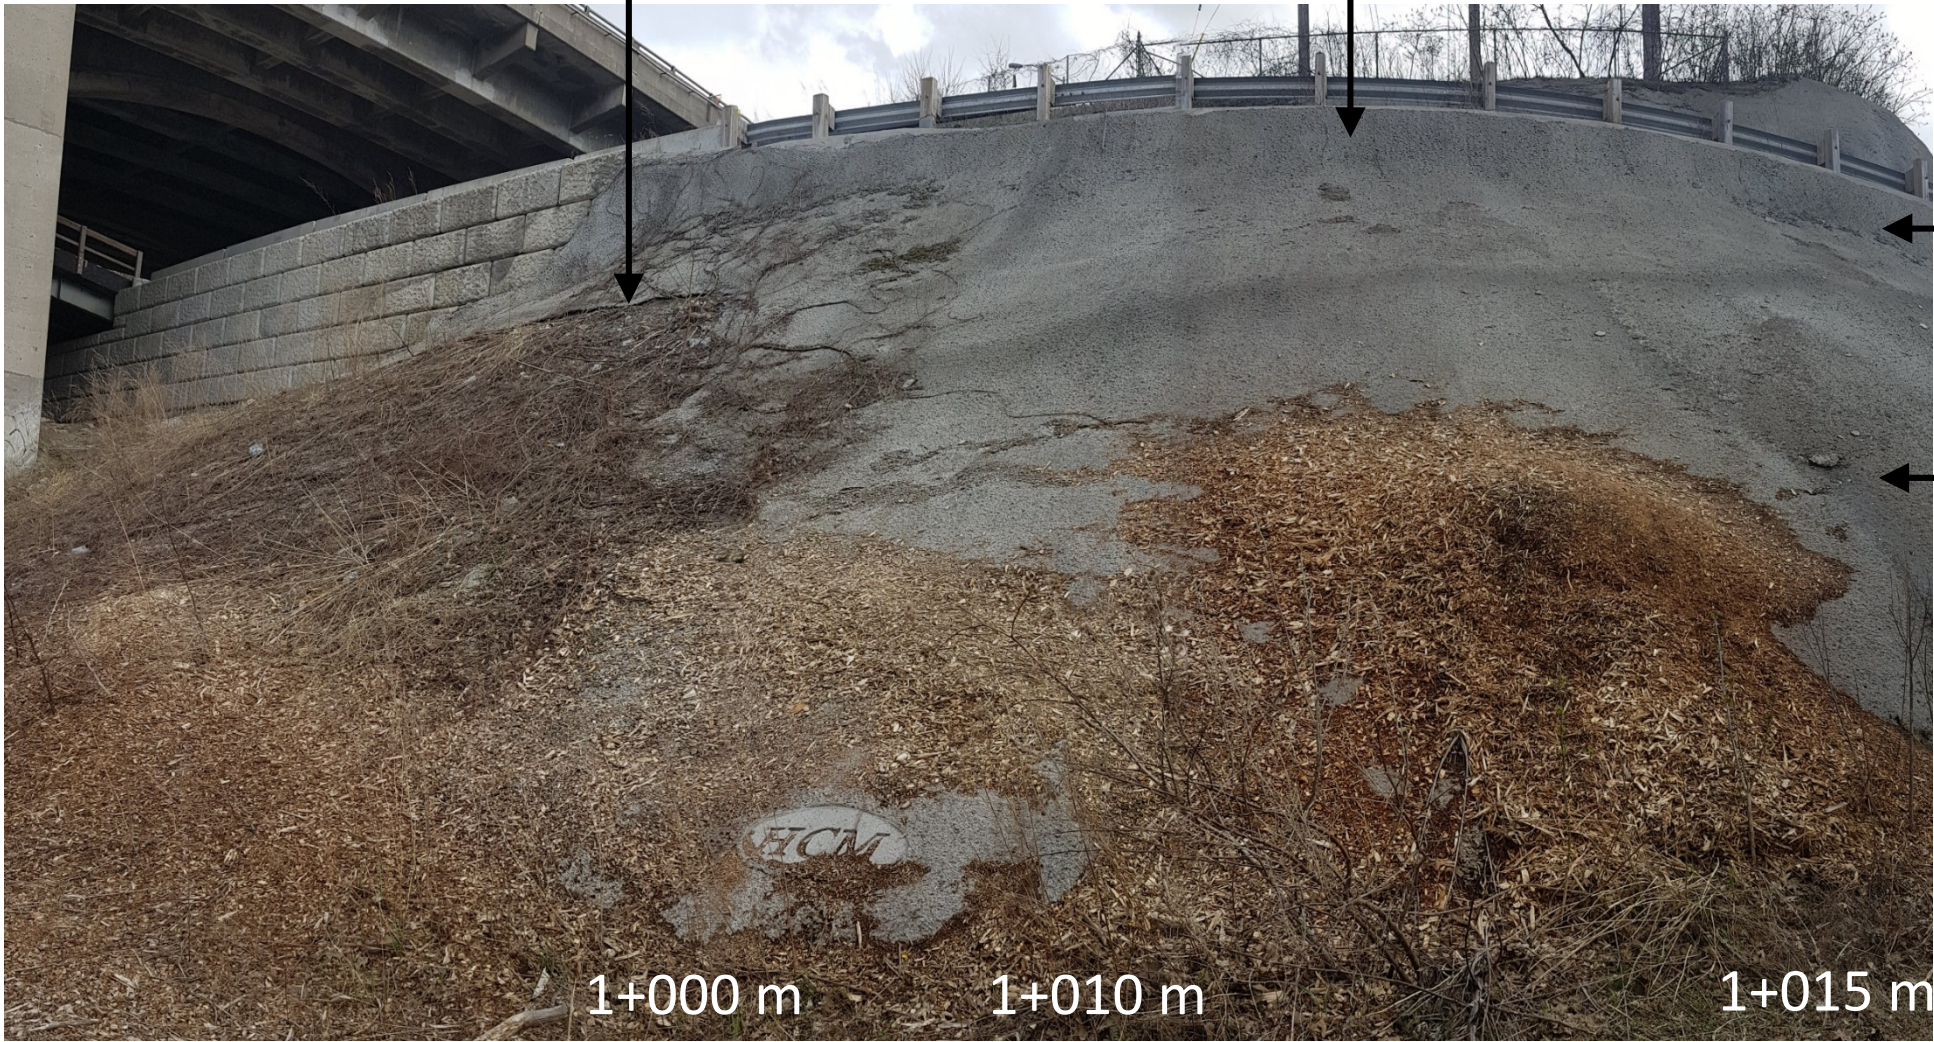
Shotcrete lip, vegetation growing underneath

Small vertical cracks

Rock debris  
from road

Eroded surface  
from surface  
runoff

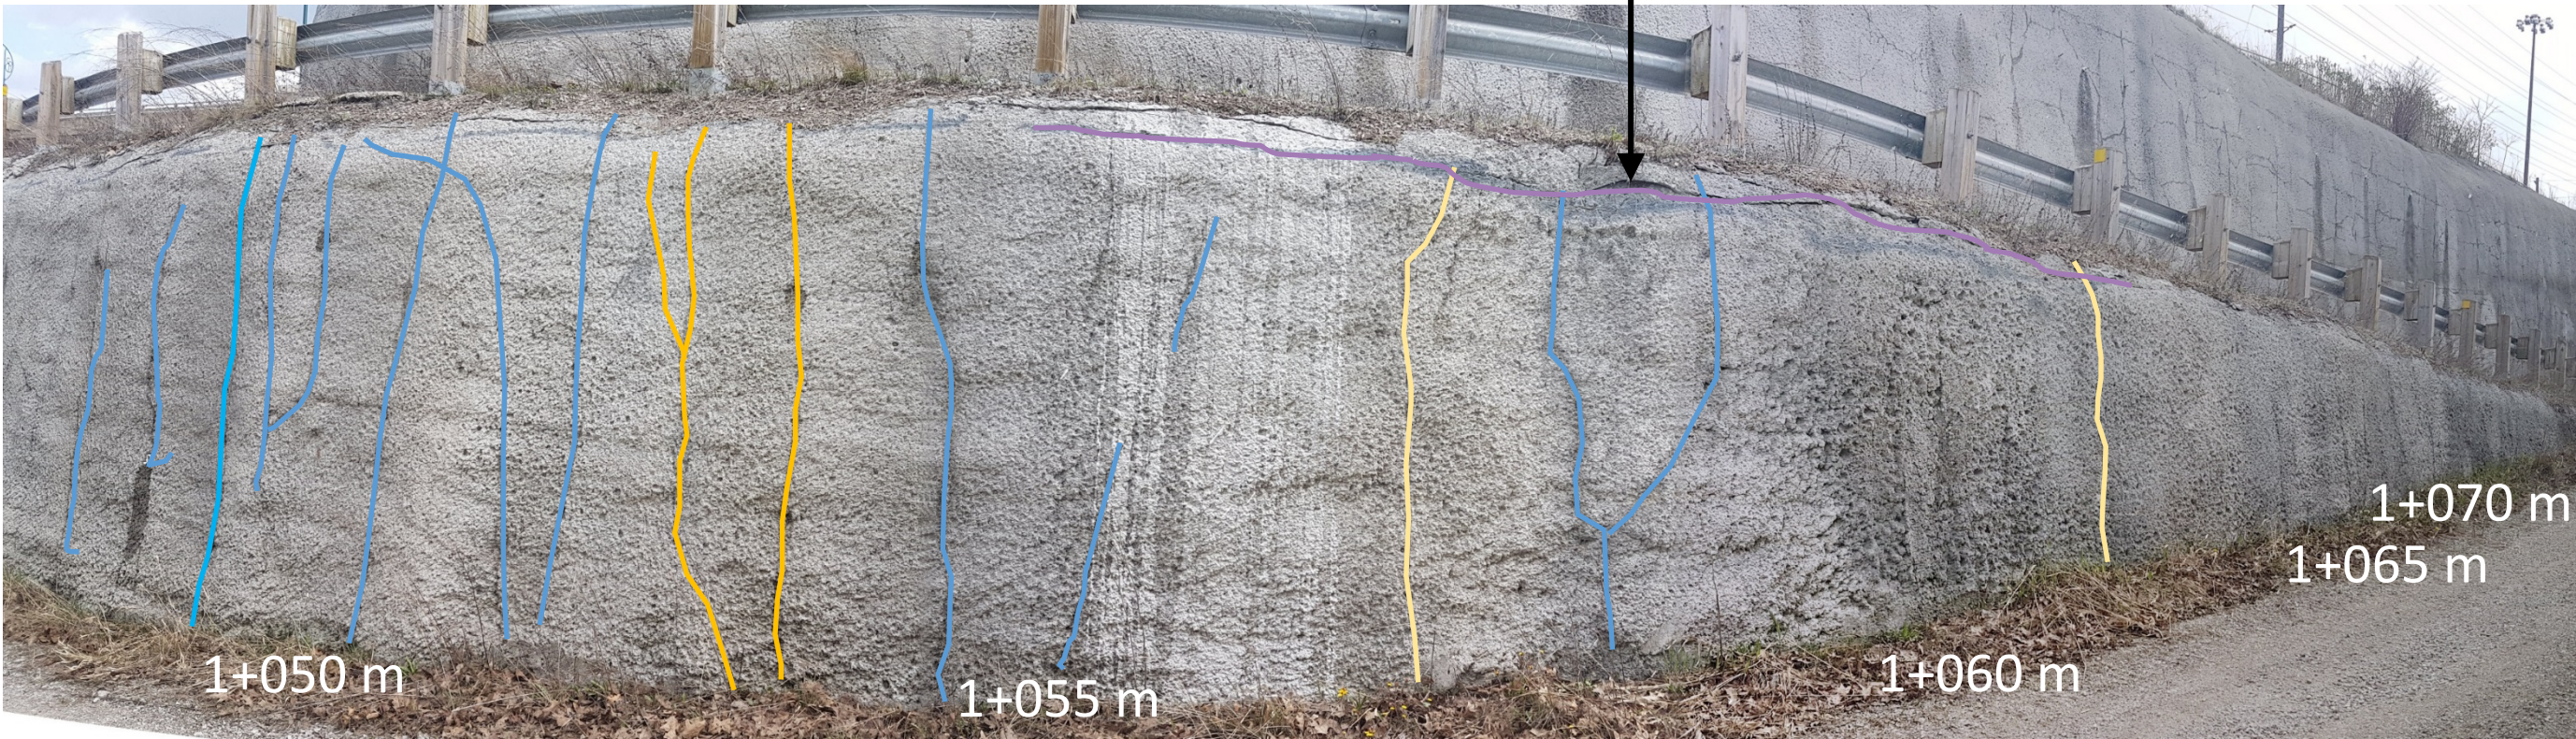
**FIGURE 19**

Major overhanging horizontal joint, top layer of shotcrete hanging over vertical wall, open, dry, 1-5 mm

Surface runoff from below gravel layer at top

Eroded/pitted large seeps, discolouration on healed joints

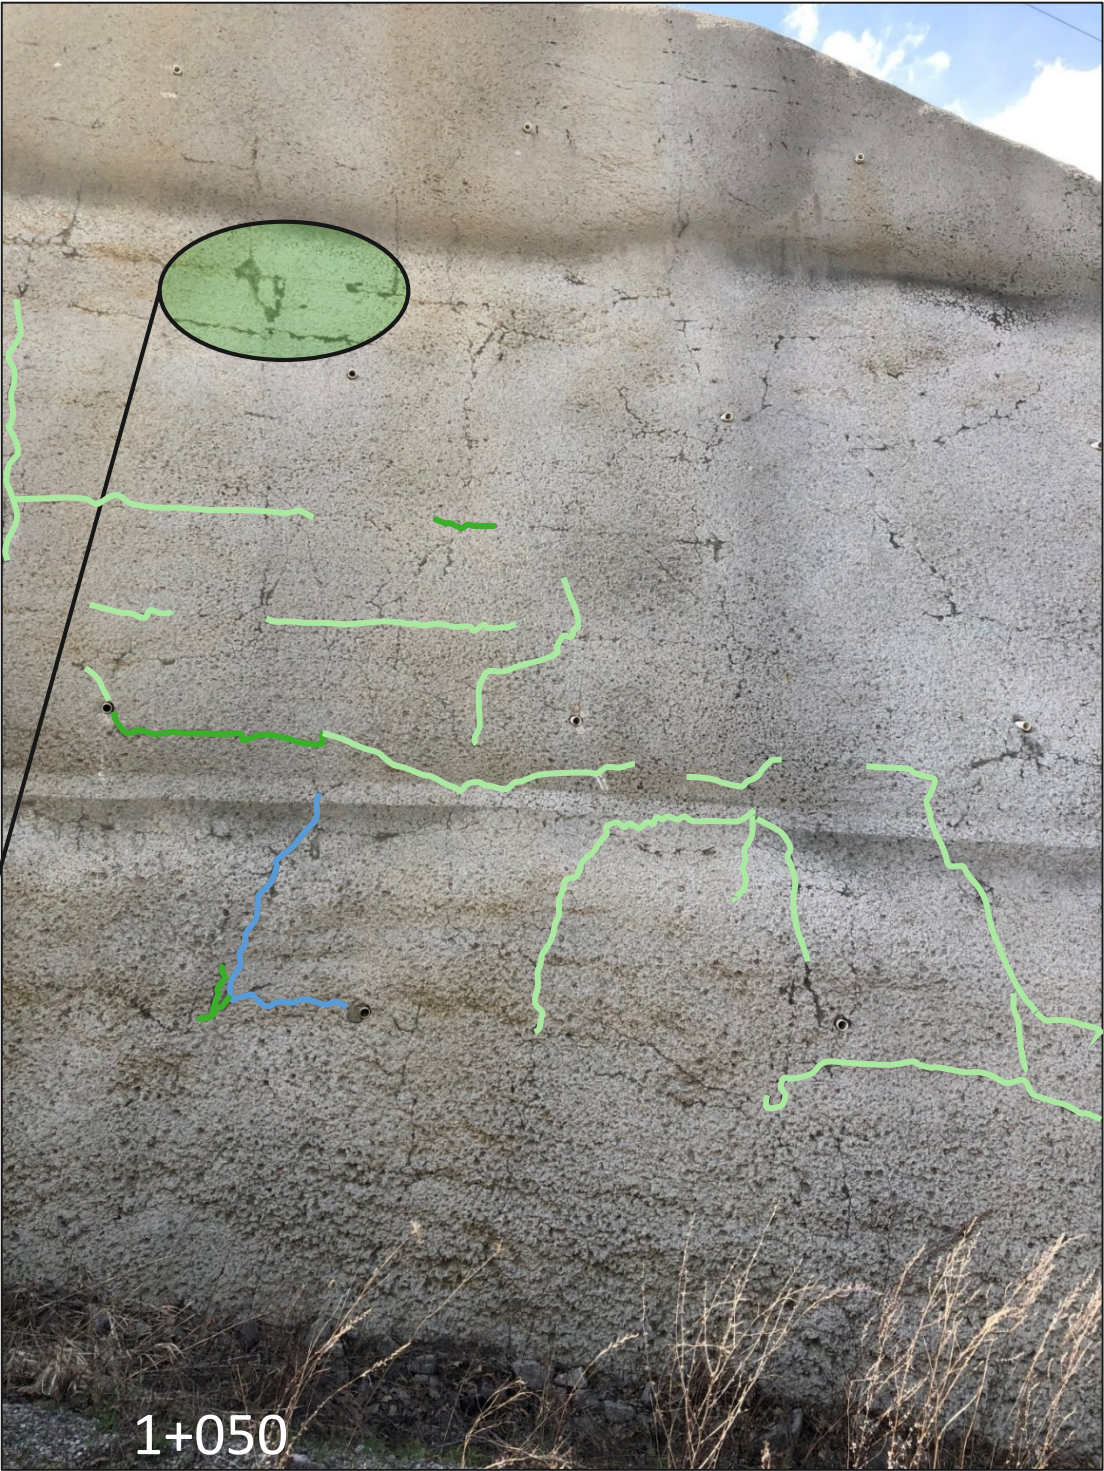
**FIGURE 20**

Seepage from  
intersecting  
vertical and  
horizontal  
fractures

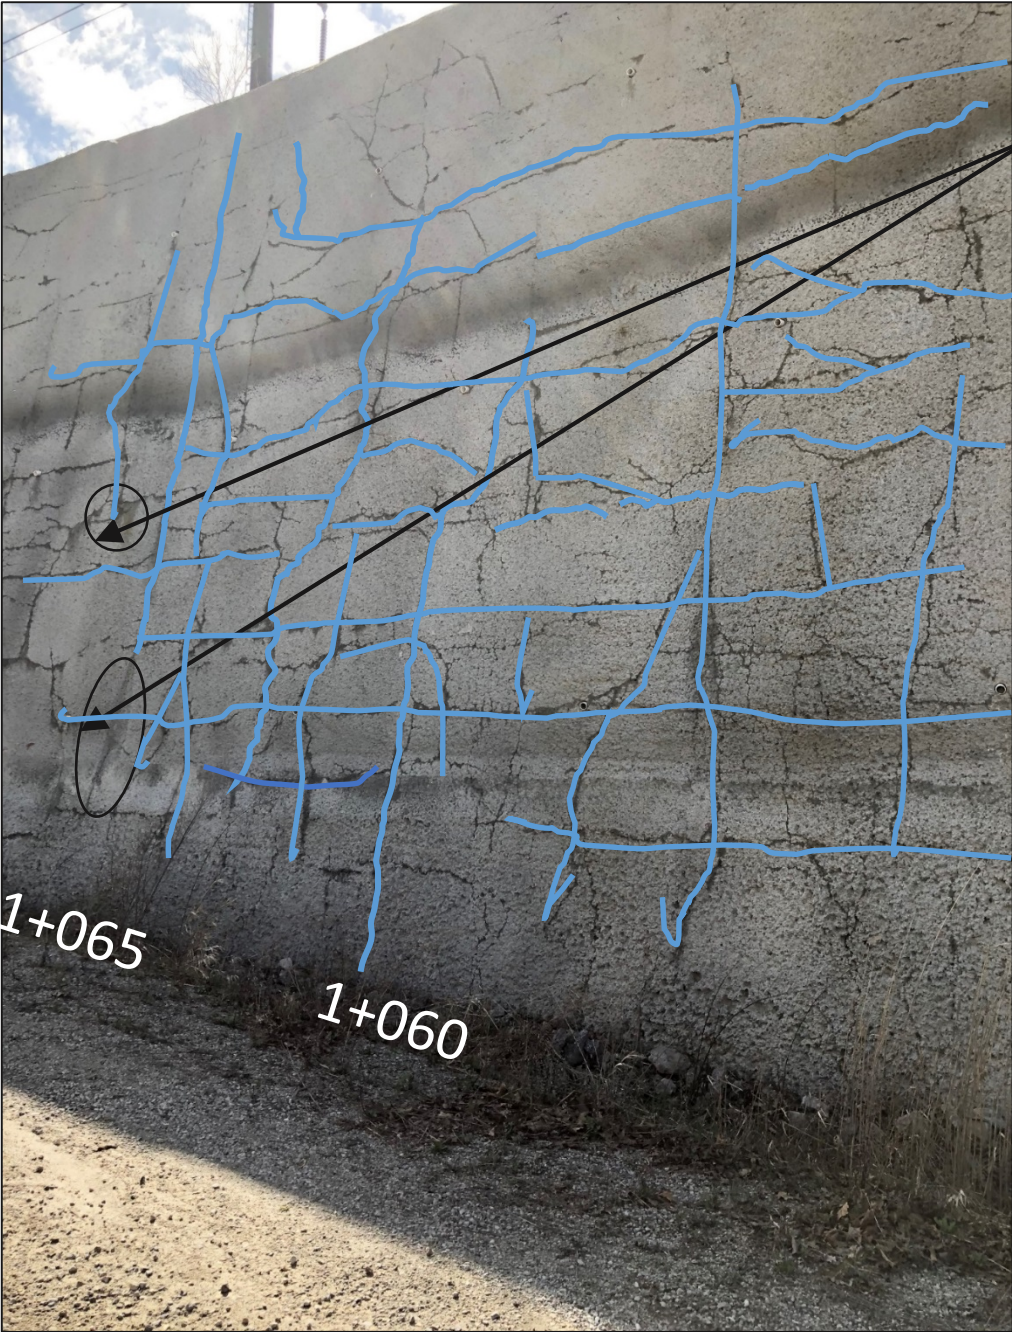
**FIGURE 21**

Zone of  
Greenish-brown  
discoloration

Base of the  
shotcrete  
has a  
'pitted'  
texture due  
to erosion

Minor seepage at  
Intersection of  
vertical and  
horizontal  
fractures, 1-2 mm  
apertures.

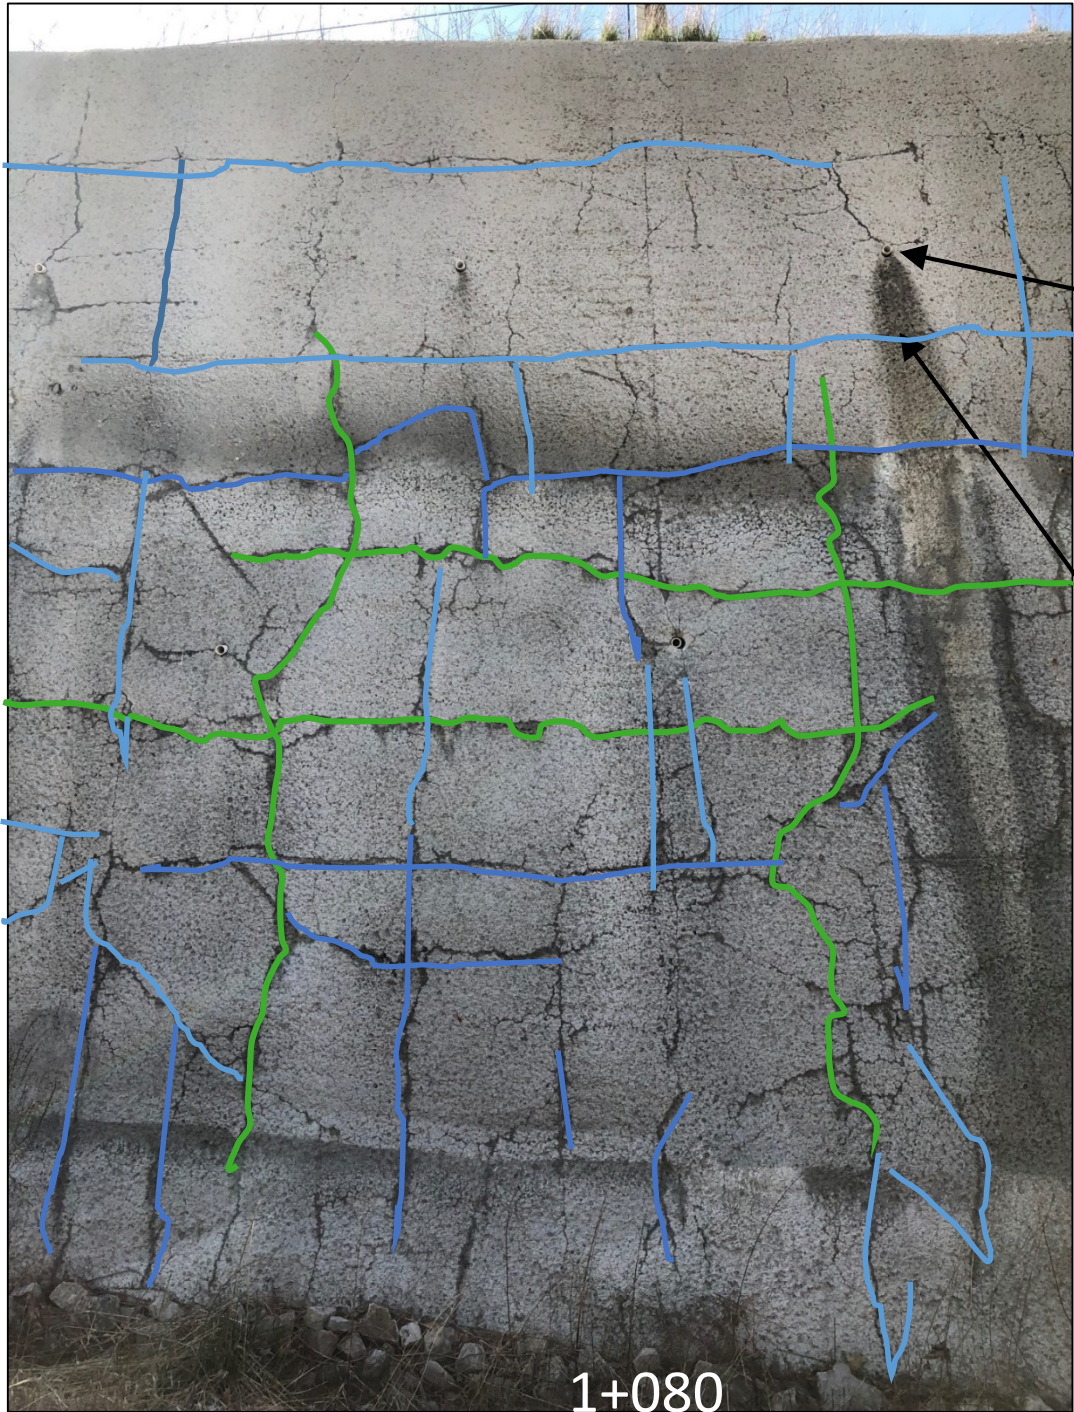
FIGURE 23

Active  
Drainpipe

Light grey/yellow  
discoloration  
along drainage  
path

**Overall:** Various  
vertical/horizontal  
fractures, some seepage,  
0.5 m – 4 m length

Healed  
fracture,  
Light grey  
seepage,  
discoloration

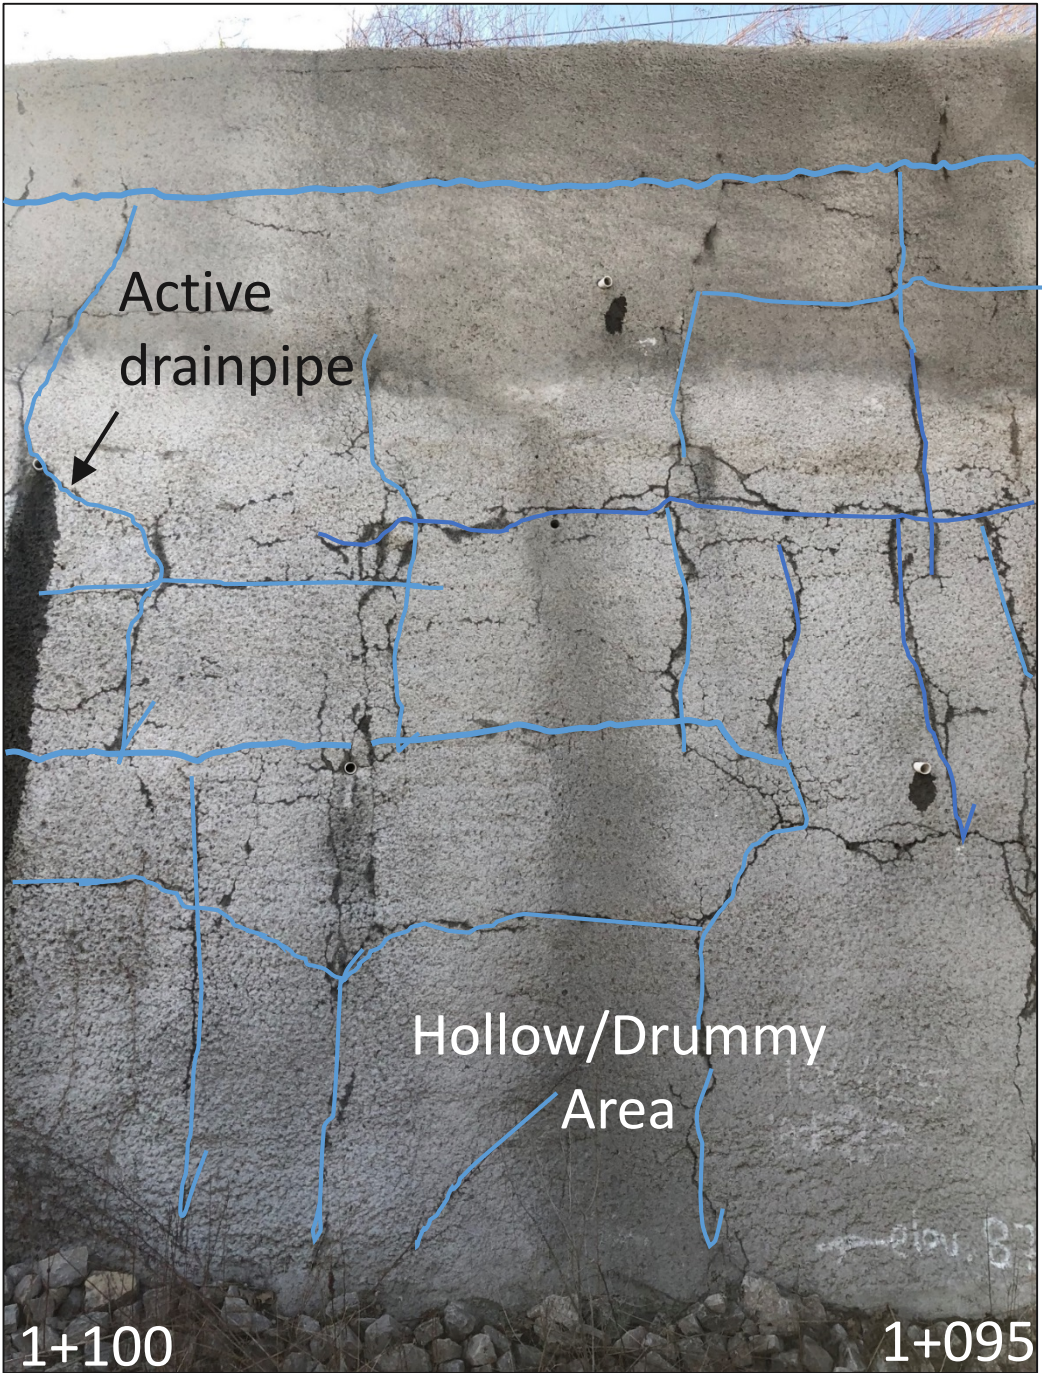
**FIGURE 24**

Active  
drainpipe

Dark  
brown/black  
discoloration  
from seepage  
at healed  
fracture.

~5 m  
long  
fracture

**Overall:** various  
vertical/horizontal healed  
fractures, minor to some  
seepage, 0.5 m – 4 m length

Active drainage  
pipes. Dark  
grey/brown  
discoloration.

Base of  
shotcrete  
exposed

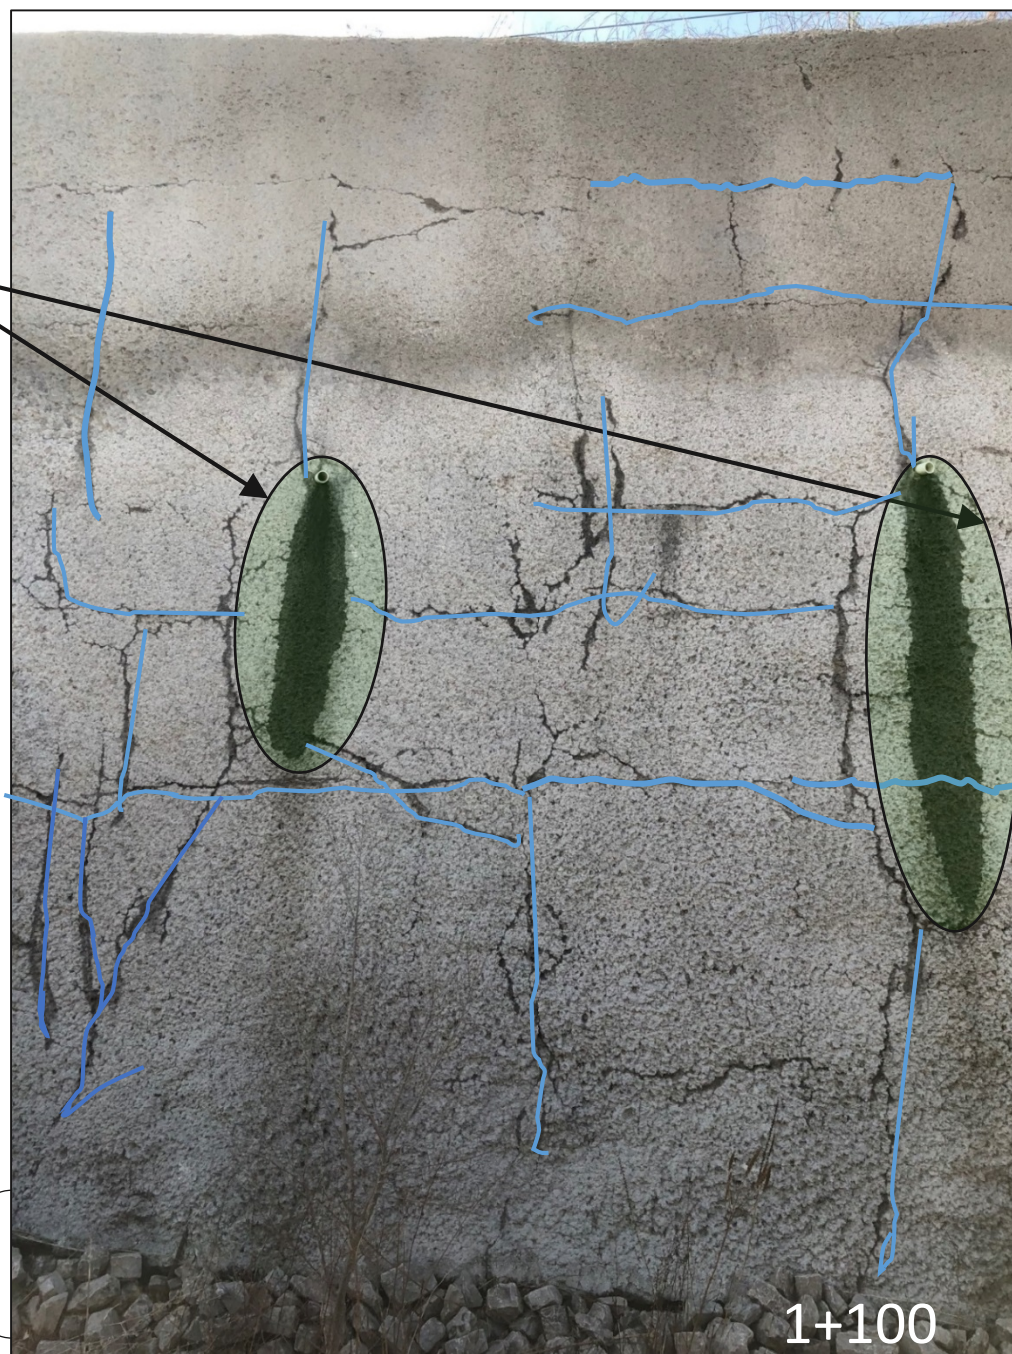
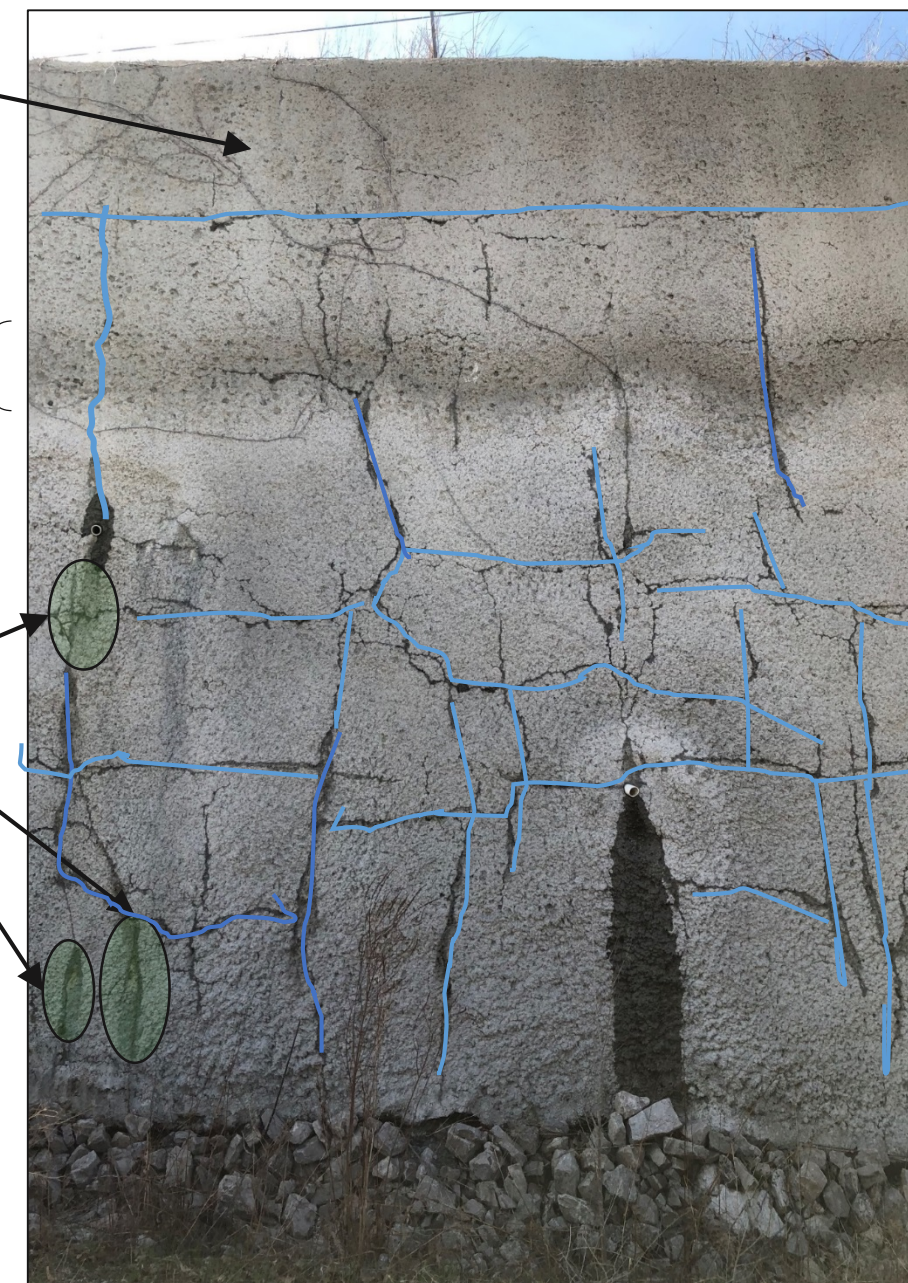
**Overall:** Various healed  
vertical/horizontal fractures.  
Minor seepage. 0.5 m – 4 m  
length fractures

Shotcrete eroded  
from water causing  
'pitted' texture.

Light grey  
discoloration  
from drainage

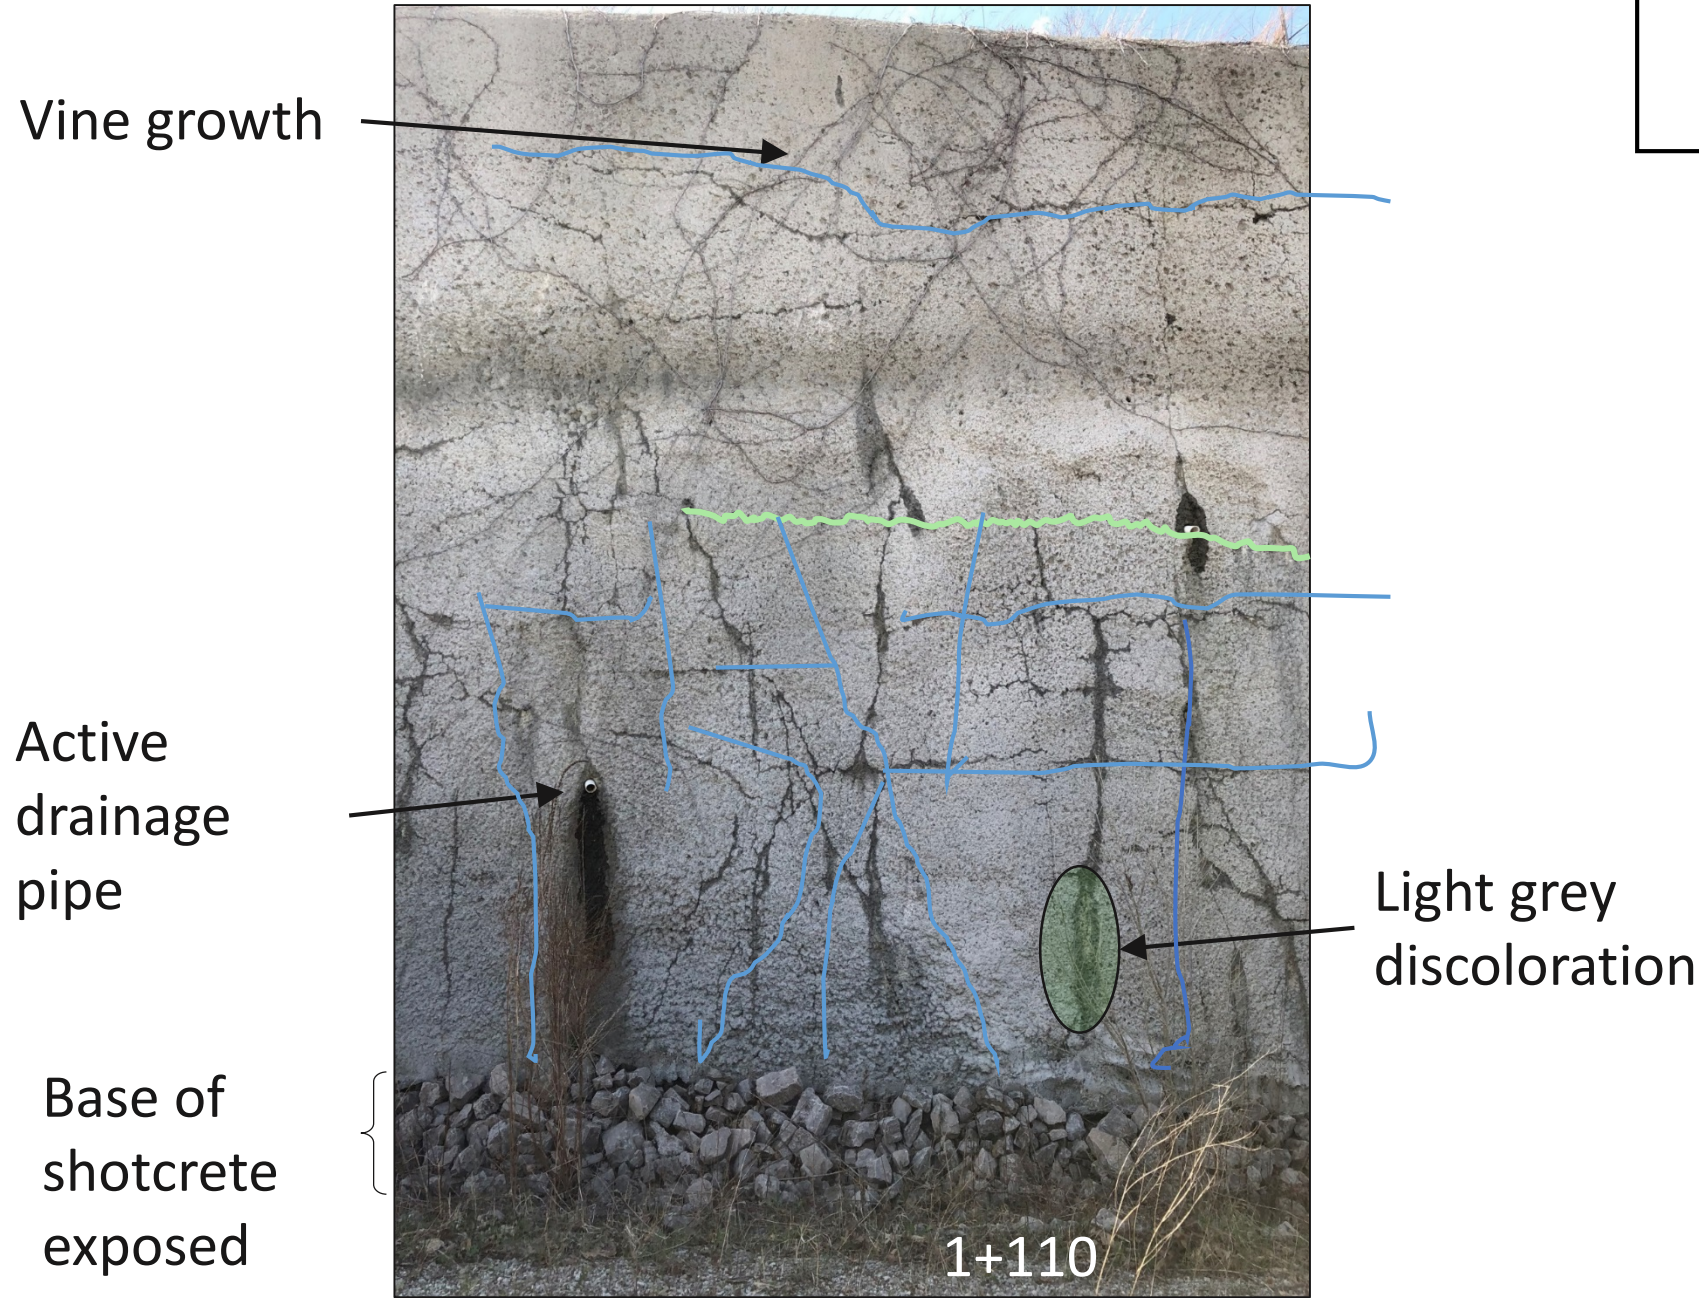
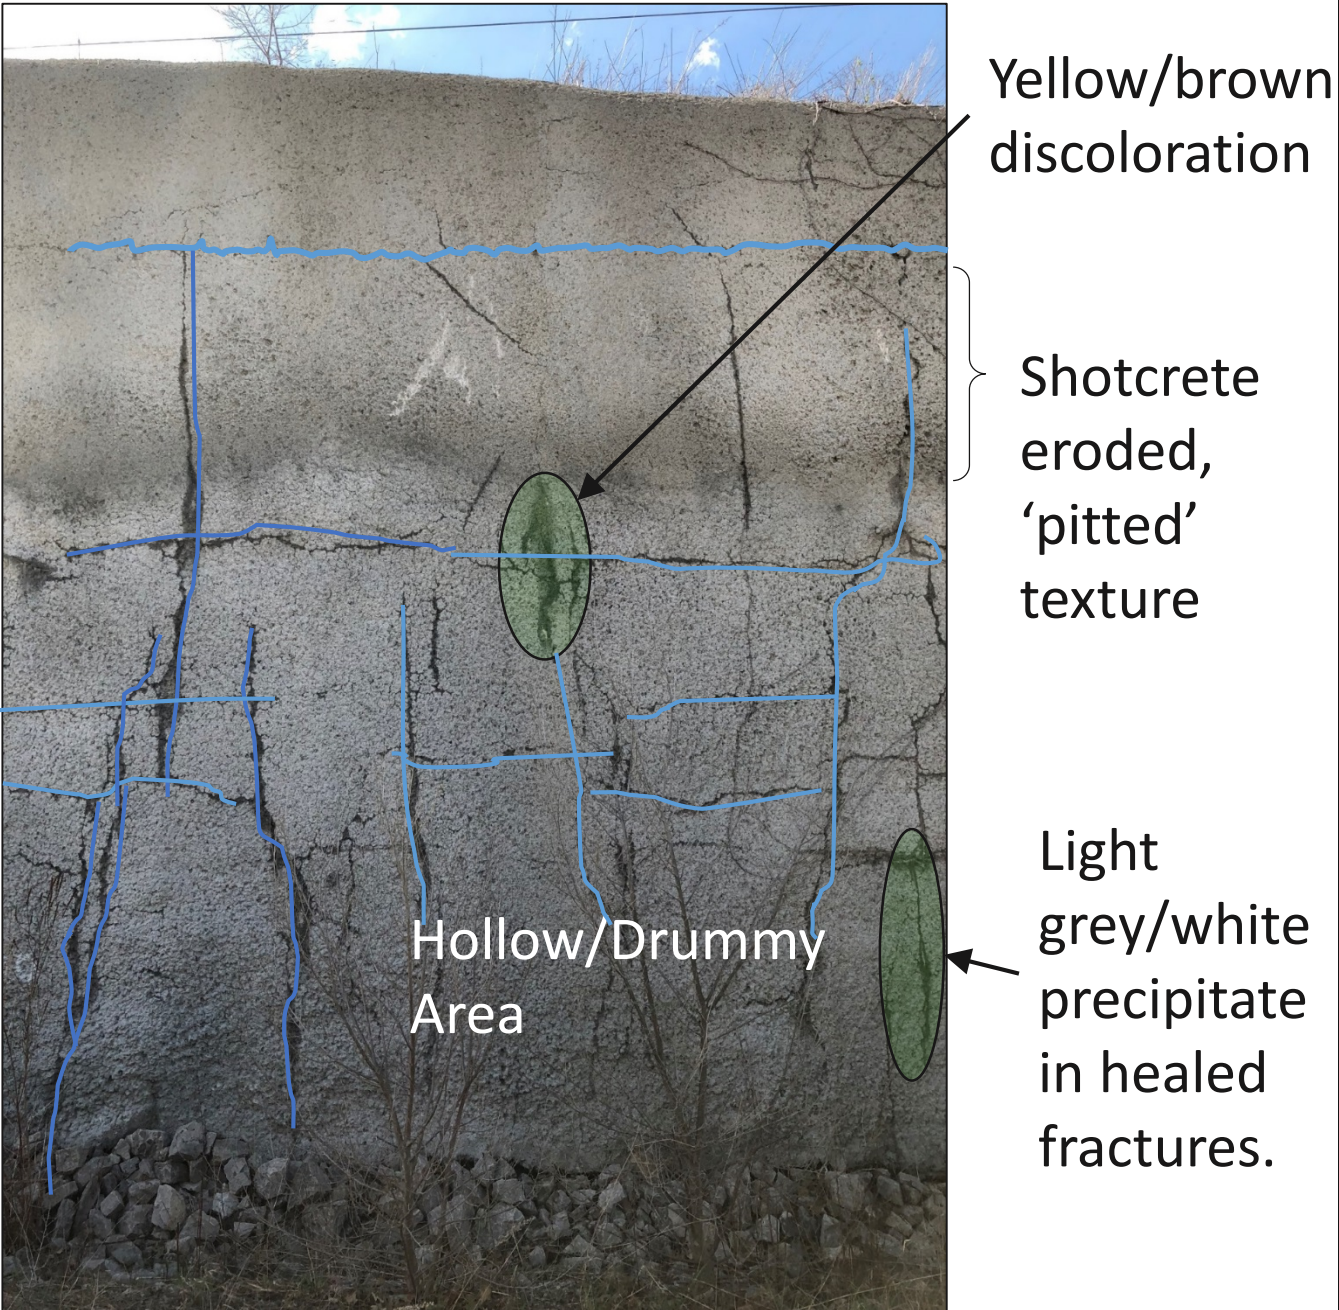
FIGURE 26

**Overall:** Various vertical/horizontal healed fractures. 0.5 m -3 m length. Minor seepage.

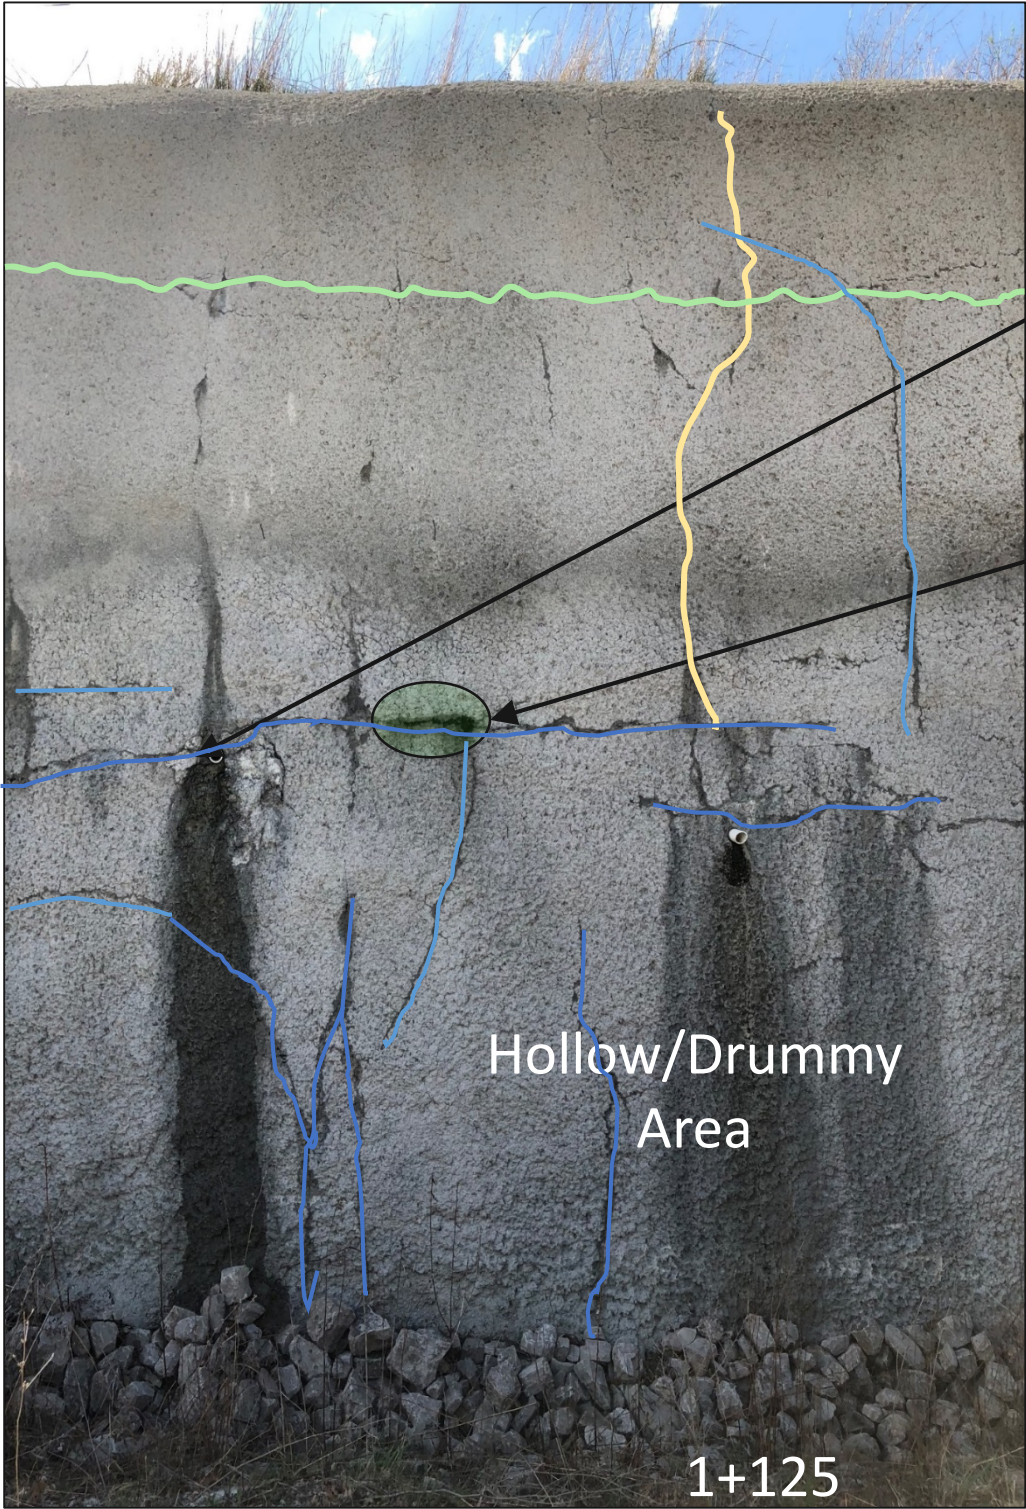
**FIGURE 27**

Continuous healed  
horizontal fracture  
(1+105 to 1+150)

Light grey  
discoloration

White precipitate  
in fracture

Active  
drainage  
pipes

Lichen  
growth

**Overall:** Various  
horizontal/vertical healed  
fractures. Minor seepage.  
0.25 m -3 m length.
