# Geotechnical Assessment of Shotcrete on Access Road Rock Cuts

*QEW Widening from West of Mississauga Road to West of Hurontario Street, Mississauga, Ministry of Transportation, Ontario, GWP 2002-13-00*

**Golder Associates Ltd.**

July 20, 2018

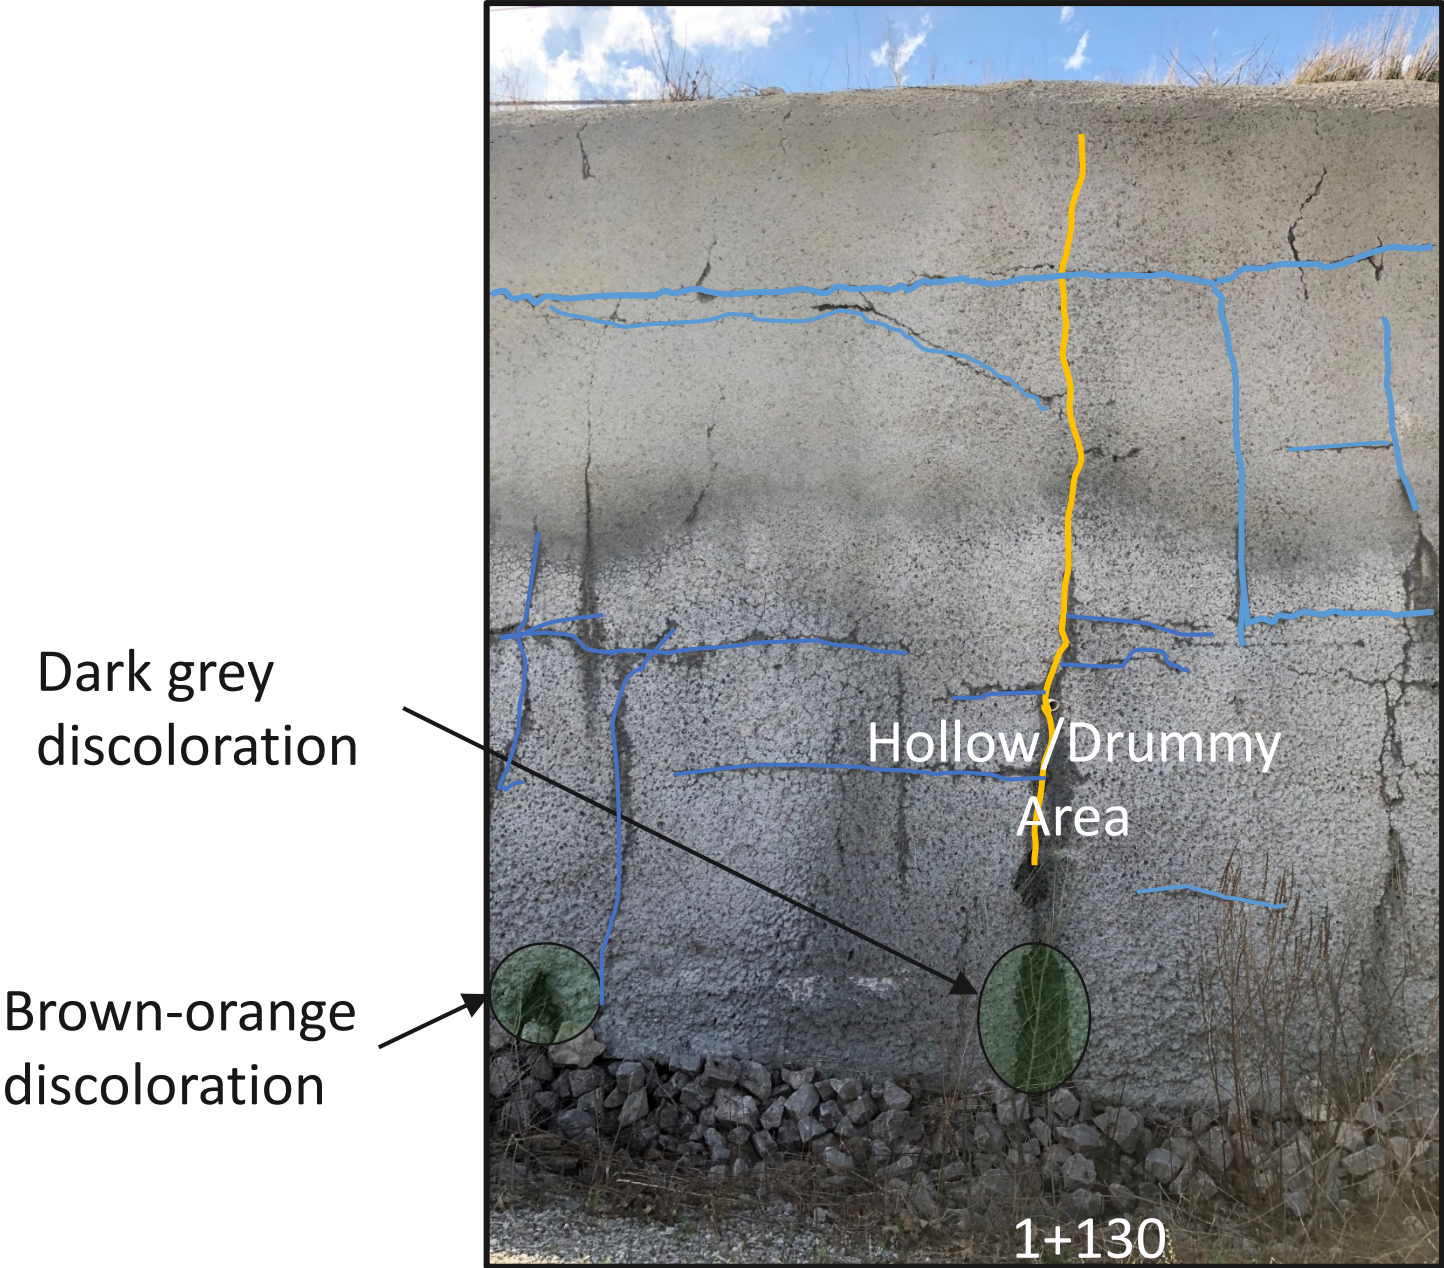
**FIGURE 28**

**Overall:** Various healed horizontal/vertical fractures. Minor seepage. 0.5 m-3 m in length. Shotcrete in good condition.

Shotcrete base exposed at some points.

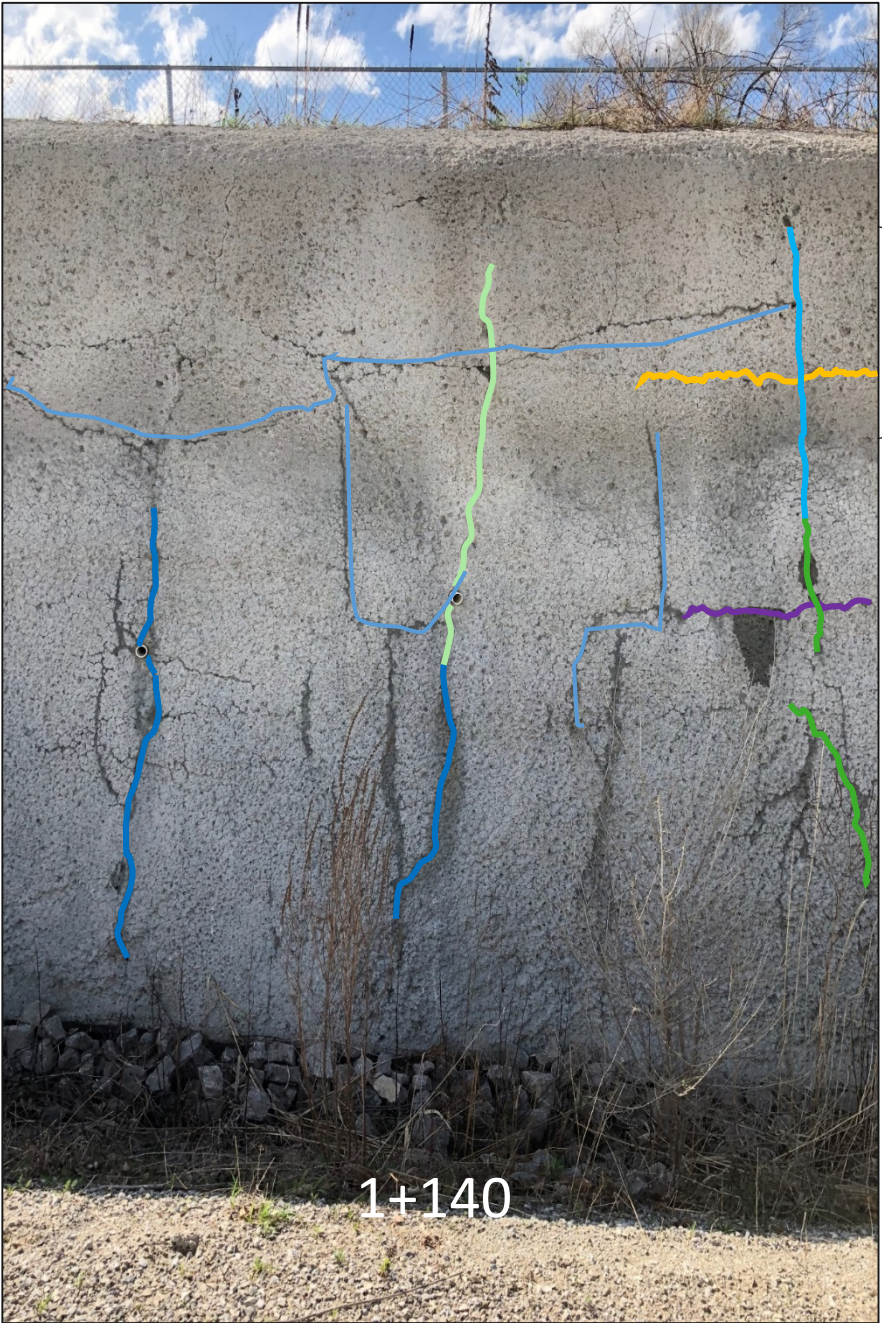
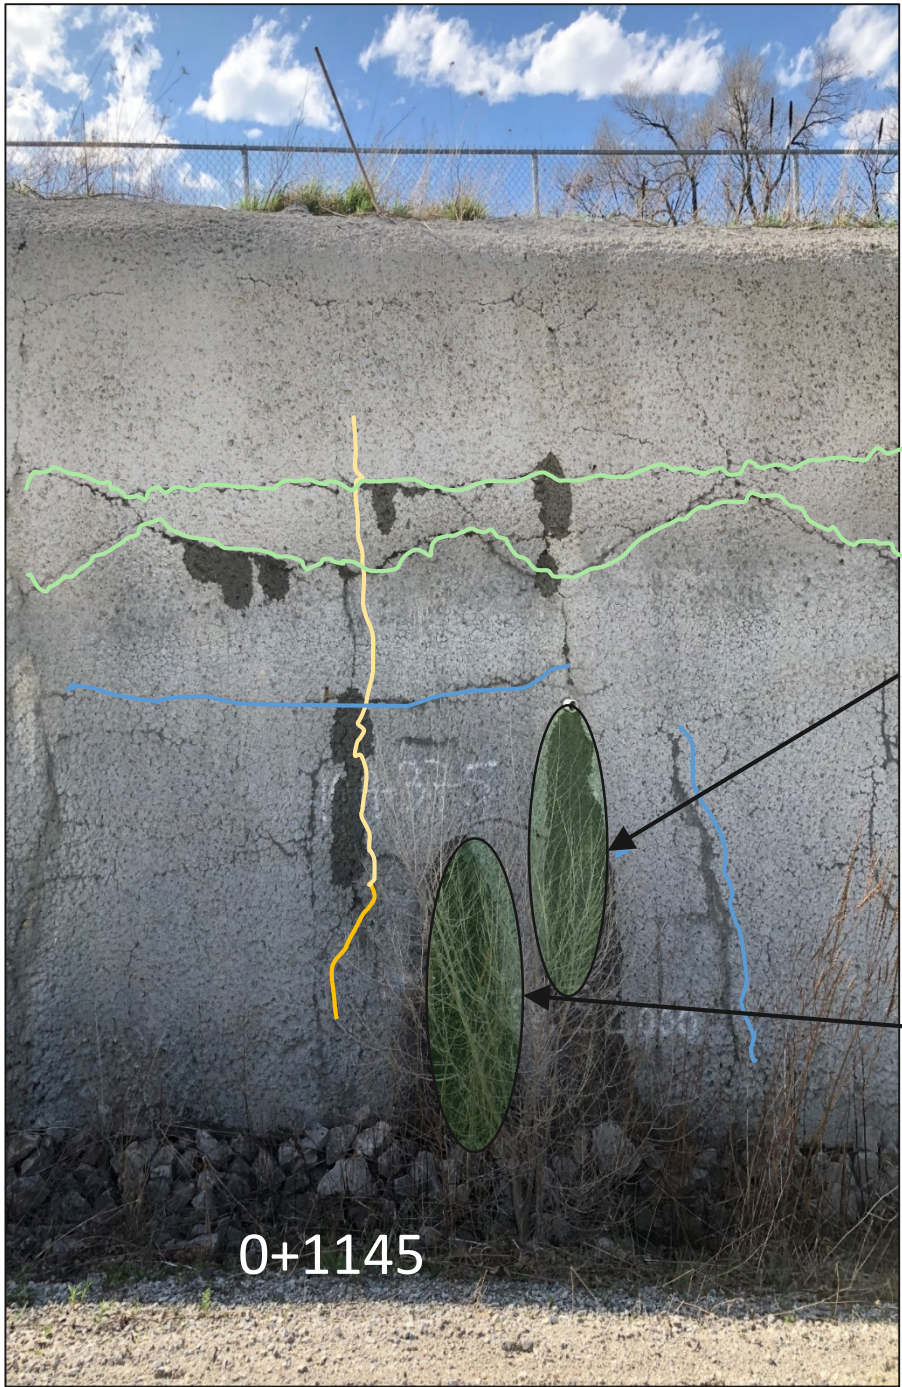
**FIGURE 29**

'Pitted' texture

Dry during field assessment on (May 9<sup>th</sup>)

Major seepage and discoloration

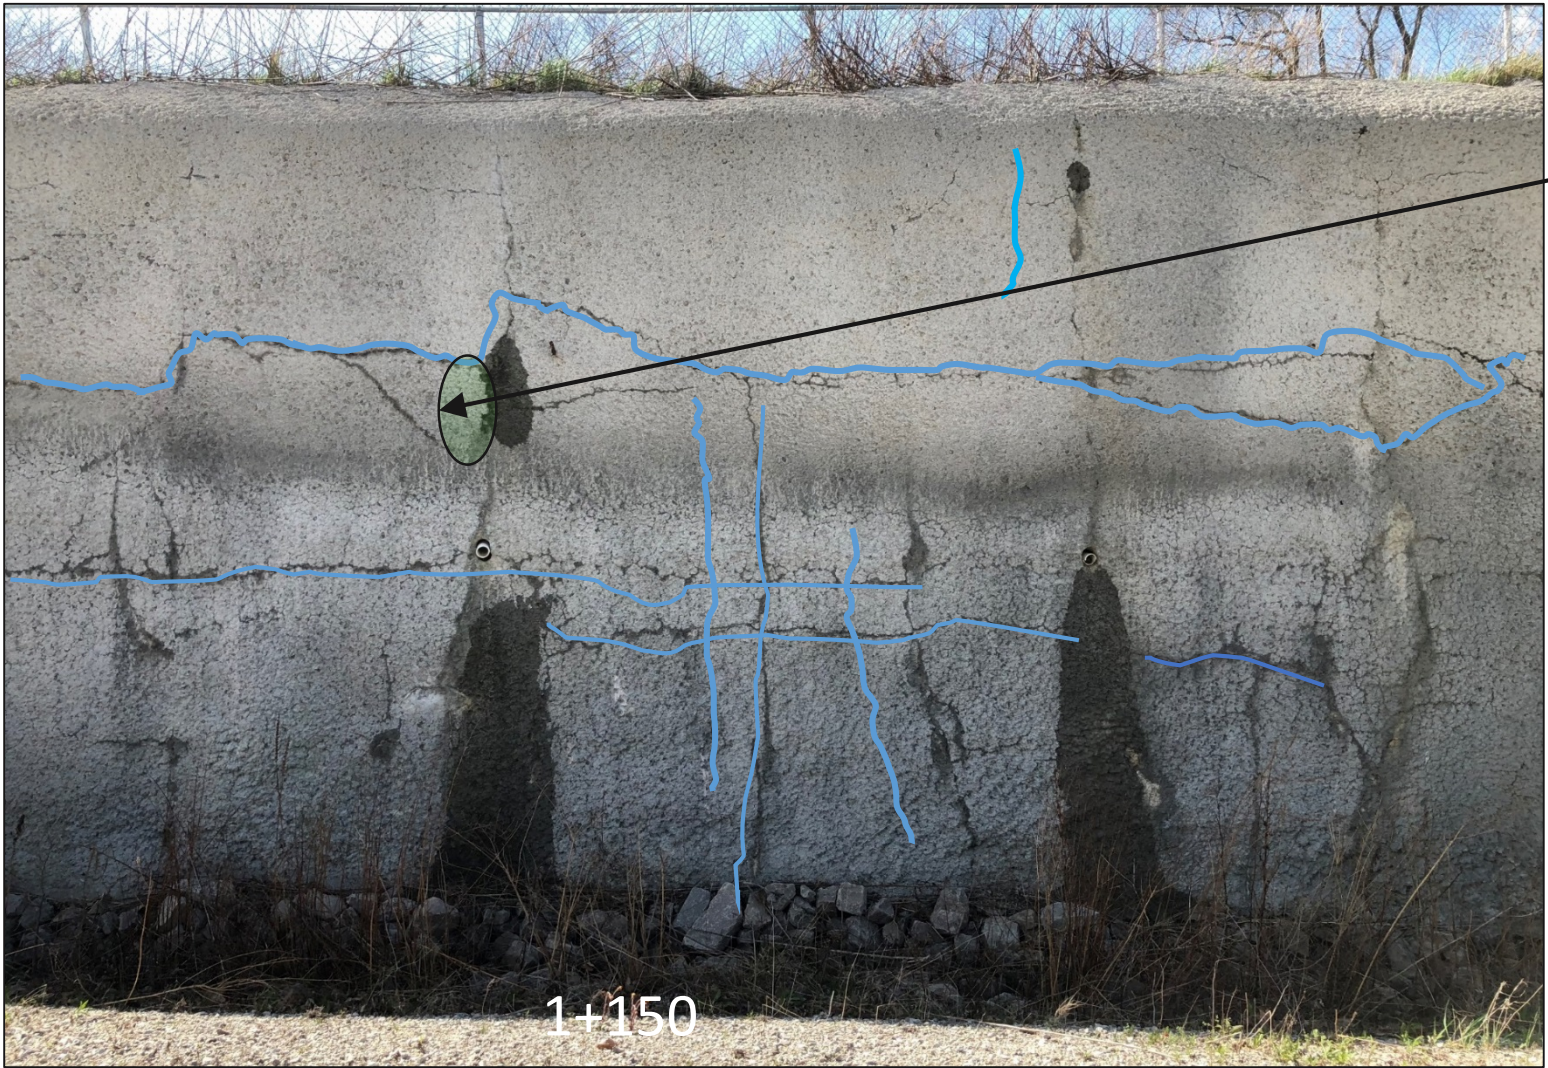
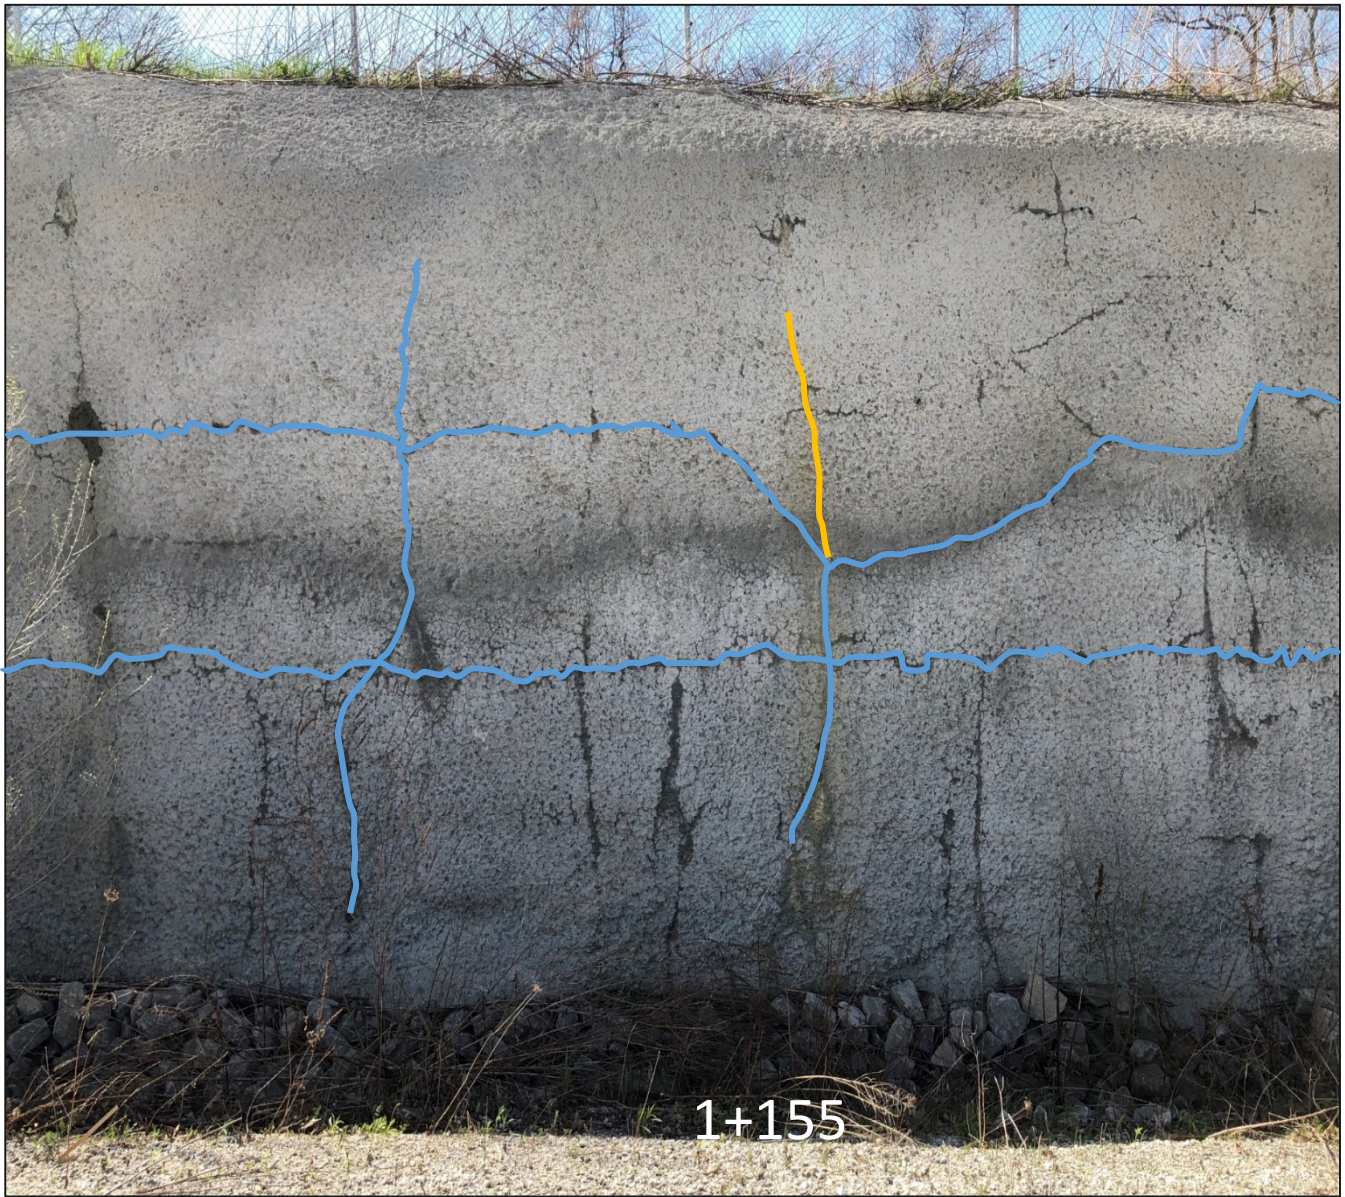
**FIGURE 30**

Seepage

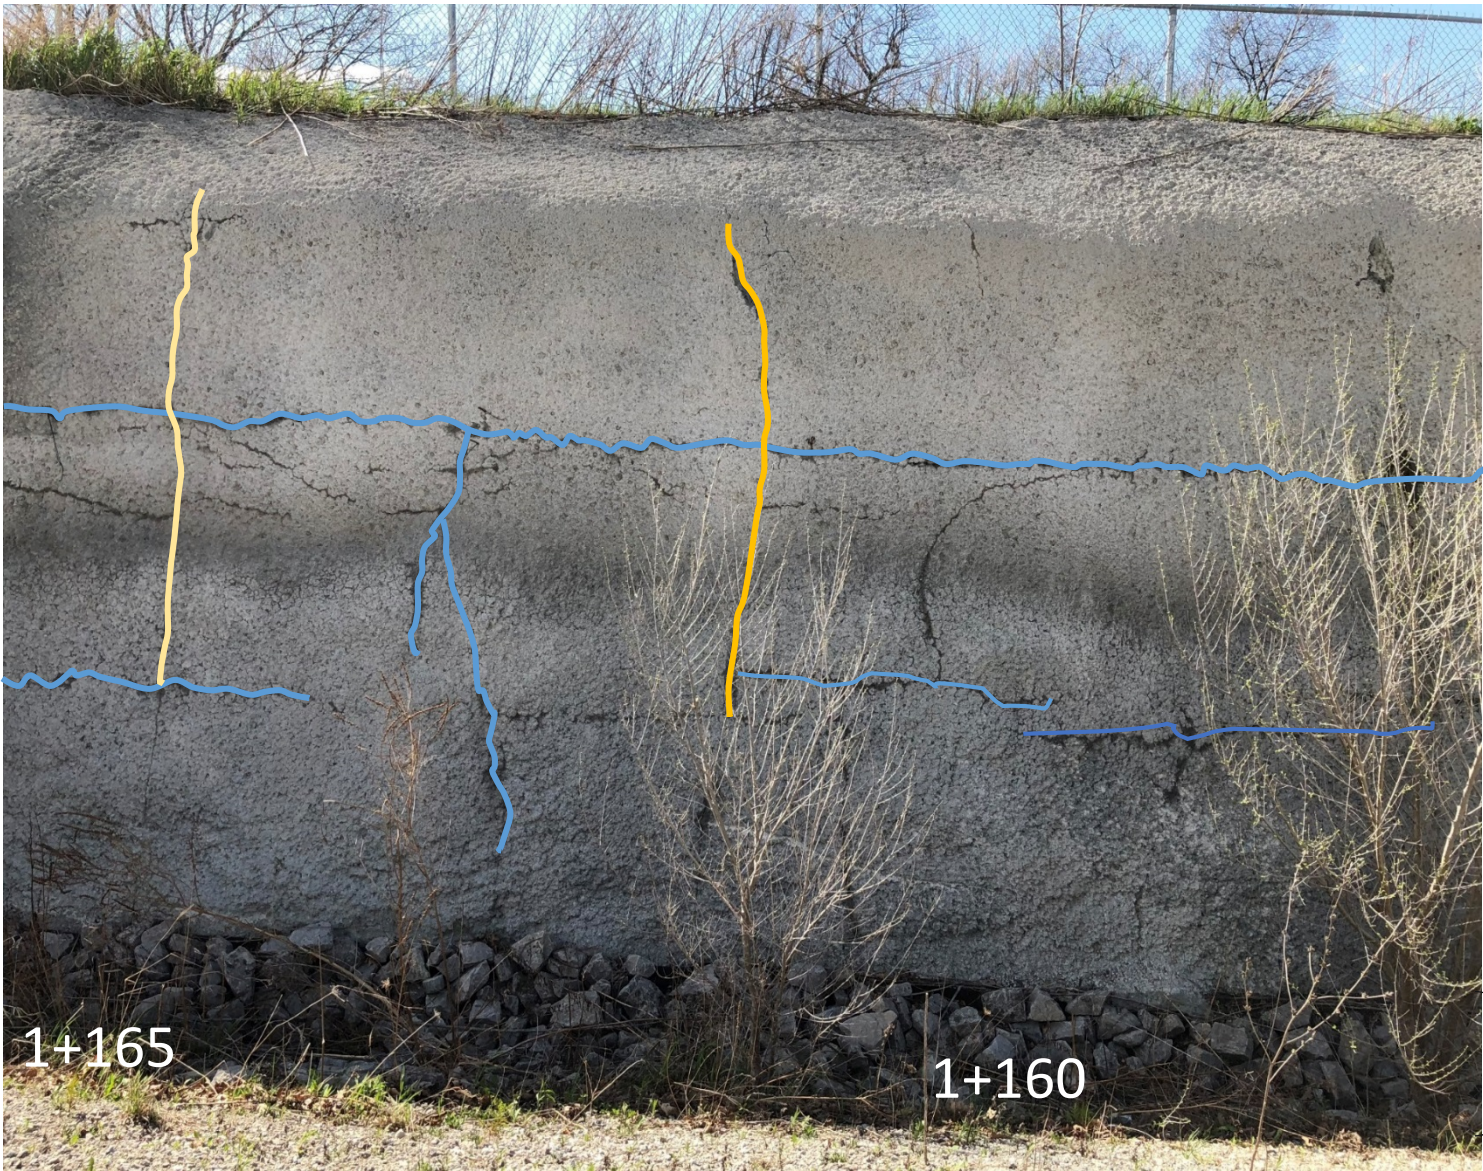
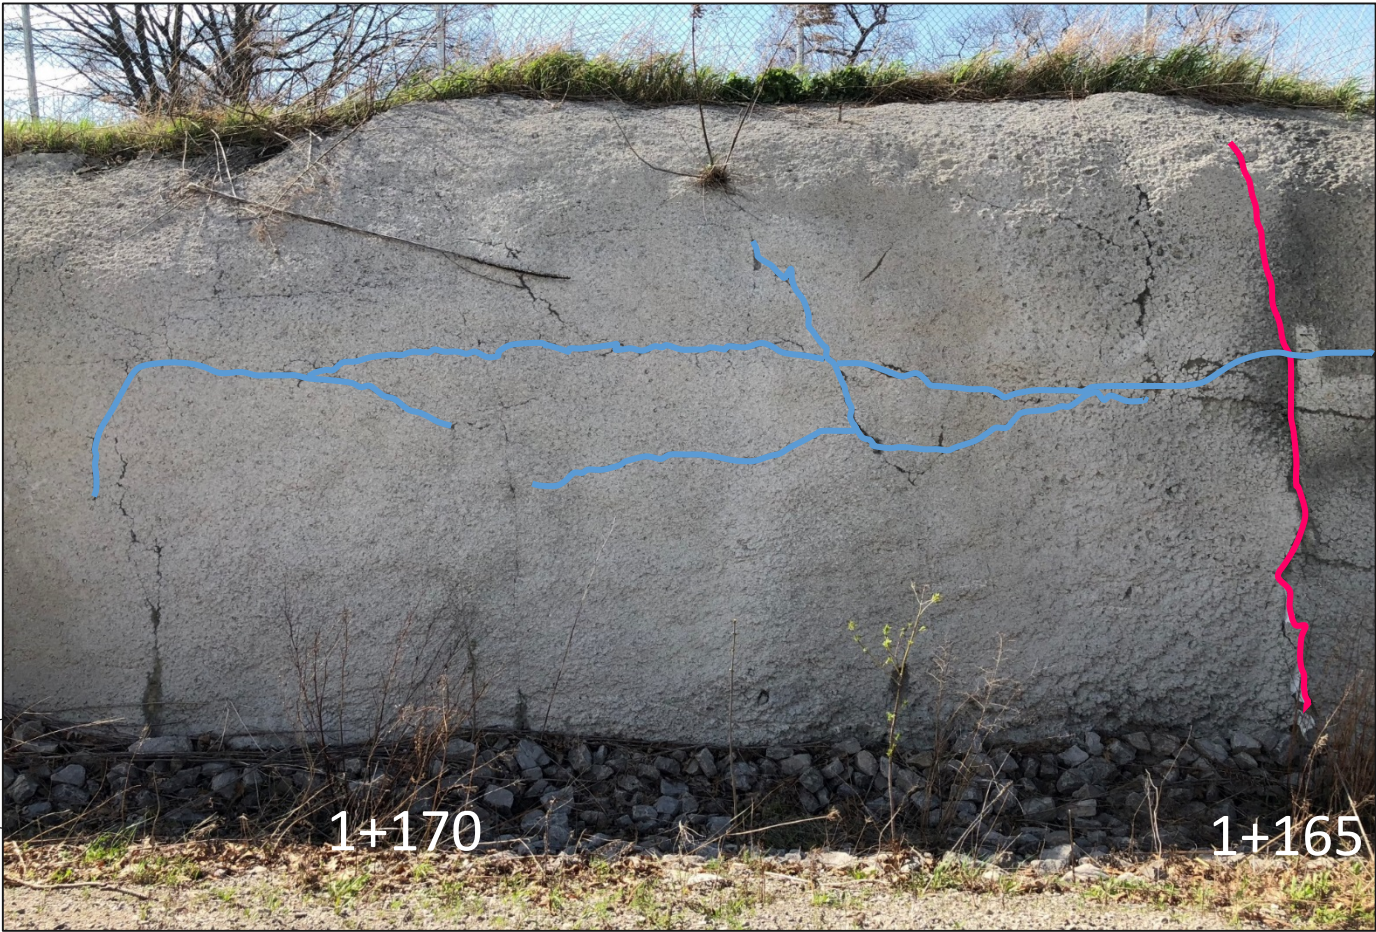
**FIGURE 31**

Mesh at  
bottom of  
shotcrete

Black mesh at  
base of  
shotcrete
