## FOUNDATION INVESTIGATION AND DESIGN REPORT

**Thorold Tunnel Rehabilitation, Site No. 34-177/T  
Highway 58, City of Thorold,  
Ministry of Transportation, Ontario  
G.W.P. 2370-16-00**

**Report Number: 1668652-2**

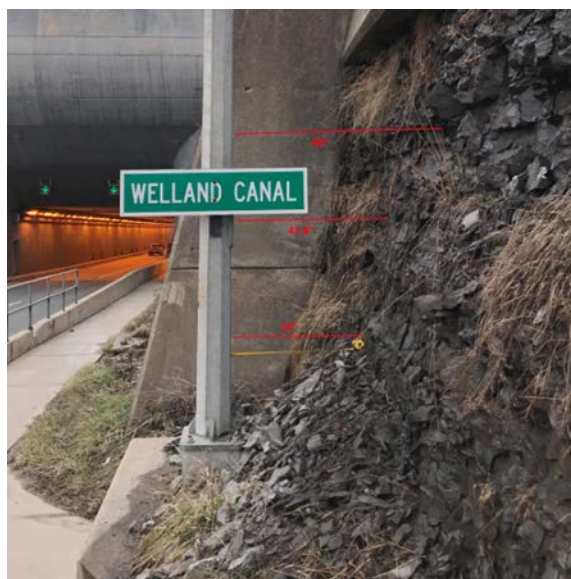
from the bedrock surface and downwards (partially covering the rock face) over a distance of about 1.5 m. A light pole is located on the north side of Highway 58, in close proximity to the rock face. At the base of the light pole, fallen rocks have accumulated. The distance from the rock face to the light pole varies vertically from about 1 m to 1.2 m (see Photograph 1), and the light pole is located about 1.9 m east of the full-height concrete wall (see Photograph 2).

Photograph 1: Looking west at the light pole (north side)

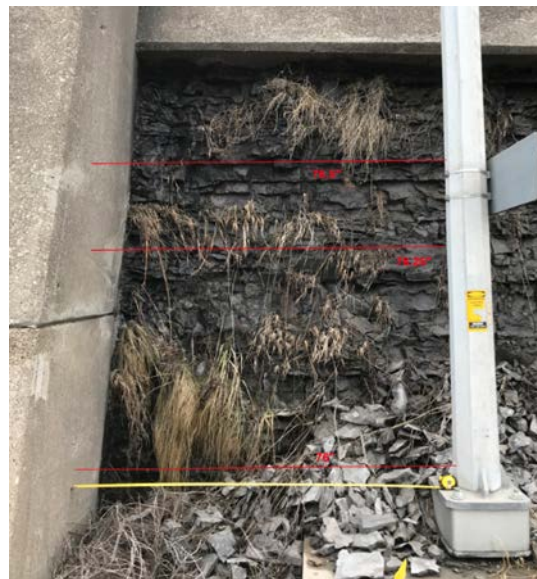
Photograph 2: Looking north at the light pole (north side)

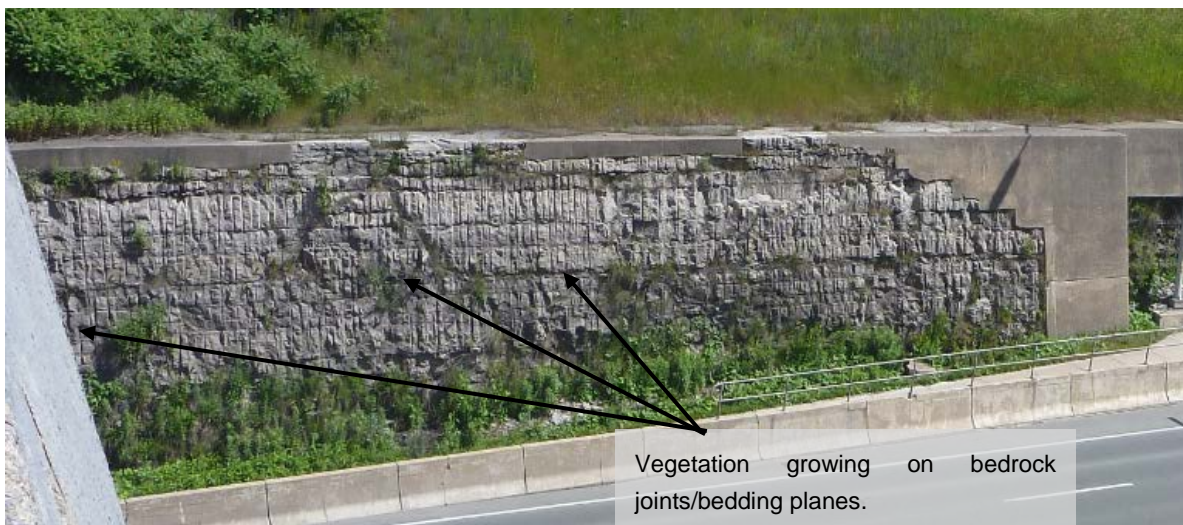
An area of exposed bedrock along the rock cut immediately east of the East Portal on the northern side of Highway 58 was examined. Based on bedrock mapping, the bedrock at the exposed rock face consists of dolomitic limestone of the Goat Island Member overlying the Gasport Member, both of which are part of the Lockport Formation. The rock face was observed to be damp with diffuse seepage occurring along the bedrock surface, and from a horizon midway up the rock cut. Vegetation (grass and small shrubs) was noted to be present along the bedding partings suggesting that seepage commonly occurs at this location. In addition, a damp rock surface and emanation of a low rate of seepage were observed at the interface of the bedrock cut and the northeast edge of the East Portal. During the winter the water seepage on the rock face freezes and forms icicles and water also seeps onto the sidewalk and freezes. There are wet swampy areas present behind the rock cut as well as standing water further north, which are inferred to be the source of the seepage water observed on the rock cut face. Rock bolts installed into the north rock cut face close to the East Portal are evident and there is also evidence of formed concrete near the crest of the slope. Rock debris has accumulated at the base of the rock face indicating that rock has fallen from the face. Selected photographs of these observed conditions are presented in Photographs 3 and 4.

**Photograph 3: Looking north at rock face east of the East Portal.**

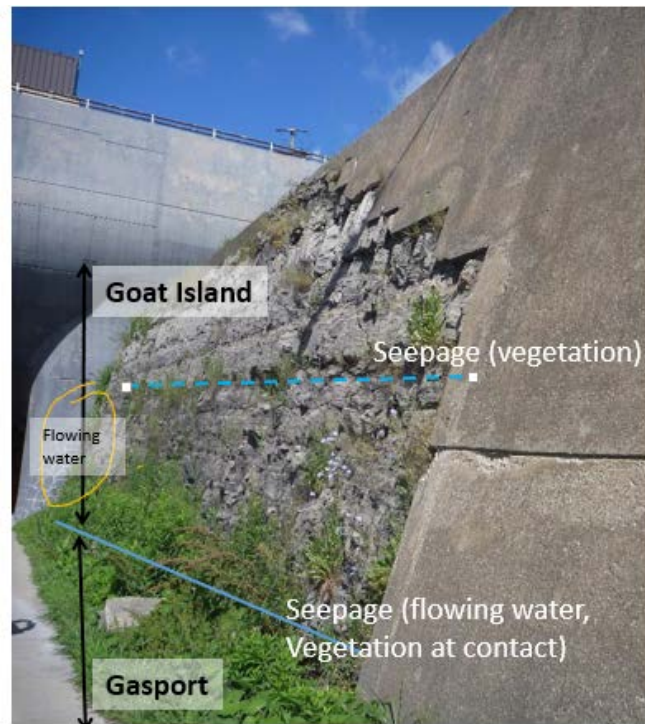
**Photograph 4: Looking westward at rock face on north side of Highway 58 east of the East Portal.**

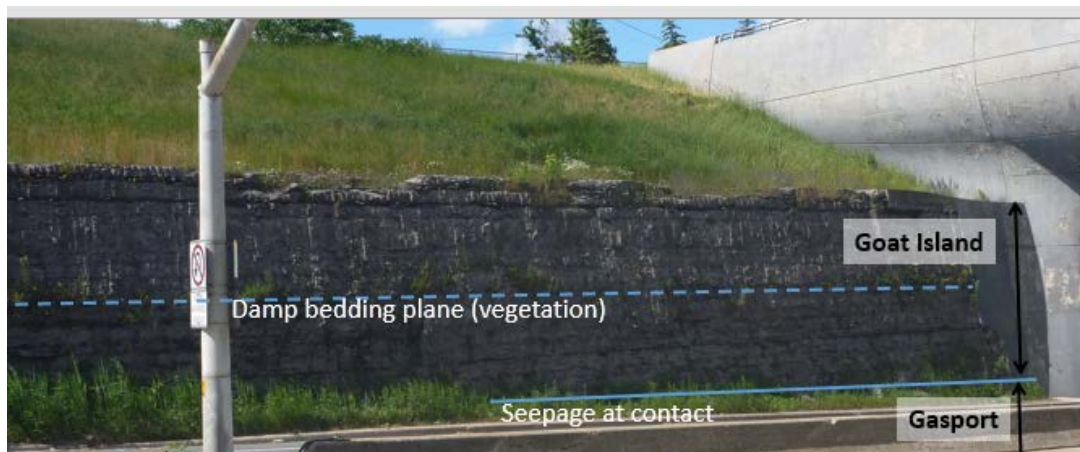
A bedrock cut is also exposed along the south side of Highway 58 east of the East Portal. This face was observed to be dry to damp, but no groundwater seepage was noted at the time of the site visit. Vegetation growth (grass) was also observed to be present along a bedrock bedding plane about halfway up the rock cut face. There is evidence of some undercutting of the rock face leaving an overhang, and rock debris has accumulated at the base of the rock face indicating that rock has fallen from the face. It is understood that historically, water seepage from the face sometimes seeps out onto the road surface and has the potential to freeze during winter conditions. The conditions on the south face east of the East Portal are shown in Photograph 5.

**Photograph 5: Looking south at south rock cut face east of the East Portal.**
