FOUNDATION INVESTIGATION AND DESIGN REPORT

**HIGHWAY 556 - BEAVER FALLS CULVERT REHABILITATION,
19.9 KM EAST OF HIGHWAY 17 (SITE NO. 38S-0037/C0)
DEROCHE TOWNSHIP, ALGOMA DISTRICT, ONTARIO
MINISTRY OF TRANSPORTATION, ONTARIO
GWP 5378-11-00; WP 5378-11-01**

**Report Number: 1670846 ; GEOCREs No. 41K-112
Lat. 46.739170°; Long. -84.134088°**

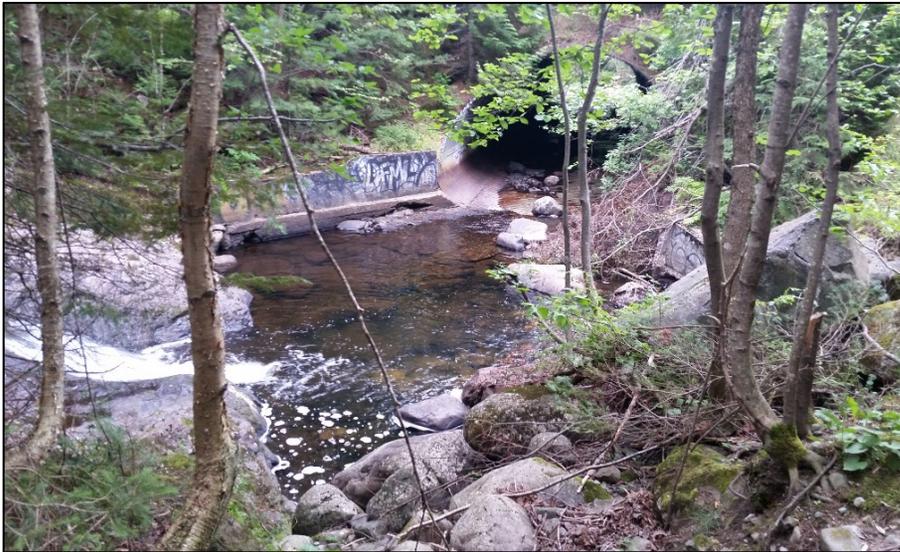
It is noted that bedrock outcrops were observed near the outlet of the existing culvert and are shown on Photographs 10 and 11 presented on Figure 5, but are also present upstream of the culvert inlet as shown on Photograph 1 on Figure 1.

Photograph 1: Inlet of culvert (looking northwest).

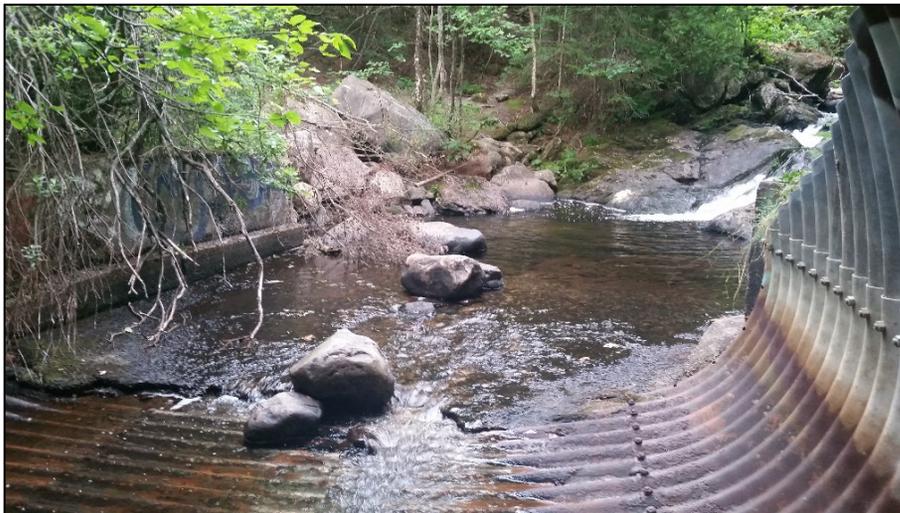
Photograph 2: Inlet of culvert and (looking south through the culvert).

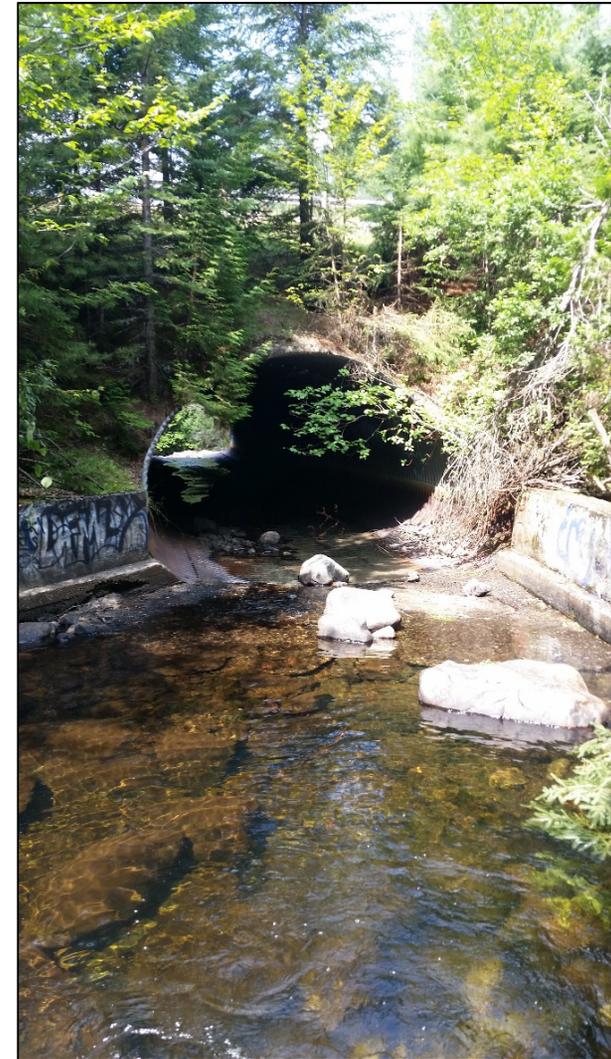
Photograph 3: Inlet of culvert (looking north).

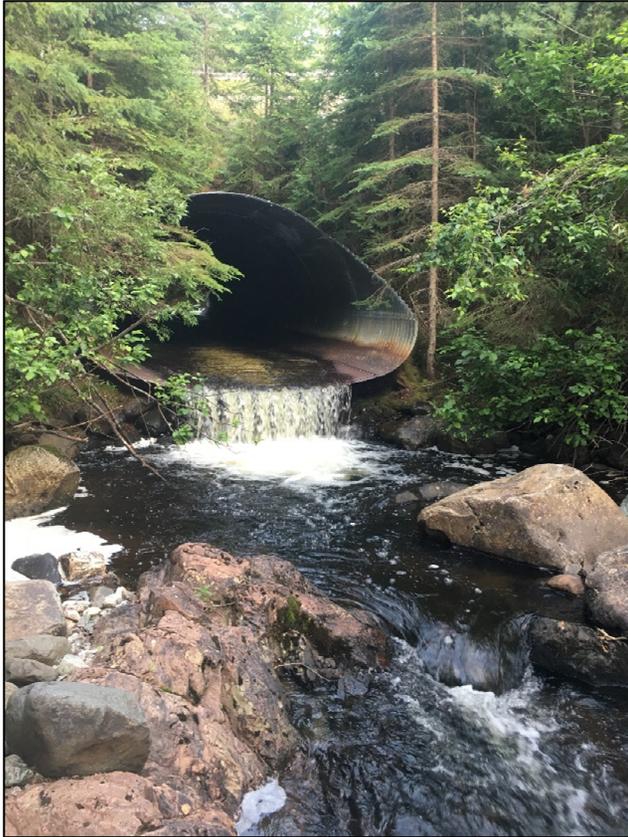
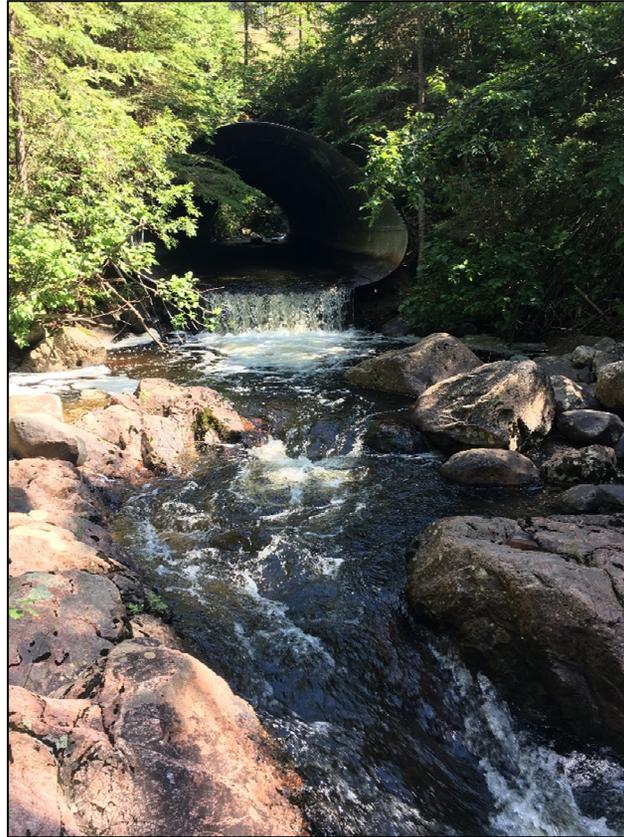
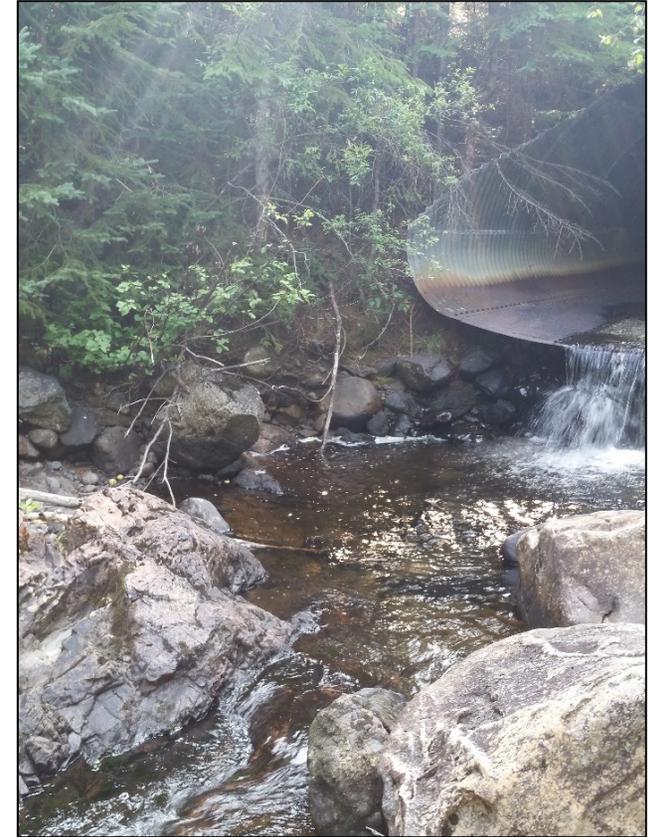
Figure 2

Photograph 4: Outlet of culvert (looking south).

Photograph 5: Outlet of culvert (looking south).

Photograph 6: Outlet of culvert (looking southeast).

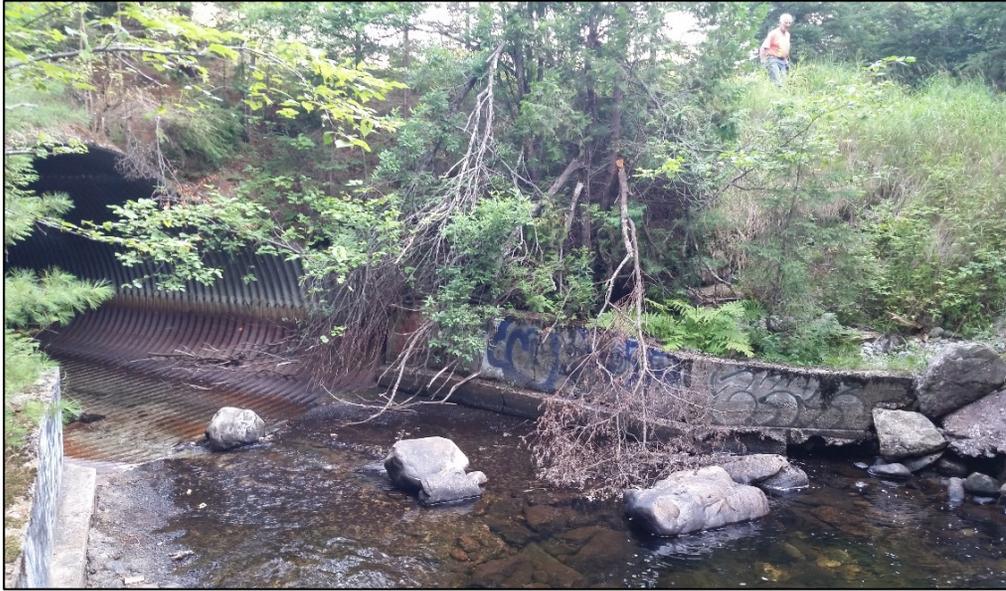
A deposit of cobbles and boulders was encountered immediately below the concrete slab at approximately Elevation 208.1 m. The cobbly/bouldery deposit was penetrated using rock coring methods and is approximately 1.9 m thick. It is expected that any coarse-grained and fine-grained particles making up the soil matrix between the cobbles and boulders may have been washed away during advancement of the drill casing using flush water. The recovered cobbles are up to about 120 mm in size and are shown on Figure B1 in Appendix B. Although the recovered rock core samples do not indicate the presence of boulders (i.e., all measured rock core samples are less than 200 mm in size), boulders are inferred to make up this deposit given the presence of large boulders found at the creek bed (refer to Photographs 2 and 3 which are presented on Figure 1 and Photographs 7 and 8 which are presented on Figure 3).

Photograph 7: Concrete retaining wall on the east side of the culvert (looking northeast towards the inlet).

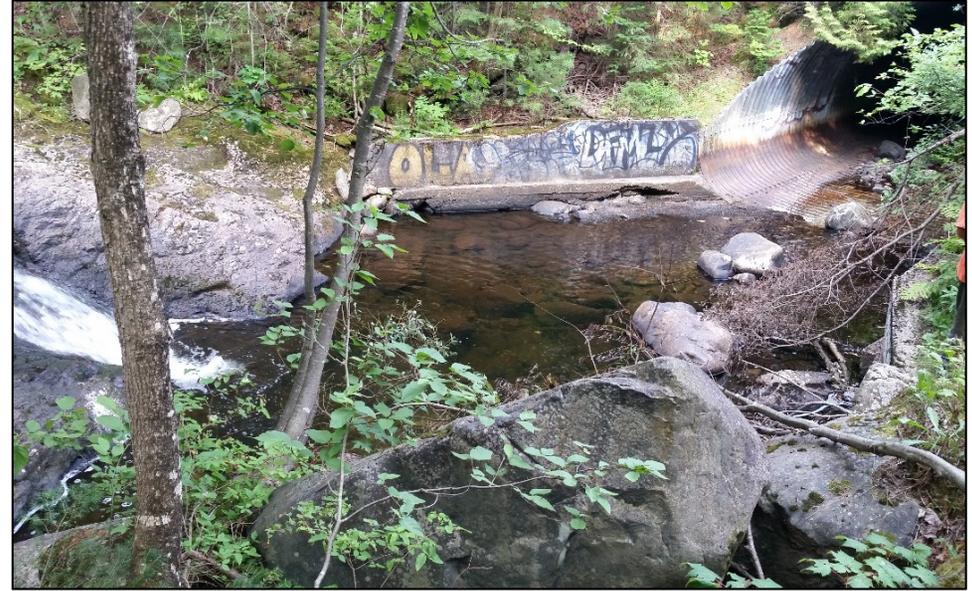
Photograph 8: Concrete retaining wall on the west side of the culvert (looking northwest towards the inlet).

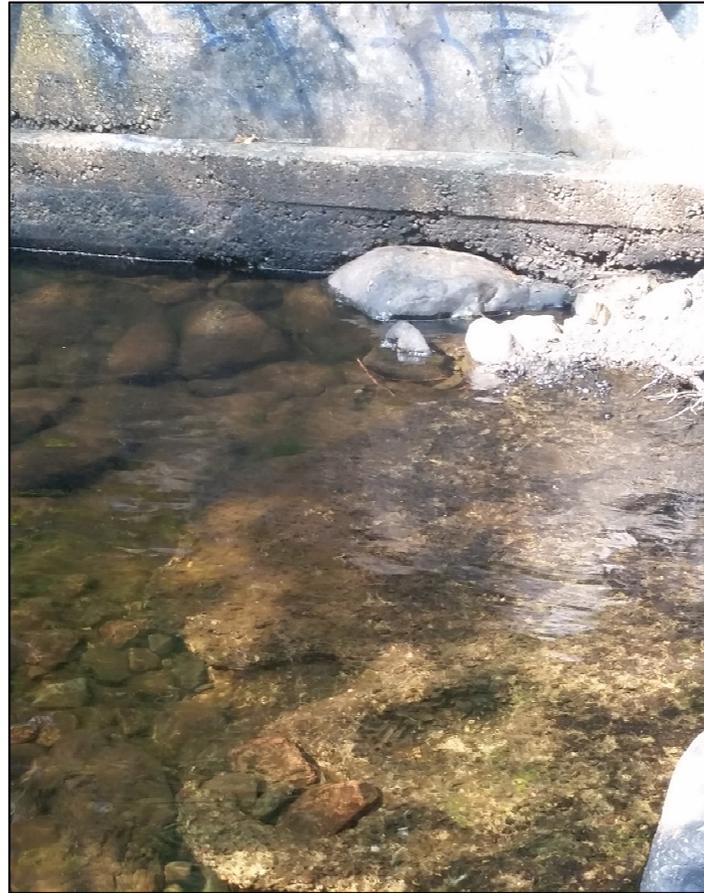
Figure 4

An approximately 300 mm thick layer of concrete was encountered at the surface of Borehole BFC-01 which was advanced through a concrete apron at the inlet of the culvert. The top of the concrete slab is at about Elevation 208.4 m. The top of the concrete apron was in poor to fair structural condition and is shown on Photograph 9 which is presented on Figure 4.

Photograph 9: Existing concrete apron near the inlet of the culvert (looking down at the concrete slab near the existing retaining wall located on the east side of the culvert)

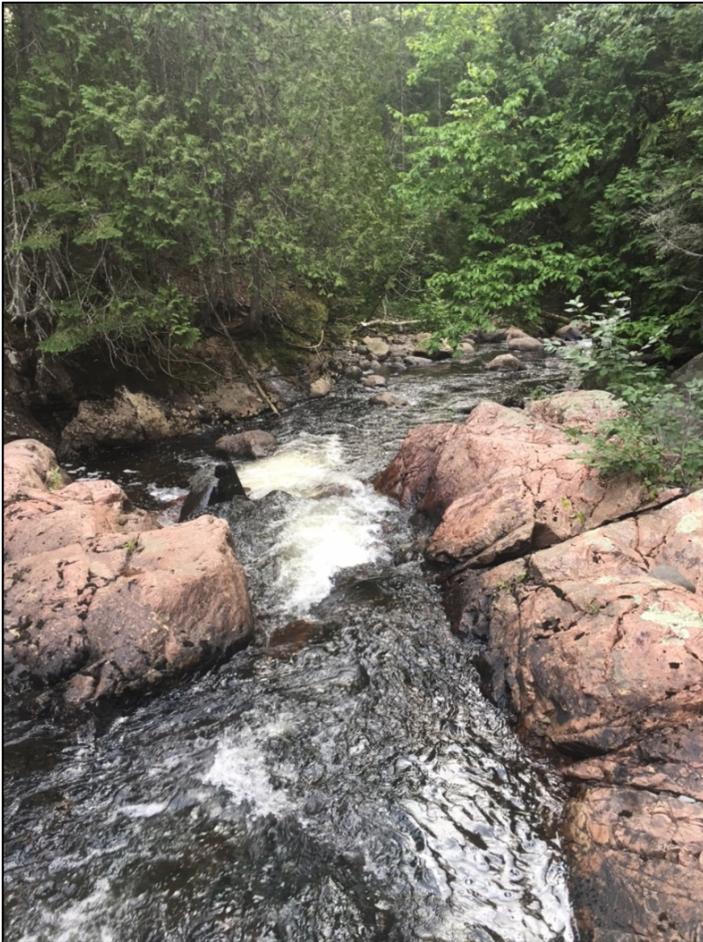
Photograph 10: Bedrock outcrops immediately downstream of the outlet of culvert and (looking north).

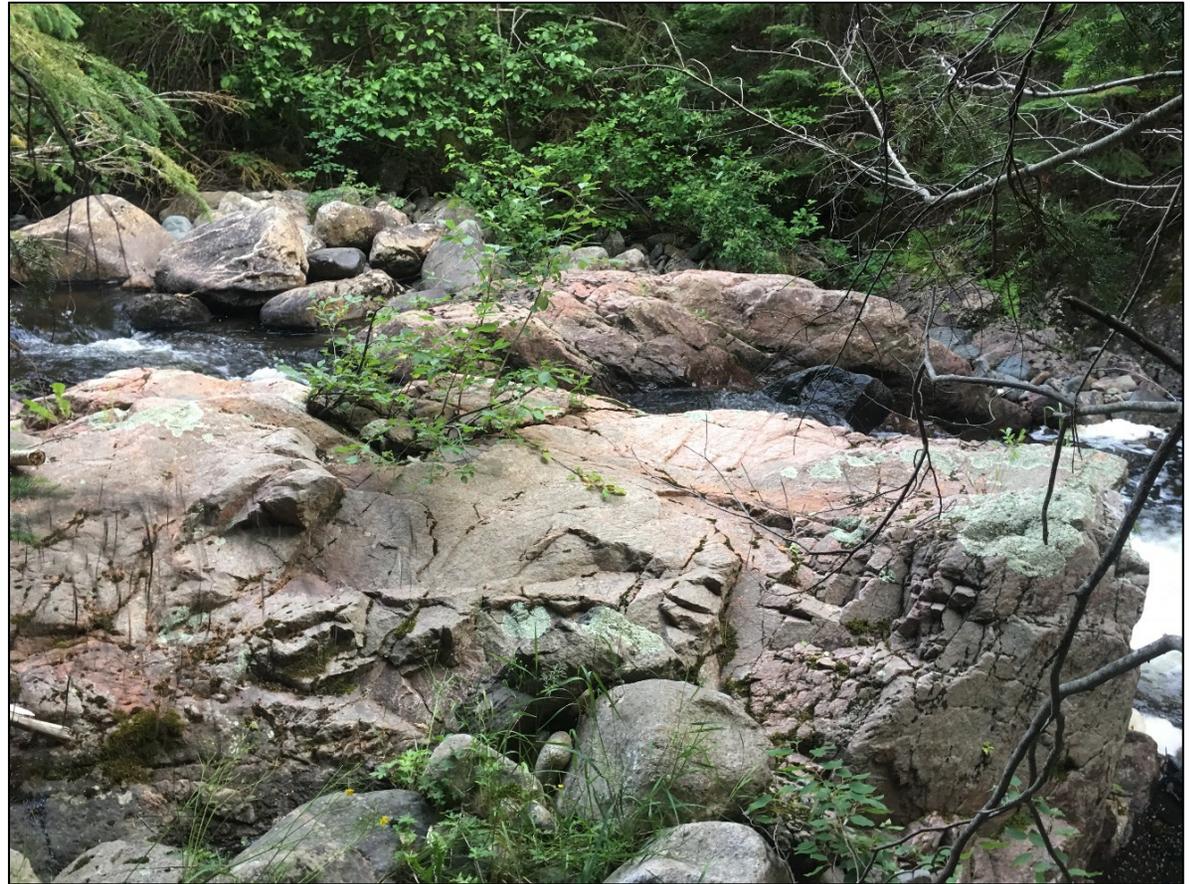
Photograph 11: Bedrock outcrops immediately downstream of the outlet of the culvert (looking east).

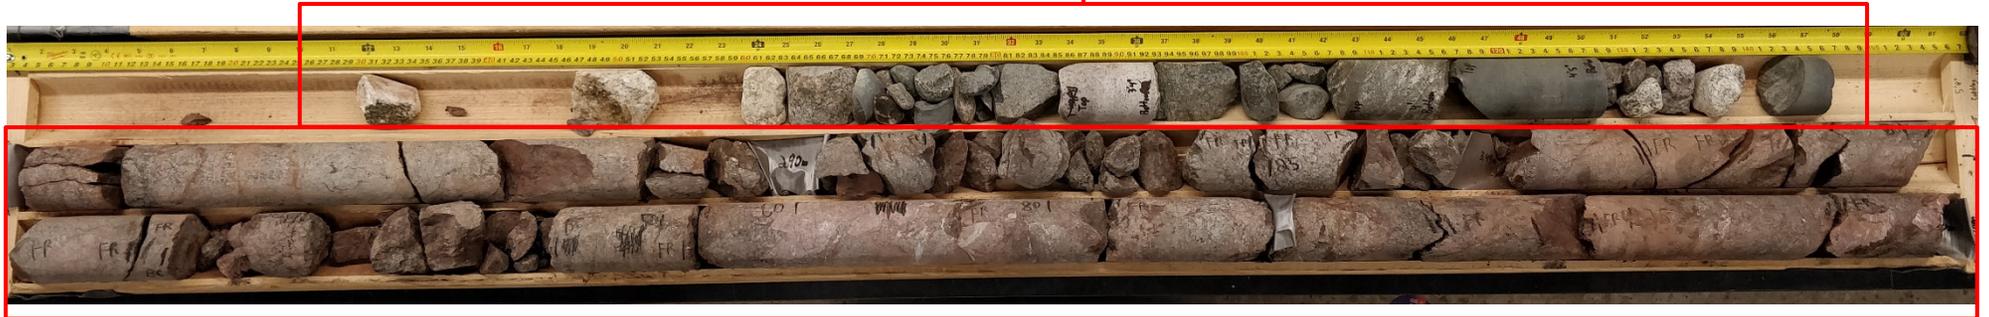
Based on a review of the cored bedrock samples, the bedrock consists of granite rock. The bedrock is described as slightly weathered to fresh, massive, pink, medium to coarse grained, faintly porous, strong to very strong granite. The bedrock details are presented on the drillhole record in Appendix A. Bedrock core photographs are shown on Figure B1 in Appendix B.

The Total Core Recovery (TCR) measured on the rock core samples ranges between about 80% and 100%, and the Solid Core Recovery (SCR) ranges between about 22% and 81%. The Rock Quality Designation (RQD) measured on the rock core samples generally ranges from about 52% to 100%, indicating a rock mass of fair to excellent quality as per Table 3.10 of CFEM (2006). A RQD of 0% was measured on Run No. 2 between depths of about 2.90 m and 3.49 m below the top of the existing concrete apron, indicating a rock mass of very poor quality. The very low RQD is attributed to frequent broken core zones.

Borehole BFC-01: Cobbles cored between depths of about 0.30 m and 2.20 m; bedrock cored between depths of about 2.34 m to 5.50 m
