TECHNICAL MEMORANDUM

Project No. 1786658 WO#30

**FOUNDATION ENGINEERING SERVICES TO ASSESS PERFORMANCE OF HIGH FILL EMBANKMENT
HIGHWAY 405 EASTBOUND BETWEEN STA 10+820 AND STA 10+880
FORT ERIE, NIAGARA REGION, ONTARIO
ASSIGNMENT NO. 2017-E-0016-30, WO#30, G.W.P. 2112-19-00
MTO Geocres No.: 30M3-321**

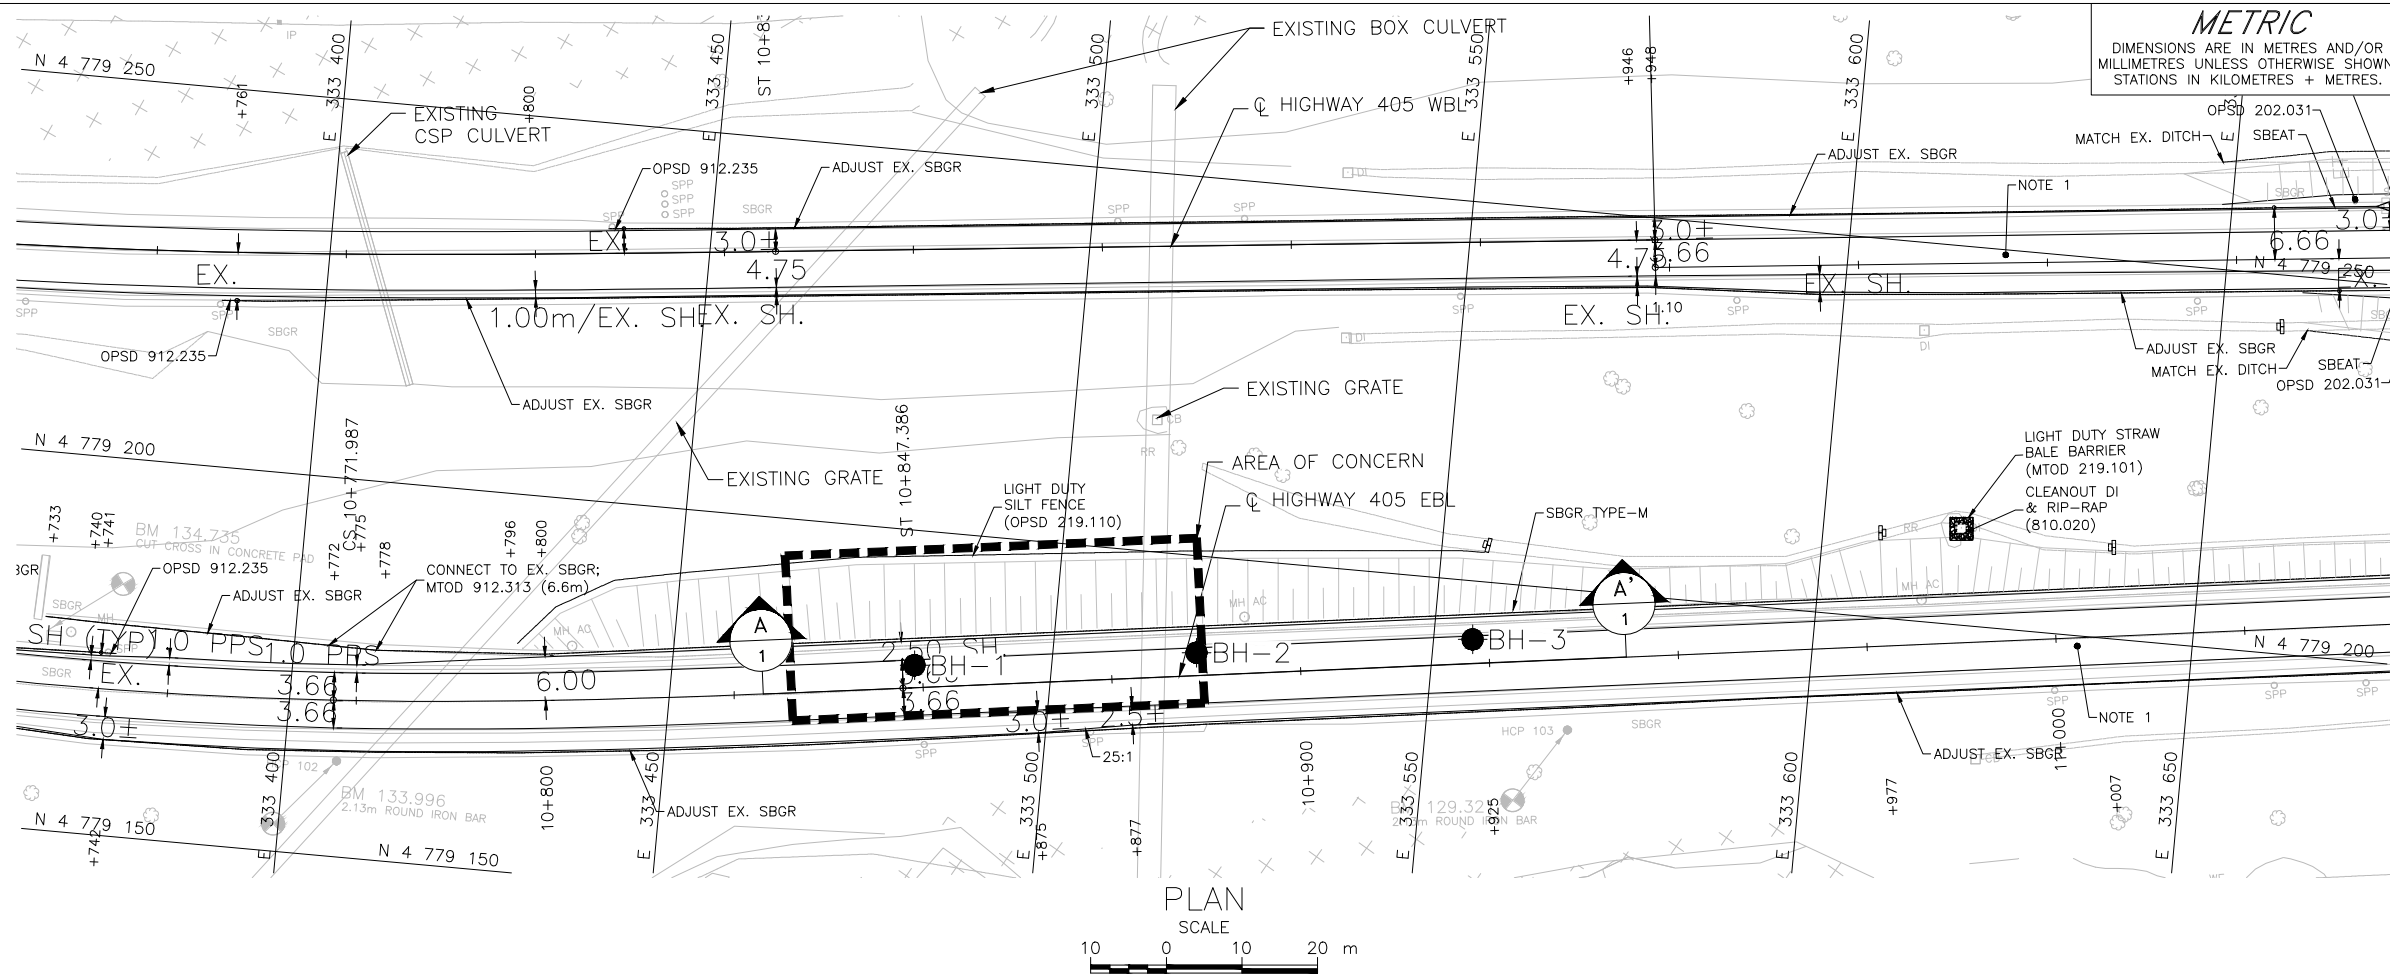
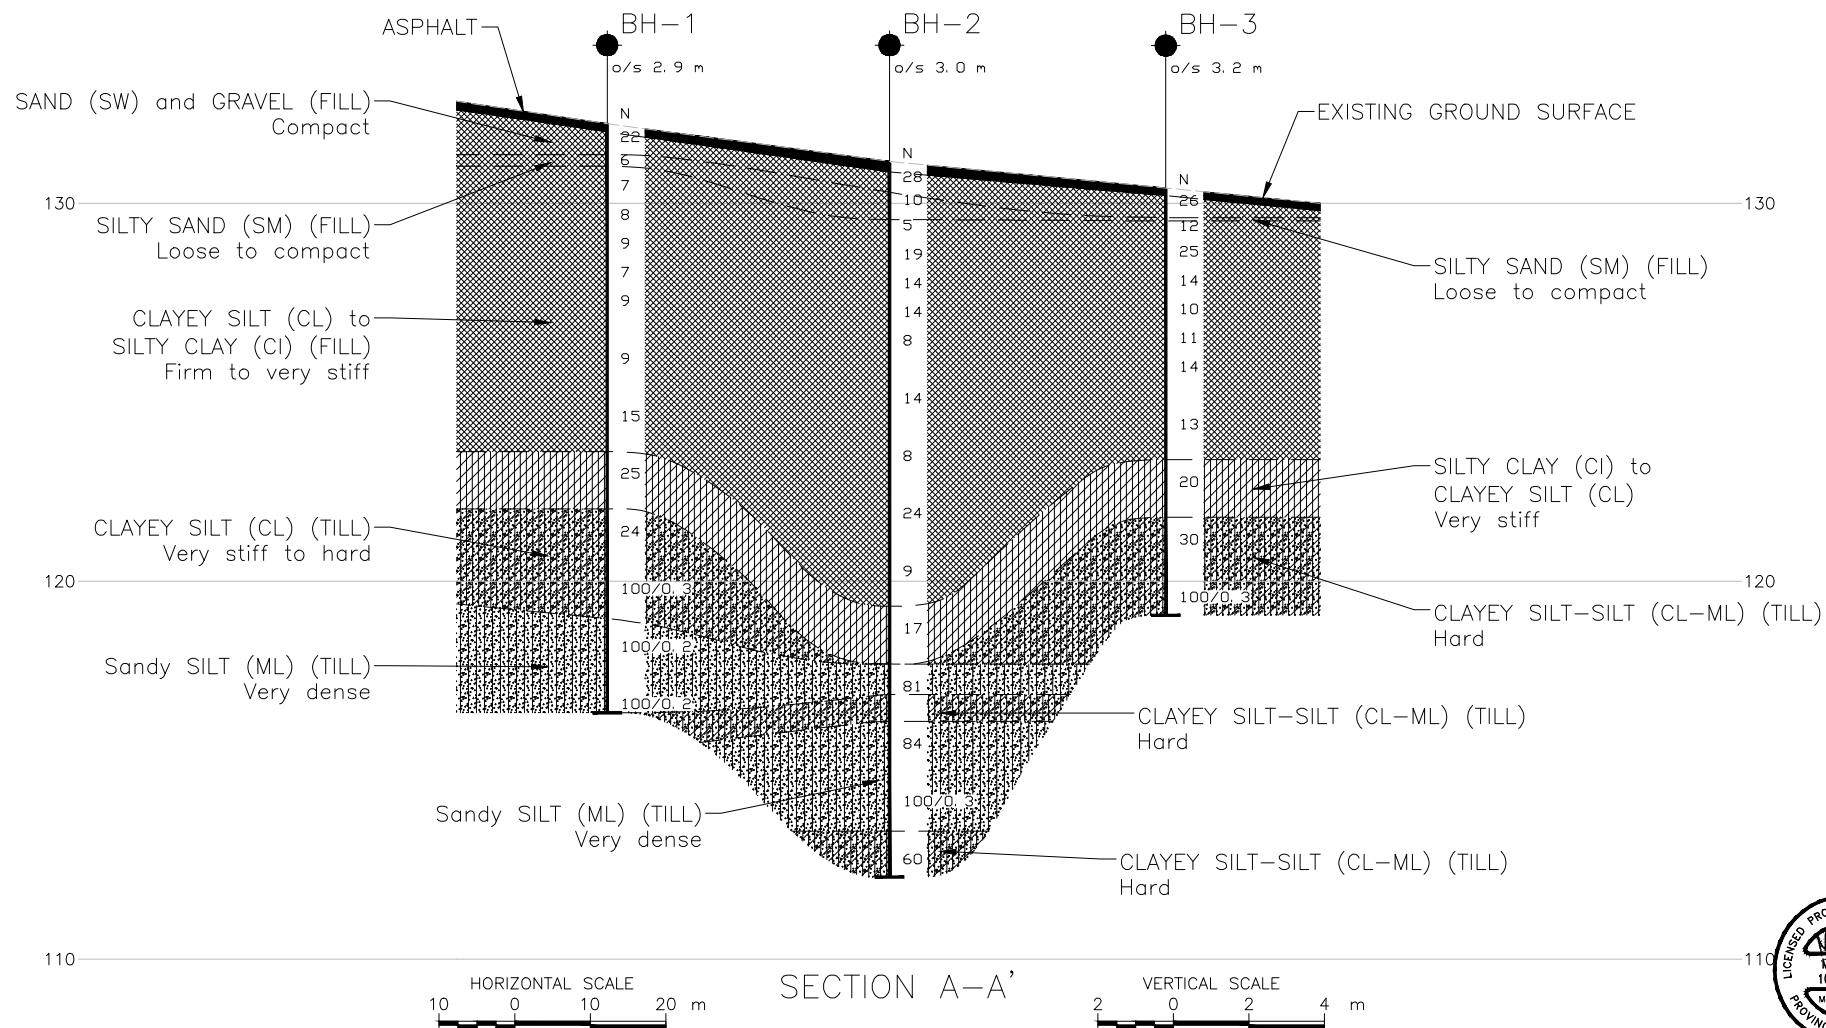
HIGHWAY 405
EMBANKMENT INVESTIGATION
STA. 10+820 TO STA. 10+880
BOREHOLE LOCATIONS AND SOIL STRATA

Three boreholes (designated as Boreholes BH-1 to BH-3) were advanced on March 17 and 18, 2020 as part of the foundation investigation and as shown on Drawing 1. The field investigation was carried out using a GT8 track-mounted drilling rig supplied and operated by Landshark Drilling of Brantford, Ontario. Boreholes BH-1 and BH-2 were advanced using nominal 150 mm inner diameter hollow stem augers followed by tricone advancement using drilling mud. Borehole BH-3 was advanced using nominal 60 mm inner diameter hollow stem augers. Soil samples were generally obtained at 0.75 m and 1.5 m intervals of depth, using nominal 50 mm outside diameter and 35 mm inside diameter split-spoon samplers driven by an automatic hammer

The stratigraphic boundaries shown on the borehole records and on the stratigraphic profile on Drawing 1 are inferred from non-continuous sampling, observations of drilling progress and the results of SPTs, and therefore, represent transitions between soil types rather than exact planes of geological change. Furthermore, subsurface conditions will vary between and beyond the borehole locations, however, the factual data presented on the borehole records governs any interpretation of the site conditions.

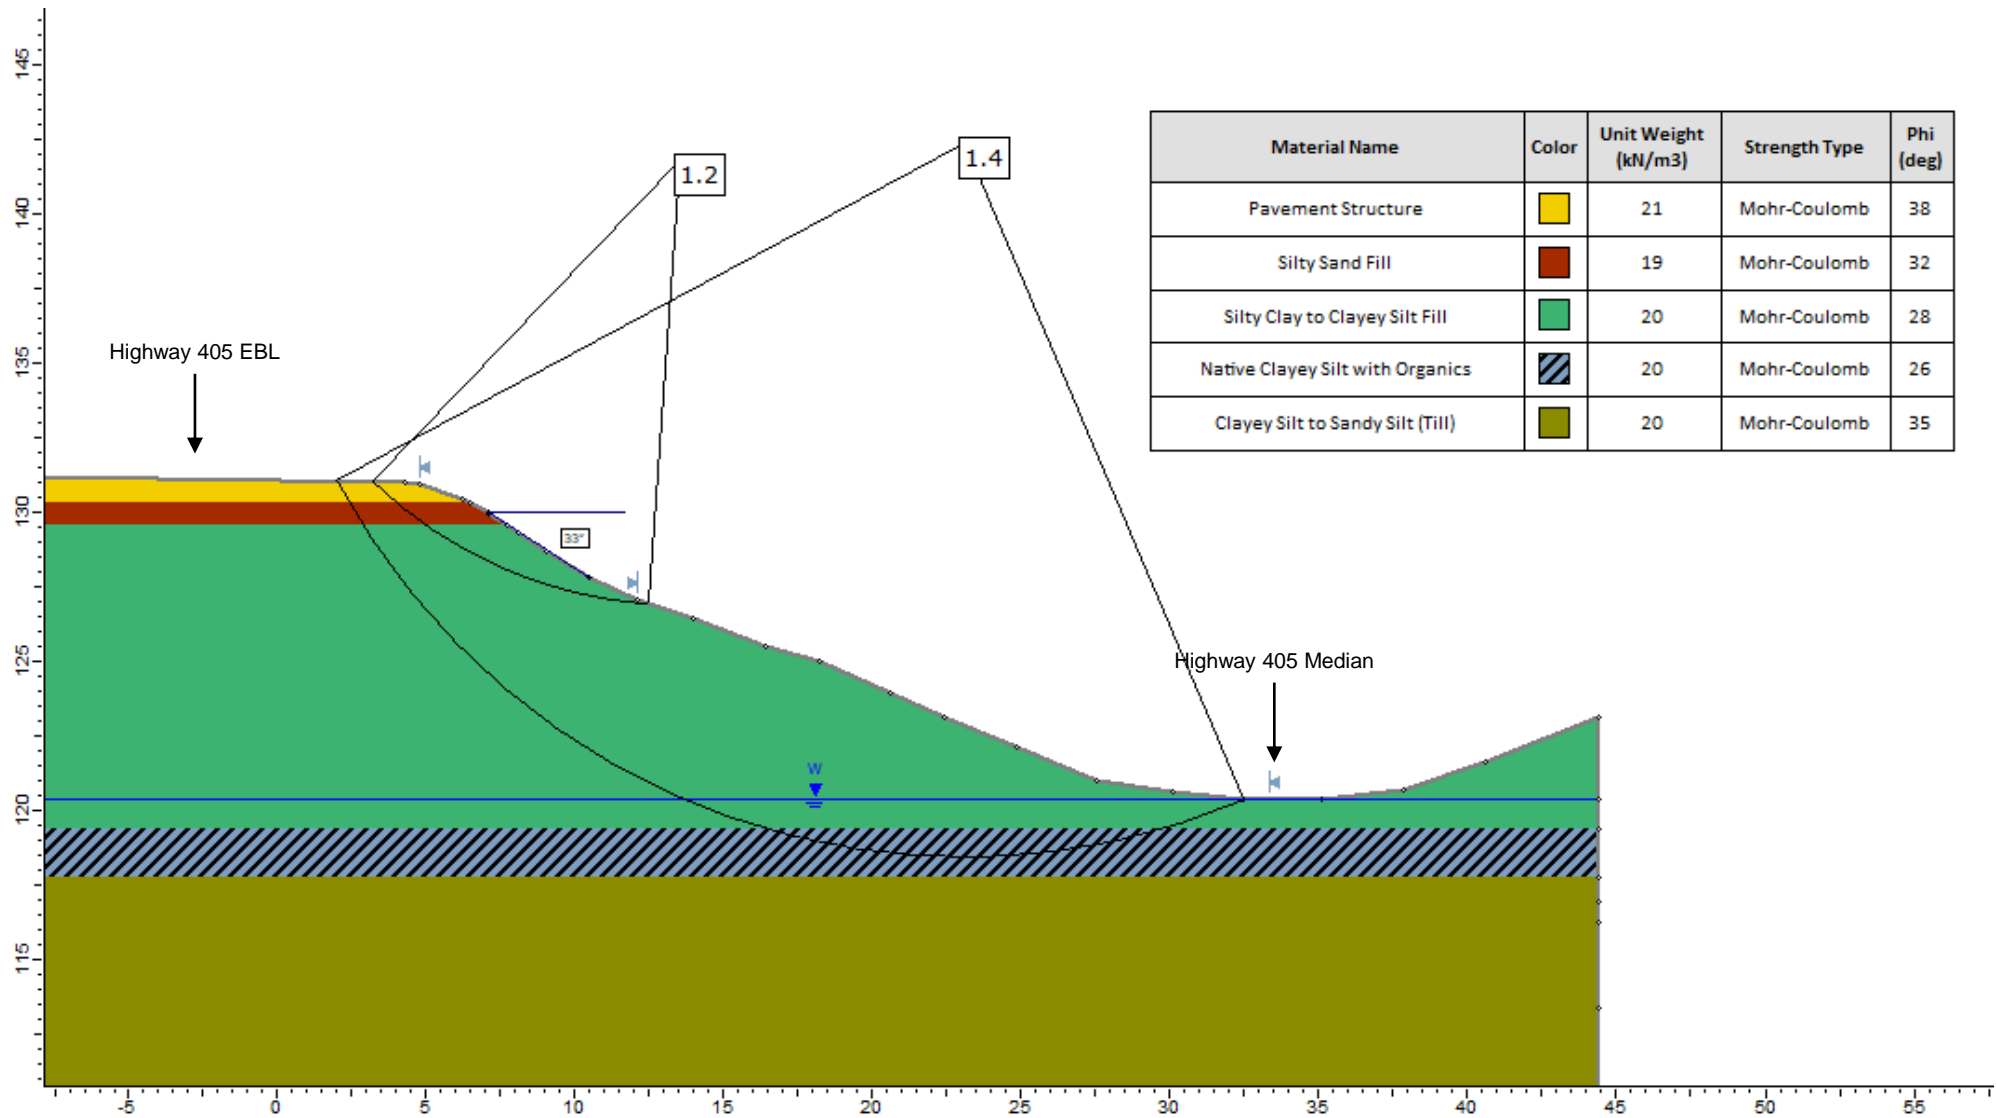
Shallow surficial failure surfaces (with a Factor of Safety below 1) were calculated in the upper steepest portion of the embankment slope. Figure 1 also shows a failure surface where a factor of safety equal to 1.2 was calculated where the toe of the failure surface daylighted at about the mid-slope of the embankment, consistent with the pictures of the observed failure that occurred back in 2006 (refer to Golder 2007 report). If a perched groundwater surface is modeled near the ground surface of the slope (i.e. assuming near surface soils become saturated from surface water due to inadequate drainage and/or localized surface water accumulation), the factor of safety reduces to less than 1.

- Global stability analysis calculated a factor of safety of 1.4 against global instability. Shallow (surficial sloughing) failure surfaces along the upper portion of the embankment slope calculated factors of safety slightly above 1. When a temporary “saturated” condition within the upper portion of the fill is modelled, the factor of safety for shallow instability was calculated below 1.

Based on the results of the stability analyses, the calculated factor of safety against global instability is considered adequate. However, a factor of safety near 1 was calculated for shallow (surficial sloughing) failures in the upper portion of the slope where the geometry was measured to be steeper than 2H:1V. In addition, a factor of safety below 1 was calculated for a temporary saturated upper slope where the failure surface is consistent with the location of the previously observed shallow failure and pavement cracking on site.

Option 1 – Do Nothing: Given there is a low risk of global instability or future large settlements in the area of concern and the fact that the highway has been in operation for over 50 years, consideration could be given to rehabilitating this area as currently planned and repairing any future cracking / surficial sloughing at this localized area as required during regular maintenance activities;

Option 3 – Regrade Slope to 2H:1V using reinforced earth slope: Similar to Option 2; however, the near surface embankment slope soils could be reinforced with geogrid (placed along bottom of benched slope) to improve stability and erosion potential and lower the risk of future shallow failures (surficial sloughing) in this area. The surface of the regraded slopes could be covered with vegetation (seed and cover) or gravel sheeting within the upper half to control erosion and reduce the risk for future sloughing and shallow instability.

From a geotechnical / foundations perspective, the presence and performance of the storm sewer within the area of concern should be confirmed as it may influence the mitigation options proposed above. Alternatively, assuming the previous drainage improvements were carried out in this area as part of the 2007/2009 Contract, *Option 3 – Regrade Slope to 2H:1V using reinforced earth slope* is considered to be the preferred alternative.

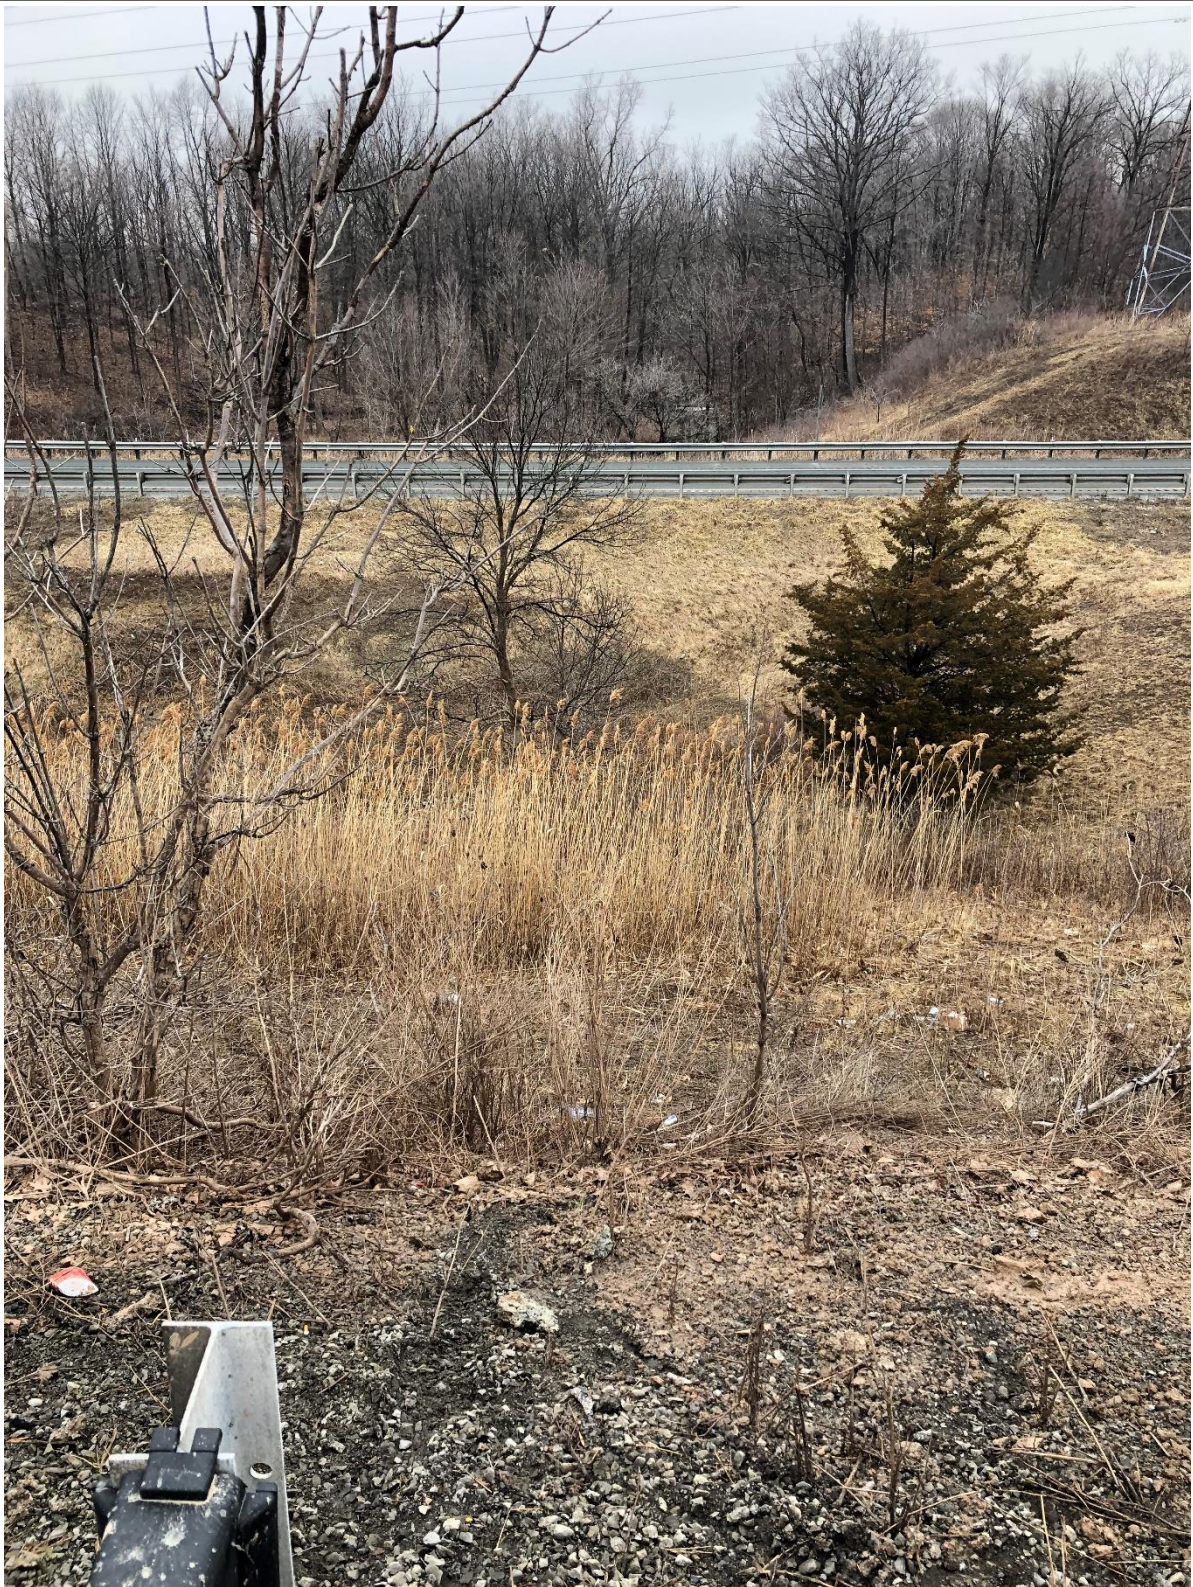
FIGURE C1

- Active erosion / water seepage was not observed on the north or south sides of the Highway 405 EBL embankment;
- Some surficial surface water rills were evident in the granular fills on the south side of the Highway 405 EBL slope;

- No signs of slope instability or cracking / bulging were observed on the north or south side of the Highway 405 EBL embankment;
- The inlet for the box culvert located directly below the area of concern (at about Station 10+880) of the Highway 405 EBL embankment was observed to be free of obstructions and water was flowing freely into the structure (i.e. no ponding). A grate / catch basin was observed to be present at the midpoint of the culvert (to facilitate drainage of surface water from the median ditch between Highway 405 EBL and WBL) and was observed to be free of obstructions. Water was observed to be flowing through the culvert when looking through the grate and there was no sign of sediment build-up or obstructions.

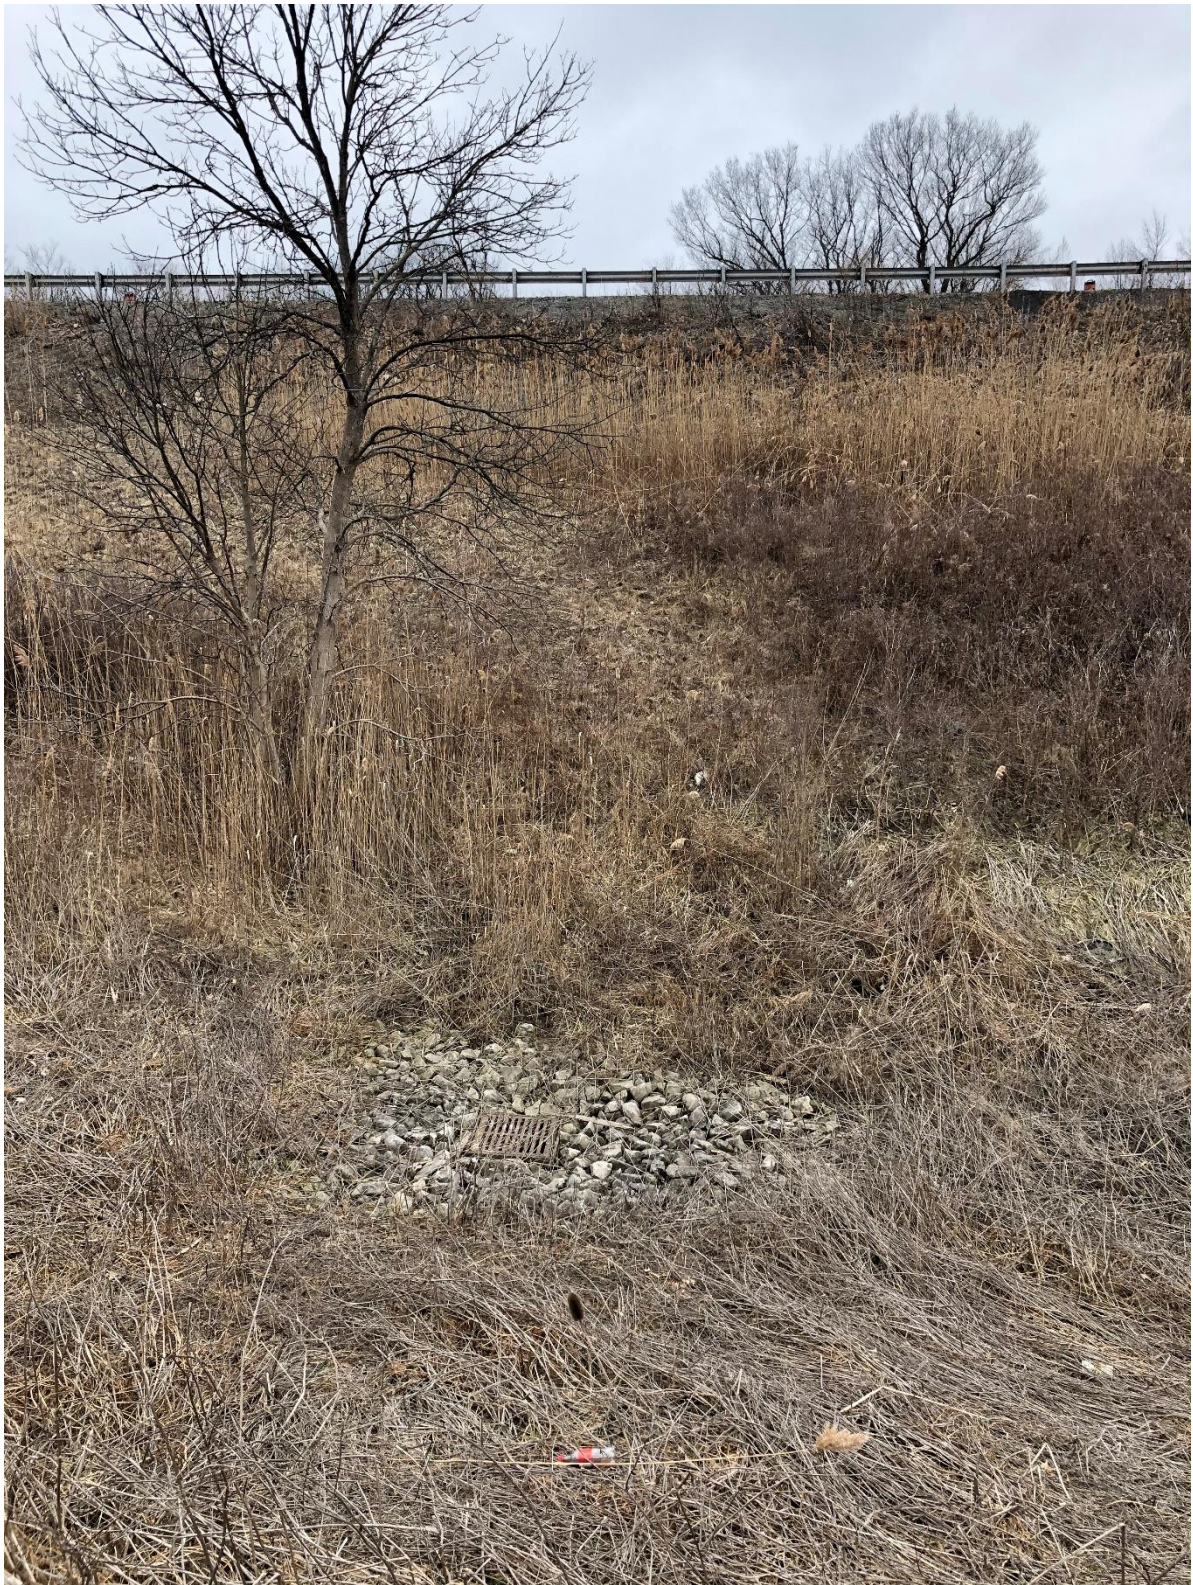
FIGURE C2

- The box culvert located west of the area of concern (Station 10+780 at the Hwy 405 EBL centreline) connects to another culvert and extends south below the QEW; thus, the inlet was not inspected. As shown in the design drawings for Contract 2009-2029, a grate / catch basin was observed to be present at the midpoint of the culvert (to facilitate drainage of surface water from the median ditch between Highway 405 EBL and WBL) and was observed to be free of obstructions. Water was observed to be flowing through the culvert when looking through the grate and there was no sign of sediment build-up or obstructions.

- In addition, the CSP culvert located below the Highway 405 WBL (Station 10+780) was observed to be free of obstructions and water was draining from the north side into the median ditch, running east along the ditchline, and entering the grate into the box culvert.

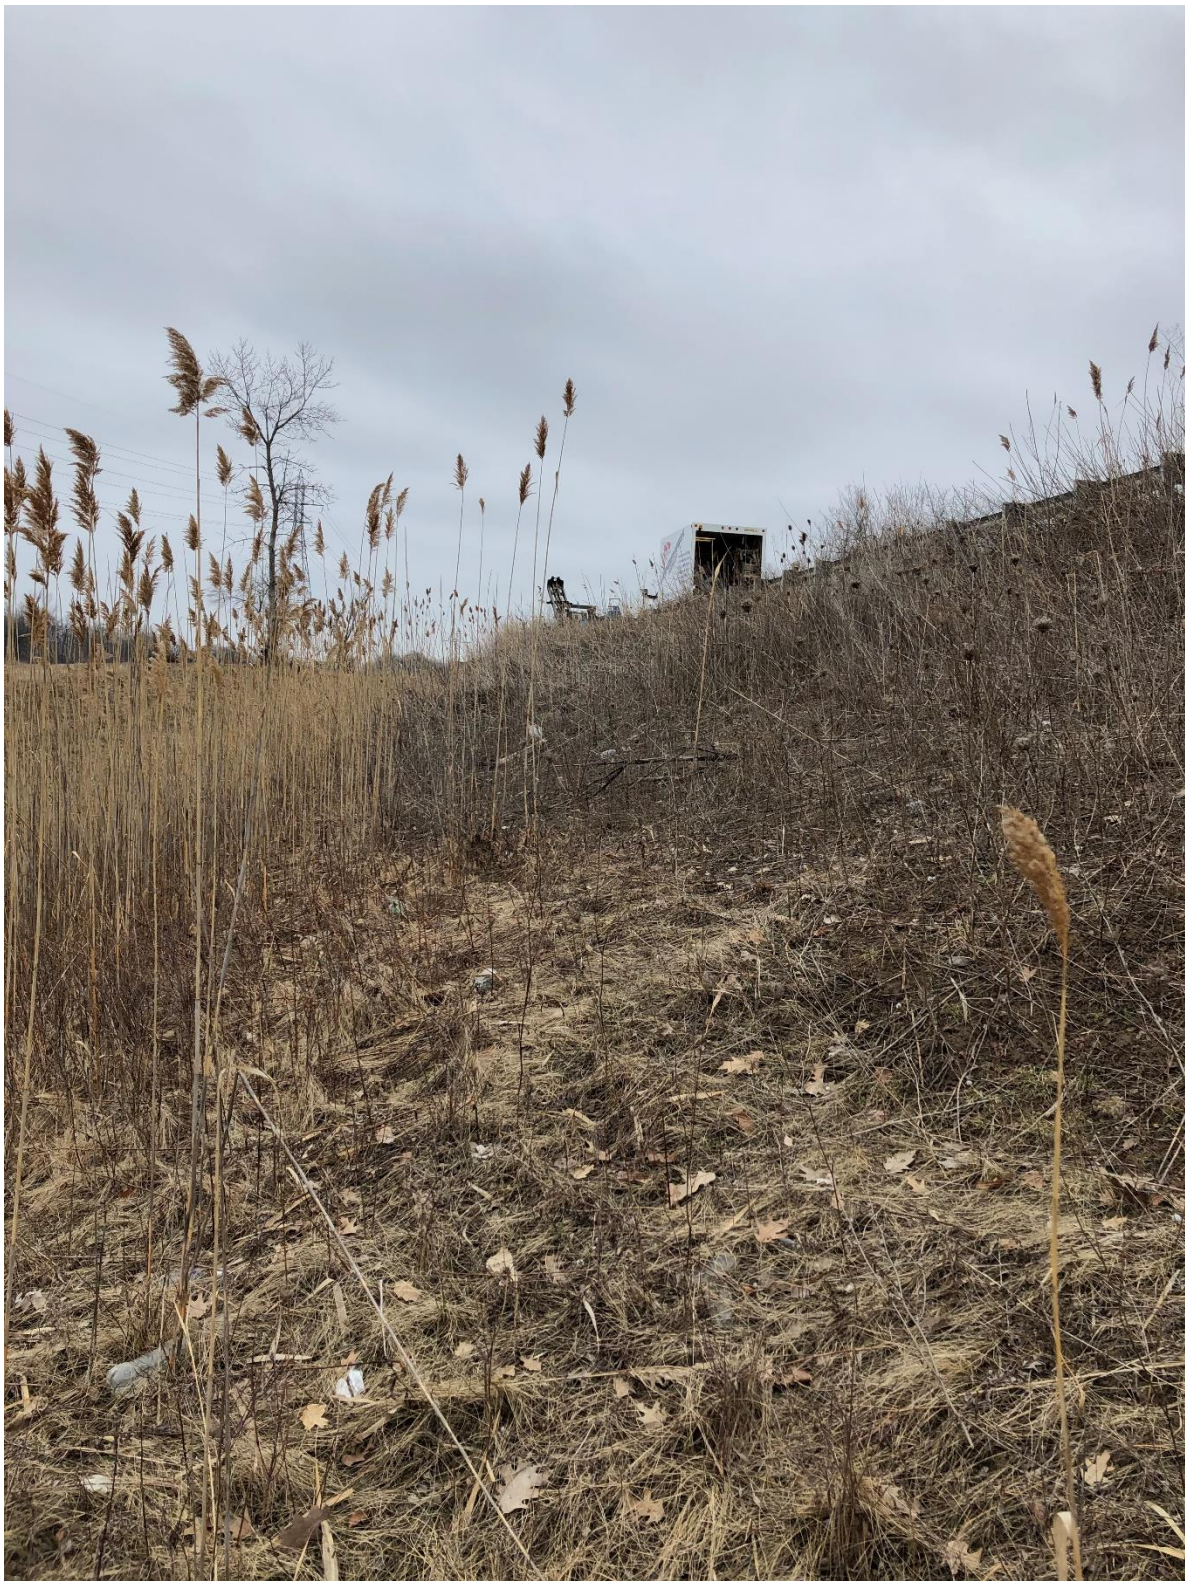
Highway 405 EBL Station 10+820 to 10+880: Slope Inspection Record	
Structures:	Two concrete box culverts allowing two streams to pass underneath Highway 405. One CSP culvert draining a small stream from the north side of the Highway 405 westbound embankment into the drainage ditch between the eastbound and westbound lanes observed
Erosion Features:	N/A
Slope Slide Features:	Minor sluffing of surficial Granular 'A' on upper portion of the slope when conducting inspection.
