**FOUNDATION INVESTIGATION AND DESIGN REPORT  
CHIPPEWA RIVER BRIDGE REHABILITATION**

**Highway 17, Site 38S-008**

**G.W.P. 5141-08-00**

**Township of Tilley**

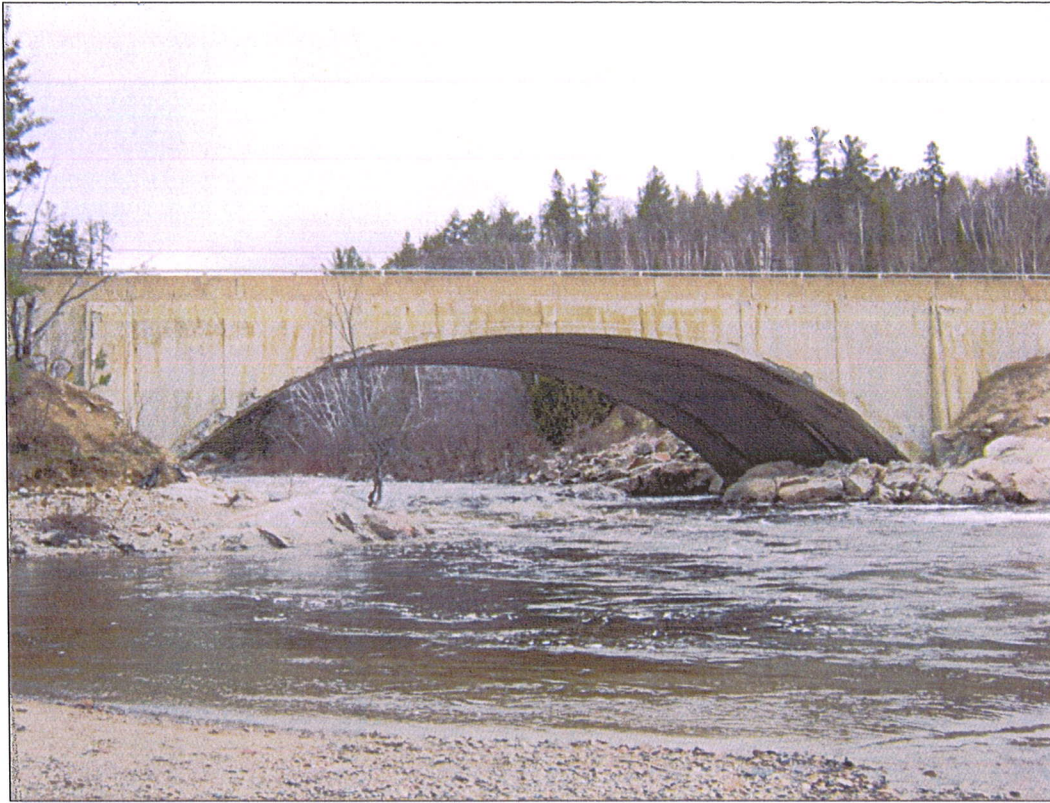
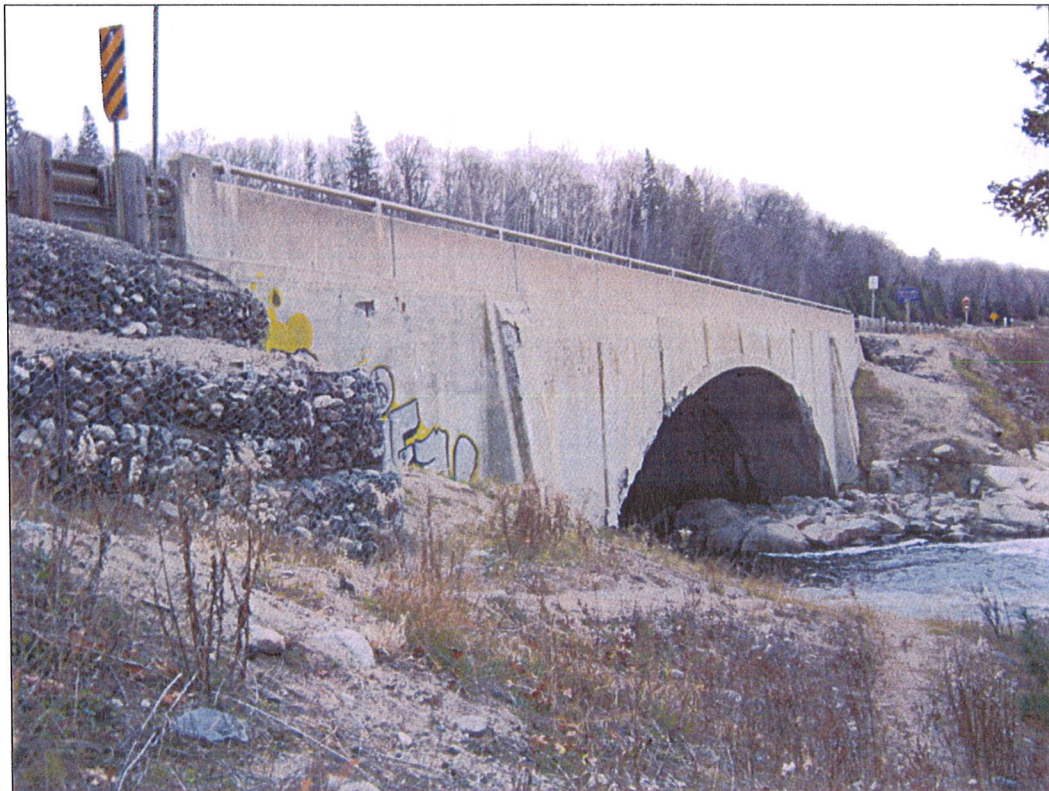
**Photographs 1 and 2 –** General view of the south side of the Chippewa River Bridge (downstream)

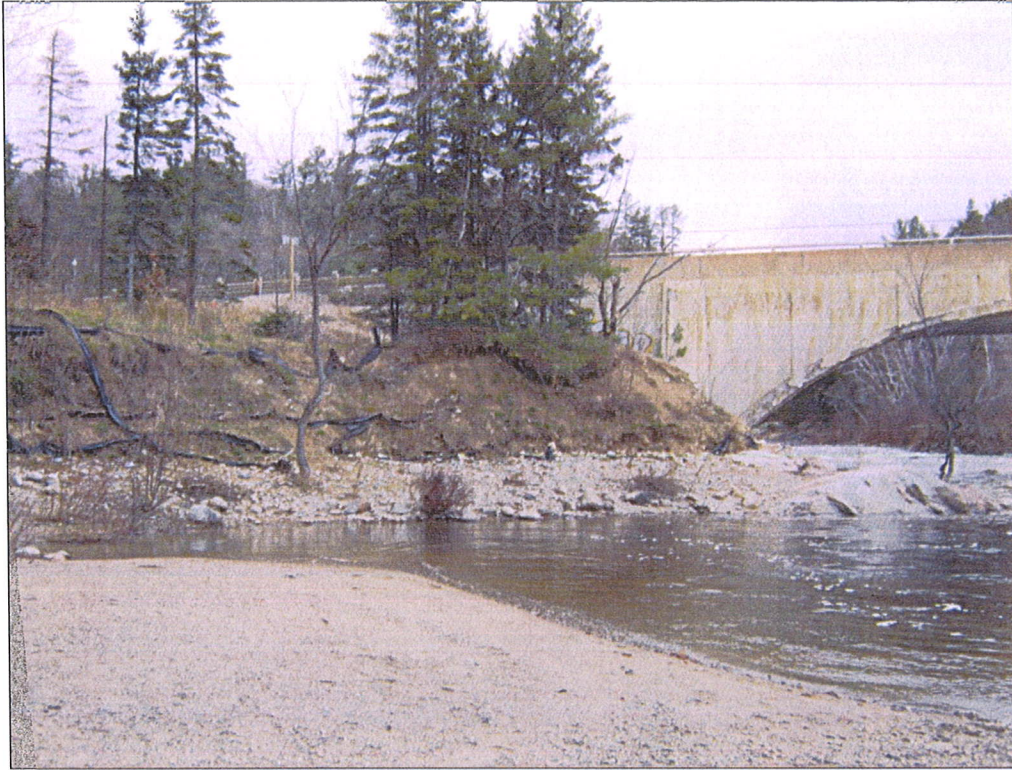
**Photograph 3** - Existing conditions of the west slopes/approaches on the south side of the bridge

The GA drawing indicates that the bridge rehabilitation will include restoration of the existing embankments and slope protection, repair of erosion at the northwest corner of the west abutment and erosion repair at sidewalk.

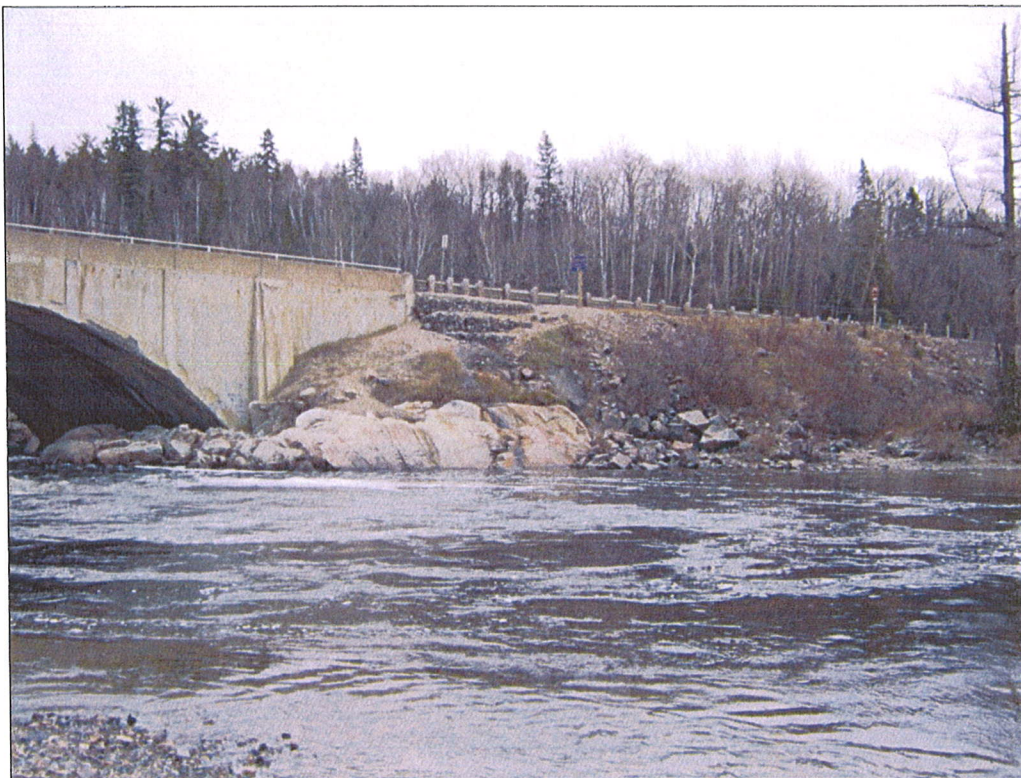
**Photograph 4** - Existing conditions of east slopes/approaches on the south side of the bridge

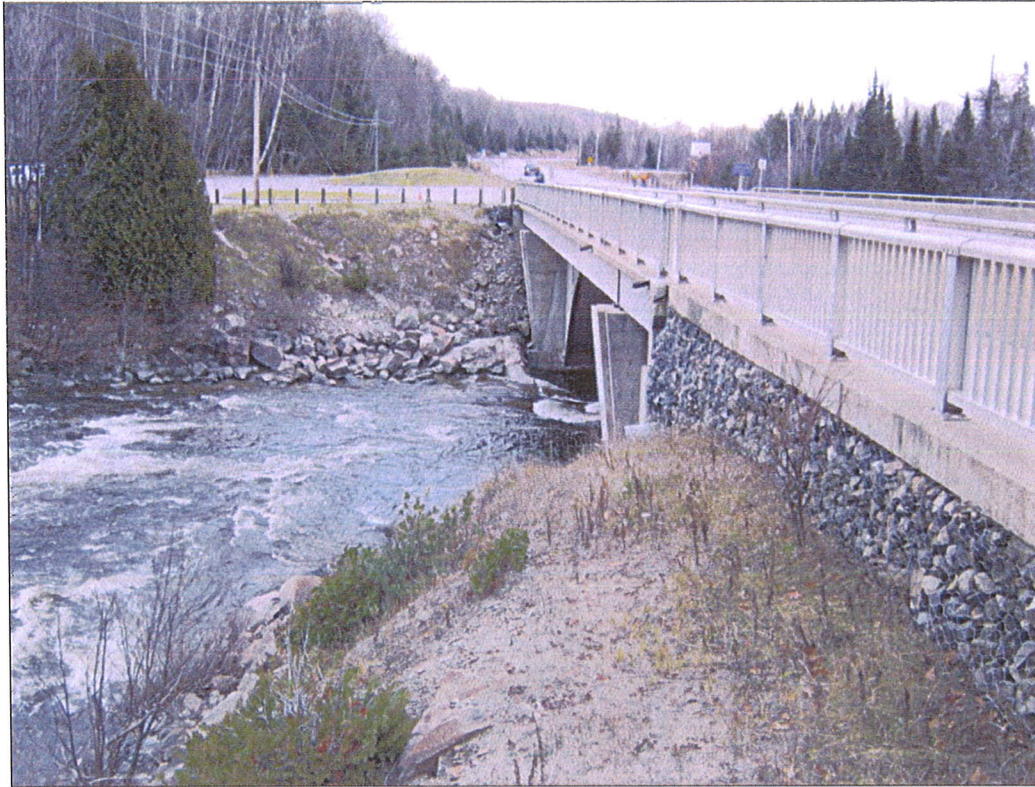
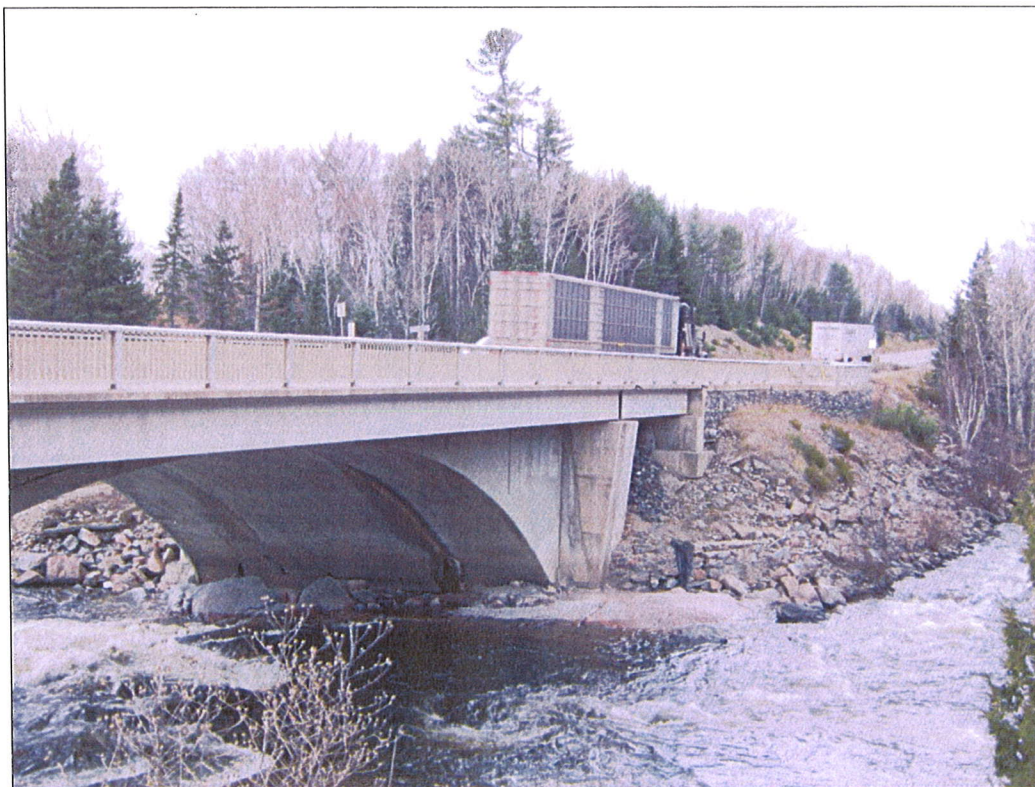
**Photographs 5 and 6- General view of the north side of the Chippewa River Bridge (upstream)**

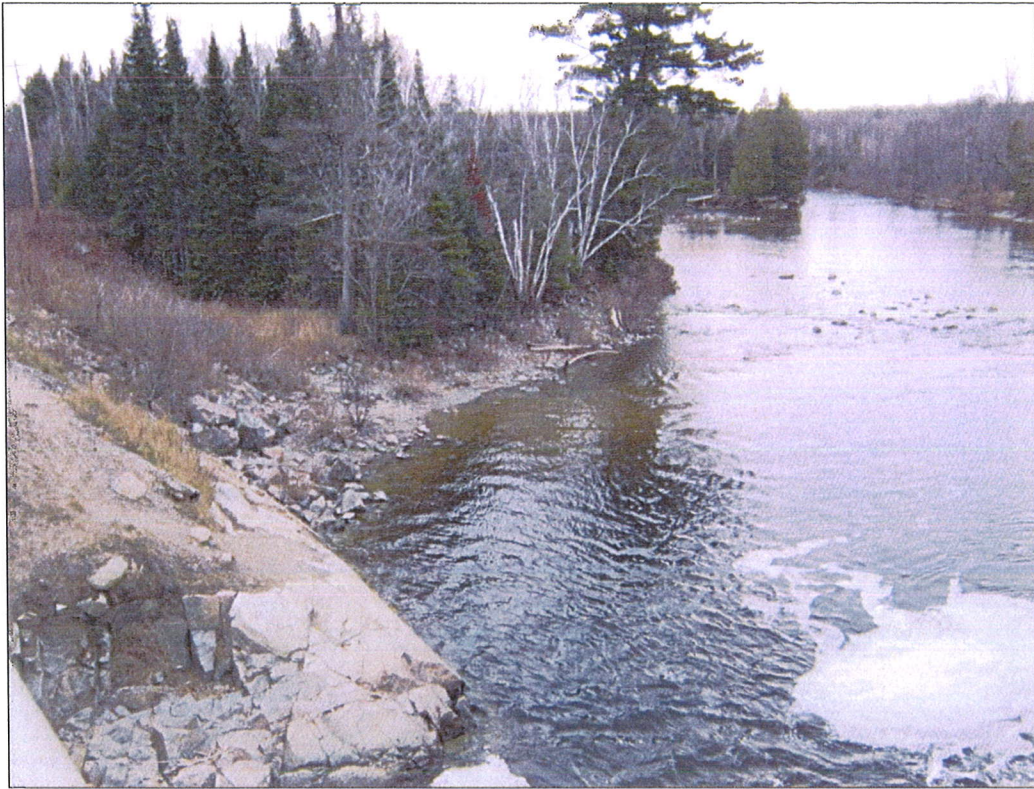
**Photograph 7-** South side of the Chippewa River Bridge (downstream)

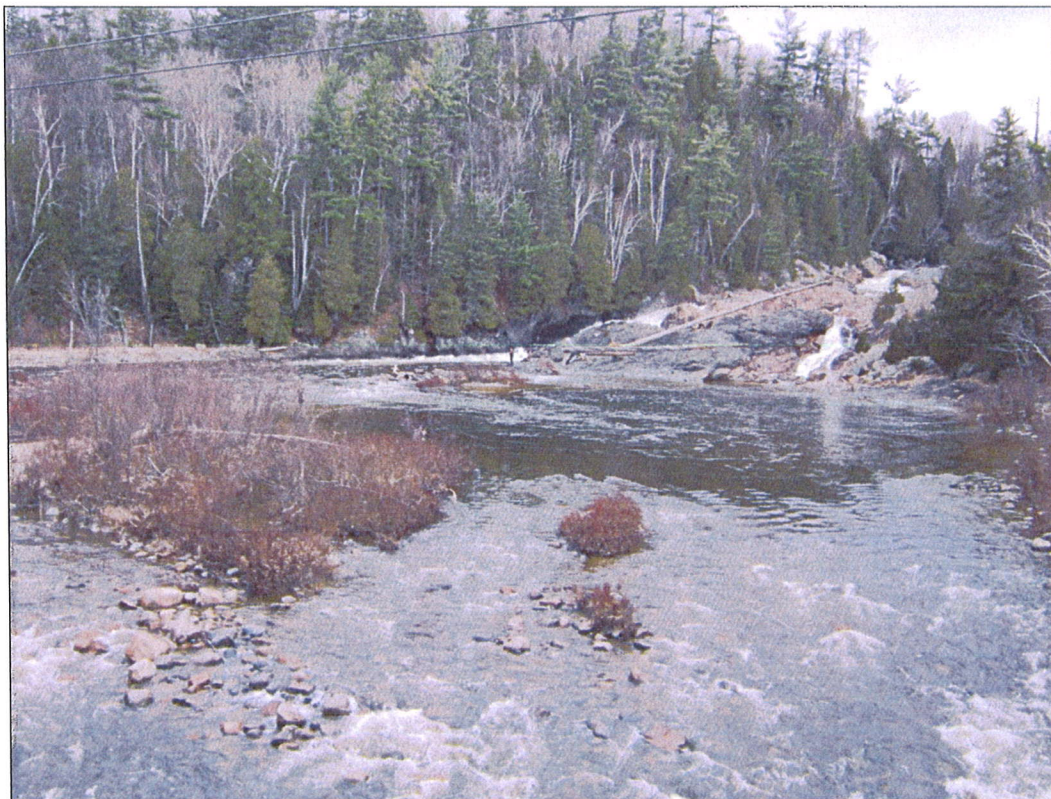
**Photograph 8-** North side of the Chippewa River Bridge (upstream)
