**FOUNDATION INVESTIGATION REPORT
CARIBUS LAKE CULVERT REPLACEMENT
HIGHWAY 11
DISTRICT OF RAINY RIVER, ONTARIO**

G.W.P. 6930-10-00, SITE No. 45-260/C

January 10, 2012
File: 19-1605-121

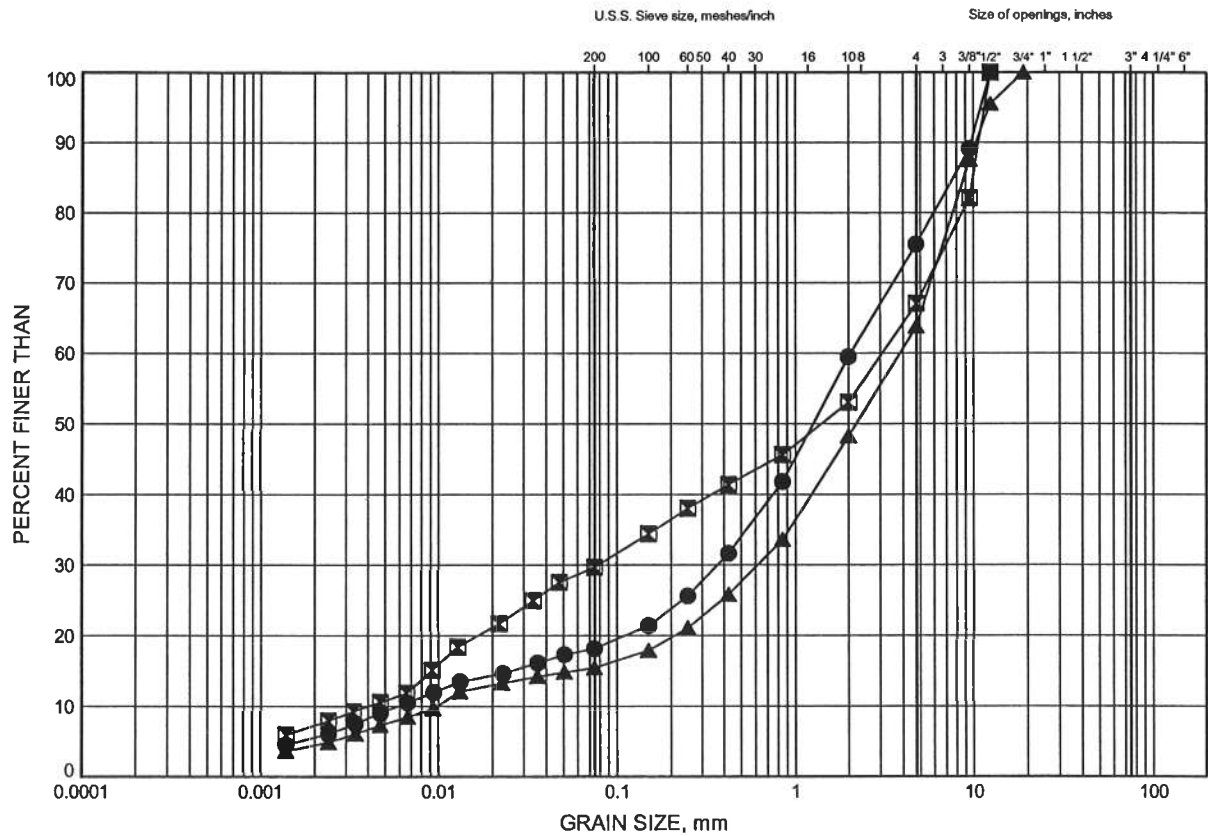
FIGURE B1

Selected samples of the fill underwent laboratory grain size analysis testing, the results of which are summarized below. These results are also presented on the Record of Borehole sheets included in Appendix A. The grain size distribution curves for these samples are shown on Figure B1 of Appendix B.

Soil Particles	Percentage (%)
Gravel	24 to 36
Sand	38 to 57
Silt	11 to 22
Clay	4 to 7

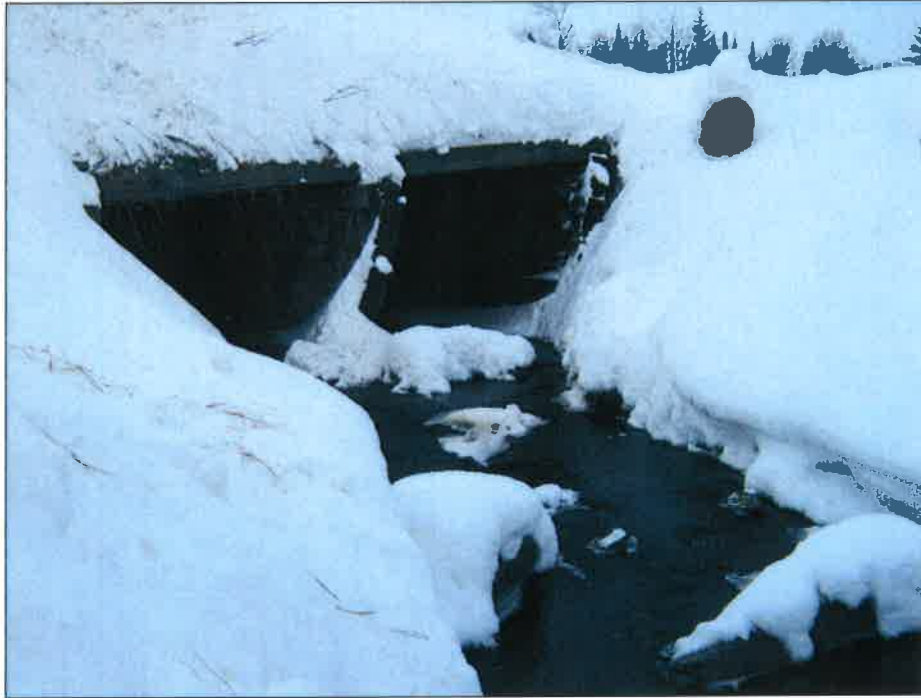
Photograph 2 – Existing conditions of north end of Caribus Lake Culvert (looking south)

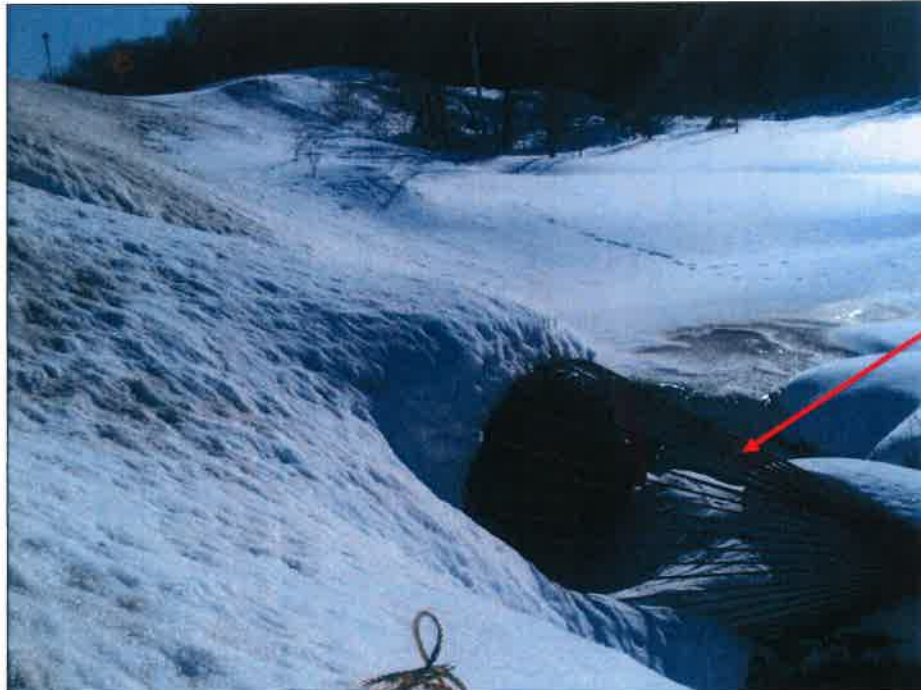
The existing Caribus Lake culvert is a 2-cell timber culvert. The cells are 2.1 m wide each and the total length of the culvert is 28 m. As observed in the field, an extension has been added to the south end (inlet) of the existing culvert. The extension consists of a 2-m diameter CSP including a shaped beaver and debris trap. The water flows through the culvert from south to north.

Beaver and
debris trap

Photograph 3– Existing conditions of south end of Caribus Lake Culvert (looking west)
