**Culvert Replacement - Cooper Creek Culvert
Highway 60
Station 16+310 – Township of Franklin
Site No. 42-042/C
GWP 5333-11-00**

FINAL PRELIMINARY FOUNDATION INVESTIGATION REPORT

Date: May 26, 2015
Ref. Nº: 14/07/14083-F7

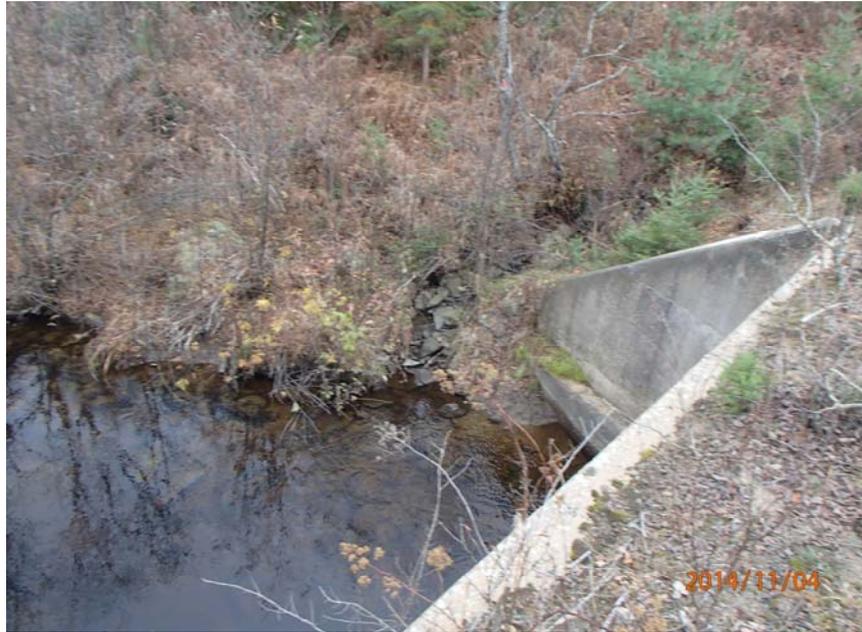
Photo: 1

Culvert Inlet – Looking Southeast

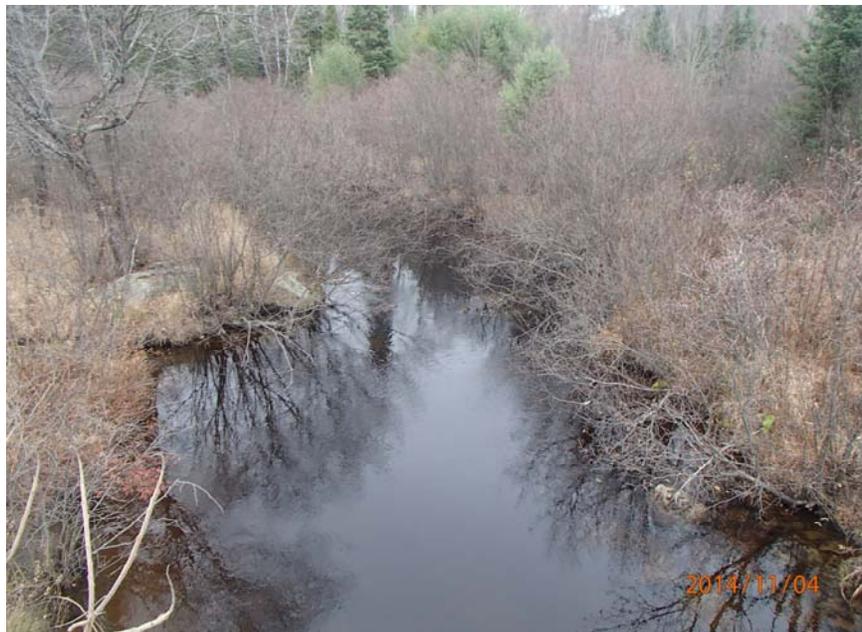
Photo: 2

Upstream at Culvert Inlet – Looking East

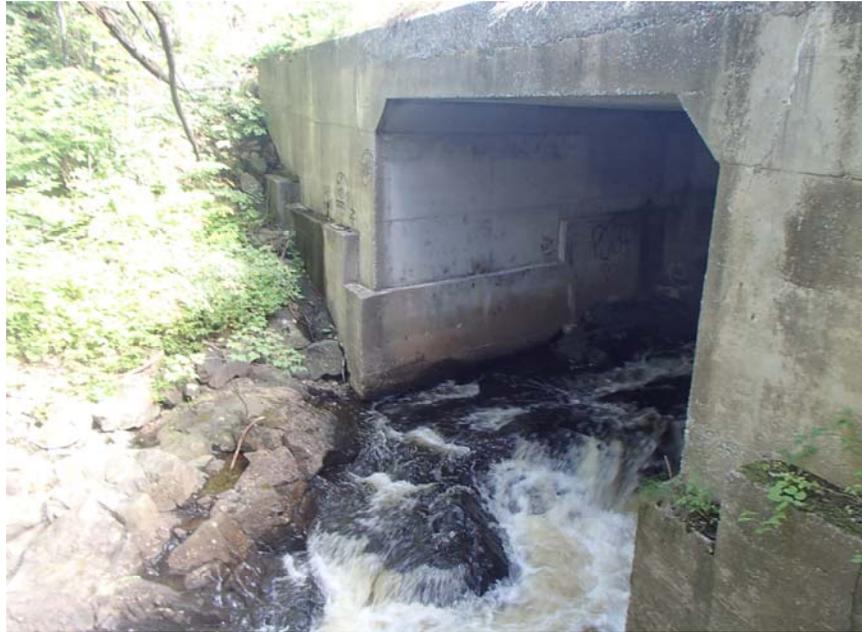
Photo: 3

Culvert Outlet – Looking Northwest

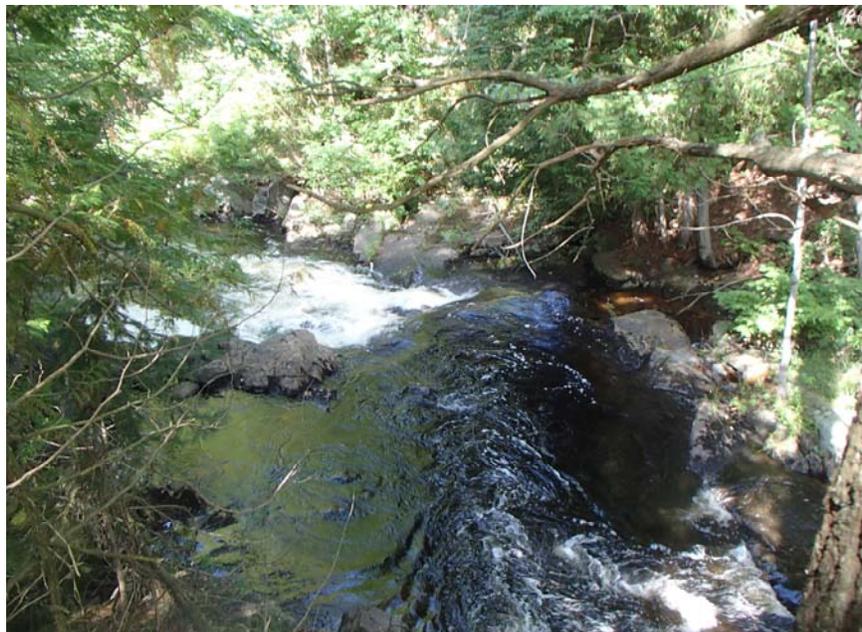
Photo: 4

Downstream at Culvert Outlet – Looking West
