**Culvert Replacement
Highway 118
Station 10+754 - Twp. of Dysart
GWP 5339-11-00**

FINAL FOUNDATION INVESTIGATION REPORT

Date: November 2, 2016
Ref. N°: 15/04/15020-F12

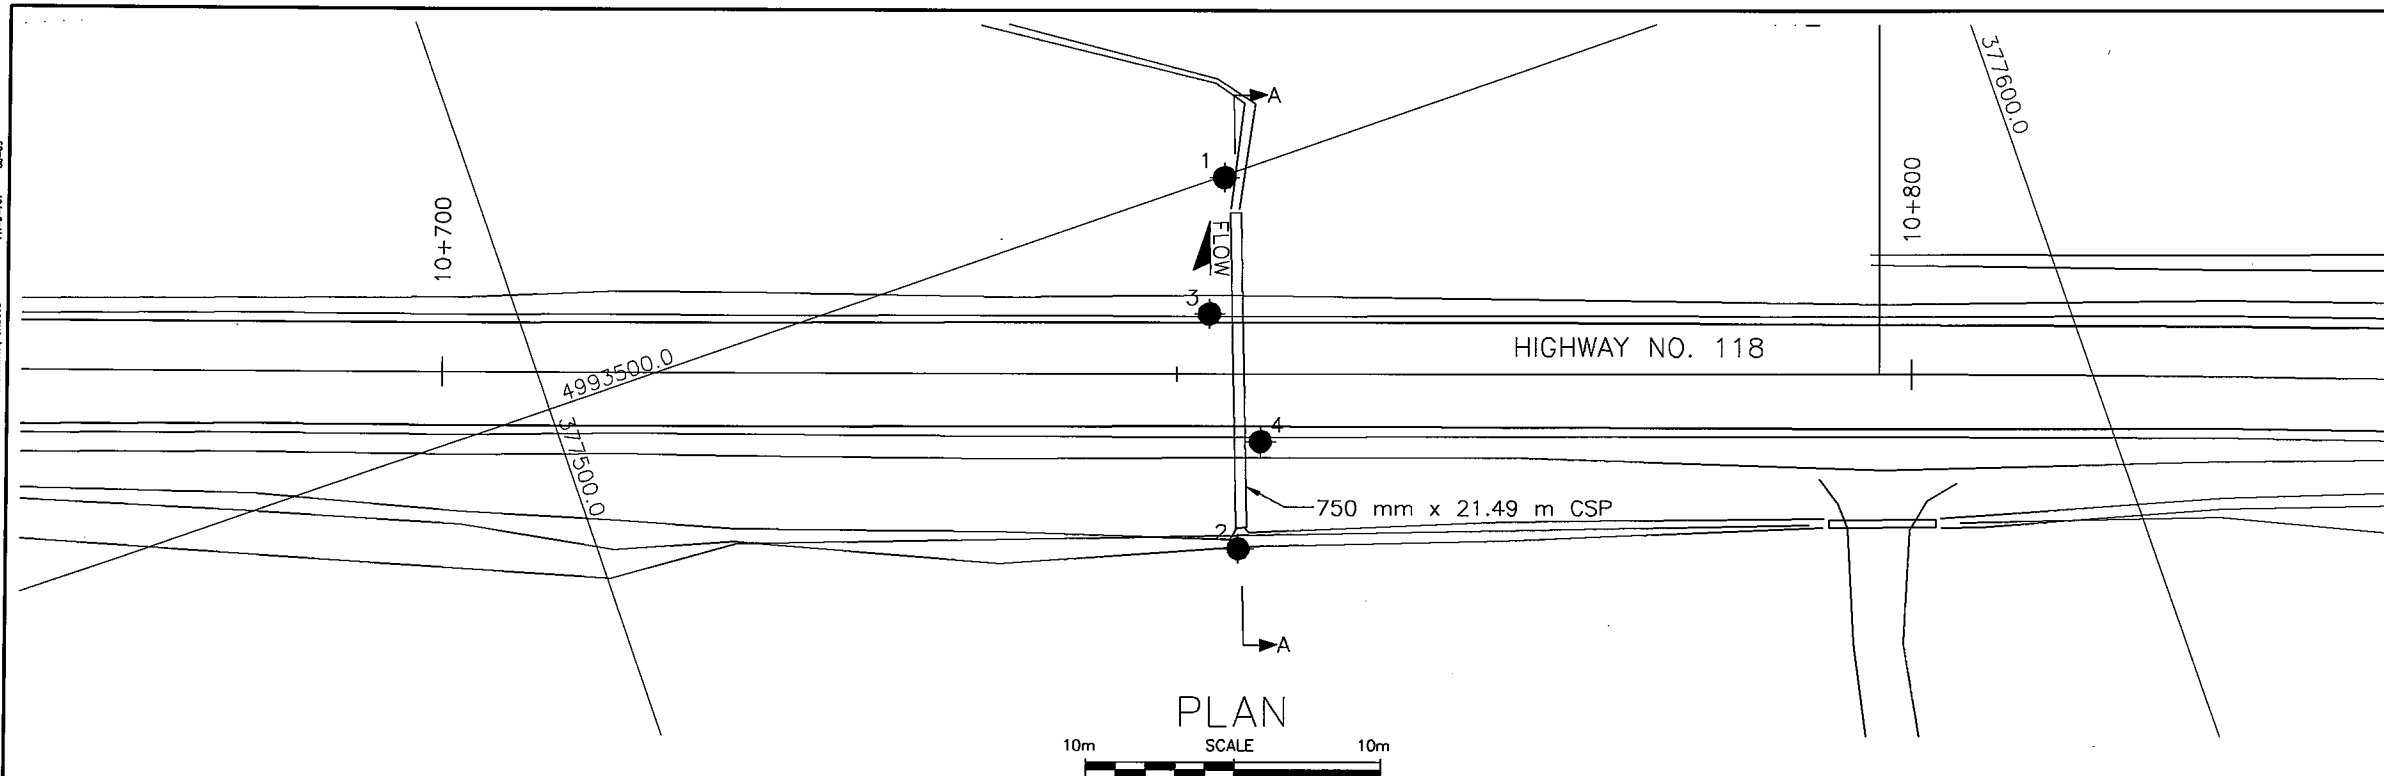
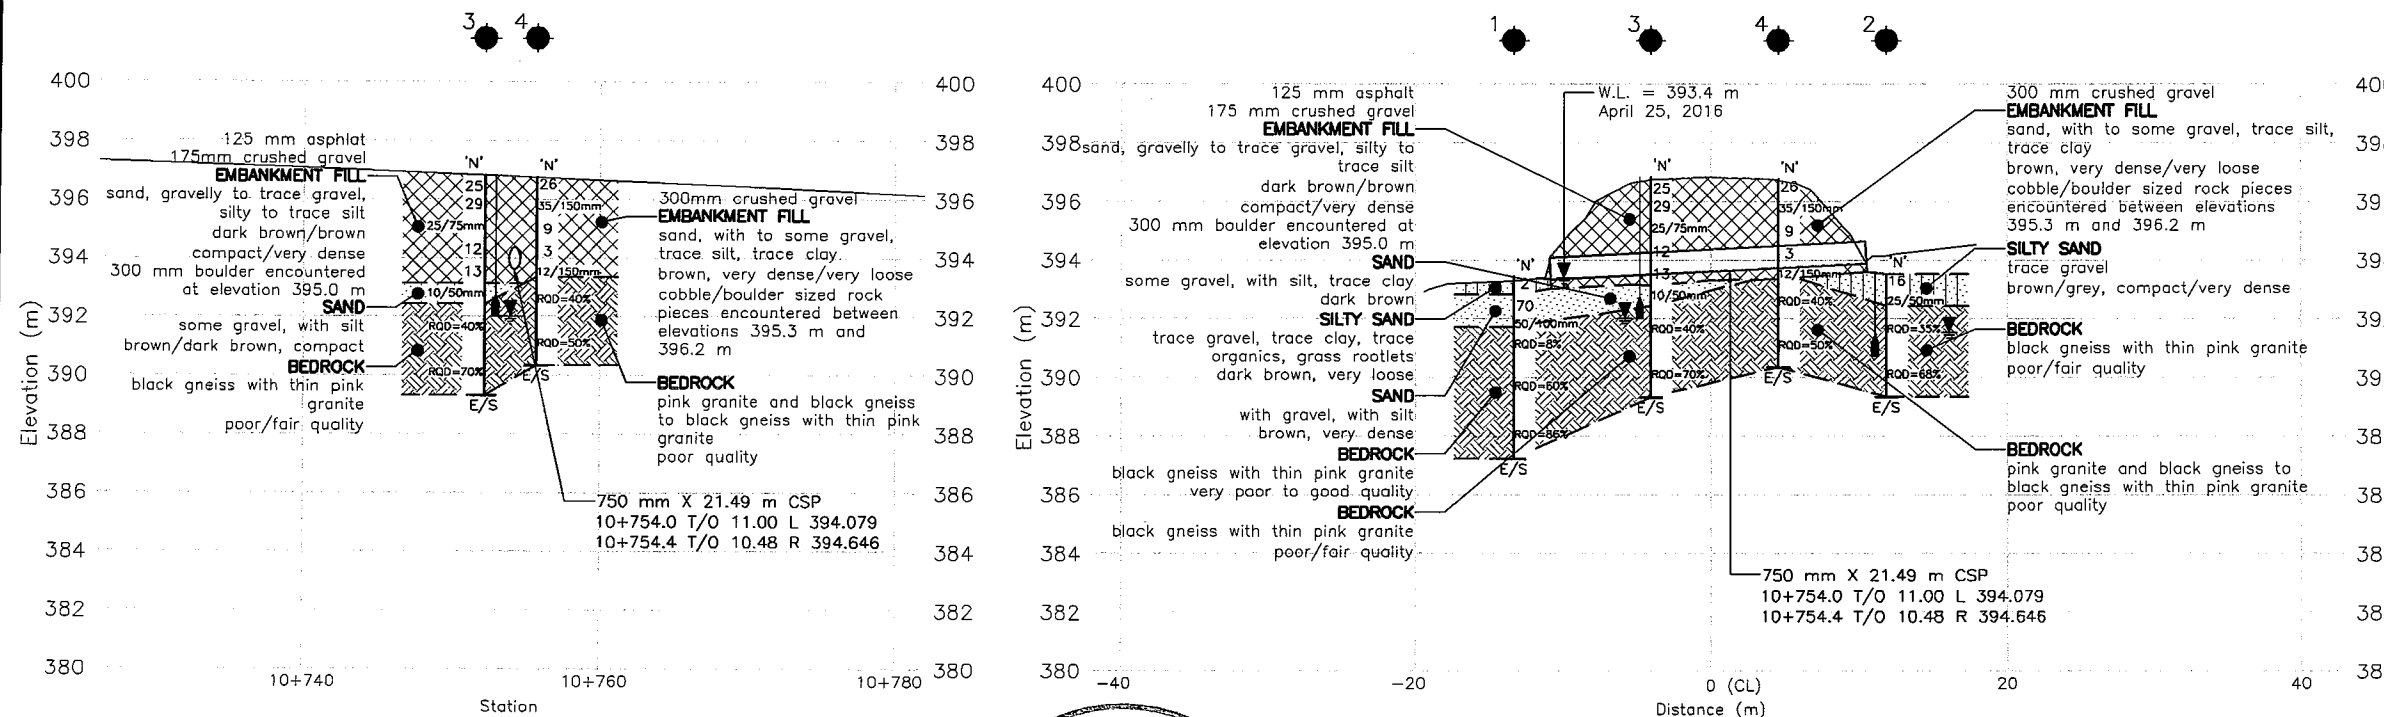
DISTRICT CONT. No. GWP No. 5339-11-00	DRAWING 2
HIGHWAY 118 CULVERT AT STA. 10+754 SITE NO.	
BOREHOLE LOCATIONS AND SOIL STRATIGRAPHY

A plan and profile illustrating the borehole locations and stratigraphic sequences is shown on Drawing No. 2, Appendix 3. During the course of the exploration program, four (4) sampled boreholes were put down at this site, with Borehole Nos. 3 and 4 advanced through the embankment, Borehole No. 2 advanced adjacent to the culvert inlet, and Borehole No. 1 advanced adjacent to the culvert outlet. At the time of the subsurface investigation, the ground surface elevations at Boreholes Nos. 1 to 4 were recorded at Elevations 393.4, 393.5, 396.8, and 396.8 m, respectively.

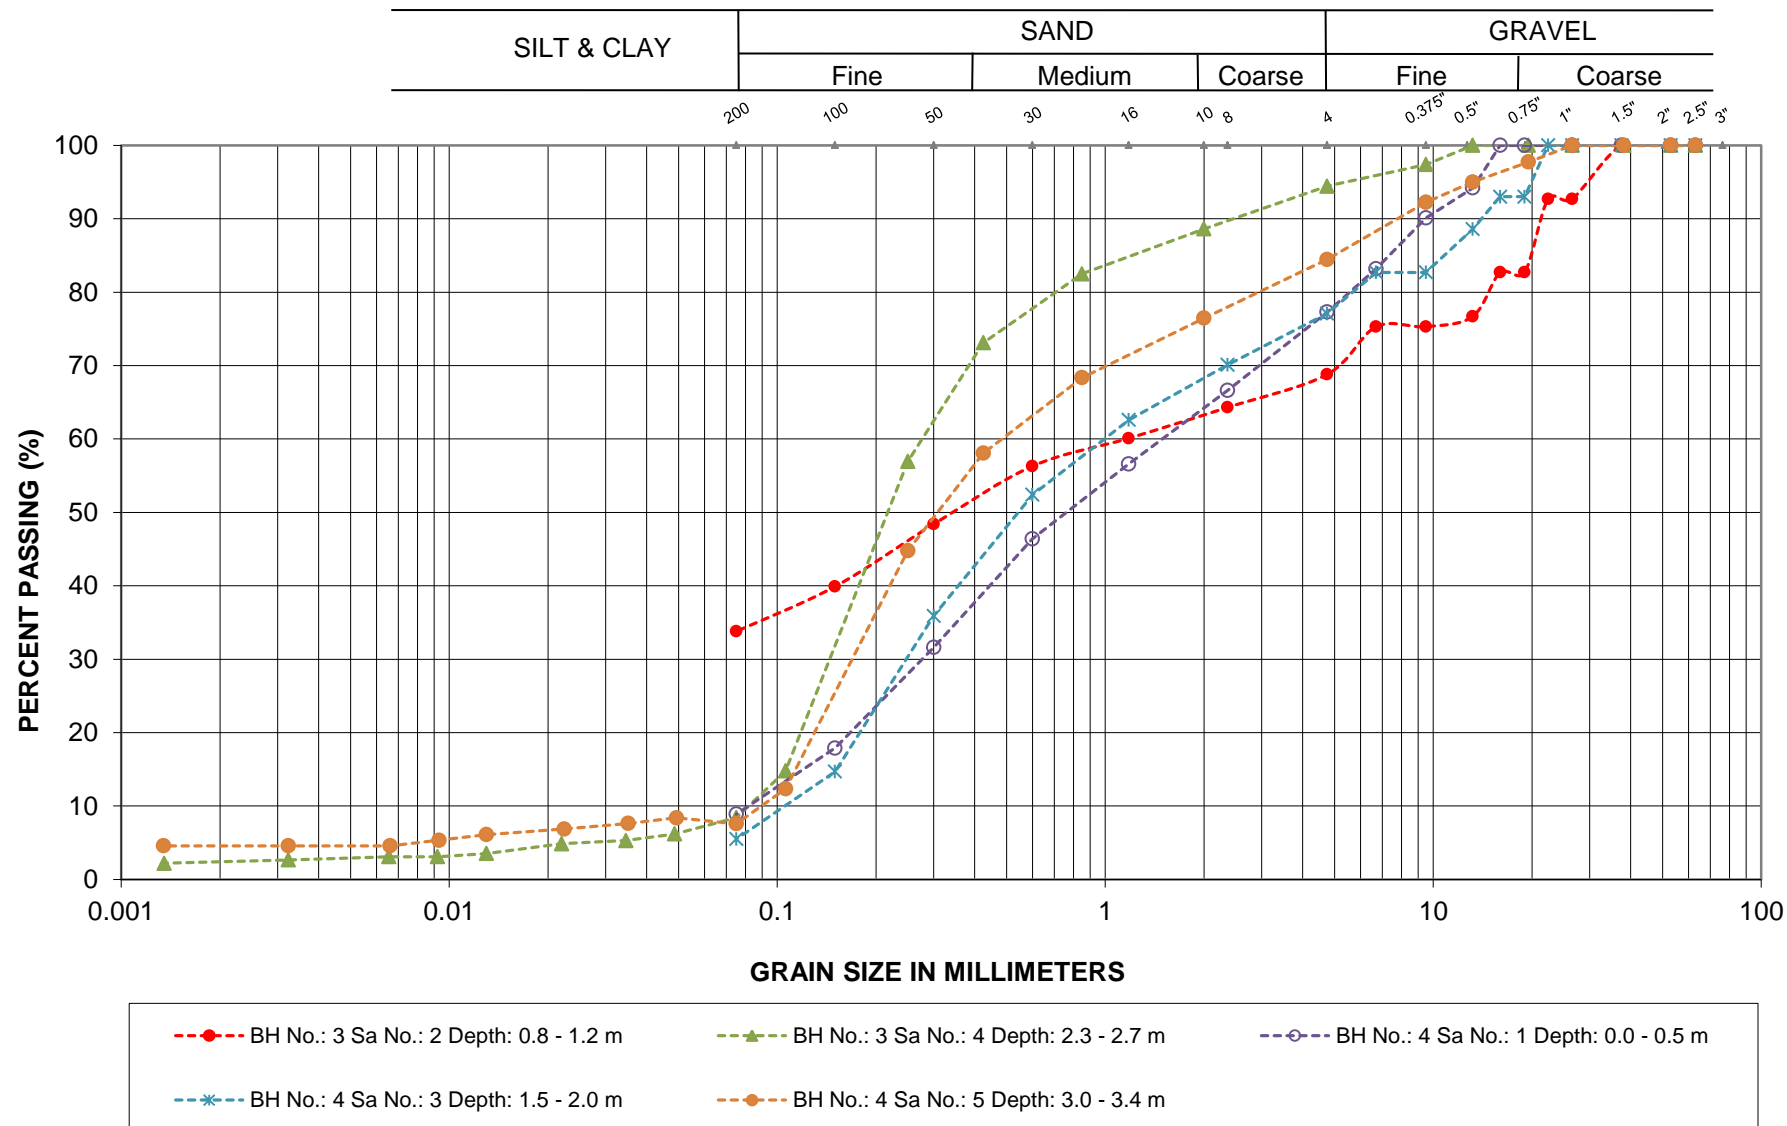
FIGURE L-1

layer. The natural moisture content measured for recovered samples from this deposit was generally in the order of 3 to 16%. Three gradation (sieve) analyses were carried out on three (3) samples of this deposit, the results of which indicated 23 to 31% gravel size particles, 35 to 71% sand size particles, and 6 to 34% silt and clay size particles (Figure No. L-1, Appendix 3). Two (2) additional gradation (hydrometer) analyses were carried out on samples of this deposit, the results of which indicated 6 to 15% gravel size particles, 77 to 86% sand size particles, 3 to 6% silt size particles, 2 to 5% clay size particles (Figure No. L-1, Appendix 3). Based on SPT 'N' values of 3 to 29 blows per 300 mm penetration and 35 blows per 150 mm penetration, the relative density/compactness of this deposit was described as very loose to very dense, but generally compact on average. This embankment fill was encountered to depths of 3.7 and 3.4 m below grade at Borehole Nos. 3 and 4, respectively (Elevations 393.1 and 393.4 m, respectively).

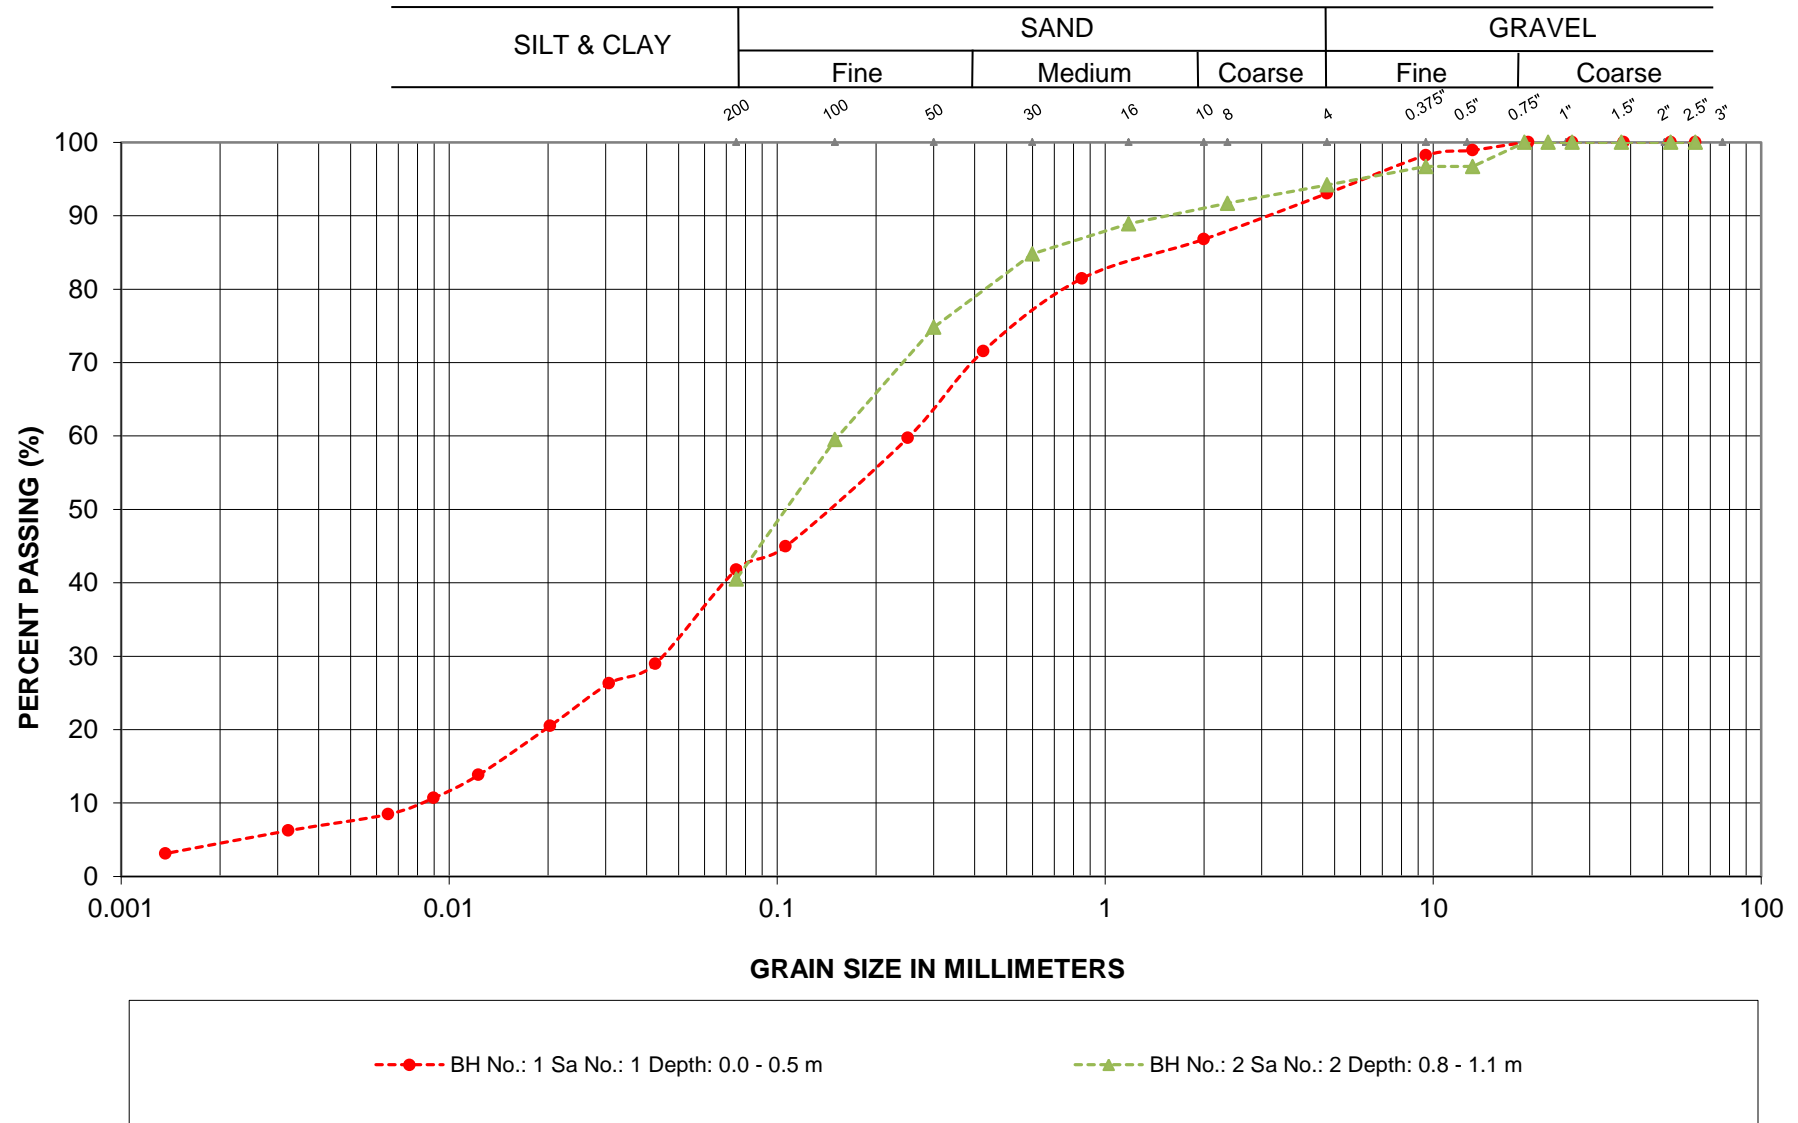
FIGURE L-2

At surface at Borehole Nos. 1 and 2, a deposit of silty sand, trace gravel, trace clay was penetrated. The natural moisture content measured on samples of this deposit was in the order of 12 to 45%. A gradation (hydrometer) analysis was carried out on one (1) sample of this deposit, the results of which indicated 7% gravel size particles, 51% sand size particles, 37% silt size particles, and 5% clay size particles (Figure No. L-2, Appendix 3). An additional gradation (sieve) analysis was carried out on one (1) sample of this deposit, and indicated 6% gravel size particles, 53% sand size particles, and 41% silt and clay size particles (Figure No. L-2, Appendix 3). Based on SPT 'N' values of 2 to 16 blows per 300 mm penetration and 25 blows per 50 mm penetration, this deposit was described as very loose to very dense. This deposit was encountered to depths of 0.6 and 1.1 m below ground surface at Borehole Nos. 1 and 2, respectively (Elevations 392.8 and 392.4 m, respectively).

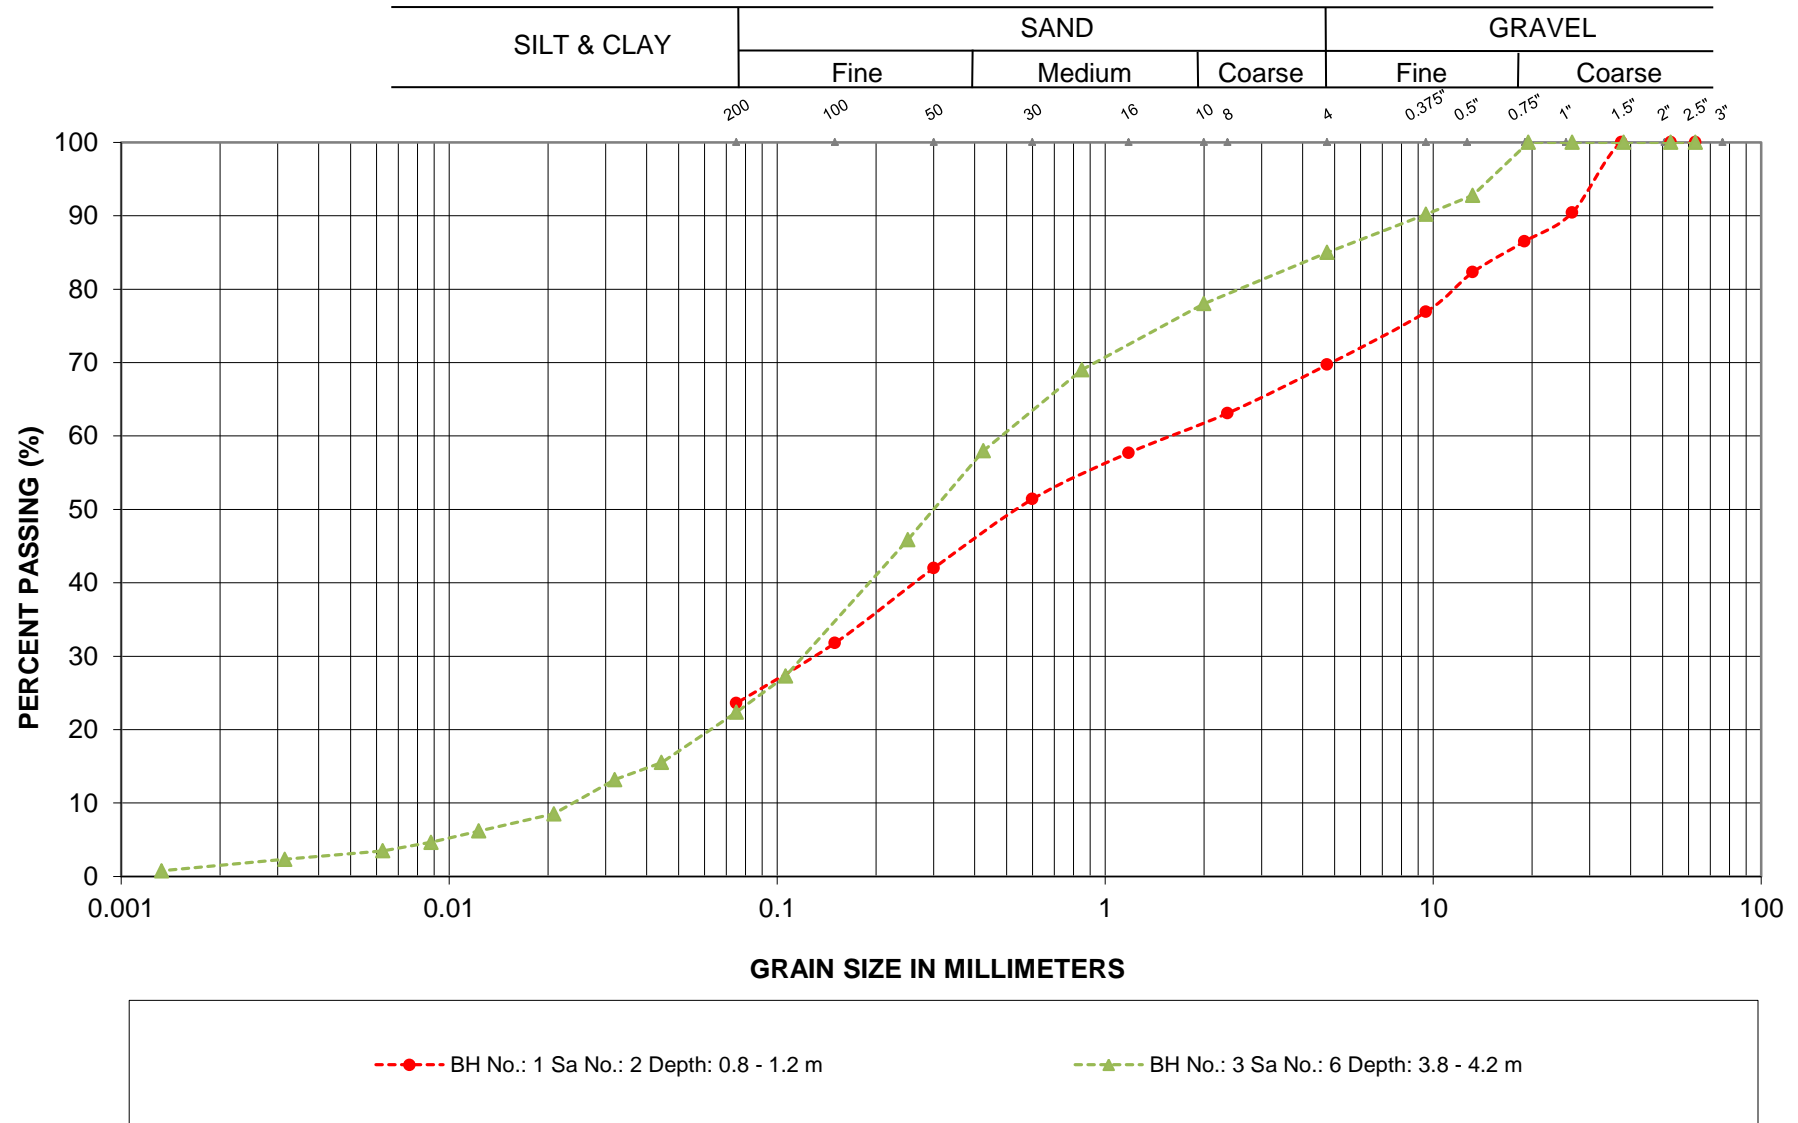
FIGURE L-3

Underlying the silty sand at Borehole Nos. 1, and underlying the embankment fill at Borehole No. 3, a deposit of sand, with to some gravel, with silt, trace clay was penetrated. The natural moisture content measured on samples of this deposit ranged from 12 to 17%. A gradation (hydrometer) analysis was carried out on one (1) sample of this deposit, and indicated 15% gravel size particles, 62% sand size particles, 21% silt size particles, and 2% clay size particles (Figure No. L-3, Appendix 3). A gradation (sieve) analysis was carried out on one (1) sample of this deposit, and indicated 30% gravel size particles, 46% sand size particles, and 24% silt and clay size particles (Figure No. L-3, Appendix 3). Based on SPT 'N' values of 70 blows per 300 mm penetration to 10 blows per 50 mm penetration, this deposit was described as very dense. This deposit was encountered to depths of 1.7 and 4.4 m below ground surface at Borehole Nos. 1 and 3, respectively (Elevations 391.7 and 392.4 m, respectively).

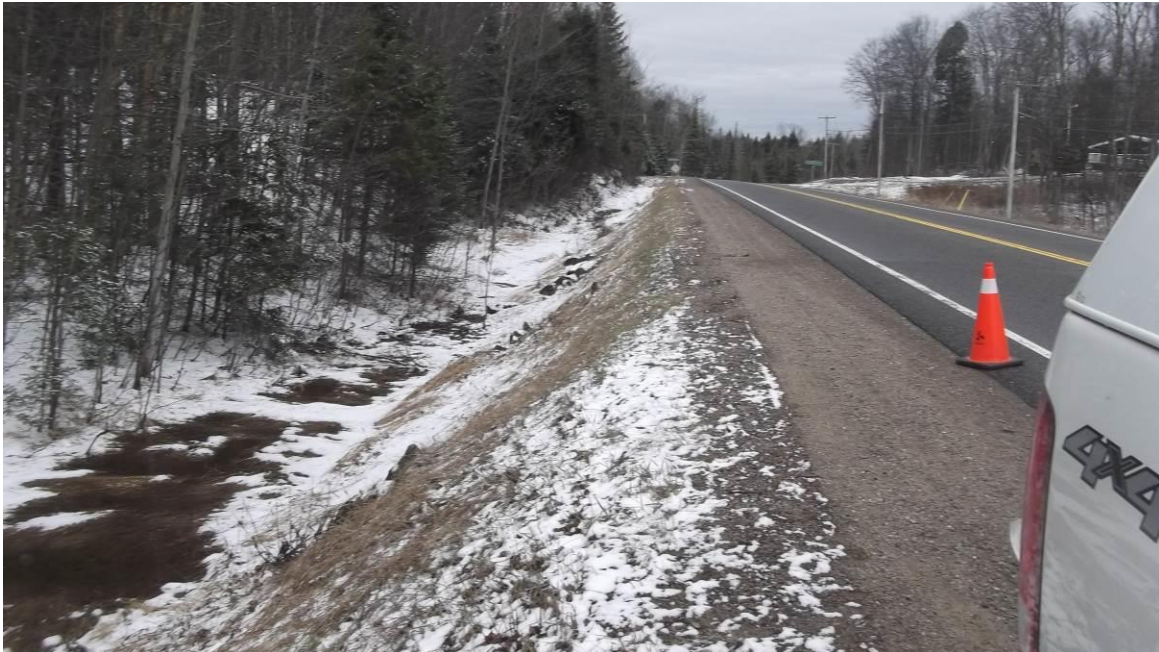
Photo: 1

Embankment at Culvert Location – Looking West

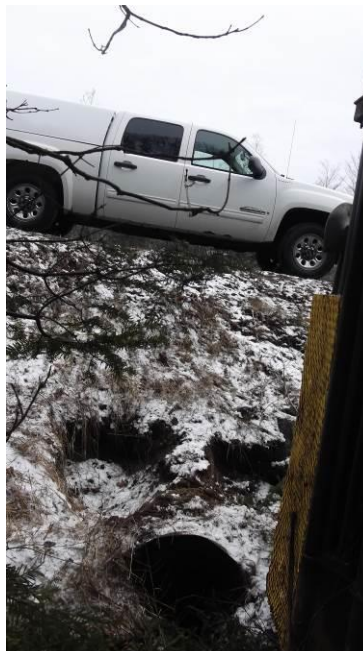
Photo: 2

Culvert Invert – Looking North

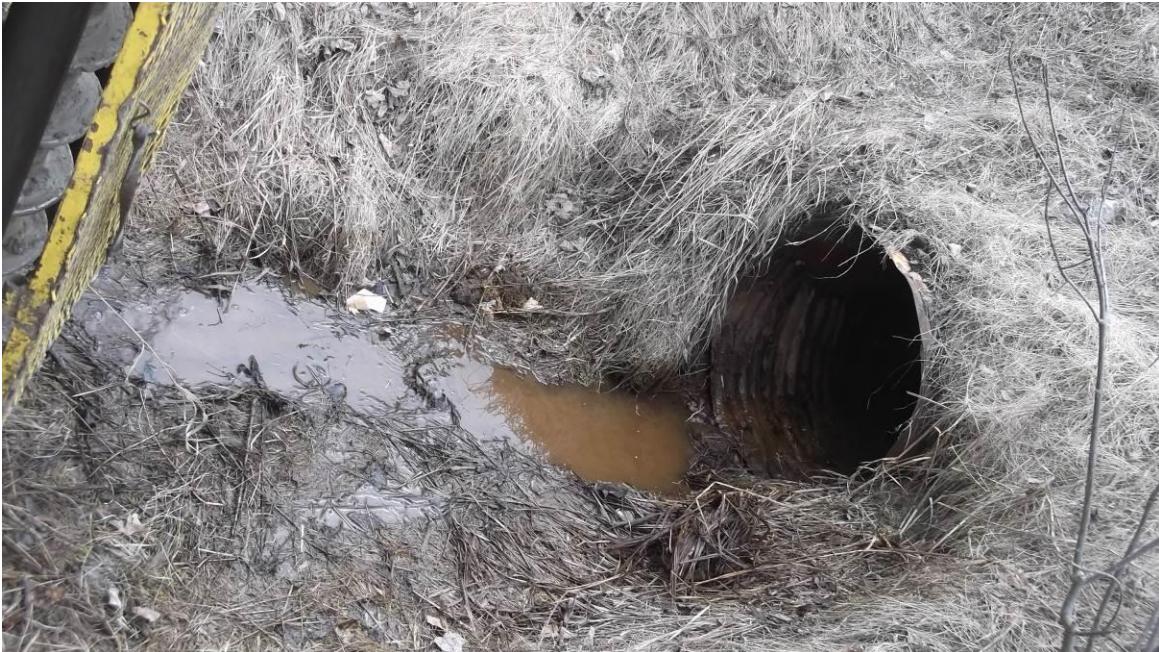
Photo: 3

Culvert Outlet – Looking Southeast

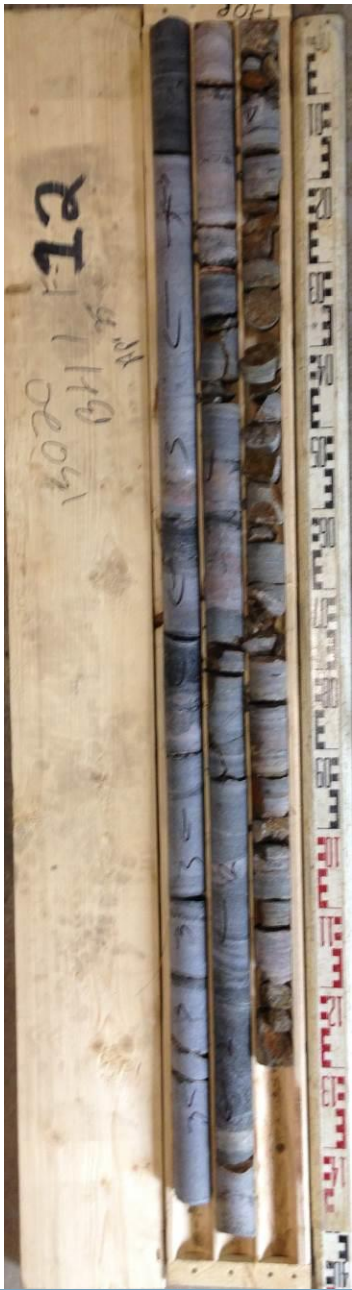
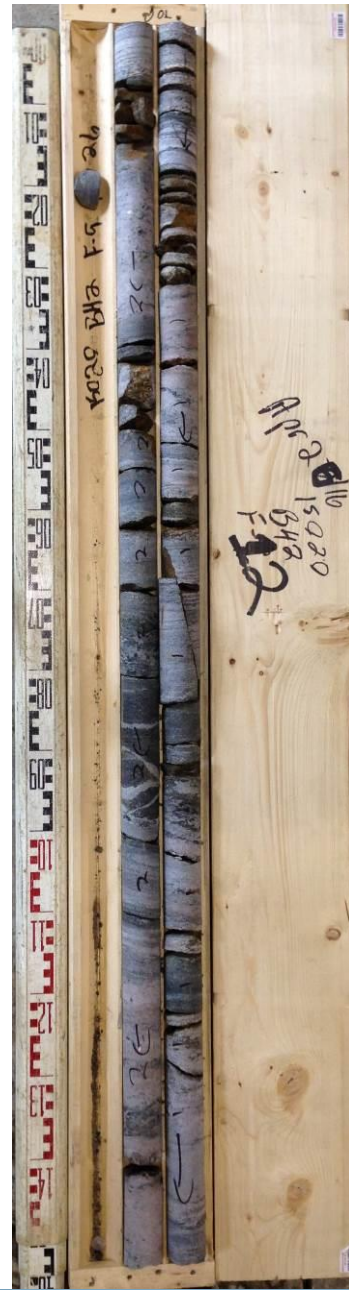
Photos: 4 and 5

Rock Cores – Borehole 1 (left) and Borehole 2 (right)

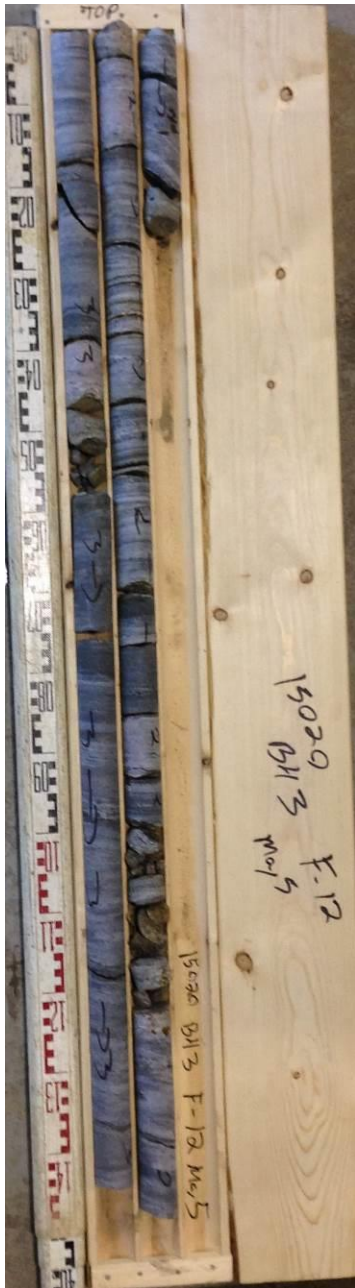
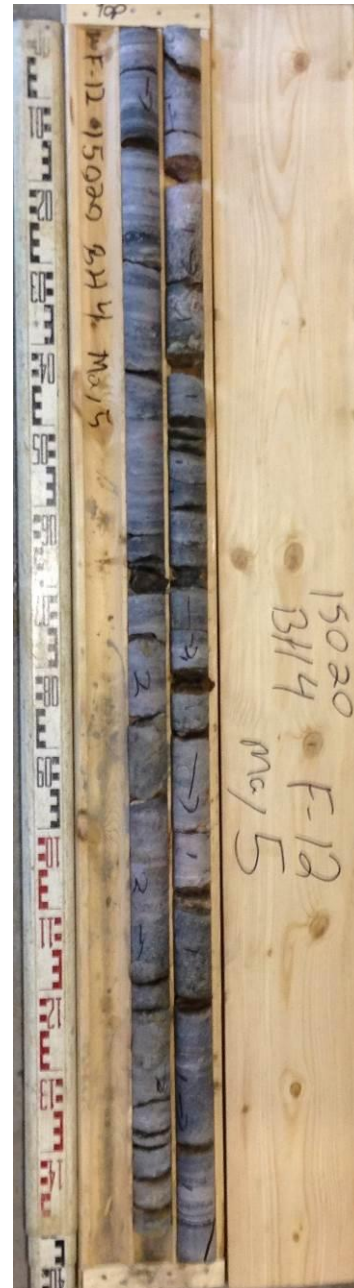
Photos: 6 and 7

Rock Cores – Borehole 3 (left) and 4 (right)
