# Memorandum Report

**Date:** April 18, 2012

**Subject:** Assessment and Recommendations for Remedial Measures for Side-Slope Erosion  
Hwy 427 SB  
North of Goreway Dr. and South of Club House Rd  
Toronto

W.O. 2012-11017  
GEOCREs No. 30M12-340

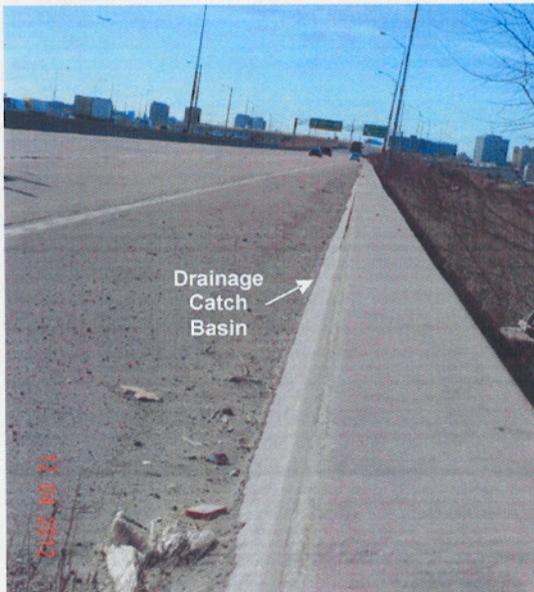
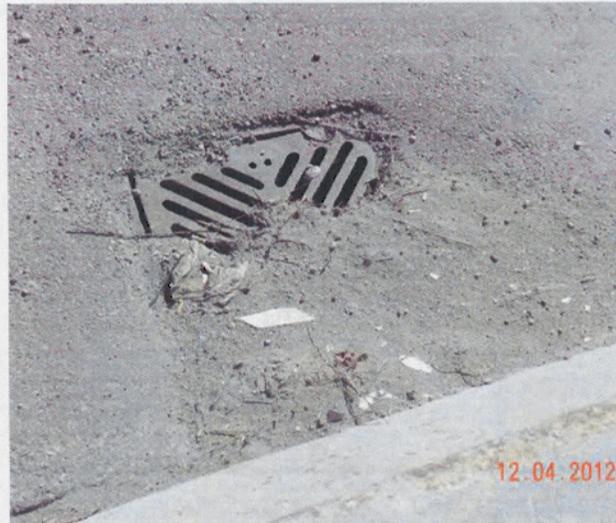
110m and at 138m south from the HWY 427 bridge abutment wall, respectively. There are no erosion features south of the Problem Area Number 3 – that is, 110m south from the abutment bridge beyond which the slope of the embankment changes to 2H:1V and is stable. The highway drainage runs along the concrete barrier at the west side road shoulder. The barrier/road interface is water tight and the water is drained through a catch basin located 110m south of the bridge abutment wall then through a 300mm diameter pipe onto the slope.

**Figure 2: Drainage of HWY 427 Southbound. Left, road shoulder with watertight barrier, top, drainage catch basin**

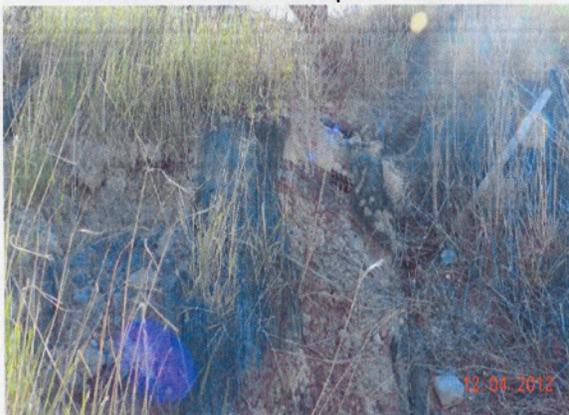
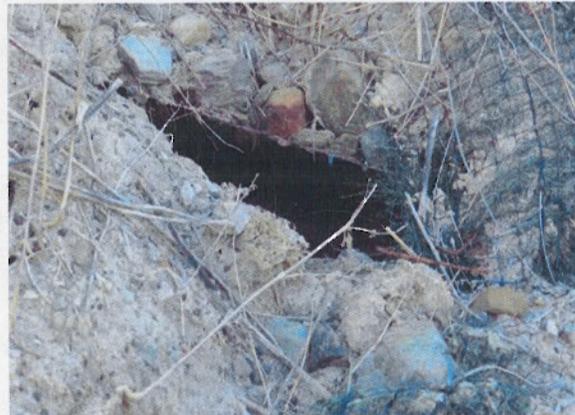
- Located at 38m south of the bridge abutment wall, and 5m from the road shoulder
- The affected area has a triangular shape with the base at the top being two meters (2m) wide and extending five meters (5m) down the side of the slope.
- It is 1m deep which is difficult to observe in Figure 4 due to the geotextile covering the side of the slope. However, Figure 3 shows the undermining and biaxial geogrid which is exposed at this site.
- There is no catch basin or drainage from the road although there is runoff over the crest of the slope.

**Figure 3: Close up of Slope Erosion Problem Area Number 1. Left, surface erosion; top, undermining and biaxial geogrid**

The fix could involve one of the following options for problem site 1 and 2.

As noted before, the steep slope is the major problem and a major cause of the erosion at these sites. It would be ideal to reconstruct the embankment with a slope of 2H:1V. However, a fence is visible at the end of the slope which indicates that MTO's right of way only extends up to the fence. Therefore, the slope of the affected area can probably not be constructed at a more stable 2H:1V geometry.

Drainage from the crest of the slope of the top of the embankment could be controlled to minimized future erosion of the slope. In order to prevent the water from running freely down the slope a curb would have to be built that will channel the water collected at the top of the slope and then release the water in an armoured outlet – probably at the existing Hwy 427 drain outlet at Problem Area Number 3.

The embankment shows patches of grass growing on the side of the slope. However, growing long rooted plants would be beneficial to hold the soil in place. As it would be expensive to re-establish the existing geogrid slope to original condition, less expensive measures could be considered including judicious application or top soil and seeding crown vetch or legume (both of which tend to have long roots) along the crest of the slope so that the vegetation would eventually spread on the side of the slope.

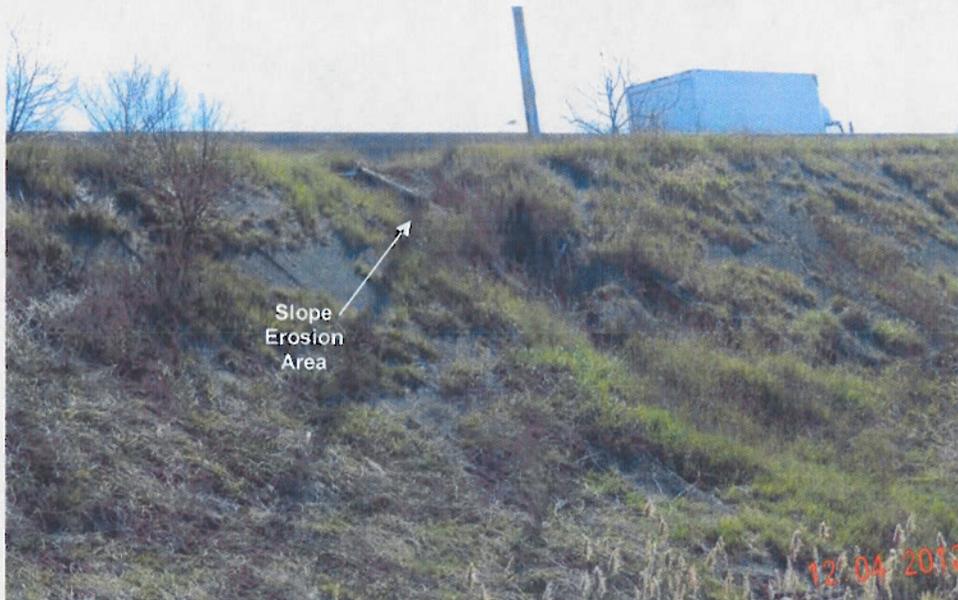
**Figure 4: Photo of Slope Erosion Problem Area Number 1**

Based on the site inspection, there are 2 categories of instabilities at this site. Problem Areas Number 1 and 2 are caused by uncontrolled drainage from the crest of the embankment (but not from highway drainage) onto the steep slope. Problem Area Number 3 is caused by undercutting of the embankment by uncontrolled outfall from the drainage pipe.

For Problem Areas Number 1 and 2, the washout water is only the collected water from infiltration on the slope and is not coming from the highway. Therefore the erosion is not as severe as at Problem Areas Number 3.

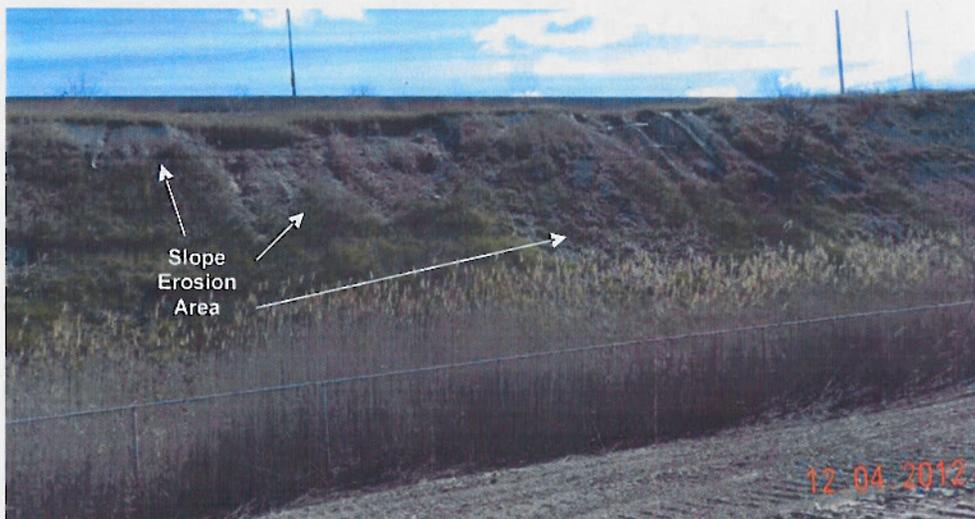
- Located from 77m to 110m south of the bridge abutment wall, and 5m from the road shoulder.
- The affected area has a rectangular shape with dimensions 3.5m down the side of the slope and 33m along the slope and with a depth of up to 1m.
- Geotextile is covering the side of the slope on the northern part (from 77m to 86m). However, from 86m to 110m south of the bridge abutment, the geotextile and the soil is being eroded away. Biaxial geogrid that has been installed at 1m lifts into the soil is visible at this part of the site and is evidence of similar reinforcement throughout the 1H:1V slope.
- No catch basin or drainage from the road is visible.

**Figure 5: Photo of Slope Erosion Problem Area Number 2**

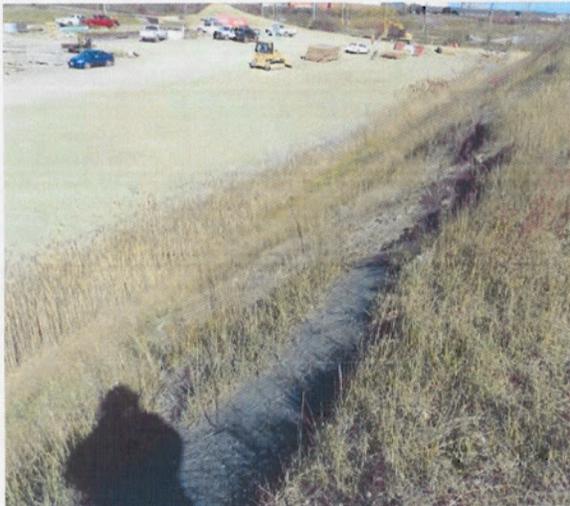
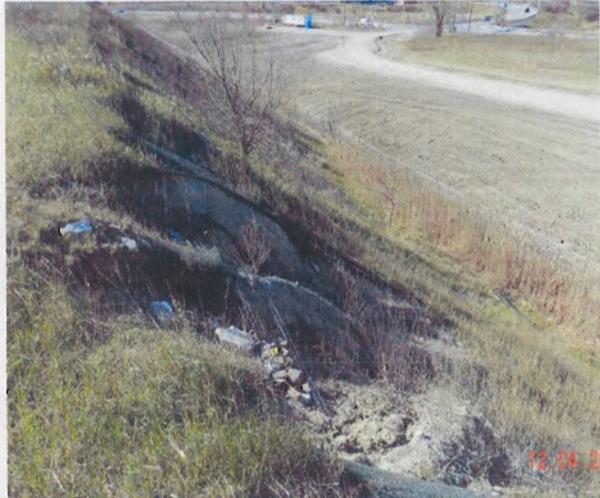
**Figure 6: Close up of Slope Erosion Problem Area Number 2. Left, northern portion, 77m-86m south of the bridge; right, southern portion, 86m-110m south of bridge.**

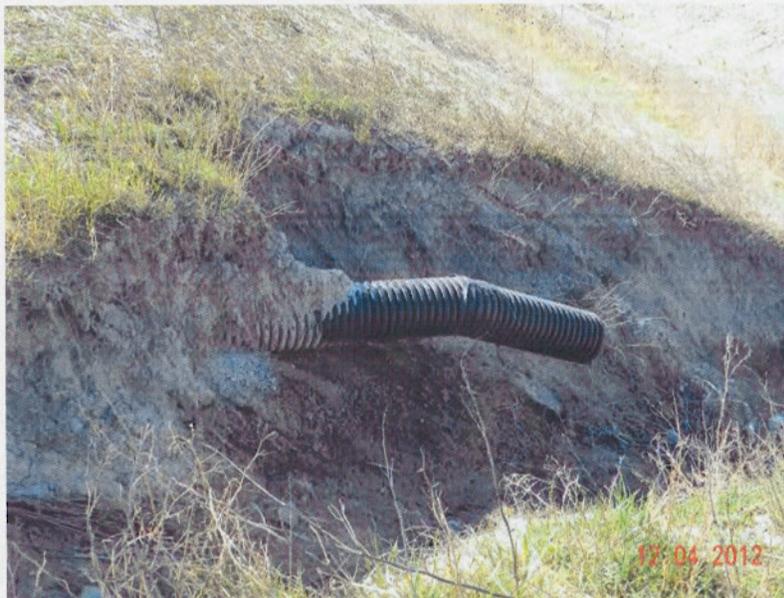
- Located at 138m south of the bridge abutment wall, and 8m from the road shoulder. The drainage catch basin is located at this point on the shoulder of the highway.
- The embankment, at this location is severely eroded. The distressed area is about 5m wide and up to about 3m deep. It also extends near the base of the slope.
- A 300mm diameter PVC pipe is visible. This pipe carries the drainage from the road to the embankment. The material around the pipe has been eroded away.
- The geotextile is has been washed away and the soil is also being eroded away. Reinforced biaxial geogrid is visible at 1m intervals but only around the affected area.

**Figure 7: Material washed away around PVC pipe at the Problem Area Number 3**

At Problem Areas Number 3, there is a much higher quantity of drainage water that flows through over the area, being all the drainage from the highway which drains into the catch basin at the shoulder of the highway and then to the embankment through the

drain pipe that outlets onto the slope. At this site, the material from around the culvert has been eroded exposing an unsupported 2m length of the drain pipe at its outlet. If left alone, more material will be eroded away, which could ultimately increase the risk to the safety of the highway.

- See Figure 9 for illustration.
- Remove slope instability debris at the bottom of the slope. The area should be trimmed to straiten out the edges for aesthetic reasons.

- Fill the entire affected area with Rip-Rap R-10 grading aggregates. The minimum thickness of the Rip-Rap R-10 grading aggregate fill shall be 300mm. All Rip-Rap R-10 grading aggregates shall be placed using rock protection construction method from the bottom up (i.e. machine place and random manner and without geotextile separator). Refer to the following Ontario Provincial Standard Specifications for construction method and material selection:
  - OPSS 511: Construction Specification for Rip Rap, Rock Protection and Gravel Sheeting
  - OPSS 1004: Material Specification for Aggregates - Miscellaneous
- The drainage pipe should be reinstalled as required connecting the catch basin with the sump. It will be discharging to armoured drainage channel specified above or onto the rock fill on the slope.

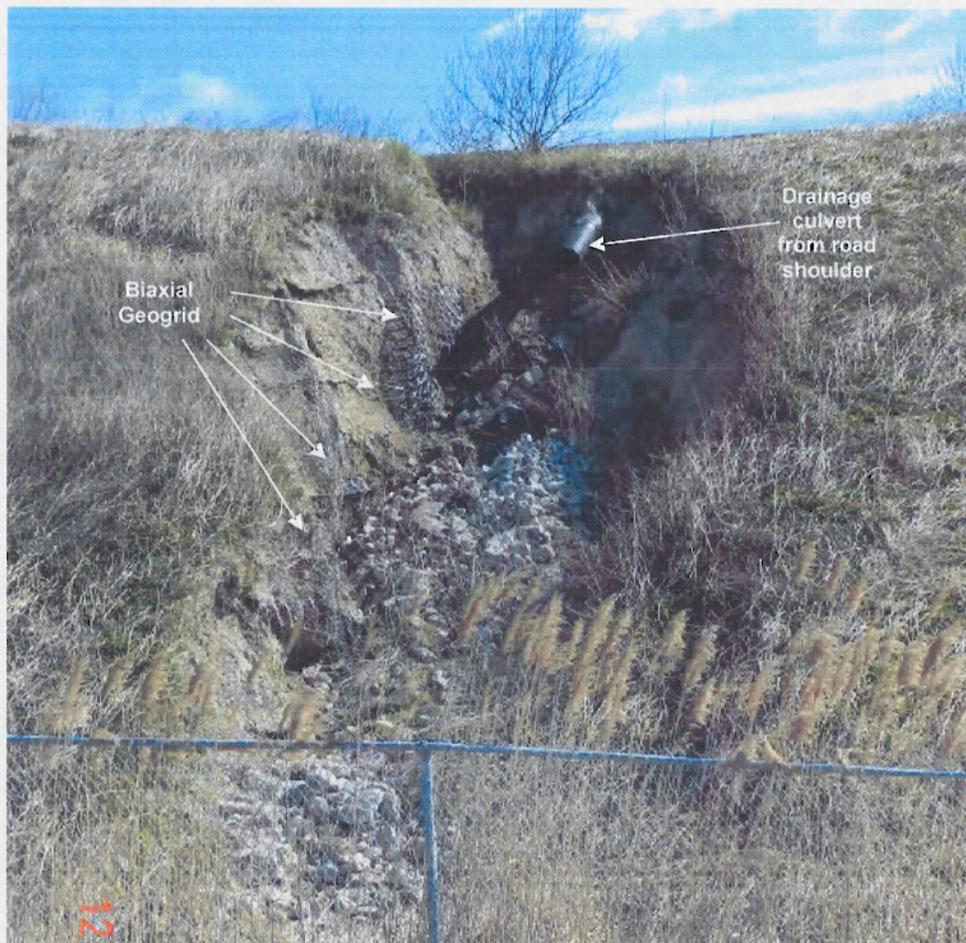
**Figure 8: Photo of Slope Erosion Problem Area Number 3**
