DRAFT
GROUT-IN-PLACE CULVERT LINING INVESTIGATION REPORT

4018-E-0001 ASSIGNMENT #5

Ministry of Transportation Ontario
c/o WSP Canada Group Limited

October 2020
Thurber File No.: 28182

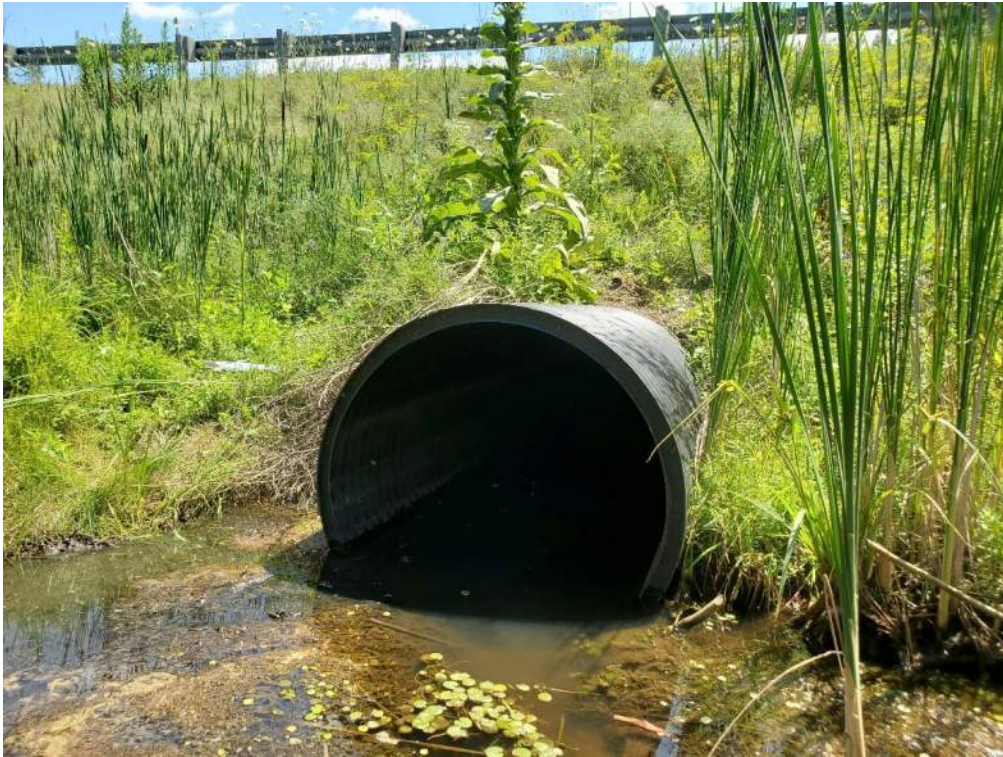
Culvert ID # 1 of 23 (4 of 99)

Photo 1: No flow at north end of culvert – looking south

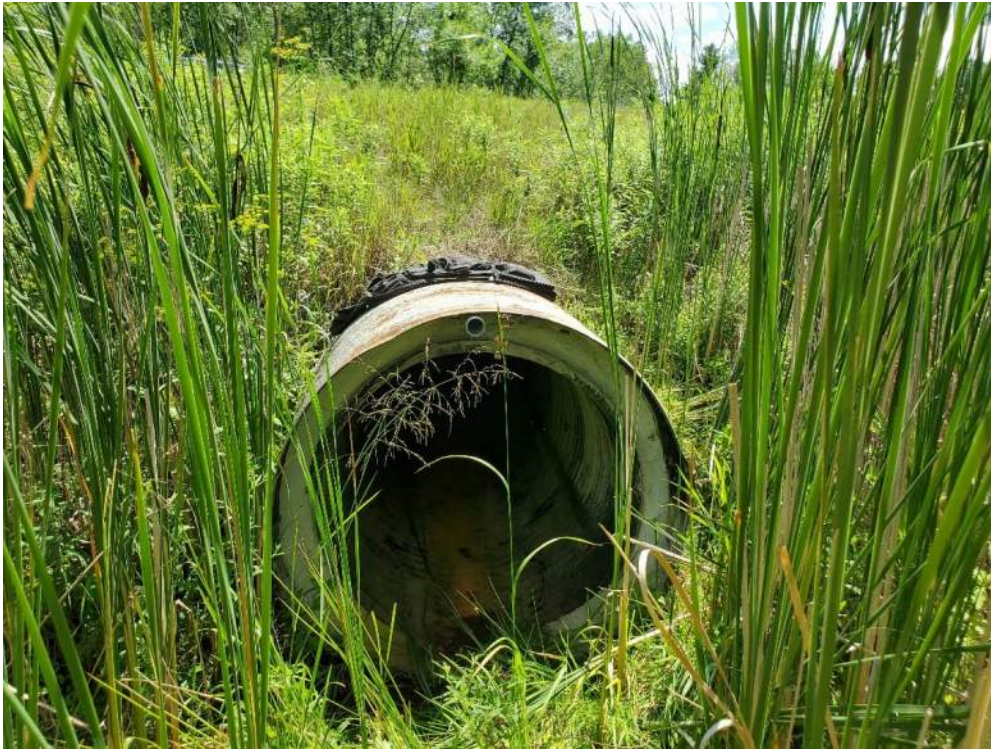
Culvert ID # 2 of 23 (6 of 99)

Photo 1: Dry conditions at north end inlet with bulrushes– looking southwest

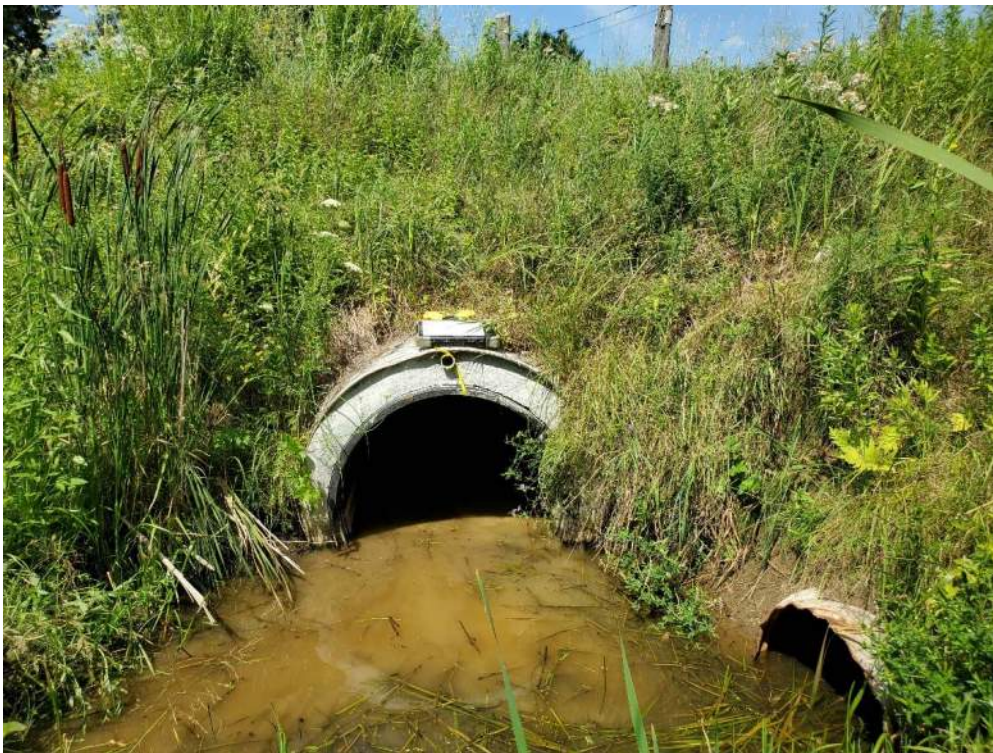
Photo 2: Standing water at south end outlet – looking northeast

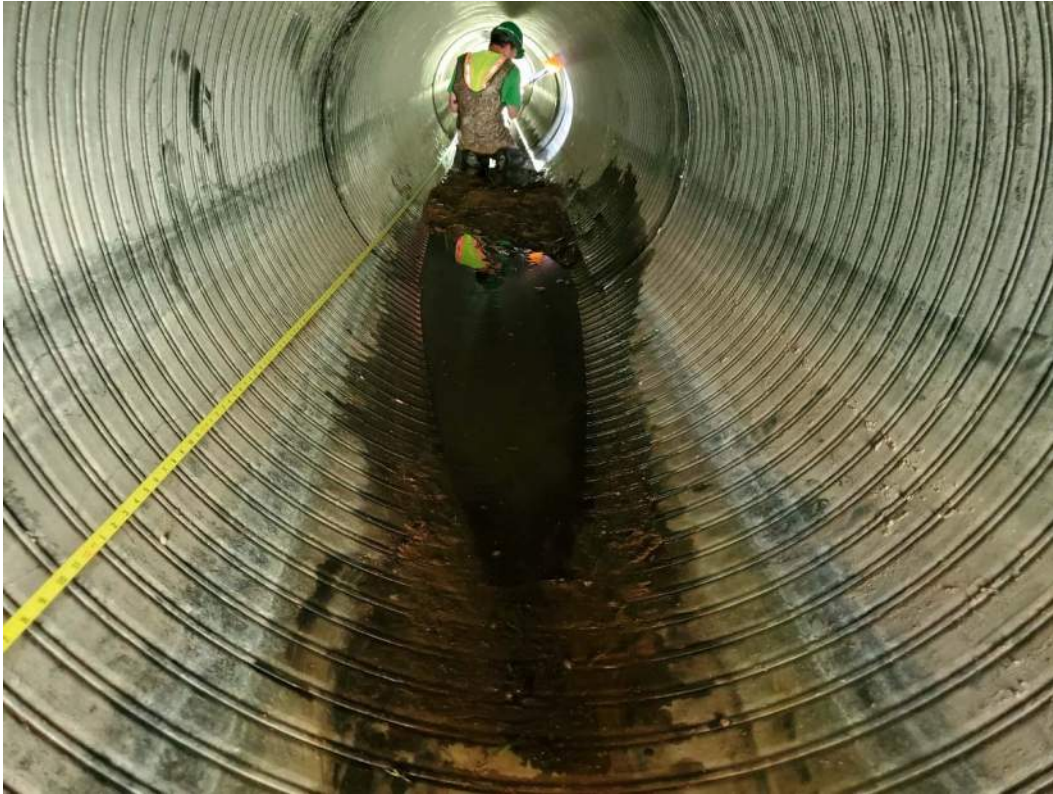
Culvert ID # 2 of 23 (6 of 99)

Photo 3: Basal sediment/muck observed from approx. 3.4m from inlet to outlet – looking south towards outlet

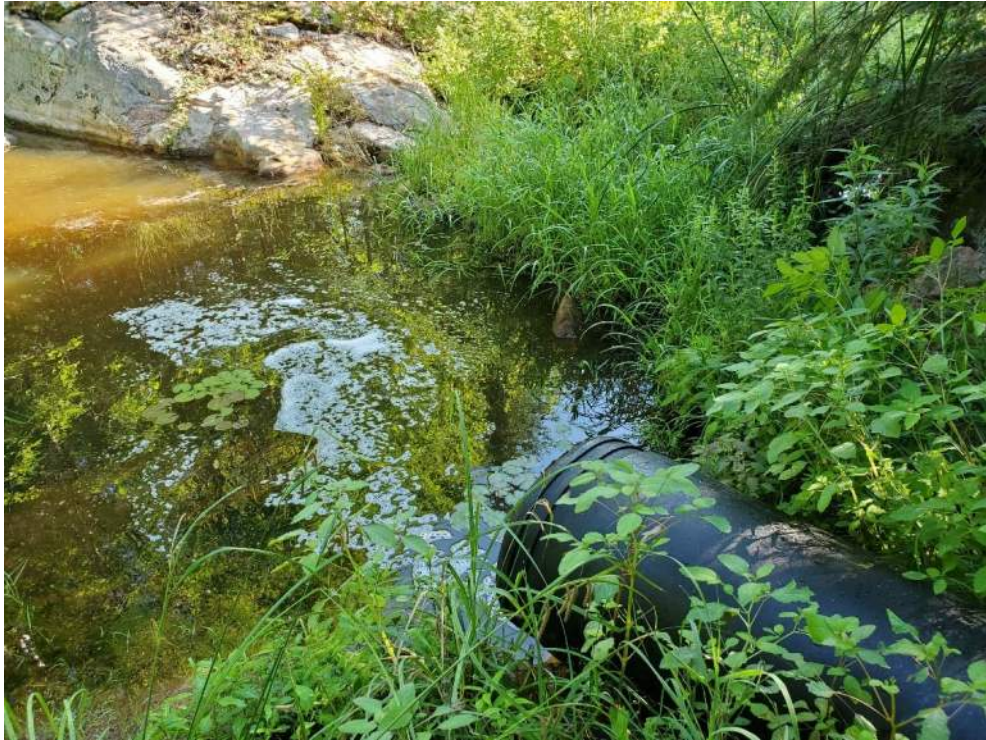
Culvert ID # 4 of 23 (21 of 99)

- At Culvert 4, the liner pipe was only visible at the outlet end and was measured to be approximately 530 mm, significantly less than the specified diameter of 1020 mm. The liner diameter was too small to allow for void screening. It was also noted that the host CSP at the inlet was broken and plugged with soil including cobbles and boulders. Grout pipes were noted at the inlet extending through a spray foam bulkhead.

Photo 1: Outlet liner (Host pipe buried in embankment)– looking northeast

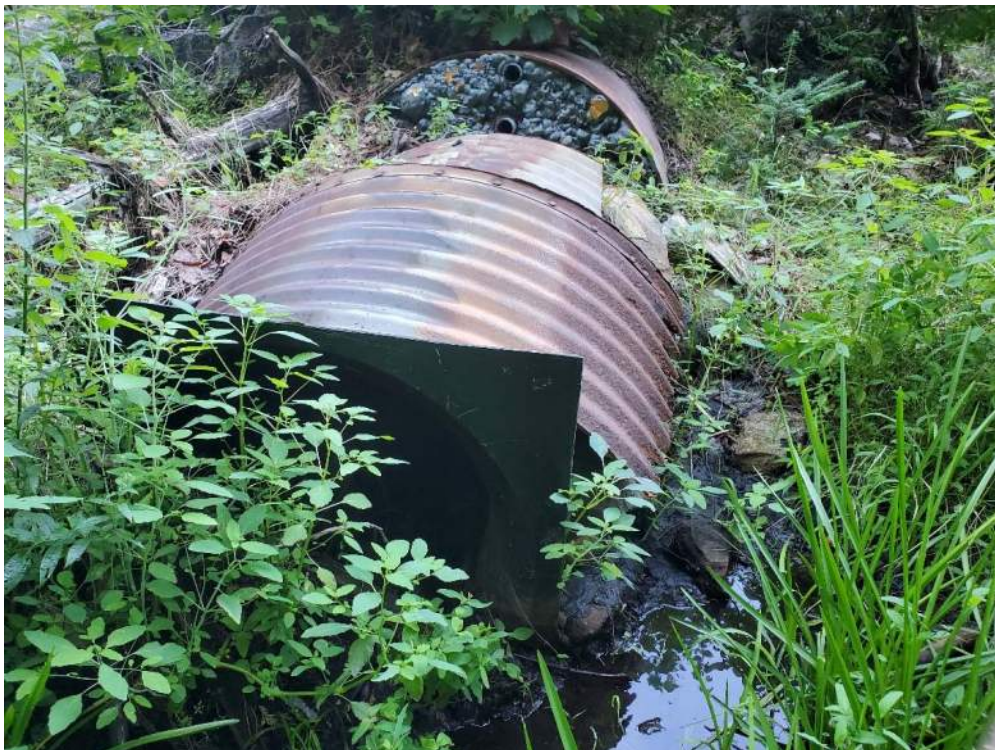
Photo 2: Liner observed in severely damaged inlet (no flow)– looking northwest

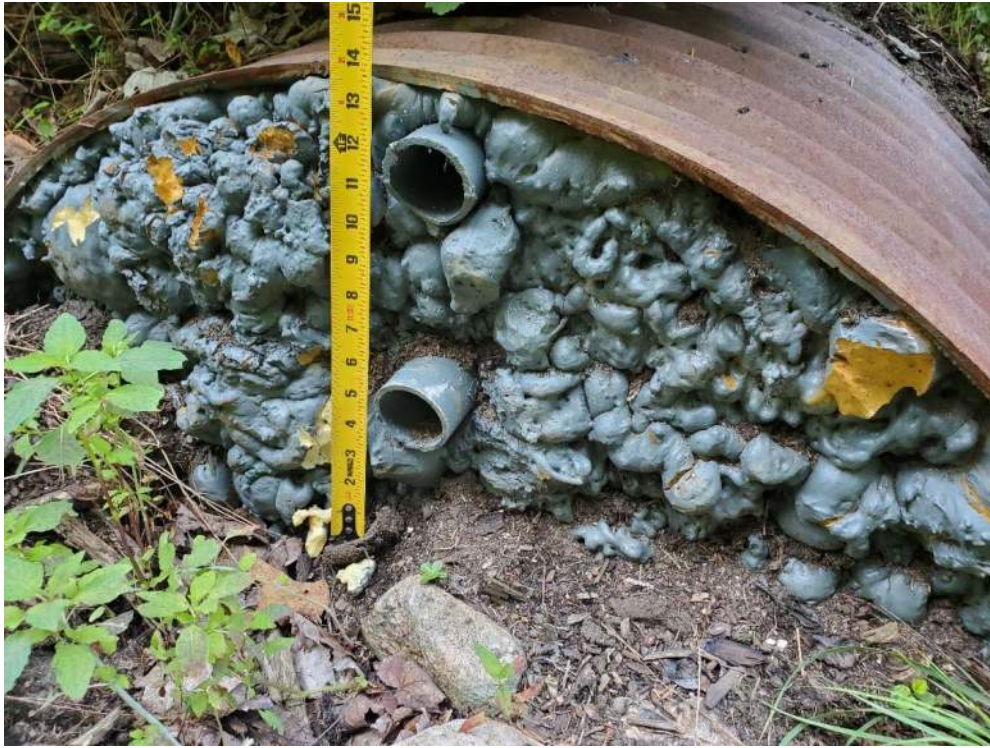
Culvert ID # 4 of 23 (21 of 99)

Photo 3: Damaged host pipe filled with spray foam insulation at inlet

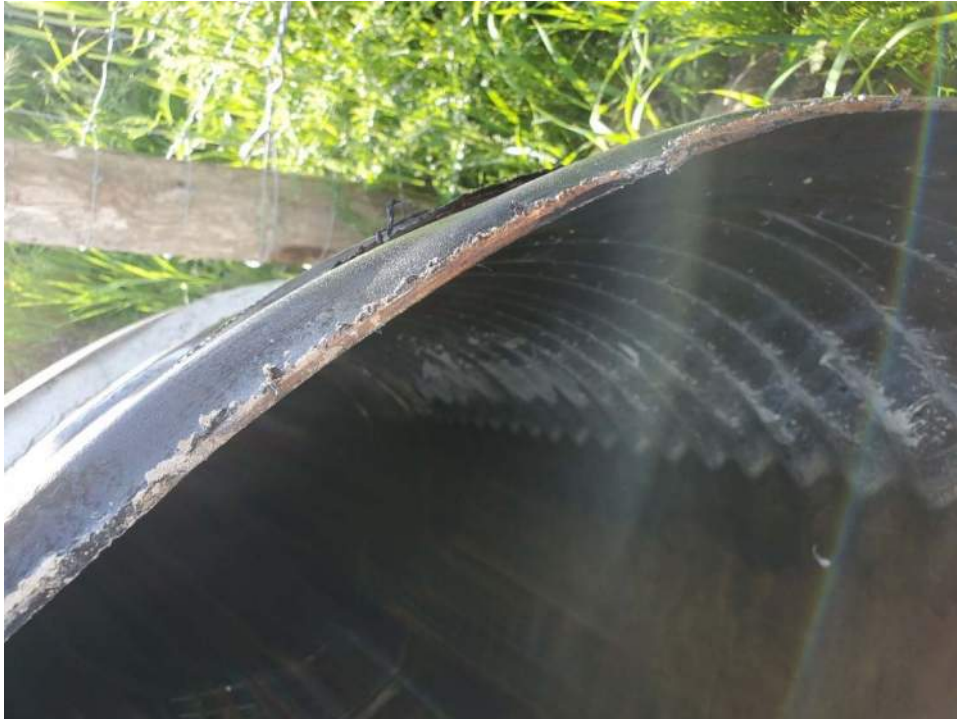
Culvert ID # 9 of 23 (47 of 99) [Culvert 1 in 2019]

Photo 3 – Rust on steel/metal liner pipe at outlet

The other nine (9) culverts (#2, 5, 6, 7, 8, 9, 16, 18 and 19) exhibited significant voids, often throughout much of the length of the pipe. It is recommended that supplemental grouting be completed to fill the void(s) at these culvert sites.

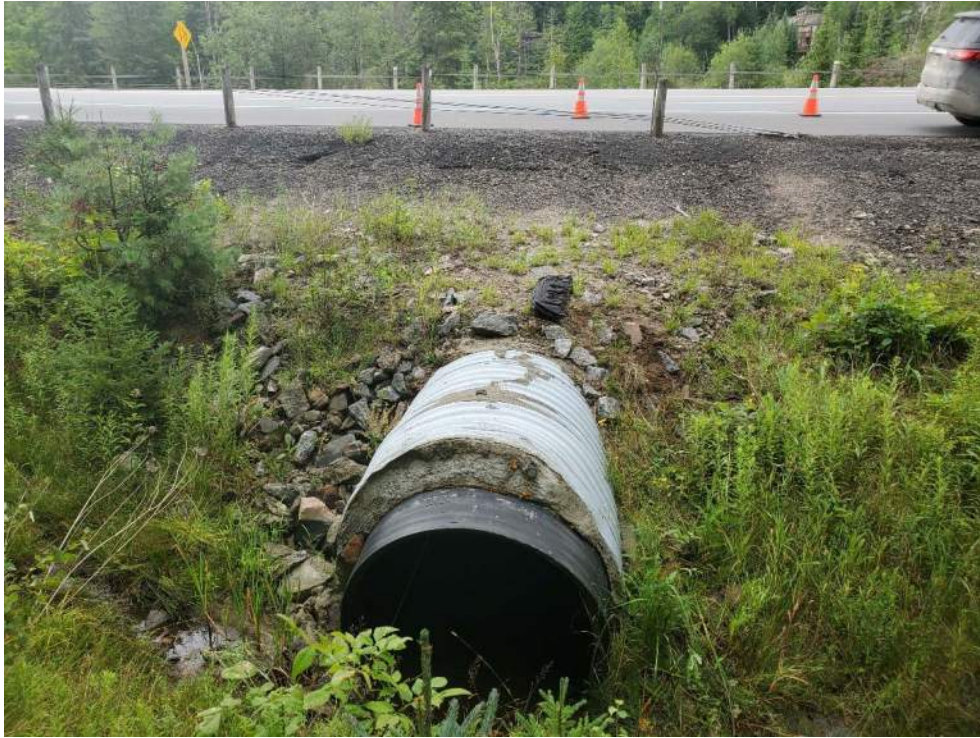
Culvert ID # 12 of 23 (58 of 99)

One localized small void was detected near the inlet of Culvert 12. Based on the endoscopy images, the liner was in contact with the host pipe near this location. This anomaly is located outside of the highway platform and the remainder of the annular void appeared to be well grouted. No remedial actions are required at this site. Some erosion of the embankment sideslopes was noted and should be monitored and maintained by the local Area Maintenance Contractor.

Photo 1: Inlet liner with irregular grouting between host pipe – looking east

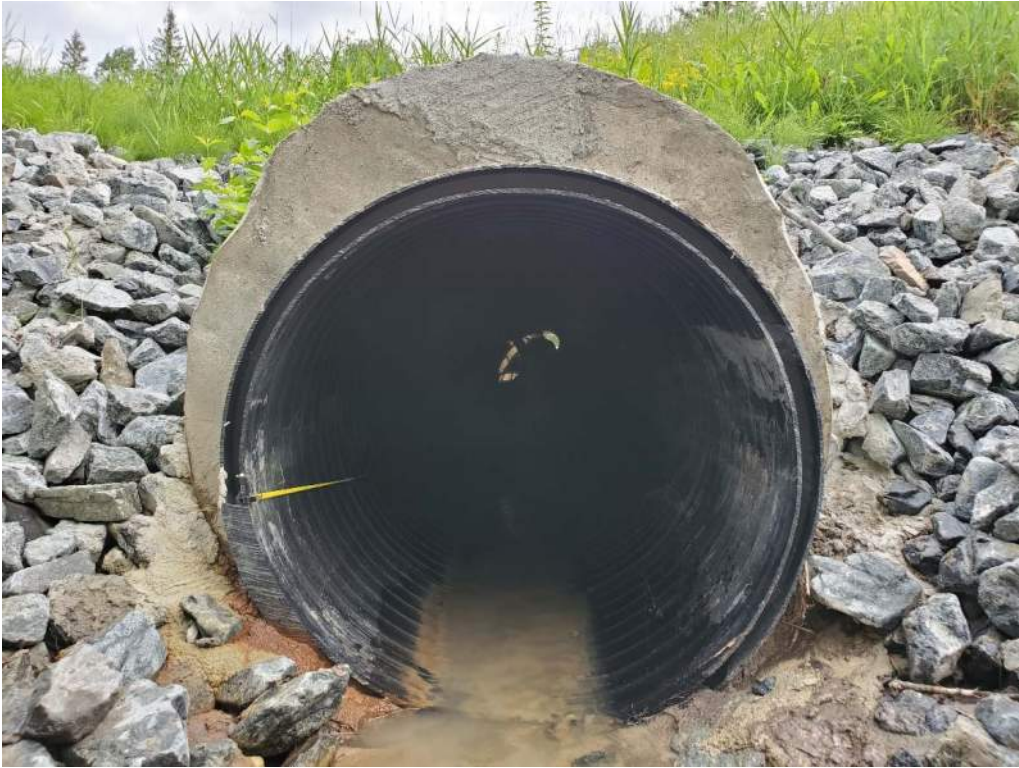
Culvert ID # 15 of 23 (69 of 99)

Grouting at Culvert #15 was generally assessed to be good with the exception of one large void (approx. 5 m in length) along the north face of the pipe. It is recommended that supplemental grouting be completed to fill the void. Some erosion of the embankment sideslopes was noted and should be monitored and maintained by the local Area Maintenance Contractor.

Photo 1: East end of culvert (outlet) surrounded by rip rap embankment exhibiting low flow and no visual grout pipes. – looking west

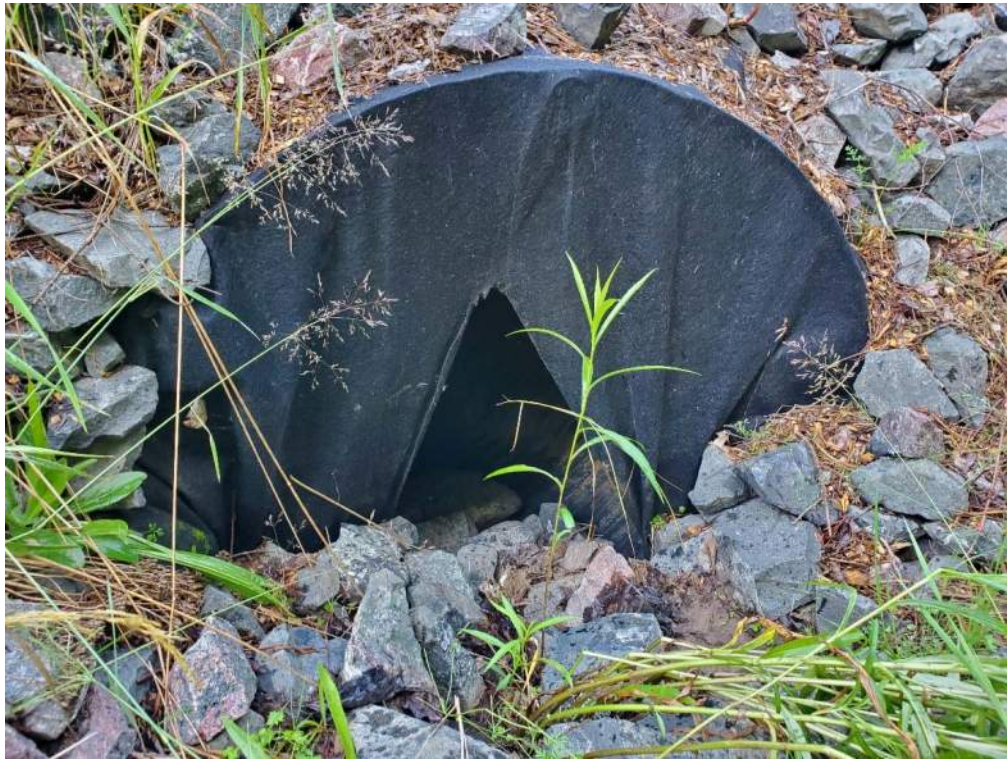
Culvert ID # 16 of 23 (71 or 99)

Photo 1: East end of culvert (inlet) covered with silt fence and surrounded by rip rap embankment. Grout is not visible. – looking west

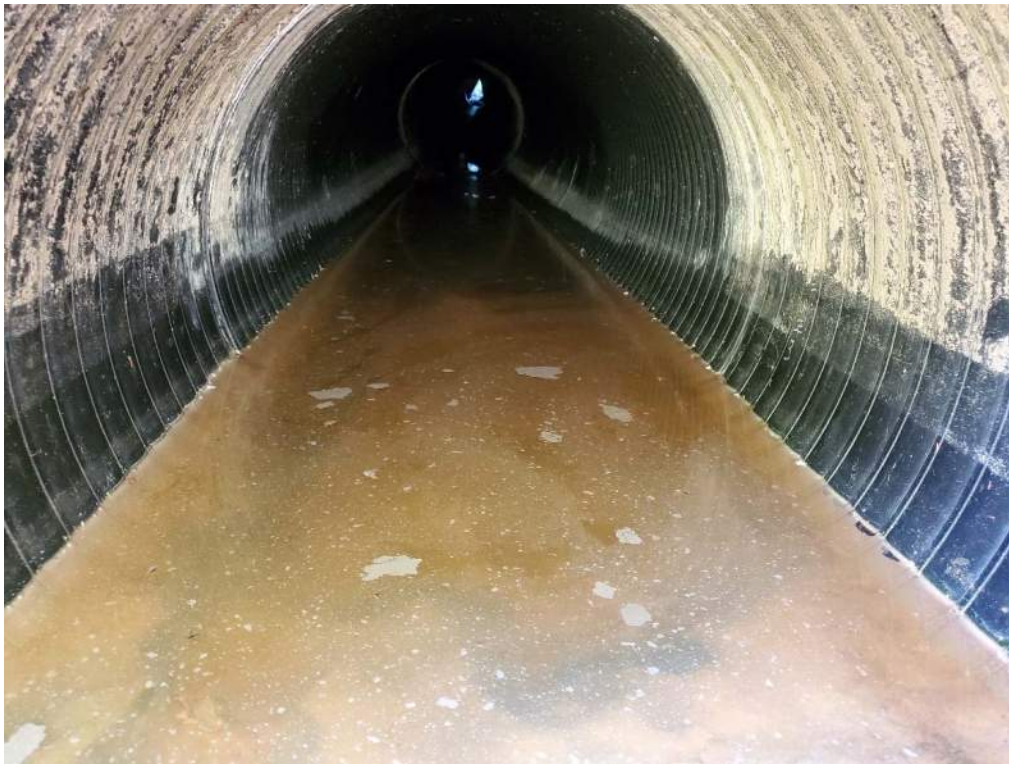
Culvert ID # 16 of 23 (71 or 99)

Photo 3: Standing water and basal sediments observed at outlet - looking east

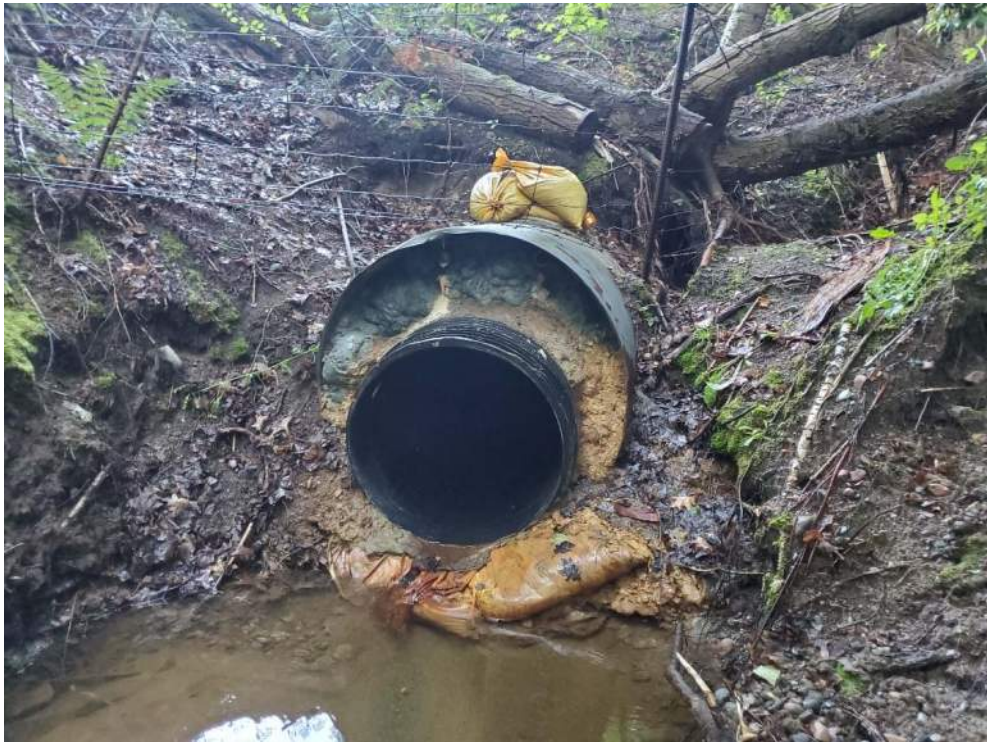
Culvert ID # 17 of 23 (72 of 99)

- The construction documents for Culvert 17 indicate that the host pipe was in very poor condition with many broken joints and ovalized sections in four different locations. The host pipe would not accommodate the specified liner pipe (1220 mm dia.). The contractor requested to reduce the liner outer diameter to 861 mm. During the Phase 2 site inspection, it was confirmed that the liner that was installed has an internal diameter of approximately 762mm. The reduced size meant that the liner was too small to allow for the planned void screening.

Photo 1: East end of culvert (outlet) in poor condition. Spray foam and sandy material utilized to fill voids – looking west

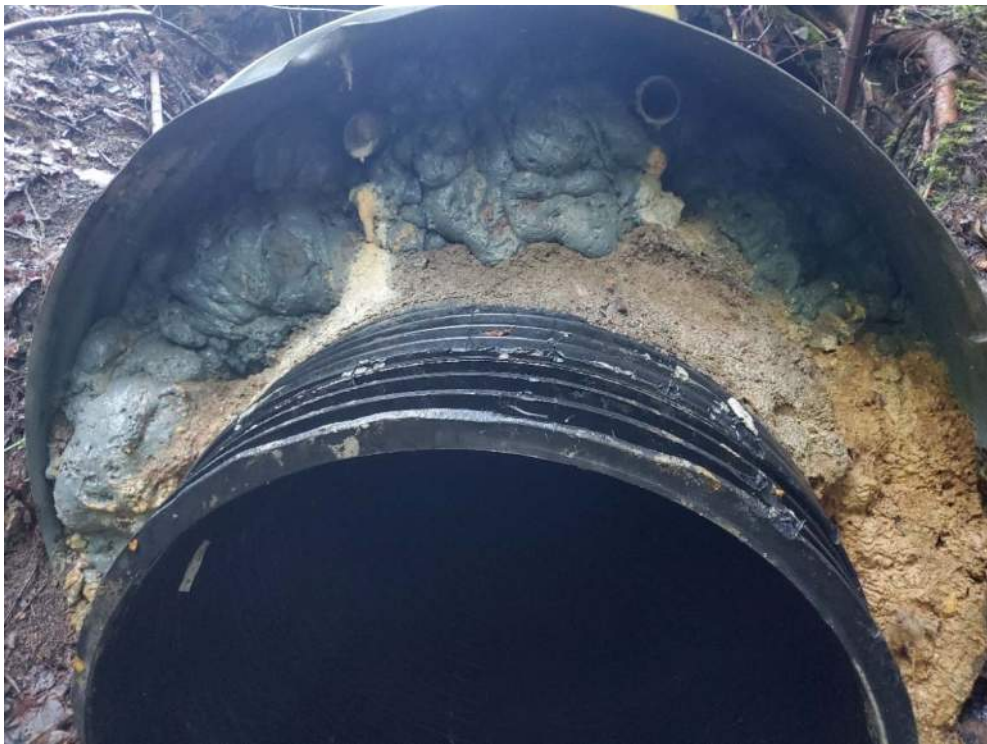
Photo 2: Cut off grout pipes noted, but no grout is visible at culvert outlet. Bulkhead appears to consist solely of spray foam and sandy material – looking west

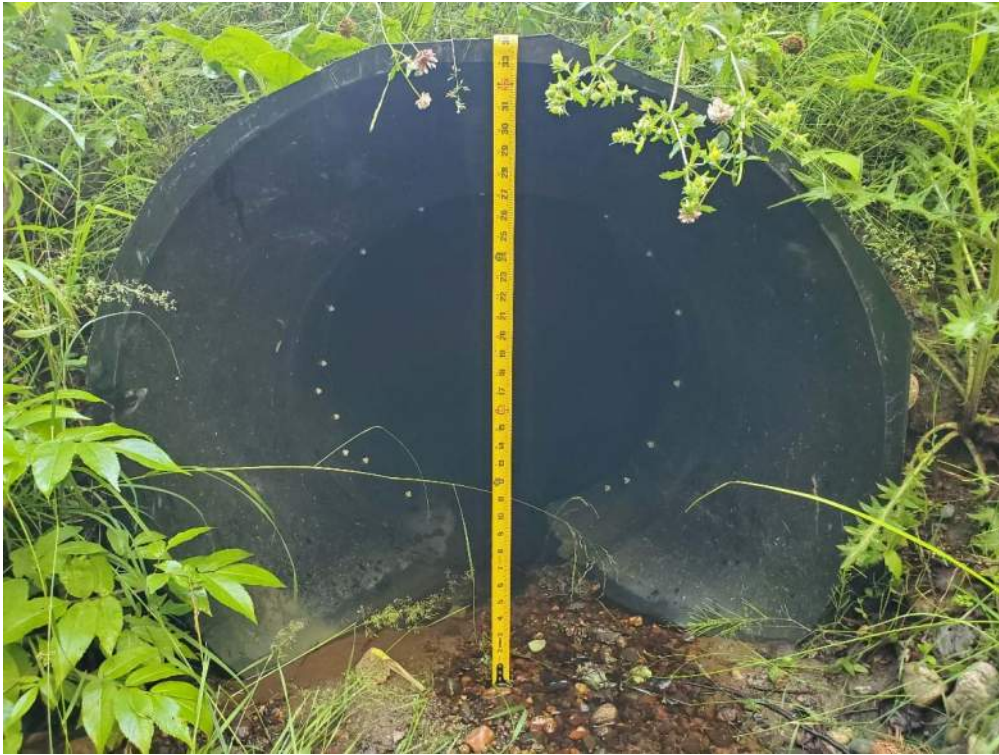
Culvert ID # 17 of 23 (72 of 99)

Photo 3: West end of culvert (inlet) trumpet entrance telescoping to smaller diameter liner. Host pipe not visible - looking south

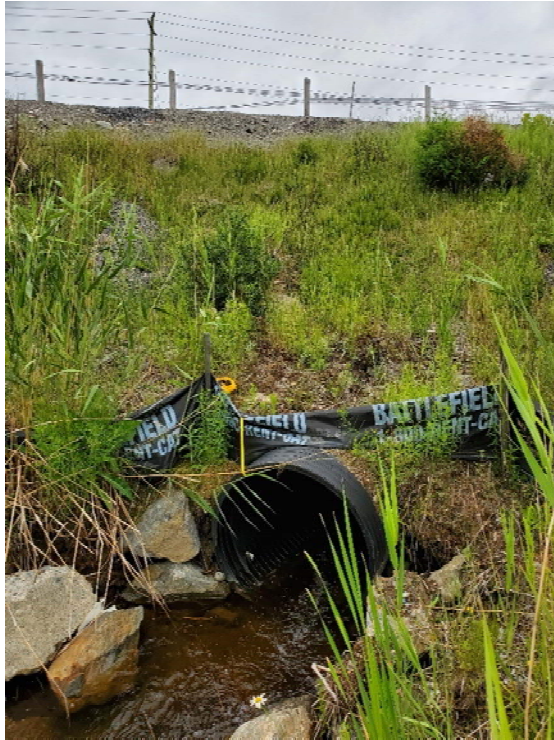
Culvert ID # 18 of 23 (75 of 99)

Photo 1: Grout and host pipe not visible at north end of culvert (outlet) – looking south

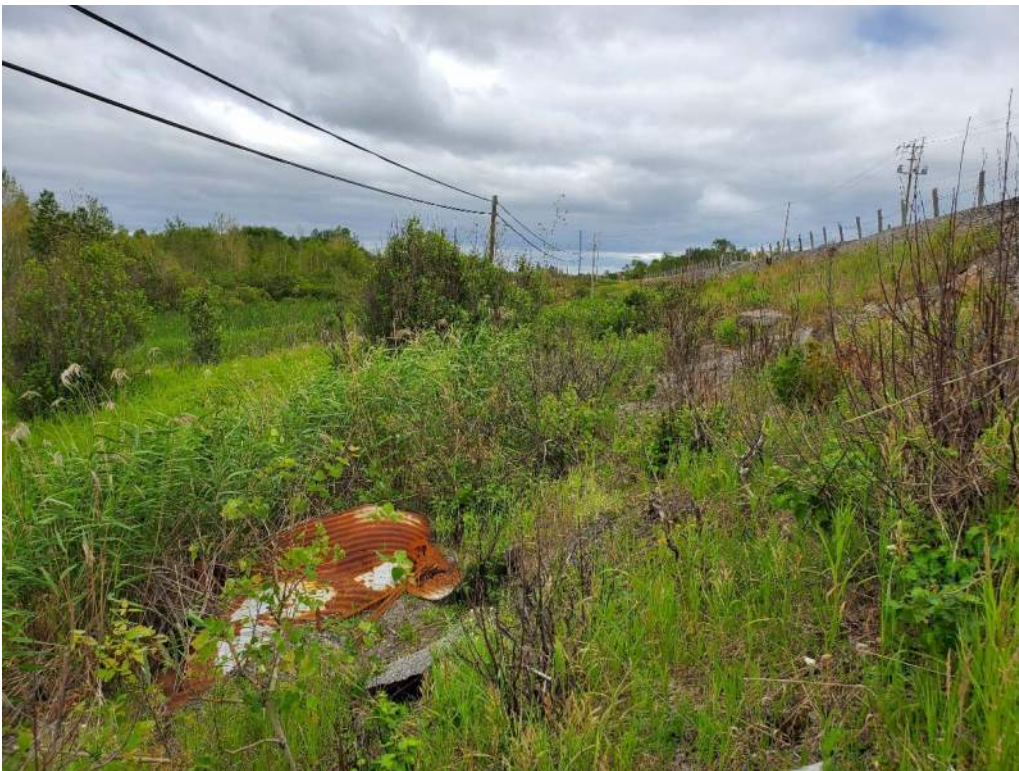
Photo 2: Rusty host pipe debris observed on northern embankment – looking east

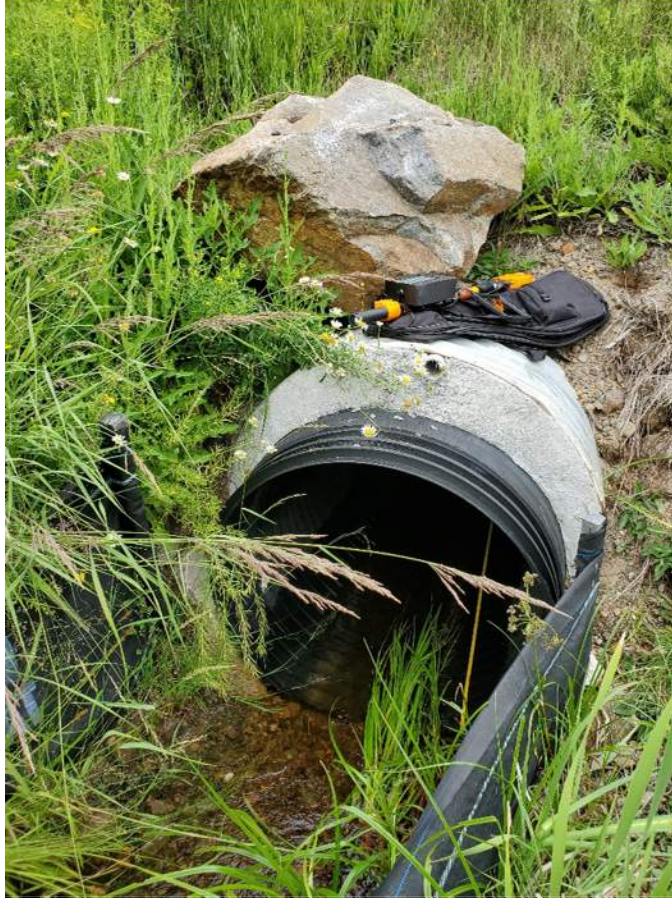
Culvert ID # 18 of 23 (75 of 99)

Photo 3: South end of culvert (inlet) exhibits good grout condition. Cut off grout pipe observed in grout fill. - looking north

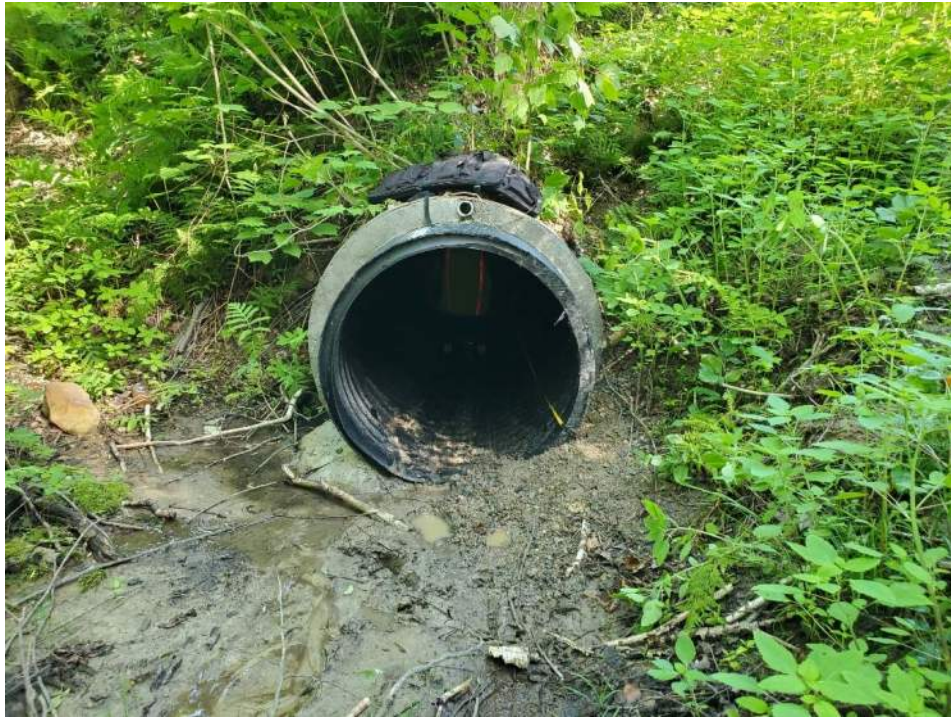
Culvert ID # 19 of 23 (76 of 99)

Photo 1: South end of culvert (inlet) exhibiting good grout condition and cut off grout pipe – looking north

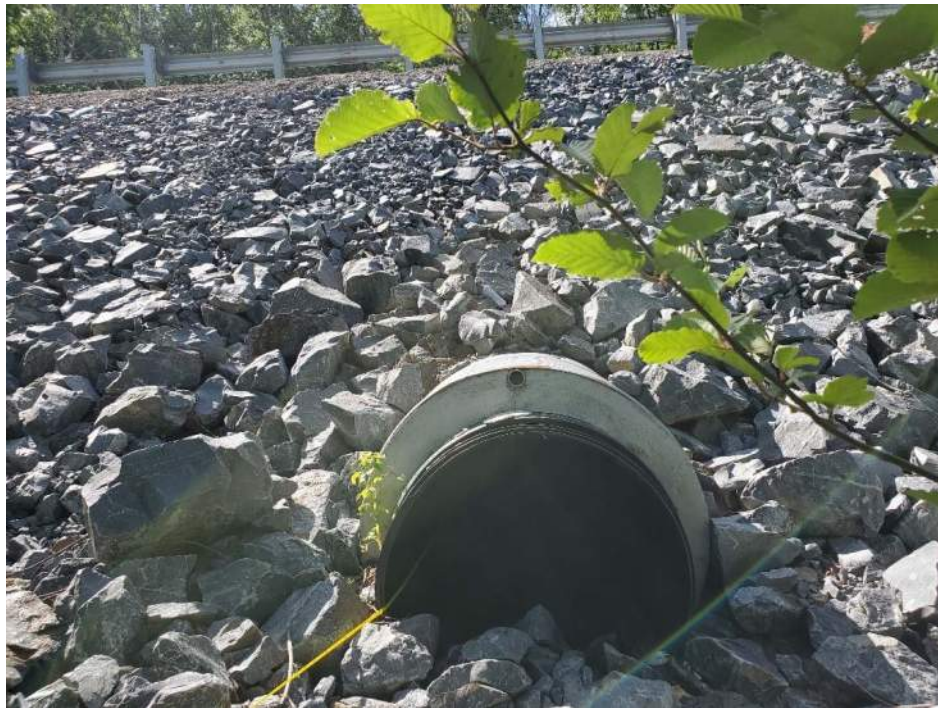
Photo 2: North end of culvert (outlet) surrounded by rock fill embankment. Cut off grout pipe noted– looking south

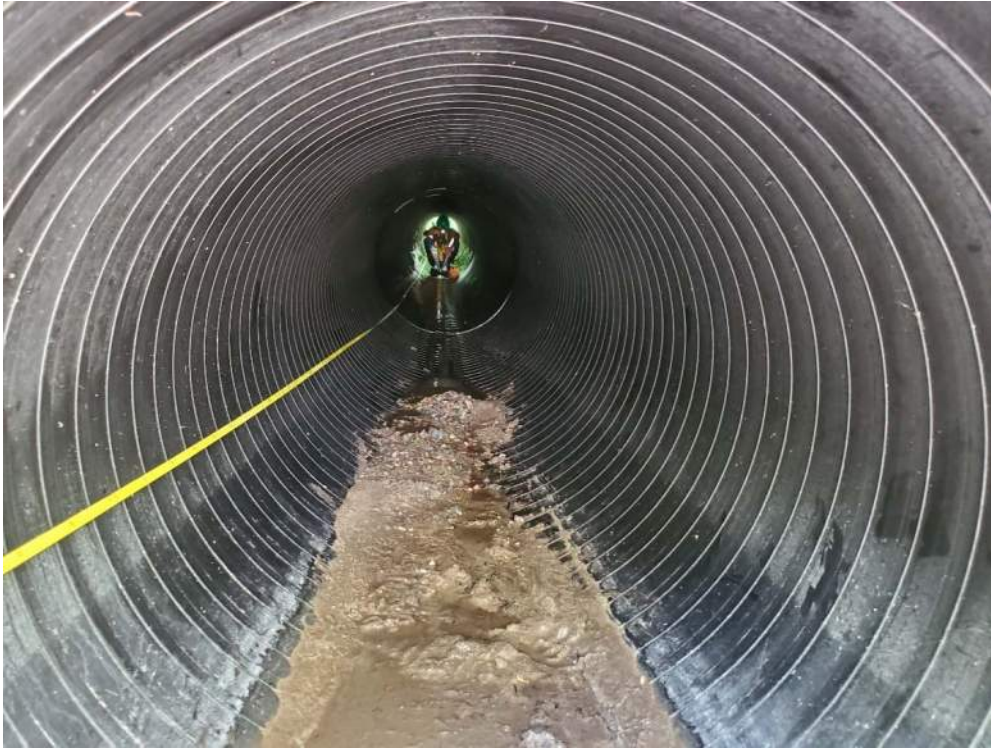
Culvert ID # 19 of 23 (76 of 99)

Photo 3: Minimal basal sediments observed near culvert outlet– looking south

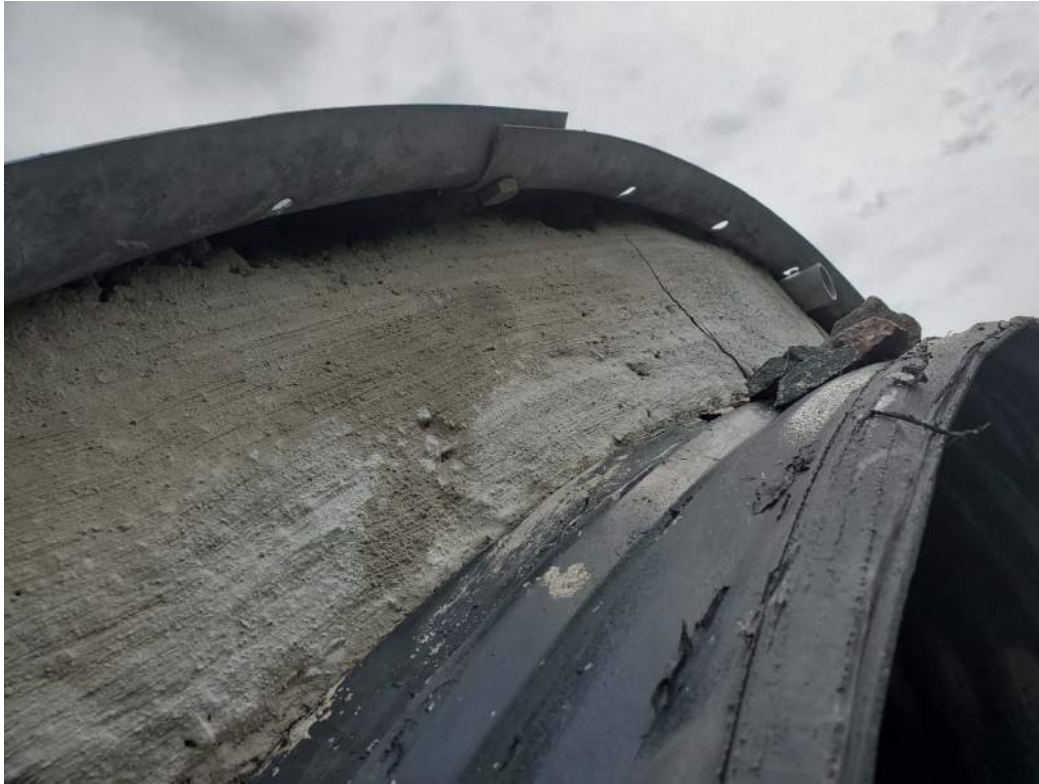
Culvert ID # 20 and 21 of 23 (77 and 78 of 99)

The overall extent of voids at Culverts #20 and 21 (twin CSP's) was less than 10%, with the majority of the annular space appearing to be well grouted, however, the voids are concentrated above the crown of the liners beneath the highway platform. It is recommended that supplemental grouting be completed to fill the voids.

Photo 3: Minimal hairline fractures observed in grout at inlet and outlet in both culverts

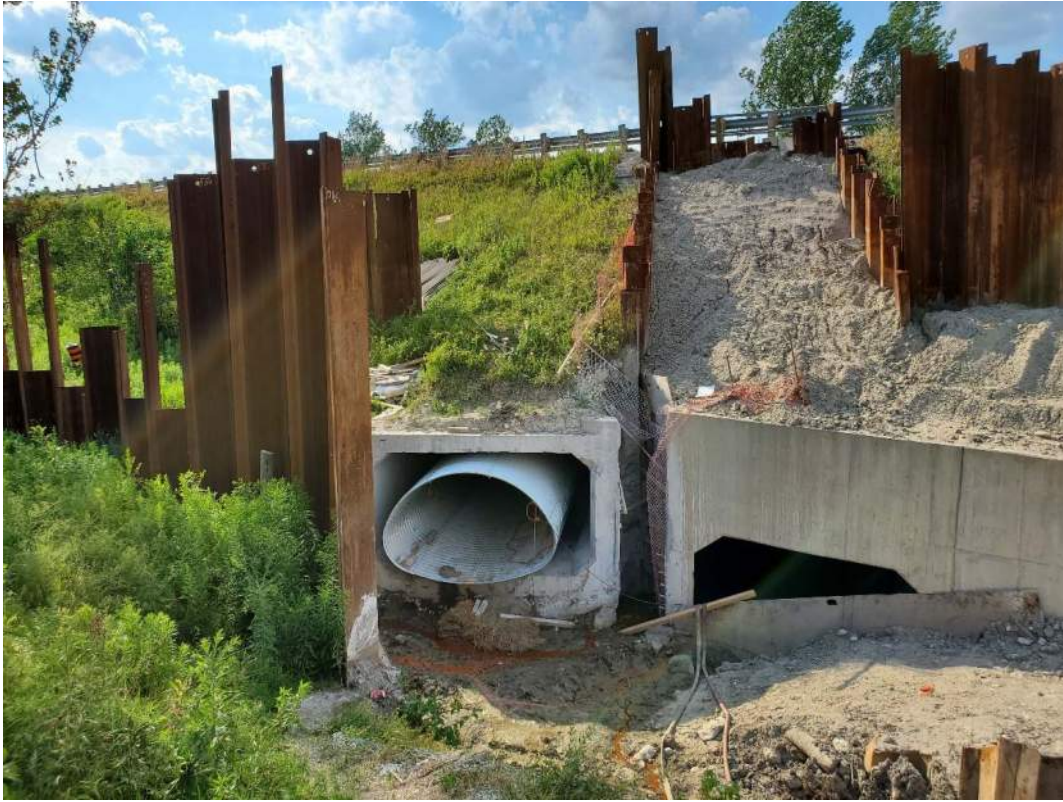
Photo 1: Liner installed but not yet grouted - active construction site – looking northwest at southern embankment

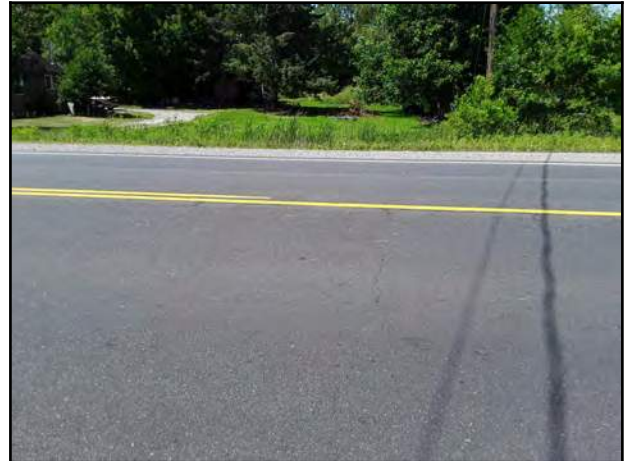
Photo 2 - Light transverse cracks.

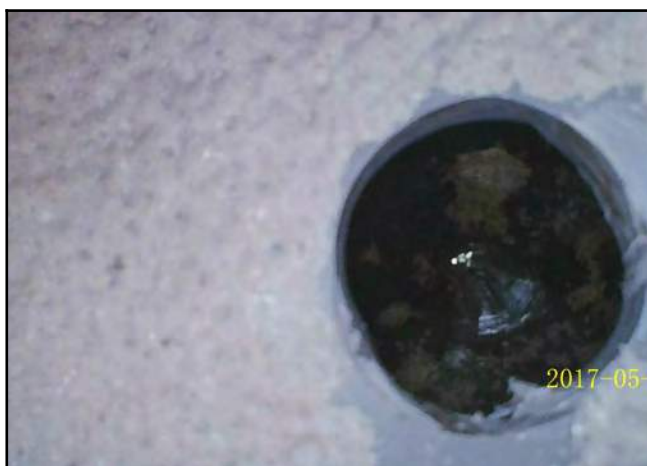
Photo 29 - V-7: Endoscope camera placed in the probe hole showing some void since host pipe is resting on Sliplined HDPE.

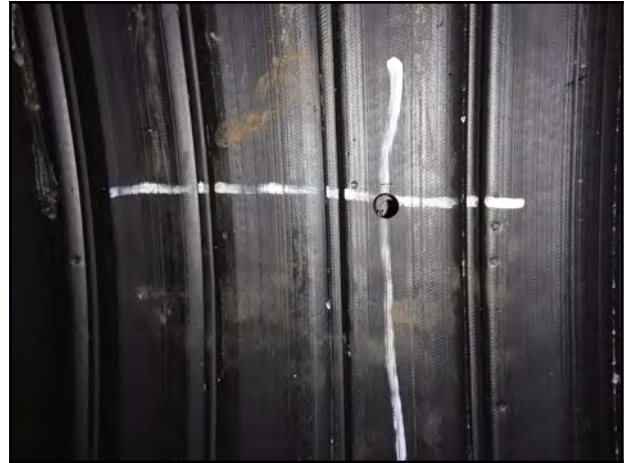
Photo 26 - V-6: Endoscope camera showing visible void.

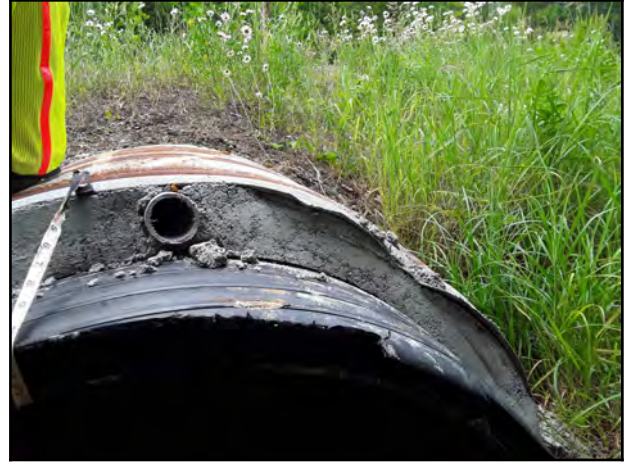
Photo 26 - Annular space of 120 mm between the existing CMP and the sliplined HDPE at inlet.

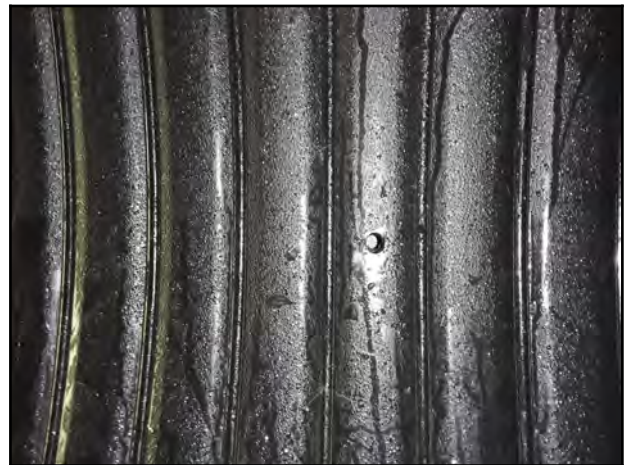
Photo 22 - 3.4 m at 8:30 with visible void.

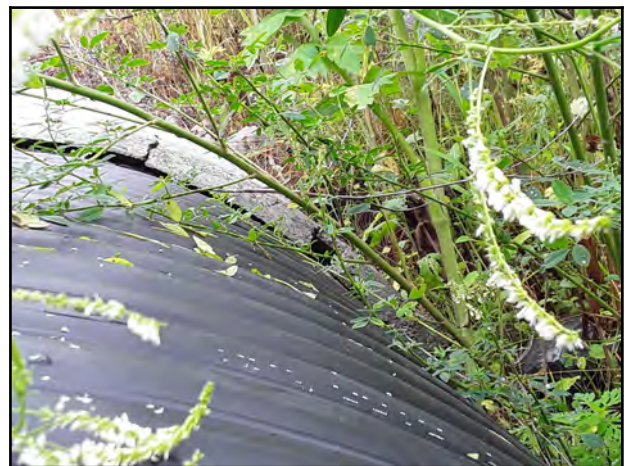
Photo 24 - Broken piece of grout at the inlet.

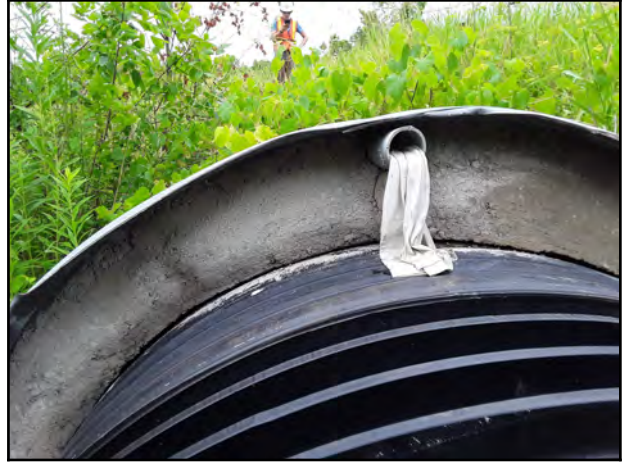
Photo 26 - Annular space of 200 mm between the existing CMP and the sliplined HDPE at outlet.

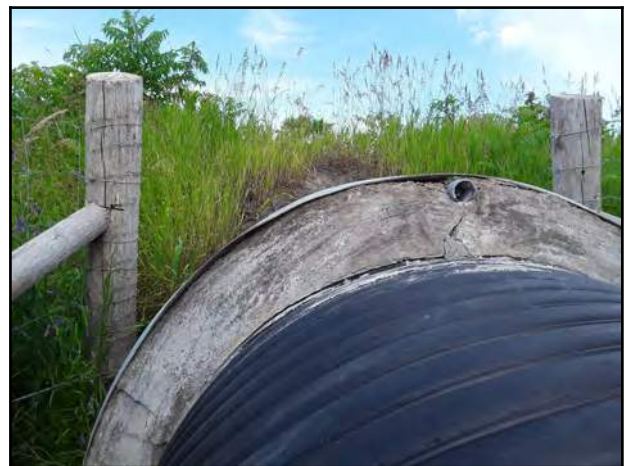
Photo 30 - Annular space of 230 mm between the existing CMP and the sliplined HDPE at outlet.

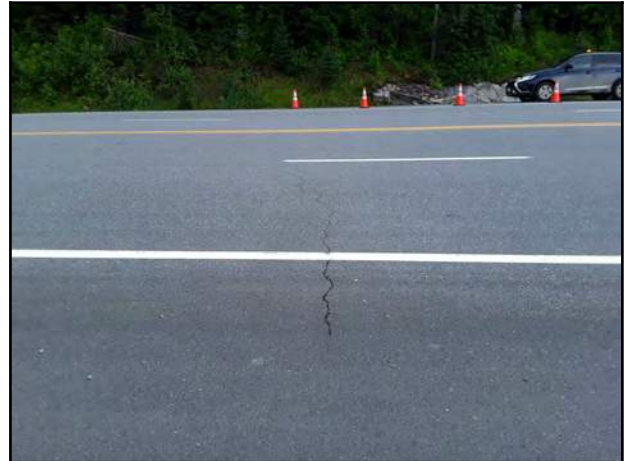
Photo 2 - Transverse crack.

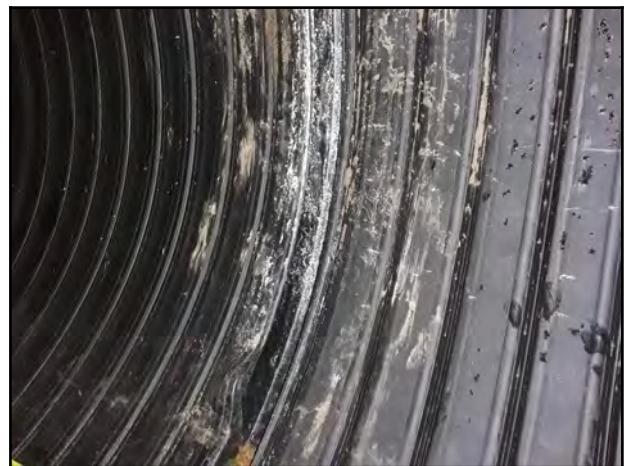
Photo 24 - V-6: Separated joint by approximately 40 mm with minor localized damage evident.

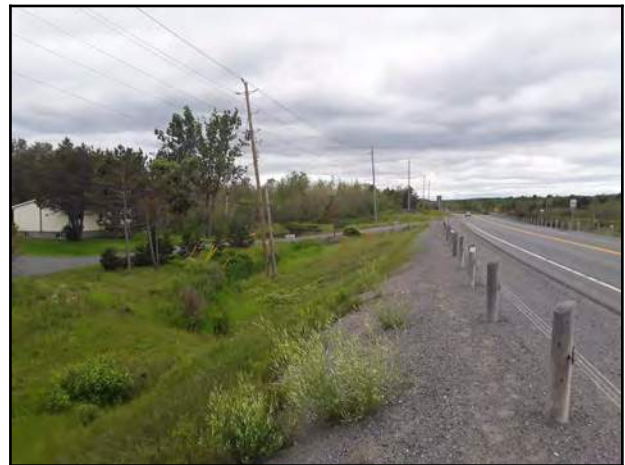
Photo 9 - Poorly repaired erosion channel on the inlet embankment.

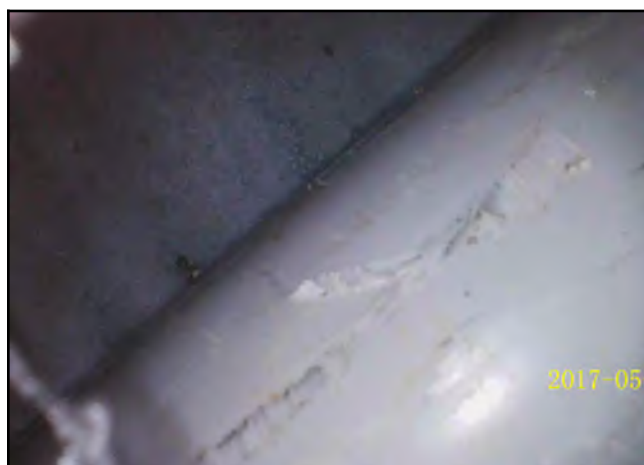
Photo 28 - V-4: Endoscope camera placed in the probe hole showing void.

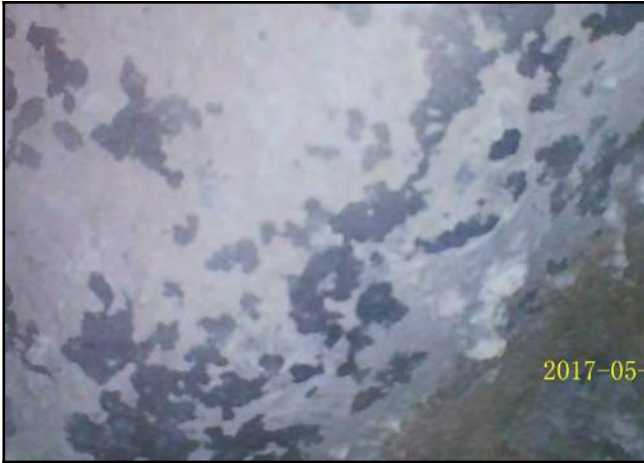
Photo 25 - V-4: Endoscope camera placed in the probe hole showing void.

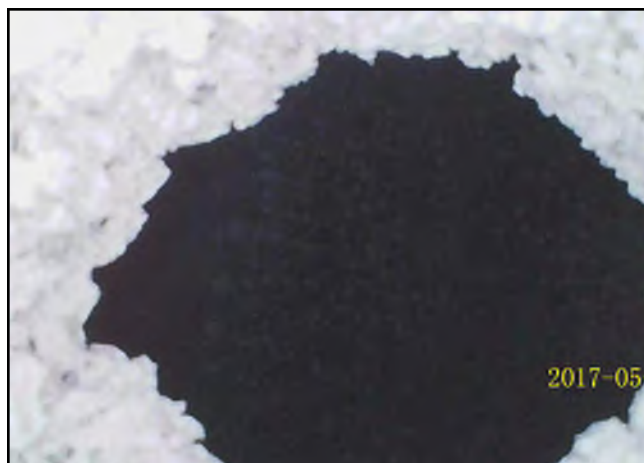
Photo 26 - V-5: Endoscope camera placed in the probe hole showing minor void.
