## Foundation Investigation and Design Report

Final Report

Replacement of the Everett Lake Tributary Culvert (#38S-0402/C0)

Highway 17, Township of Thompson, Ontario

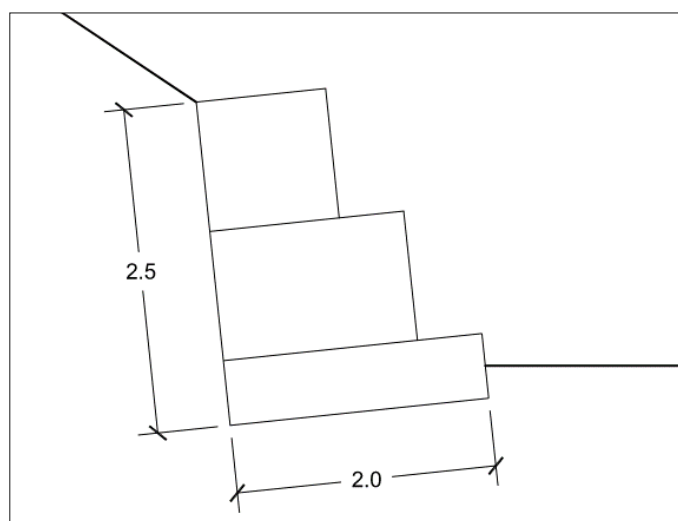
**Figure 2-1:** Anticipated Gabion Wall Section

The current Gabion wall is roughly 0.5 m taller in height than the culvert. Assuming a similar height of the new wall (approx. 2.5 m), conservatively a 2 m width base has been assumed. A cross-section of the anticipated wall section is shown on Fig. 2-1 below.

The assumed 2 m wide footing, can be designed with a factored geotechnical resistance at Ultimate Limit States (ULS) of 190 kPa, calculated using a geotechnical resistance factor of 0.5. A geotechnical resistance at Serviceability Limit States (SLS) of 100 kPa may be used. The SLS value assumes a maximum settlement of 25 mm. A Gabion wall is typically considered a flexible structure, which can sustain some settlement.

A base layer of Granular A or Granular B Type II (OPSS.PROV 1010) with a minimum thickness of 300 mm should be placed beneath the wall and extend a minimum of 500 mm horizontally beyond the foundation edges. The base material should be placed in layers not exceeding 200 mm in thickness, loose measurement, and compacted in accordance with OPSS.PROV 501, or according to OPSS.PROV 314 if Granular B Type II is used, before a subsequent layer is placed in accordance with OPSS.PROV 401. Based on the existing conditions at the site, Granular B Type II is the preferred material for the base below the water table.

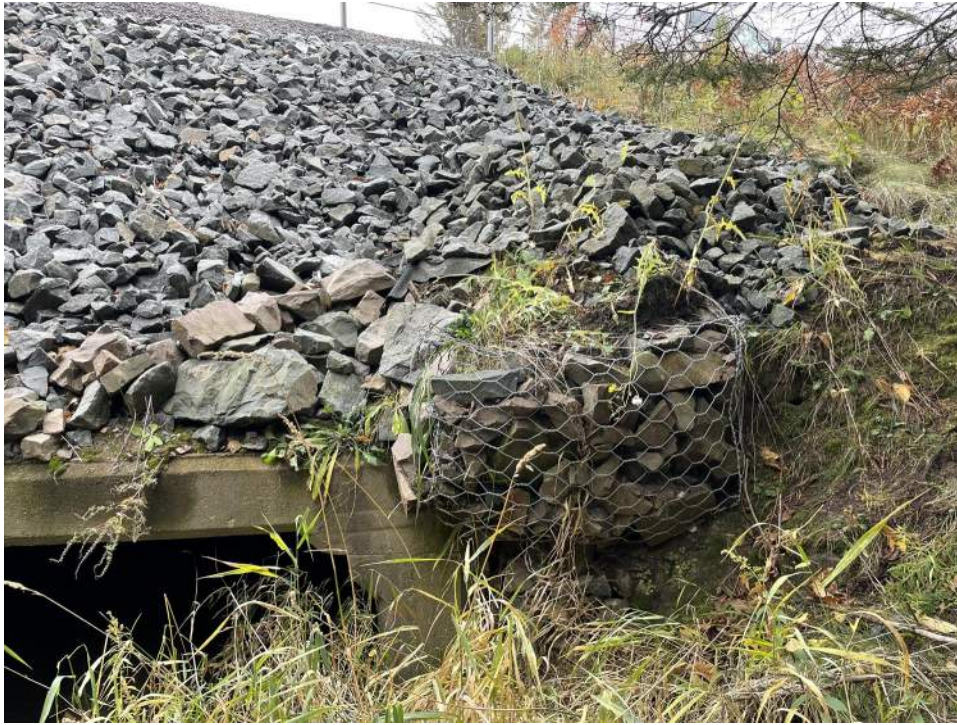
The existing culvert which conveys water below Highway 17 is a reinforced, cast-in-place, concrete box culvert having a skew angle of approximately 16° with a length of 31.8 m, a span of 3.1 m, and a height of 1.8 m. A Structure Inspection Report provided by the MTO from 2021 indicates the existing culvert is in overall fair to poor condition with scaling and cracking of the concrete and some areas of spalling with exposed corroded rebar. The embankment on the inlet (north) side has an approximate side slope of 1.5H:1V, flattening to 3H:1V near the toe, and has displayed moderate erosion. The embankment on the outlet (south) side has an approximate side slope of 2H:1V. Movement of the rock slope protection on the south embankment was observed, with rocks found in the watercourse. The southwest gabion basket at the toe of the slope has failed, with the southeast gabion basket showing tears, corrosion, and movement.

Photograph 11: Damaged Gabion Basket Wall at Outlet

The type of culvert and method of replacement is not known at the time of writing this report. However, it is assumed that the new culvert will be installed at the same location of the existing culvert having the same or similar elevation of the invert at the inlet and outlet sides. It is also assumed that the new embankment will be constructed with no grade change at the culvert location. Furthermore, it has been assumed that the Gabion Wall currently located adjacent to the outlet of the culvert will be replaced as part of the new construction.
