**FOUNDATION DESKTOP STUDY REPORT
PRELIMINARY DESIGN AND ENVIRONMENTAL ASSESSMENT
HIGHWAY 403 AT CNR SUBWAY
STRUCTURE REPLACEMENT ON NEW ALIGNMENT
HAMILTON, ONTARIO
W.O. #16-20004
SITE 36-31**

GEOCRES NO. 30M5-341

Date: November 10, 2022
File: 25963

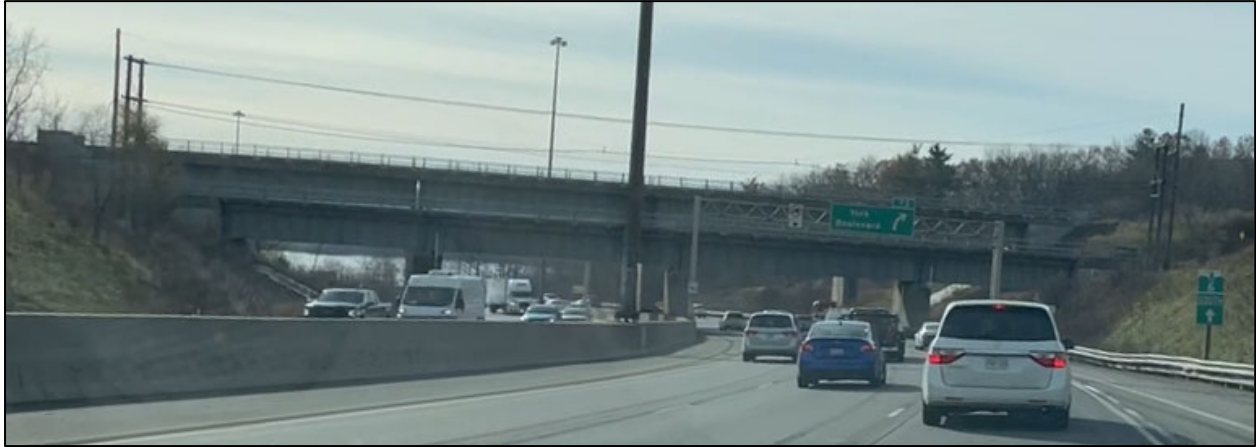
Photo 1- CNR Subway, north side
Photo taken from Highway 403 WBL on December 1, 2021

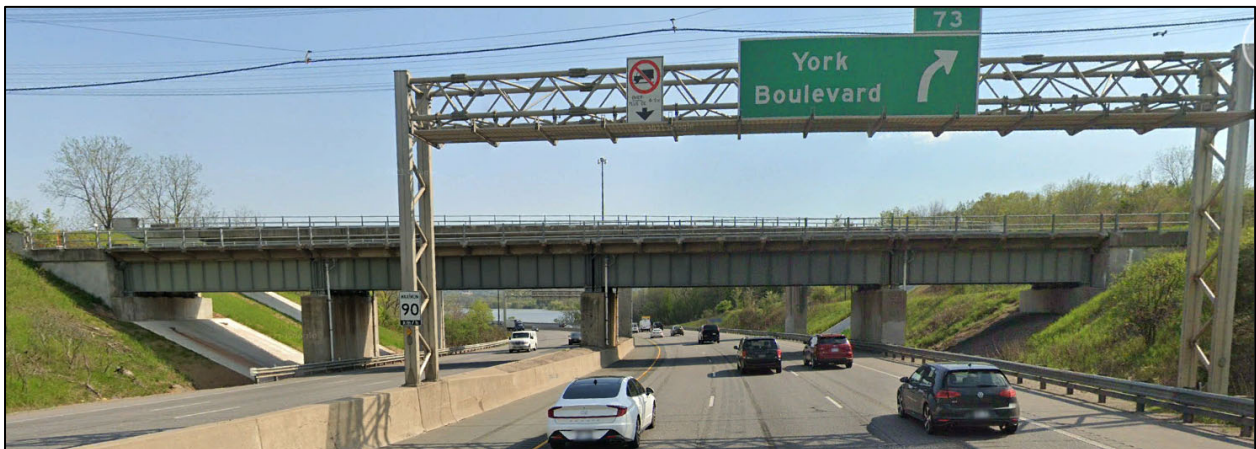
Photo 2- CNR Subway, north side
Photo taken from Highway 403 WBL on December 1, 2021

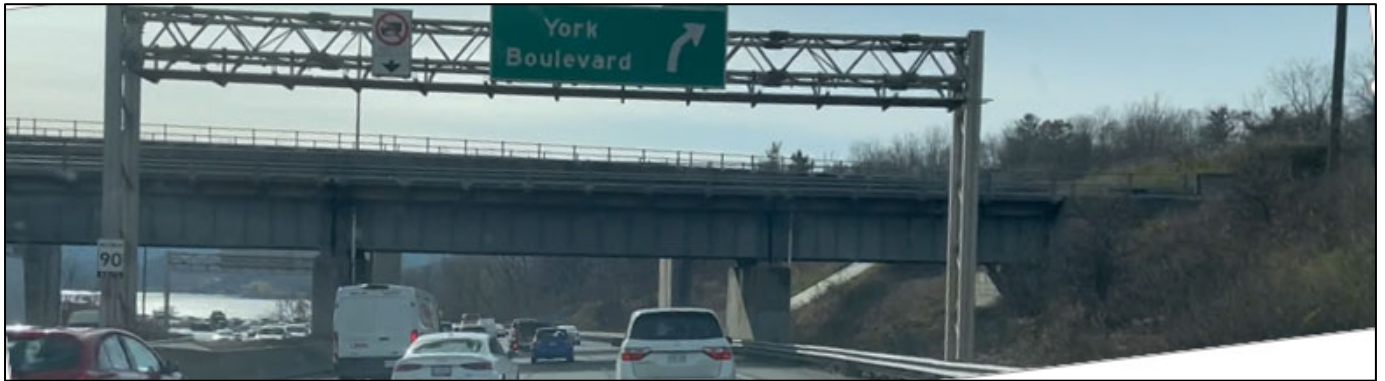
- Mid-height berms were observed along the south and north side slopes of the west approach.
- Seepage was noticed at the three rectangular piers, which are wet stained along the concrete faces. Several narrow vertical and diagonal cracks were noted on the piers.

Photo 3- CNR Subway, north side

West Abutment and Piers
Photo taken from Highway 403 WBL on December 1, 2021

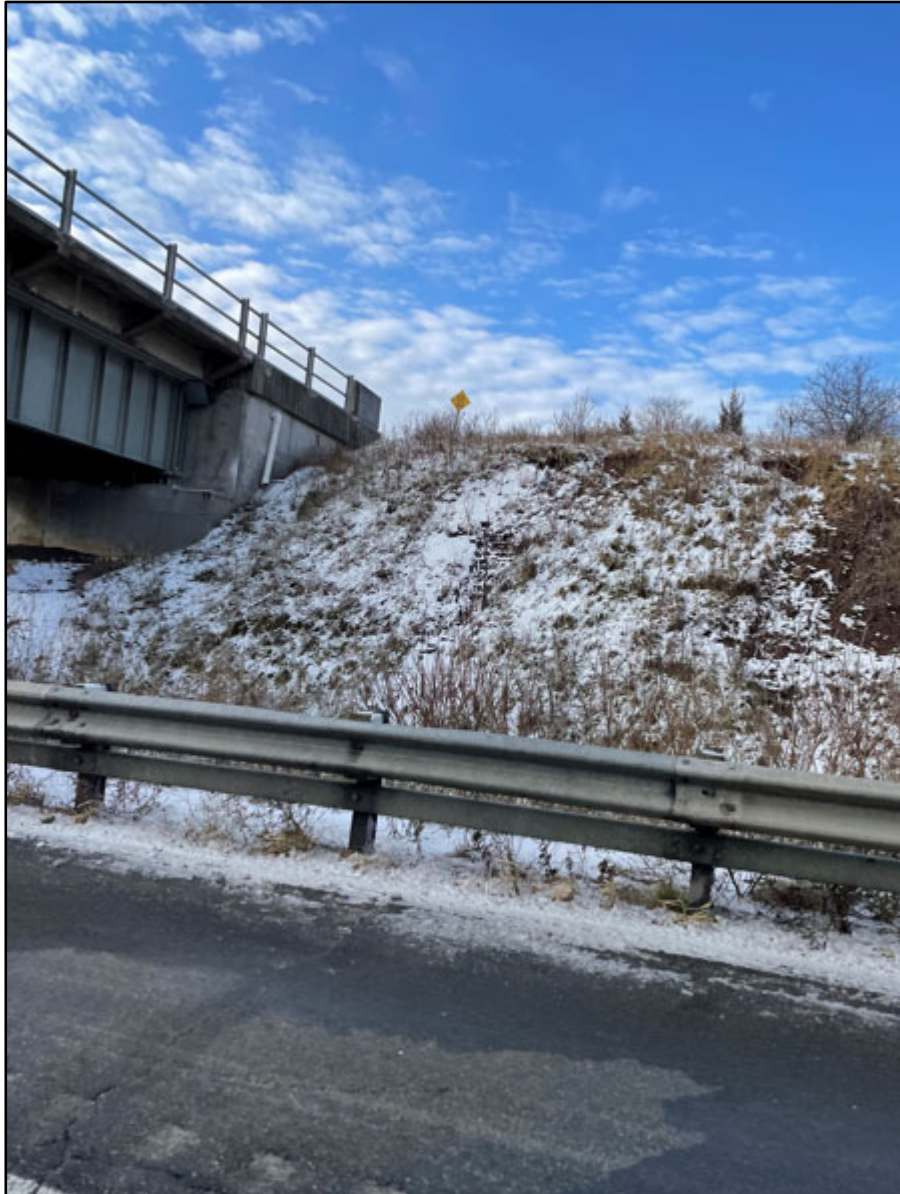
- Wet/seepage stains were noted at the abutment walls. Vertical and alligator cracks were noted at the concrete surfaces of the abutment and ballast walls.

Photo 4- CNR Subway
West Abutment, north side
Photo taken from Highway 403 WBL on December 20, 2021

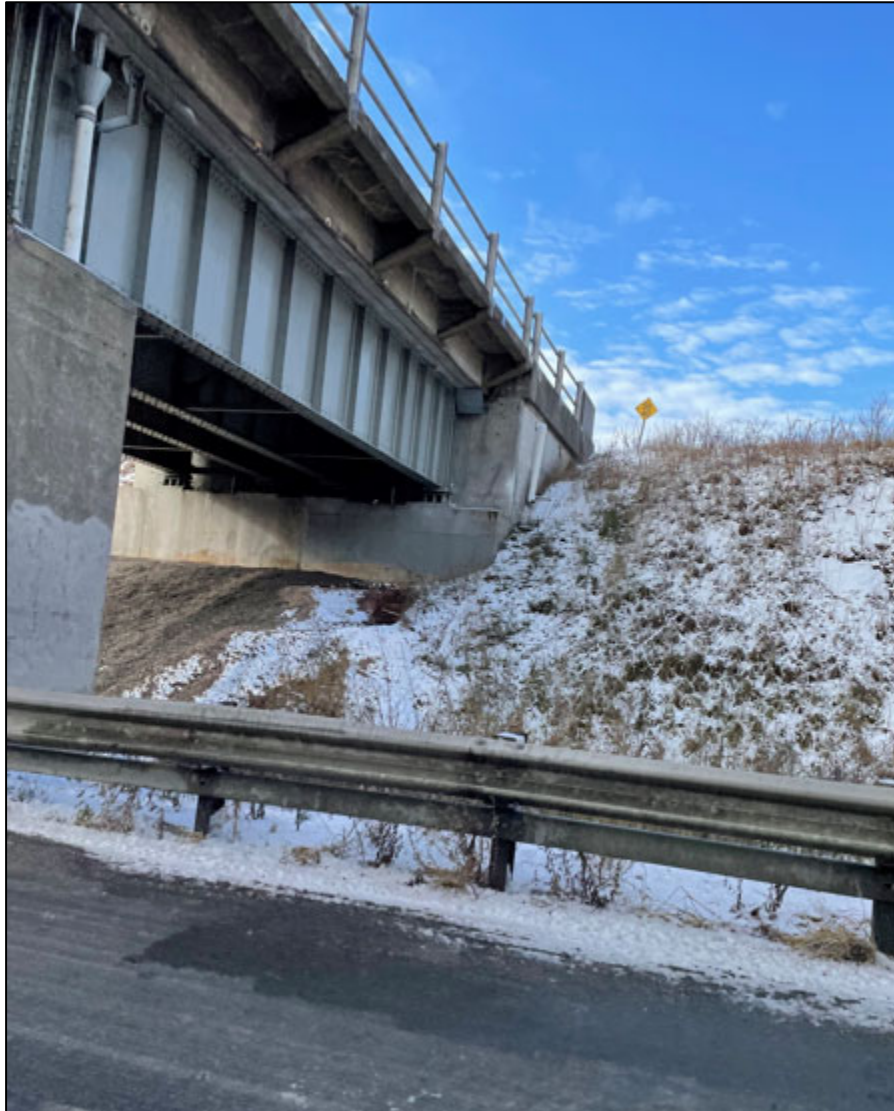
Photo 5- CNR Subway
West Abutment, north side
Photo taken from Highway 403 WBL on December 20, 2021

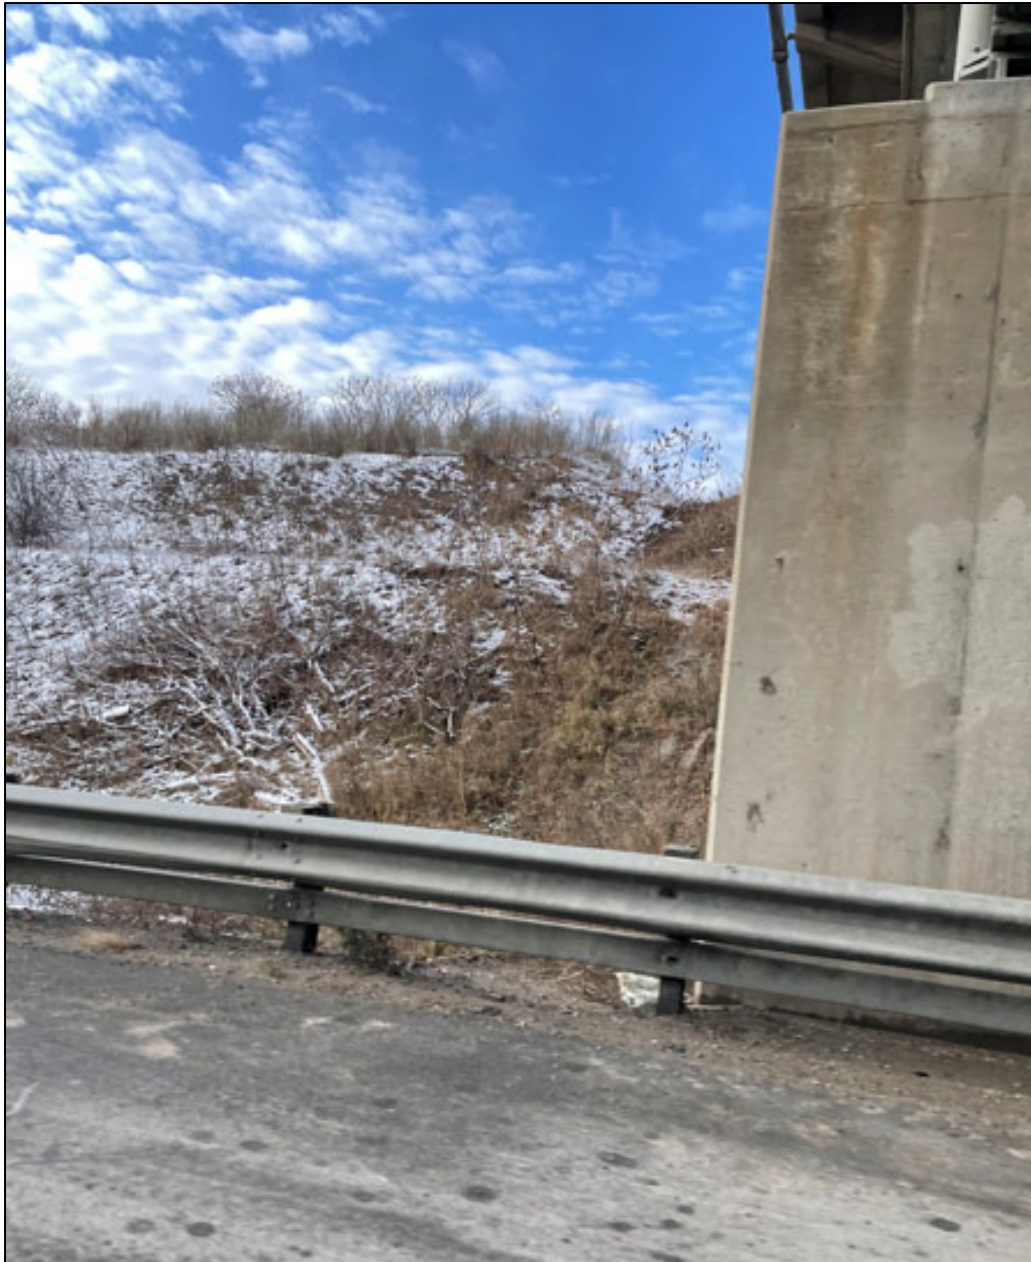
Photo 6- CNR Subway
West abutment, south side
Photo taken from Highway 403 WBL on December 20, 2021

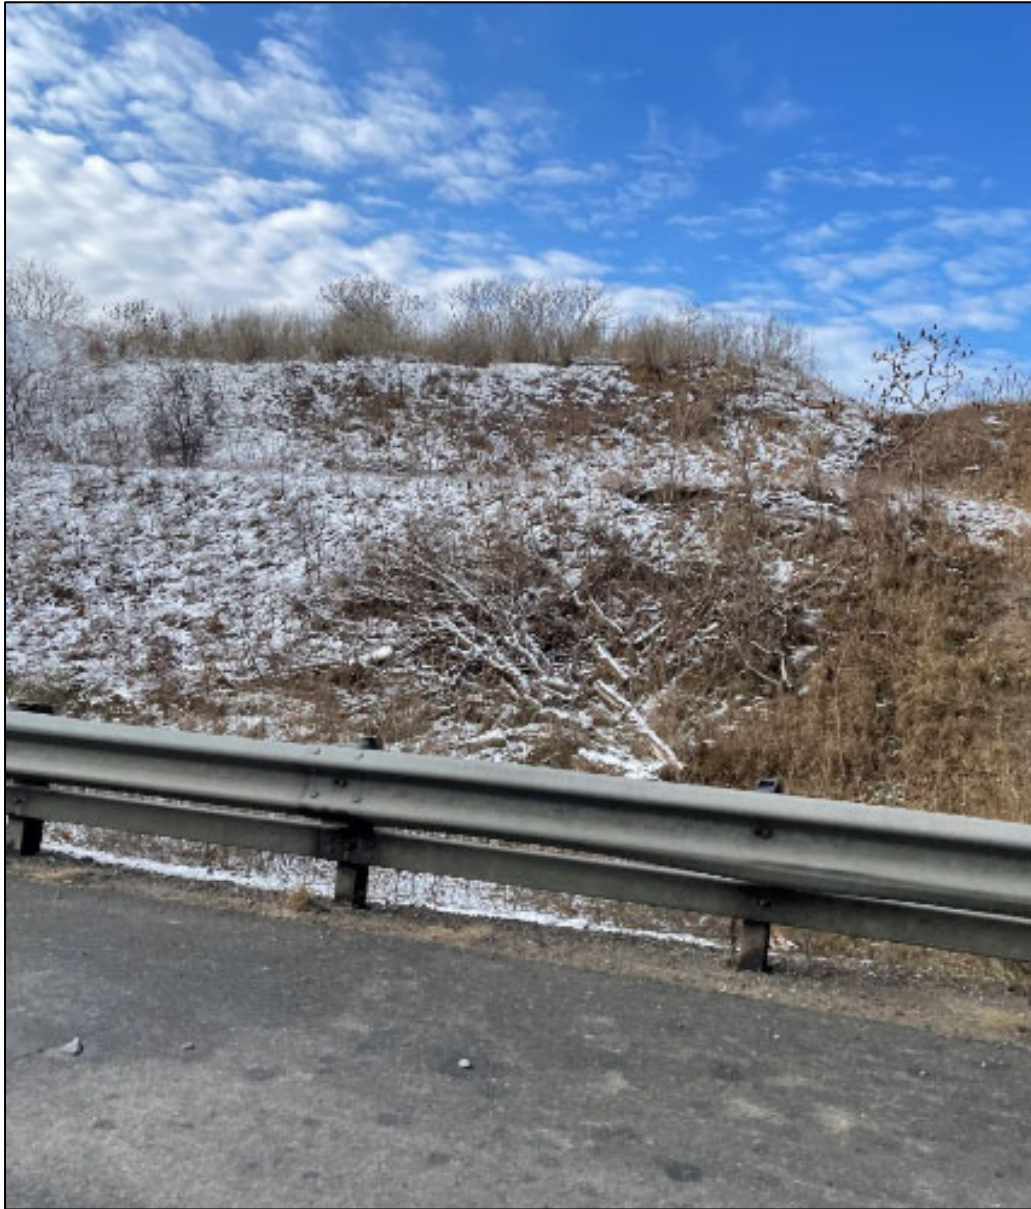
Photo 7- CNR Subway
West abutment, south side
Photo taken from Highway 403 WBL on December 20, 2021

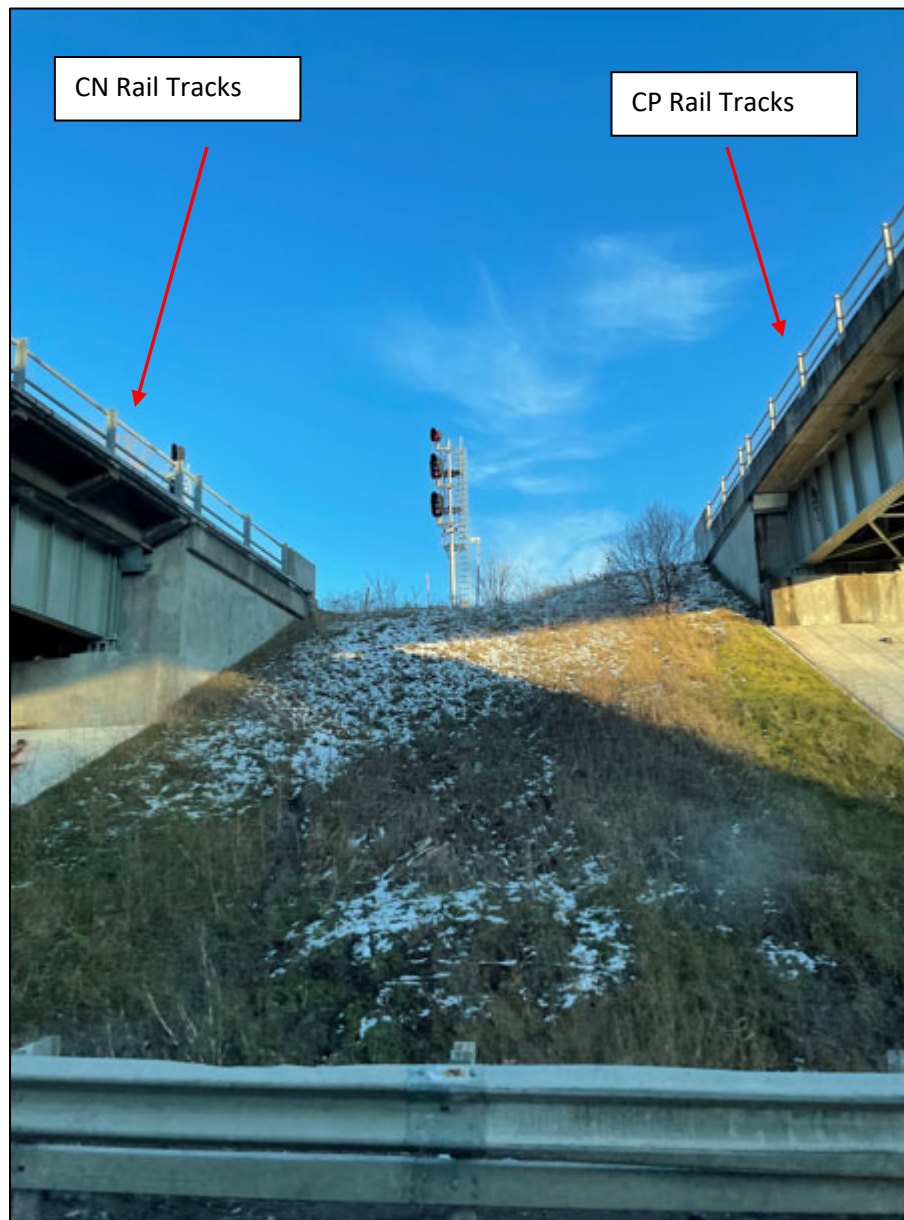
- Concrete slope paving is present on the forward slope of the east abutment. Continuous and large seepage stains were noted on the concrete slope paving from top to bottom. Pipe drains, revealing seepage, were also observed at the top of the forward slope.

Photo 8- CNR Subway
East abutment, south side
Photo taken from Highway 403 EBL on December 20, 2021

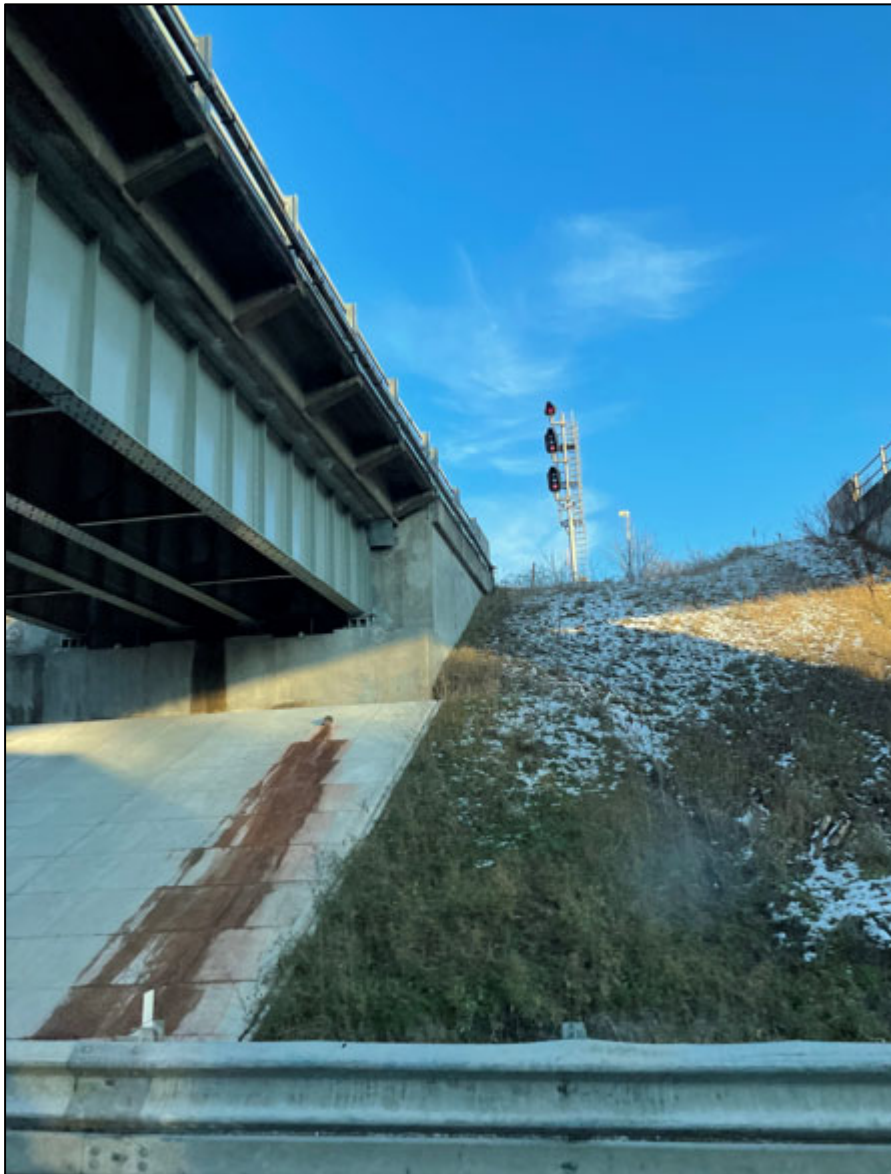
Photo 9- CNR Subway
East abutment, south side
Photo taken from Highway 403 EBL on December 20, 2021

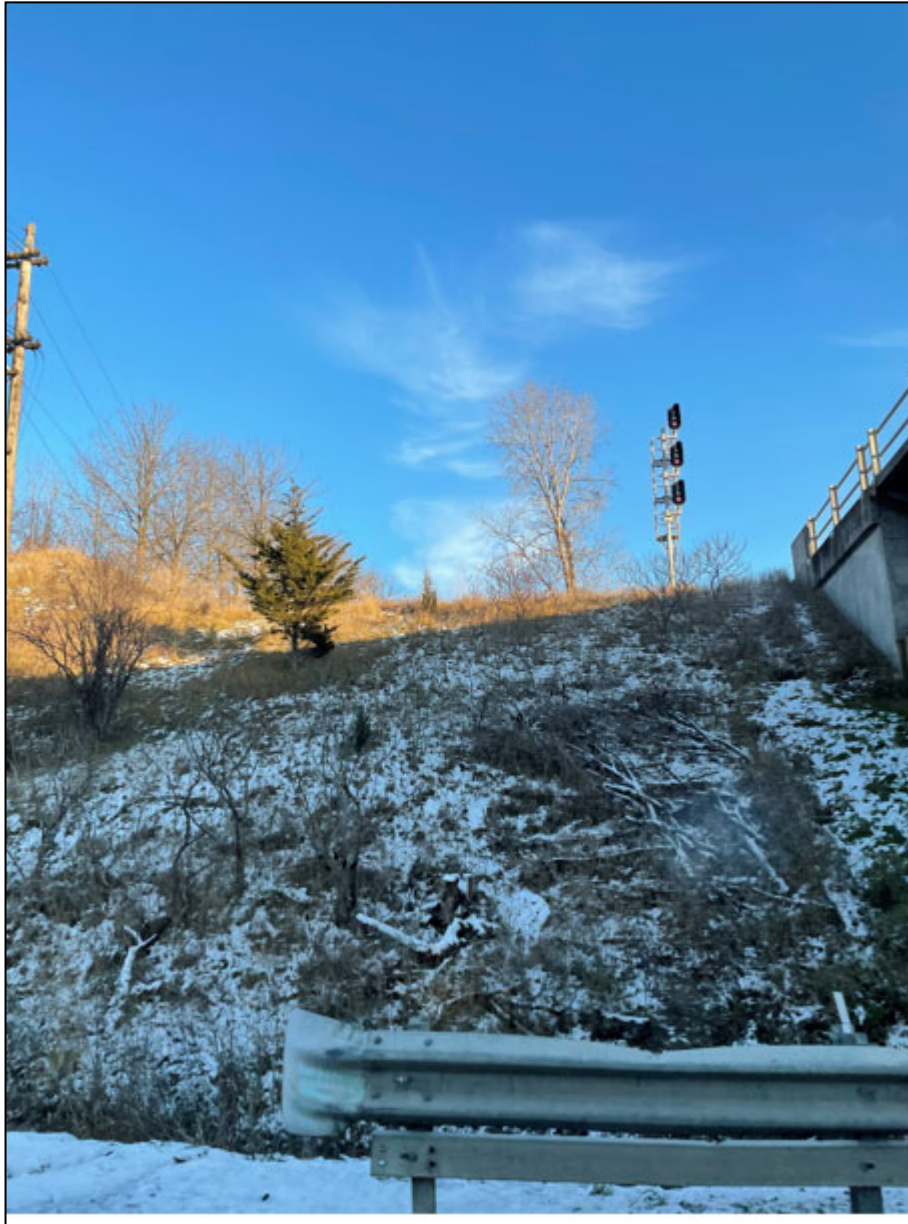
Photo 10- CNR Subway
East abutment, north side
Photo taken from Highway 403 EBL on December 20, 2021

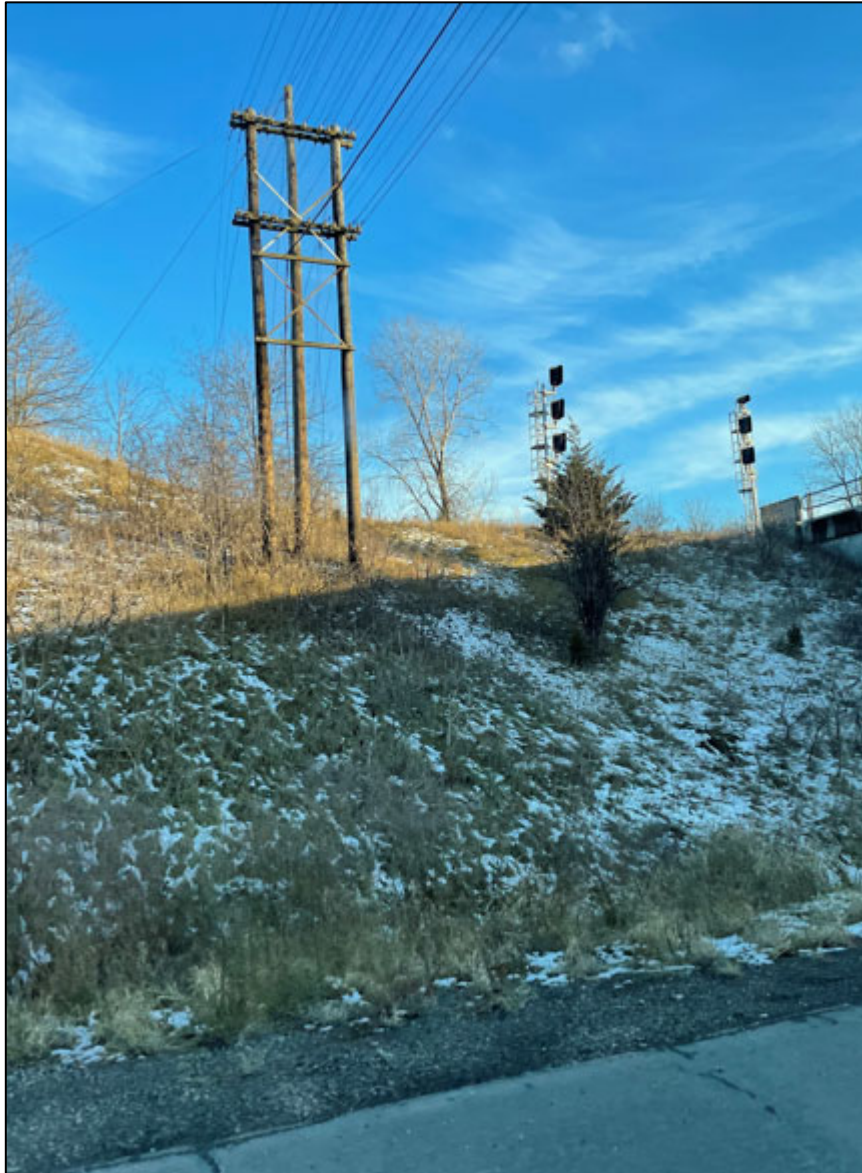
Photo 11- CNR Subway
East abutment, north side
Photo taken from Highway 403 EBL on December 20, 2021
