FINAL
FOUNDATION INVESTIGATION AND DESIGN REPORT
Culvert 38 Rehabilitation, Highway 69 – 2.0 km South of Highway 7182
Township of Shawanaga
Rehabilitation of Highway 69 and Shawanaga River Bridge
G.W.P. 5246-18-00
ASSIGNMENT NO.: 5020-E-0003
GEOCRES NO.: 41H09-004

Client Name: Egis Group

Date: August 9, 2024

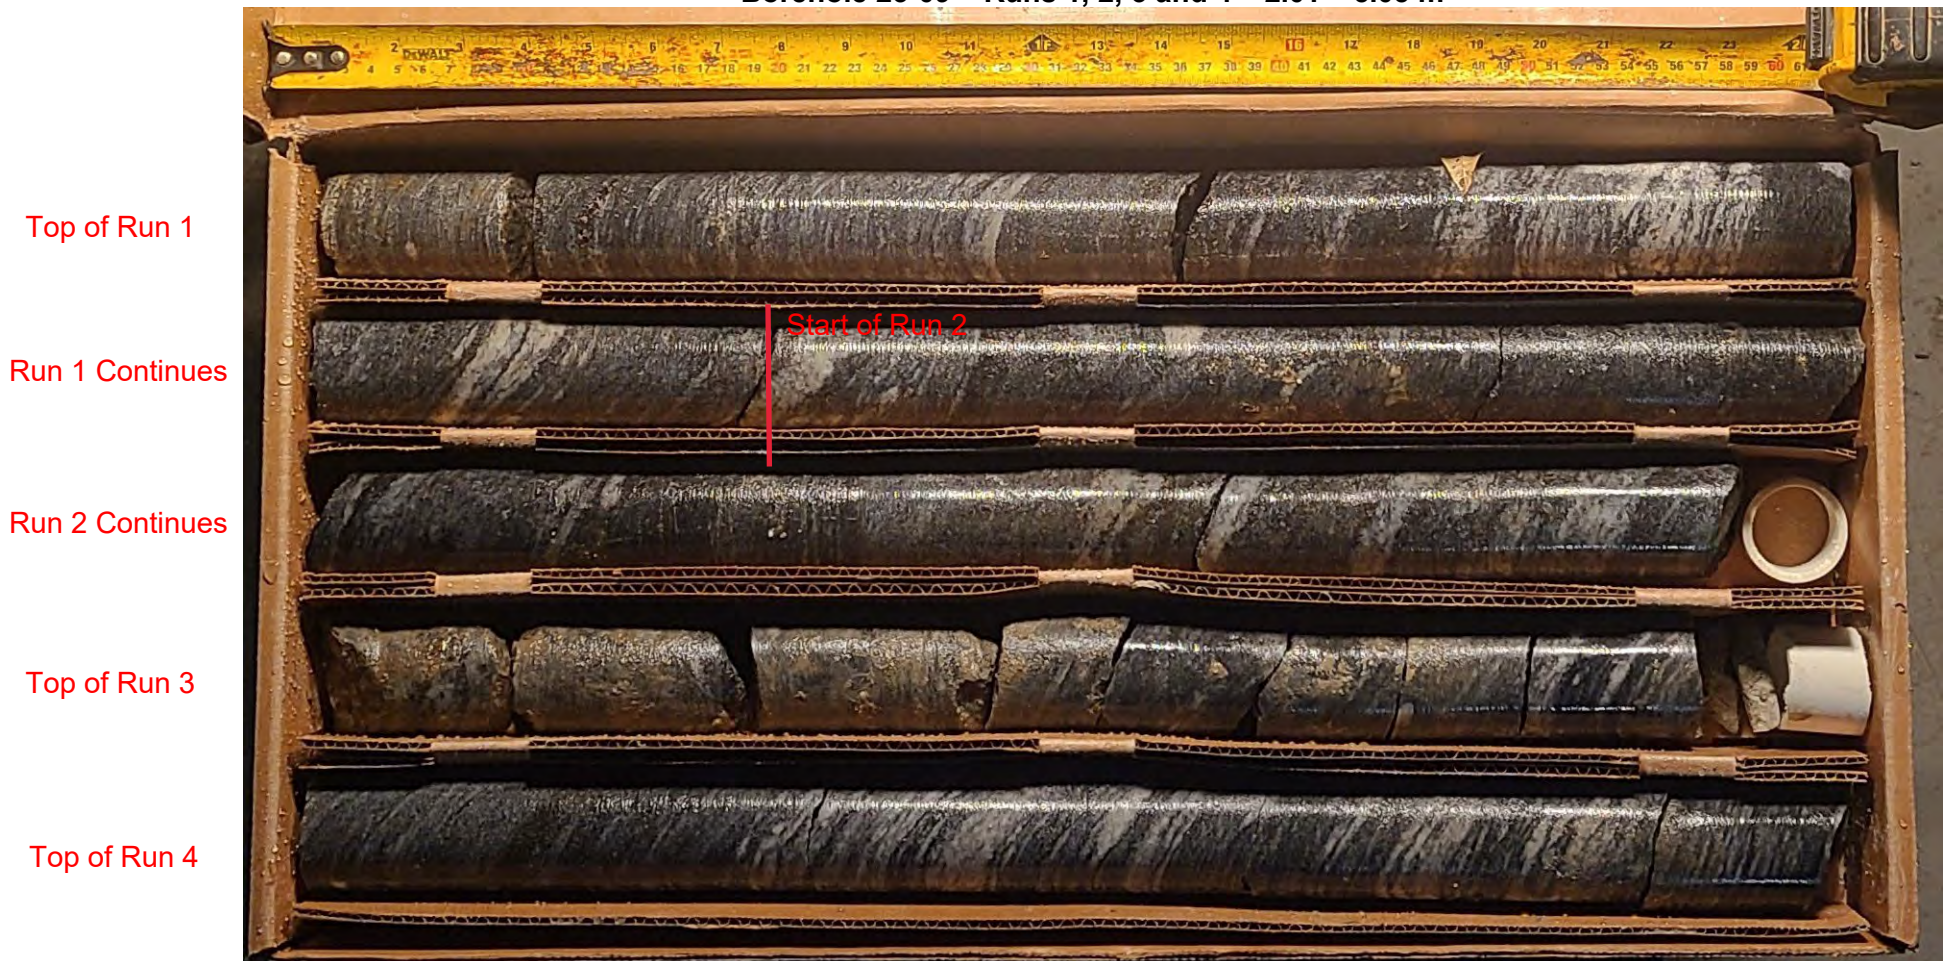
Borehole 23-09 – Runs 1, 2, 3 and 4 – 2.01 – 5.05 m

*Borehole 23-09 Run 3 was not included in assessment due to damage caused to the core while trying to remove it from the core barrel; TCR = 82%, SCR = 75%, RQD = N/A, FI = 3, 4

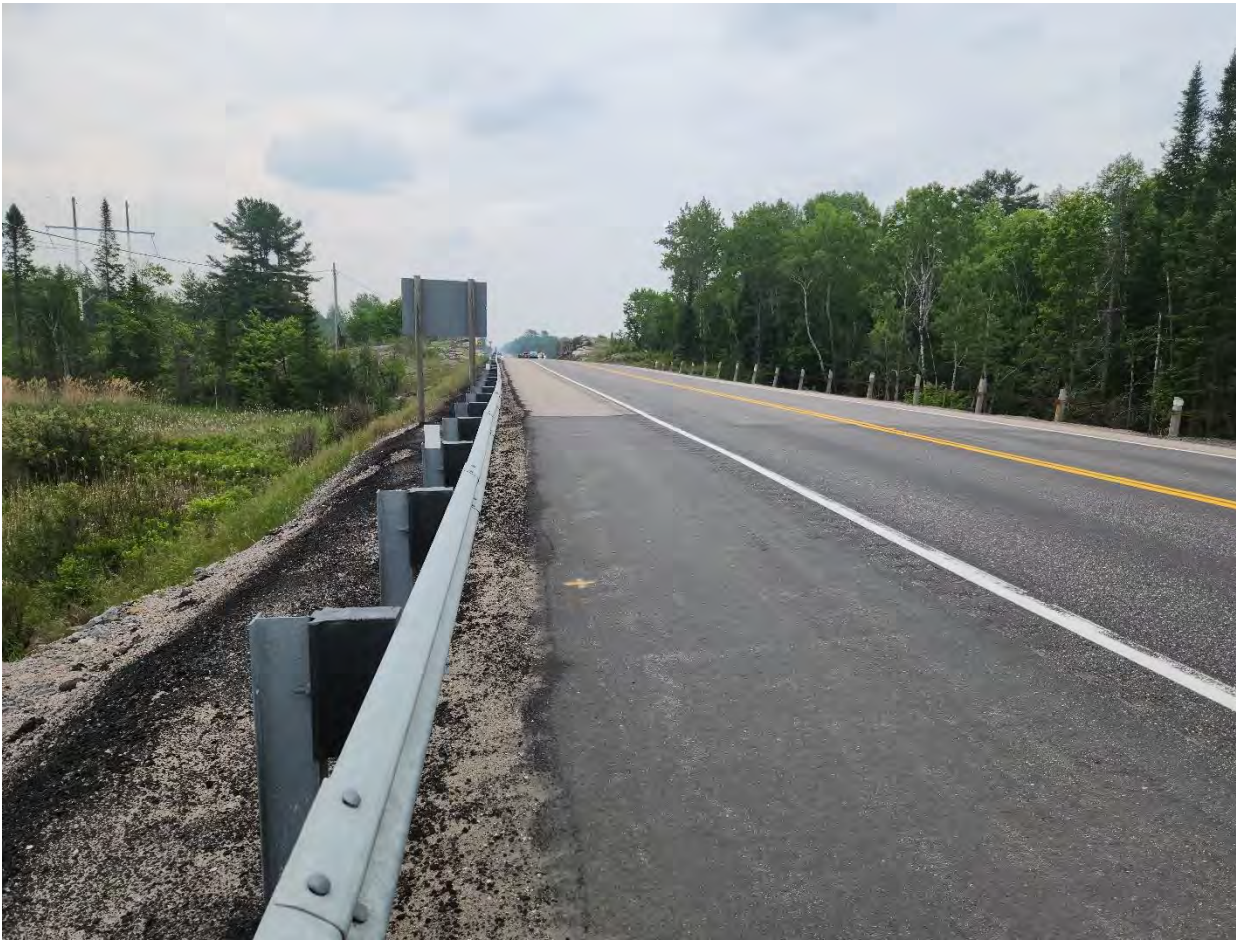
Photograph 1: East Shoulder of Highway Over Culvert 38 Looking South

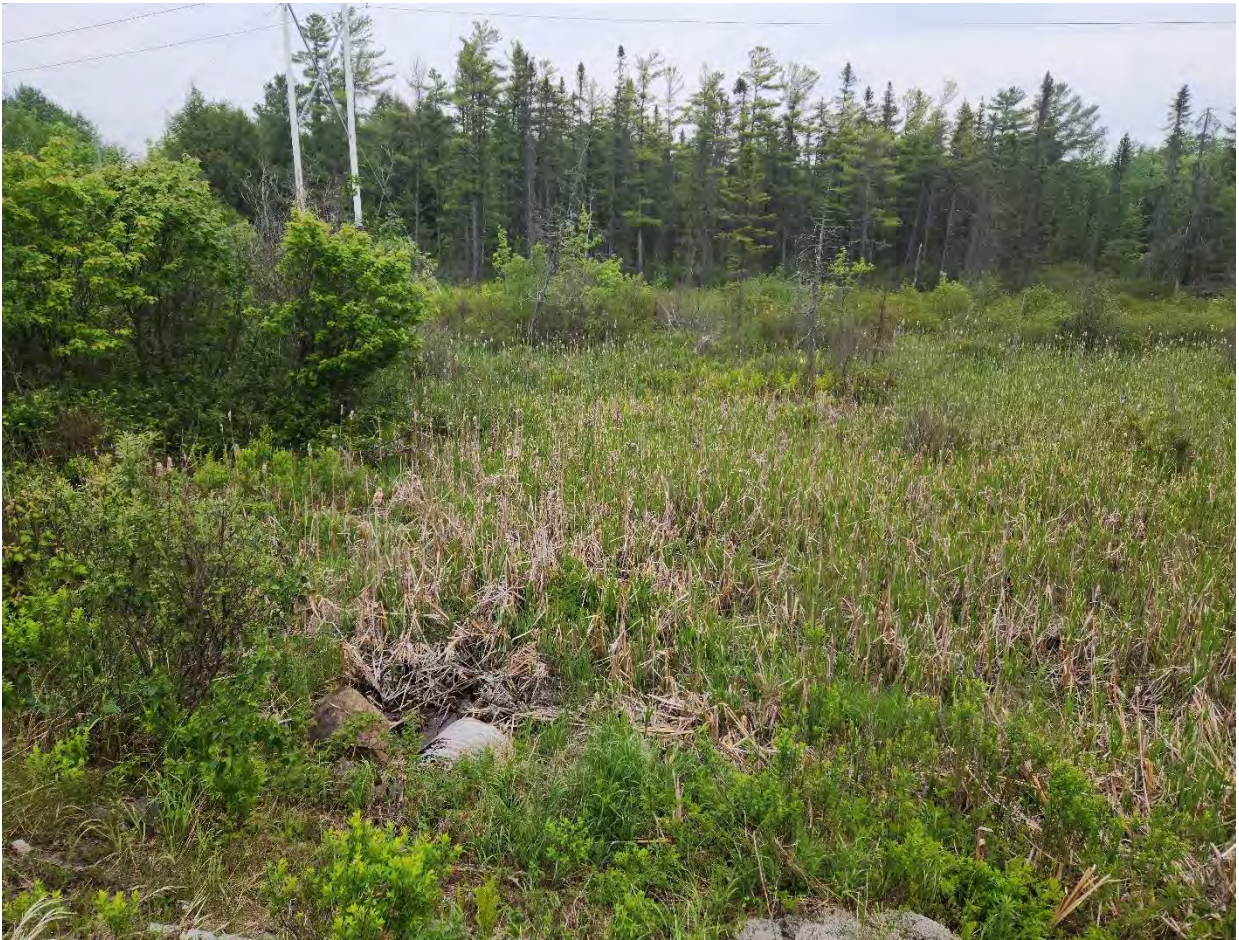
Photograph 2: Culvert Outlet, Looking East

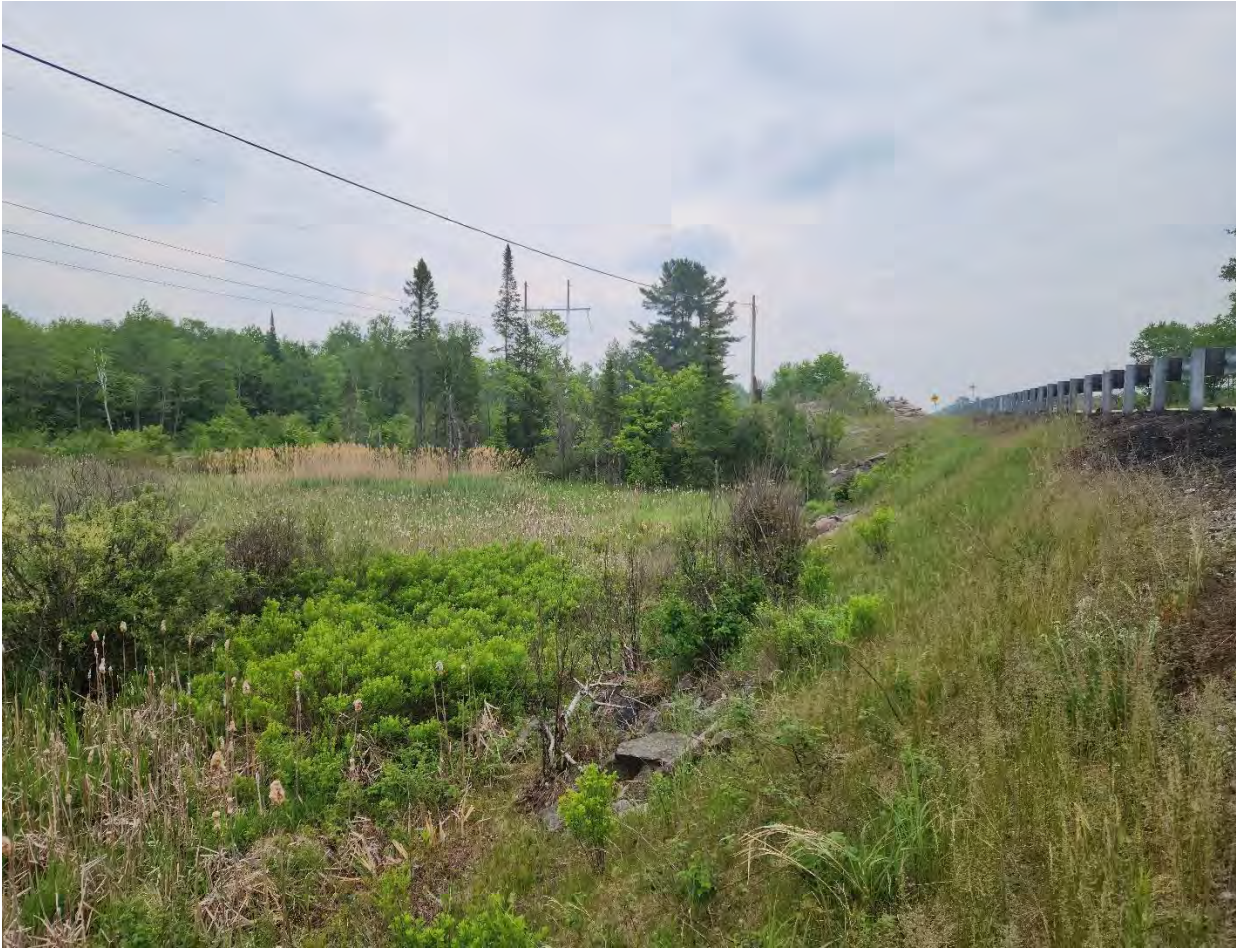
Photograph 3: Culvert Outlet, East Embankment Slope Looking South

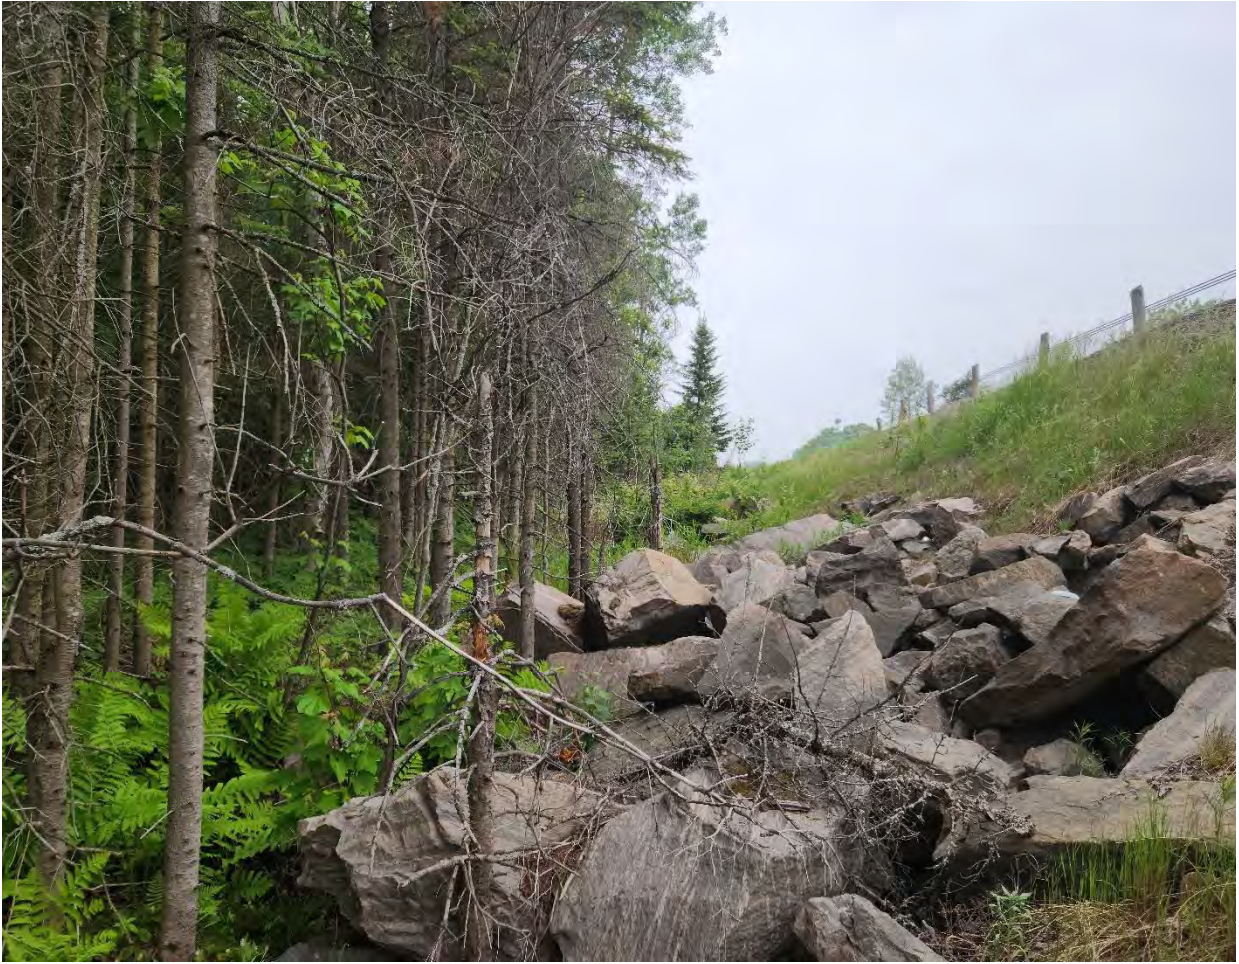
Photograph 4: Culvert Inlet, West Embankment Looking North
