**CALAMITY CREEK SLOPE FAILURE INVESTIGATION
HIGHWAY 11, 2.9 KM NORTH OF HWY 65 JUNCTION
NEW LISKEARD, ONTARIO
5018-E-0010, WORK ITEMS #7 AND #11**

G.W.P. NO. 5159-12-00

Geocres Number: 31M-133

March 2022

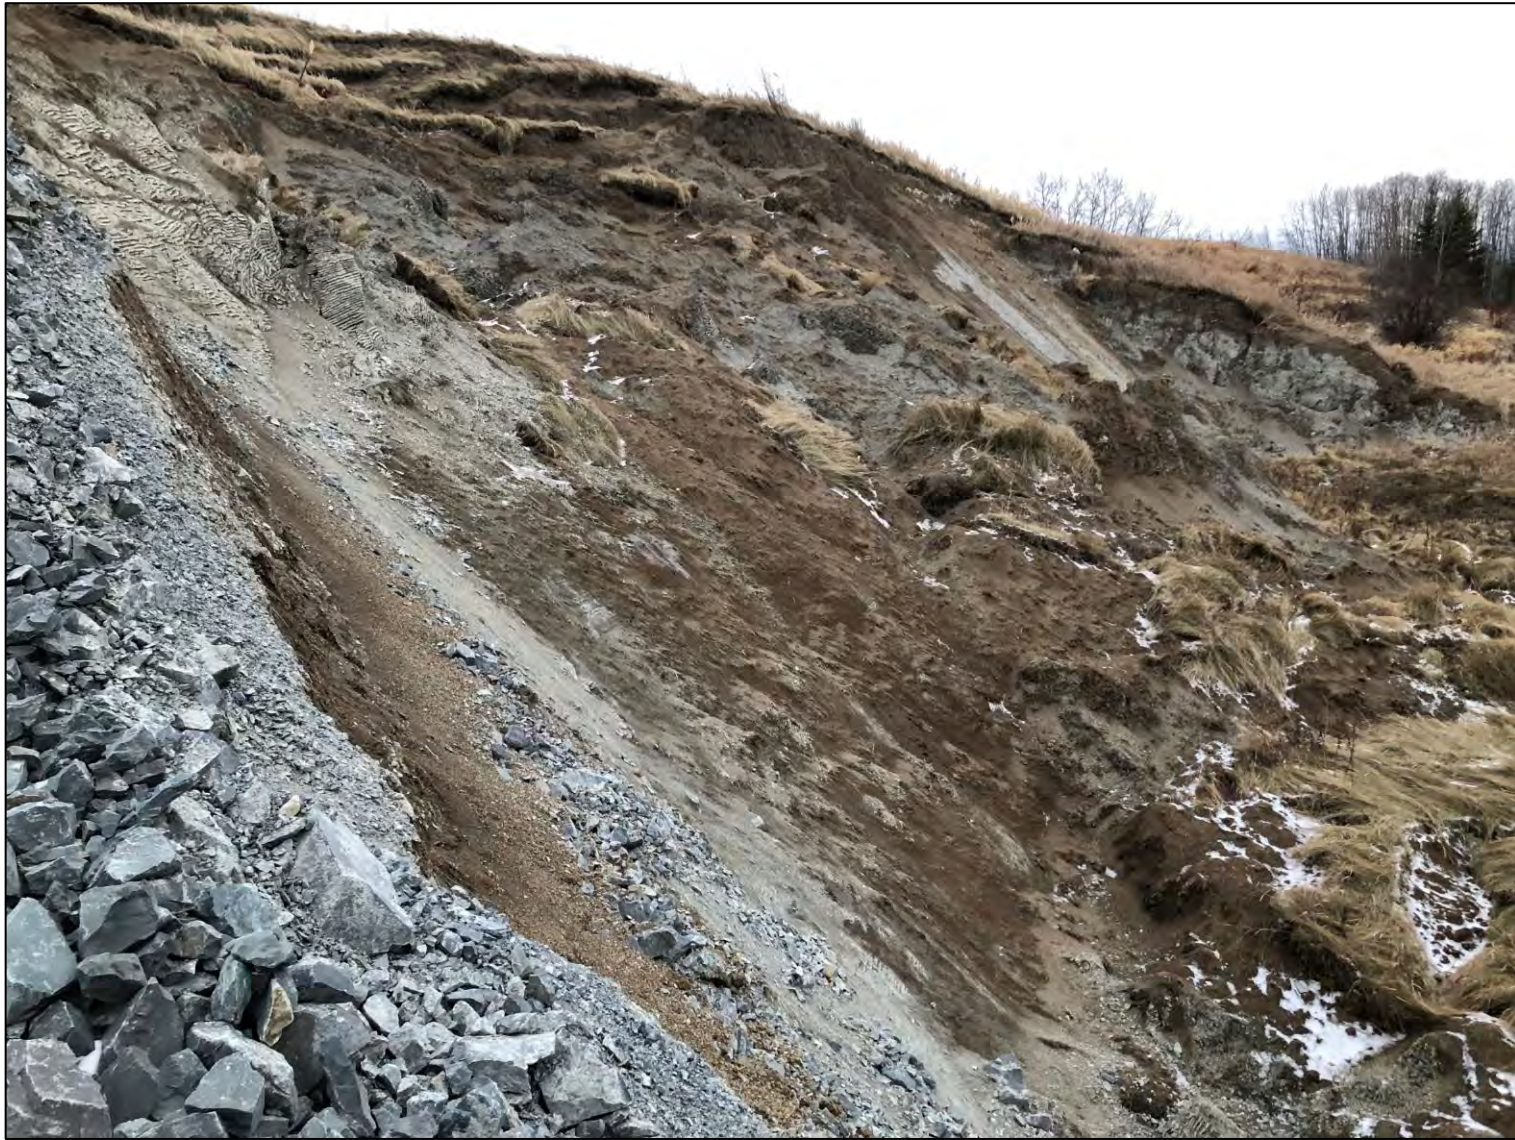
Photo 4: View of original slide scar, looking west, which is locally steeper with an angle of approximately 40 degrees. Retrogression can be seen above the original failure.

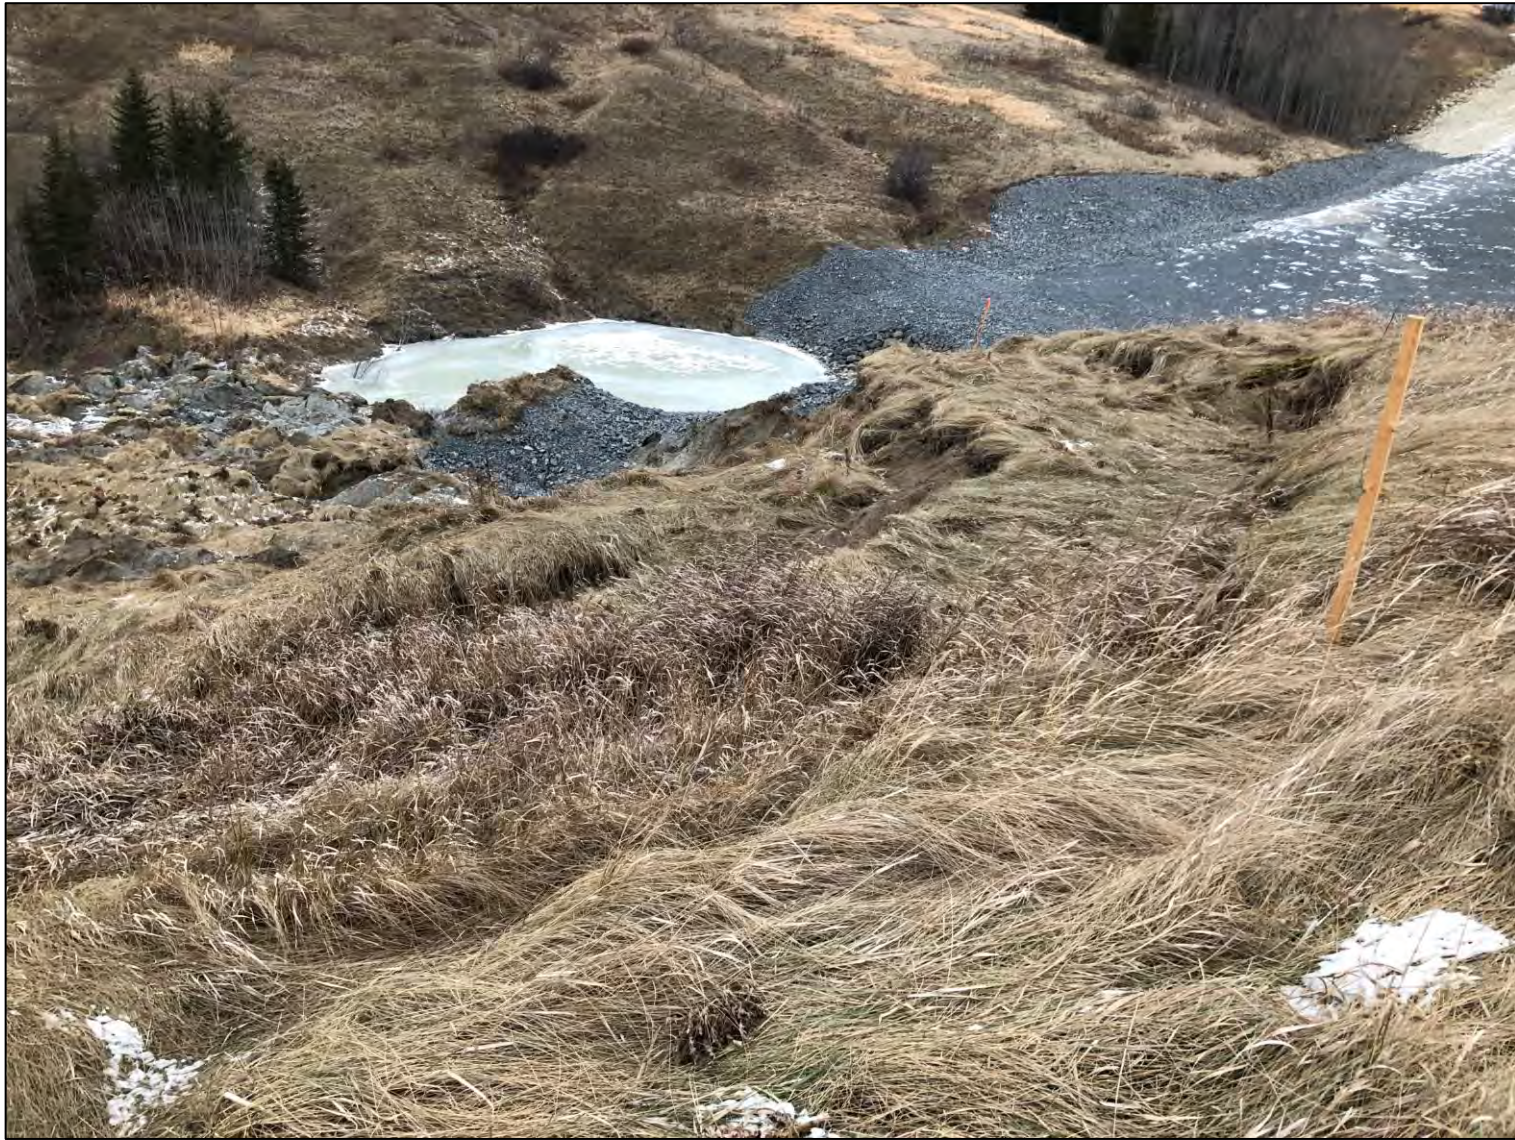
Photo 5: View showing slump blocks, looking north from above the head scarp.

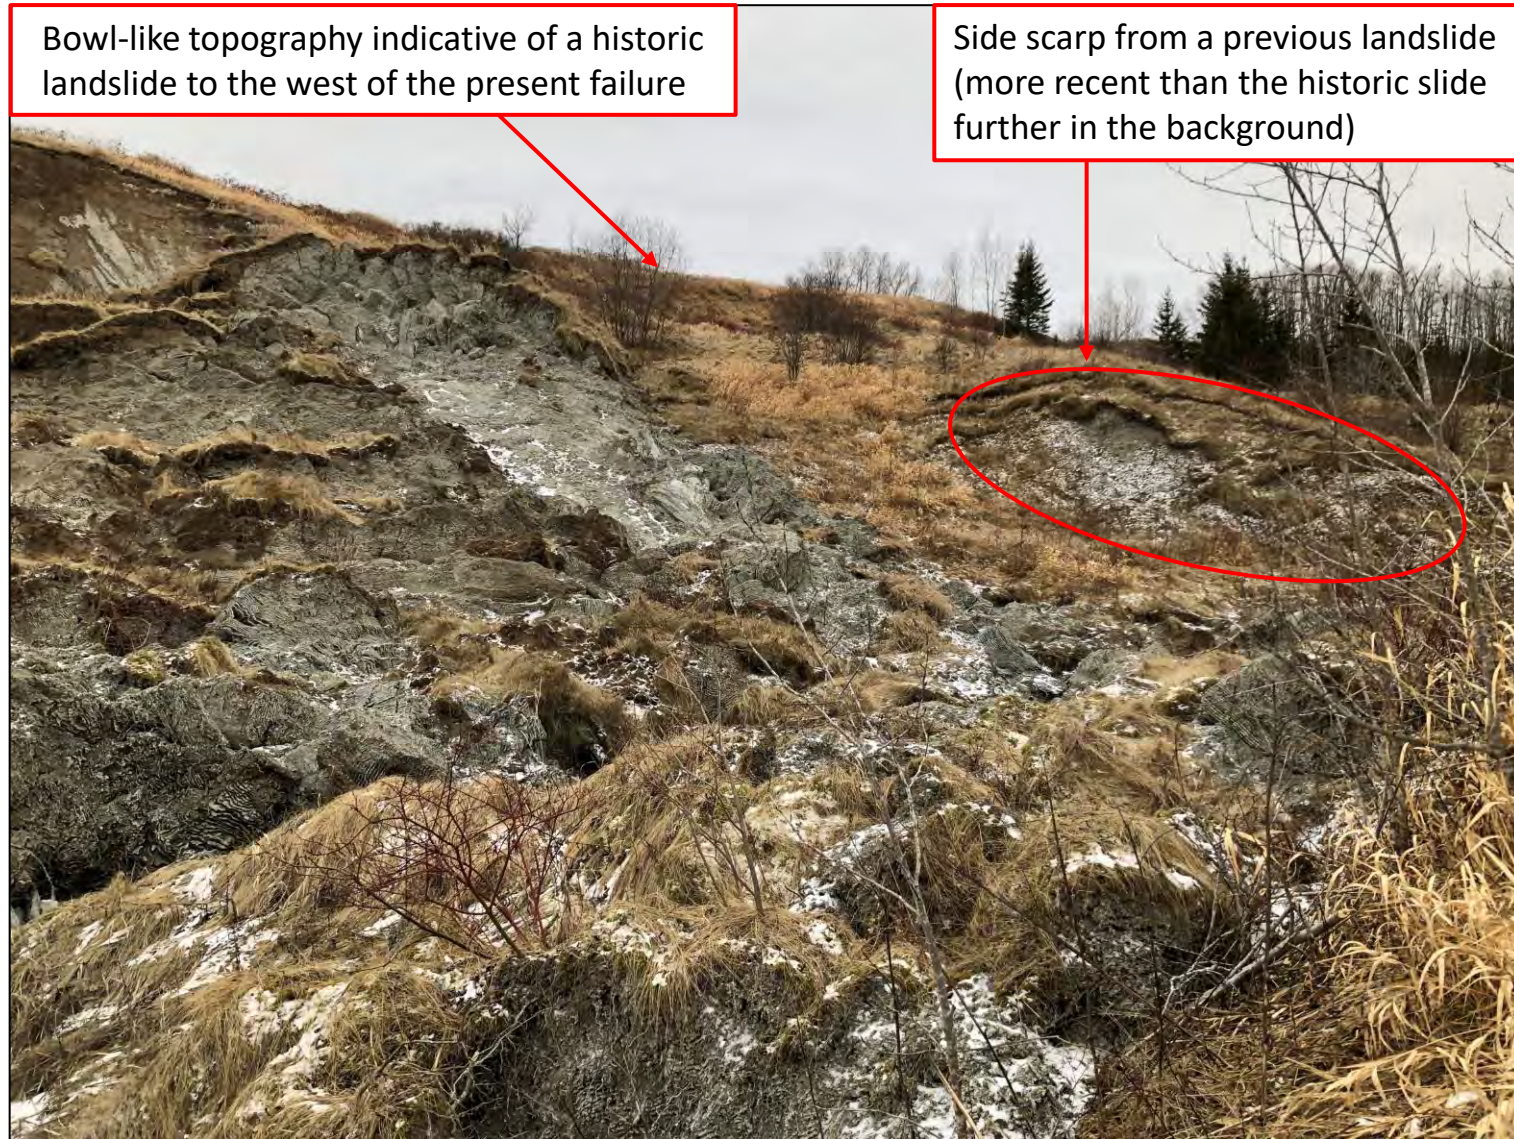
Photo 7: View looking southwest from the toe of the current failure showing the topography to the west, including a bowl-like topography indicative of a historic landslide and a more recent side scarp from a previous smaller-scale failure that likely overlapped the current failure.
December 4, 2020

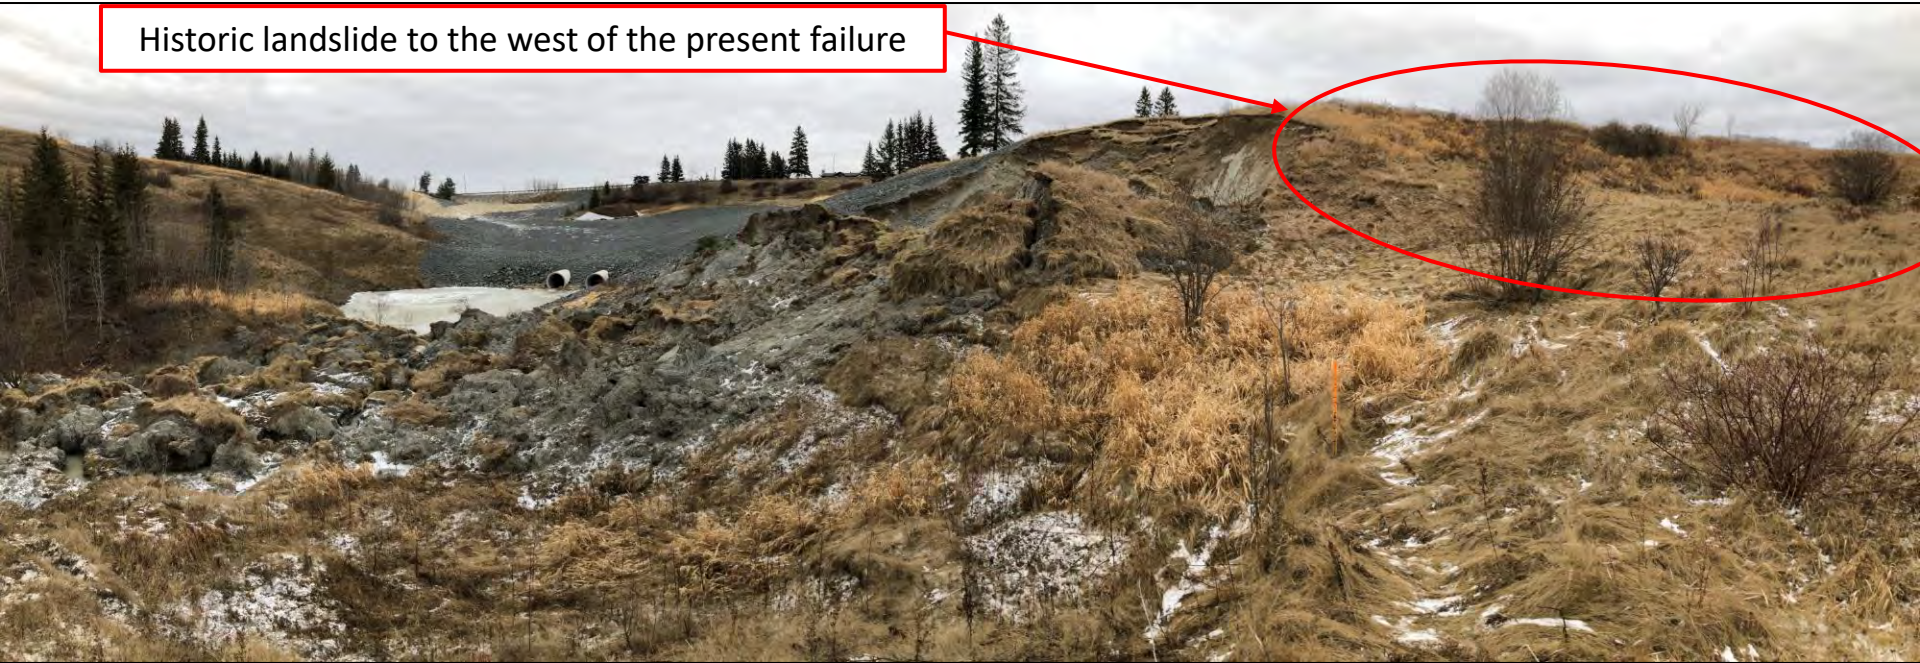
Historic landslide to the west of the present failure

Photo 8: Panoramic view of the landslide, looking northeast to southeast. Bowl-like topography to the west is likely a remnant of a historic landslide.

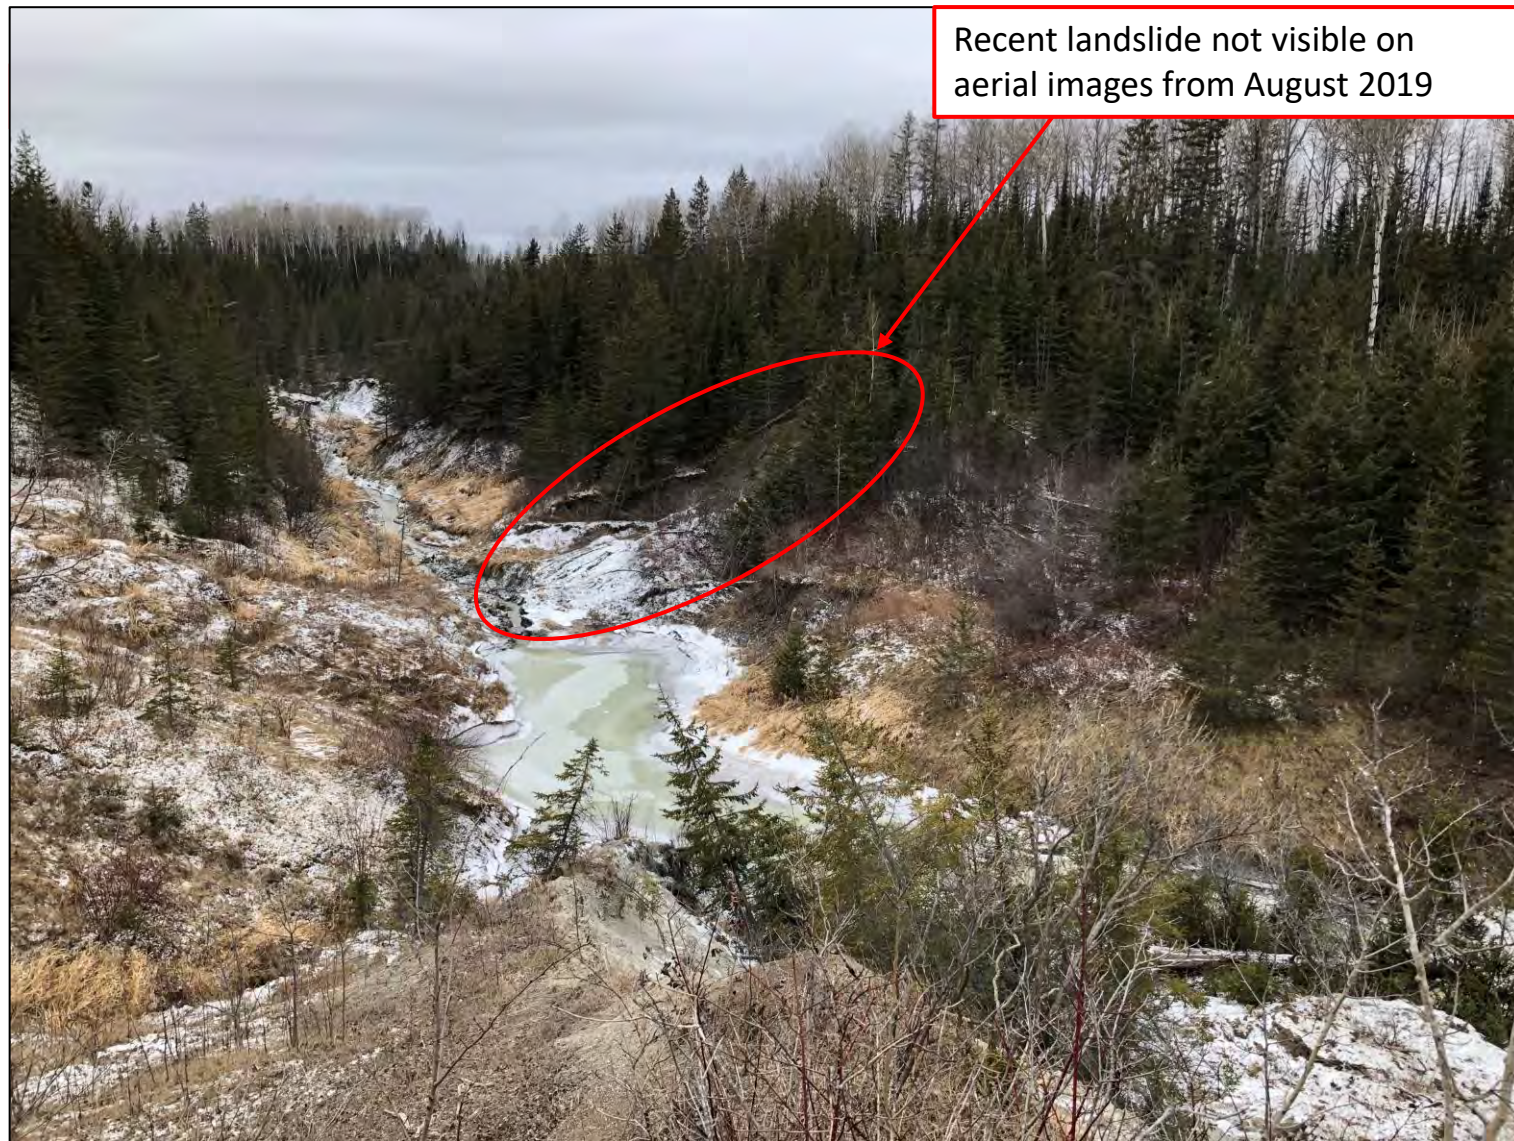
Photo 10: Looking west showing a recent landslide on the north slope of the valley, which has dammed the creek. The slide is approximately 150 m downstream of the current failure.

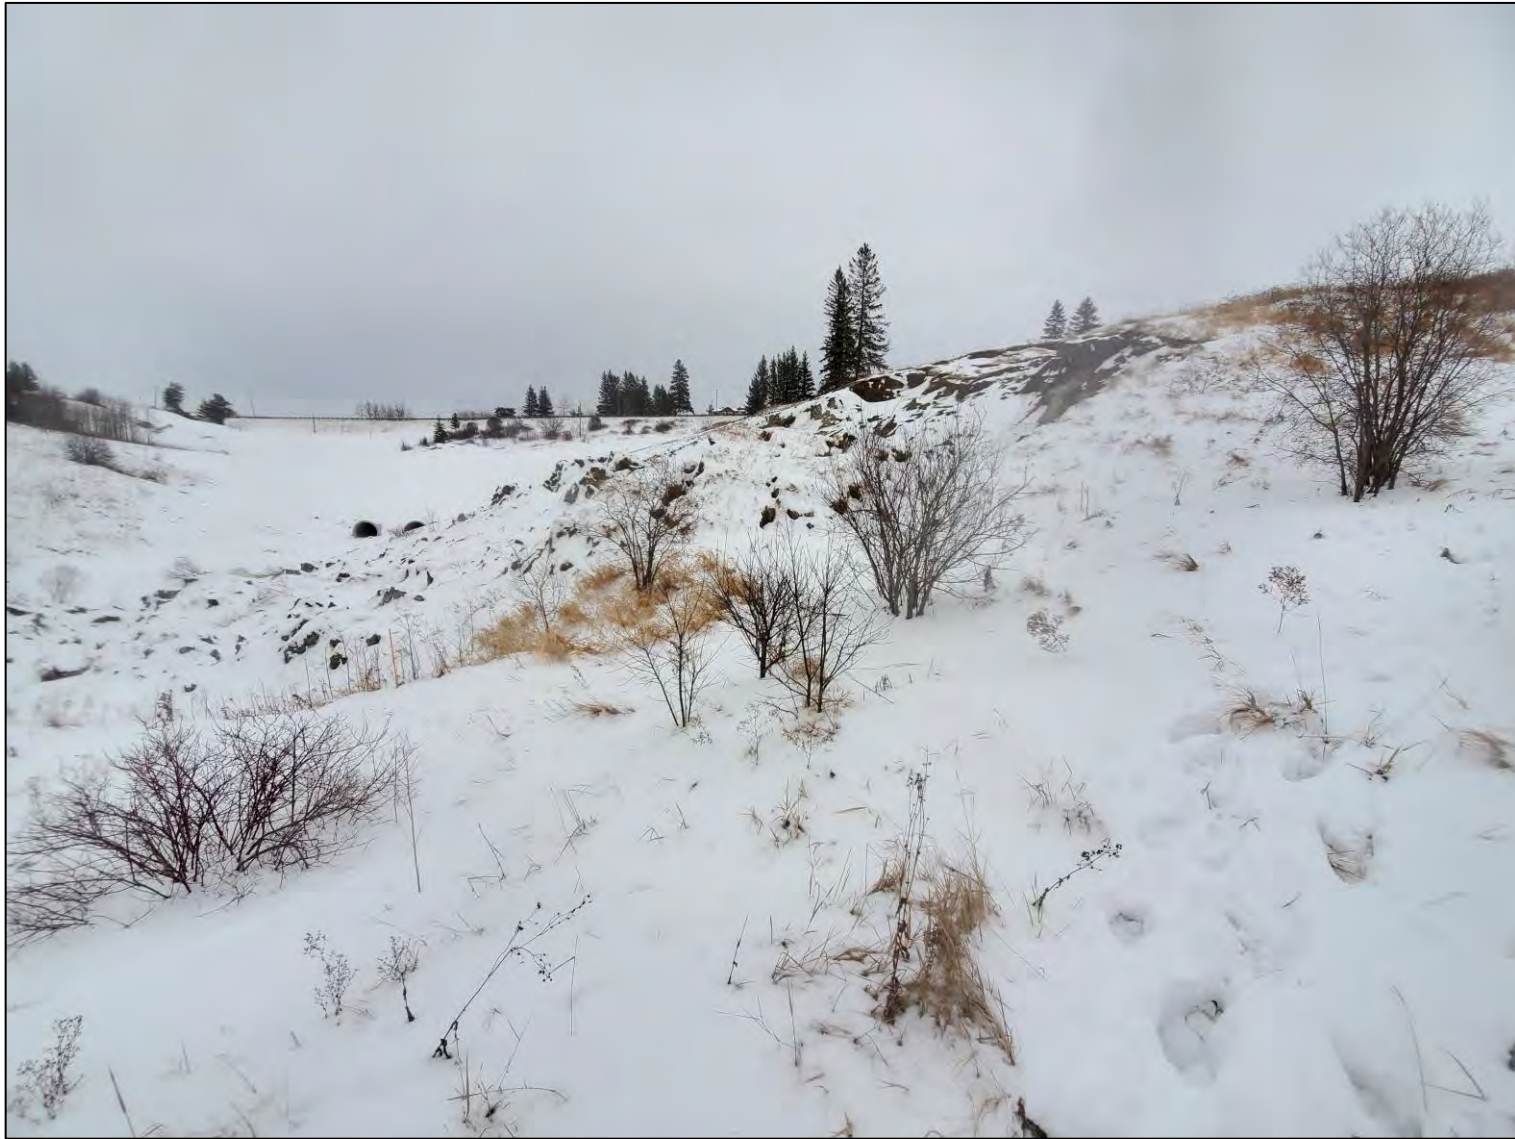
Photo 11: View looking southeast at recent landslide.

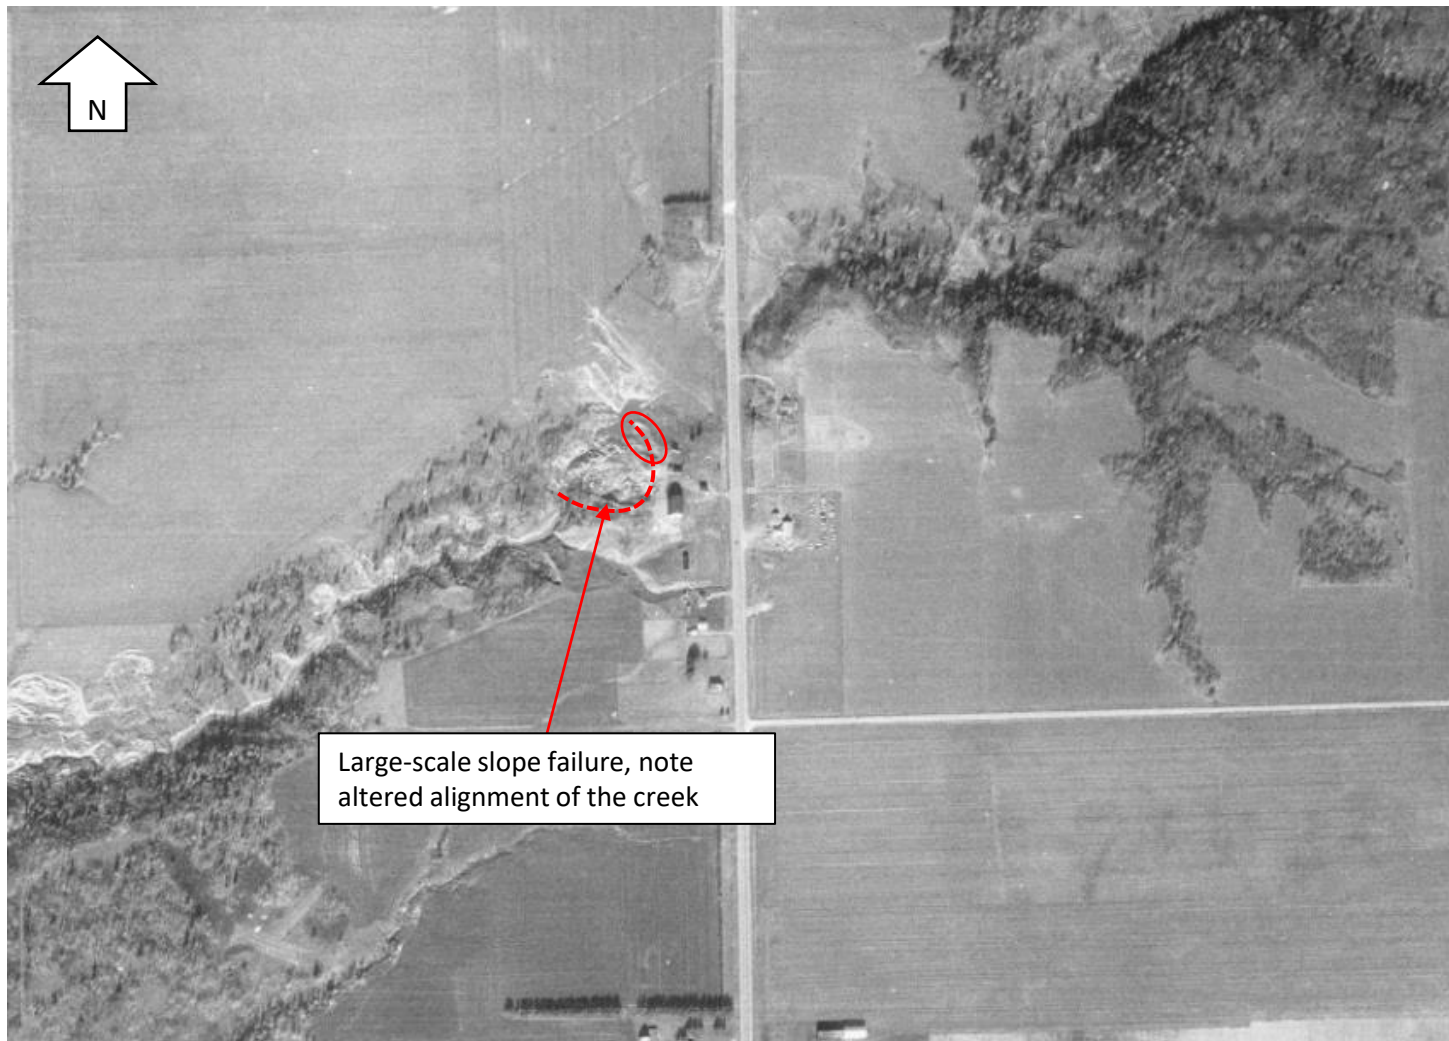
- A large landslide occurred immediately west (downstream) of the existing slope failure on the south (north-facing slope) sometime between 1963 and 1971. The landslide is not evident in the 1963 air photo, which shows an over-steepened slope and a relatively straight creek alignment. Subsequent air photos, including present Google Earth satellite imagery, show the presence of large semi-circular landslide scarp as well as a significantly altered creek alignment. The width of the previous landslide is approximately 100 to 150 m wide and 60 to 80 m long. Based on observations made during the site reconnaissance (see “bowl-like topography” of historic landslide in the photos in Appendix D), this previous failure is likely the result of a deep-seated global slope stability failure.

Large-scale slope failure, note altered alignment of the creek

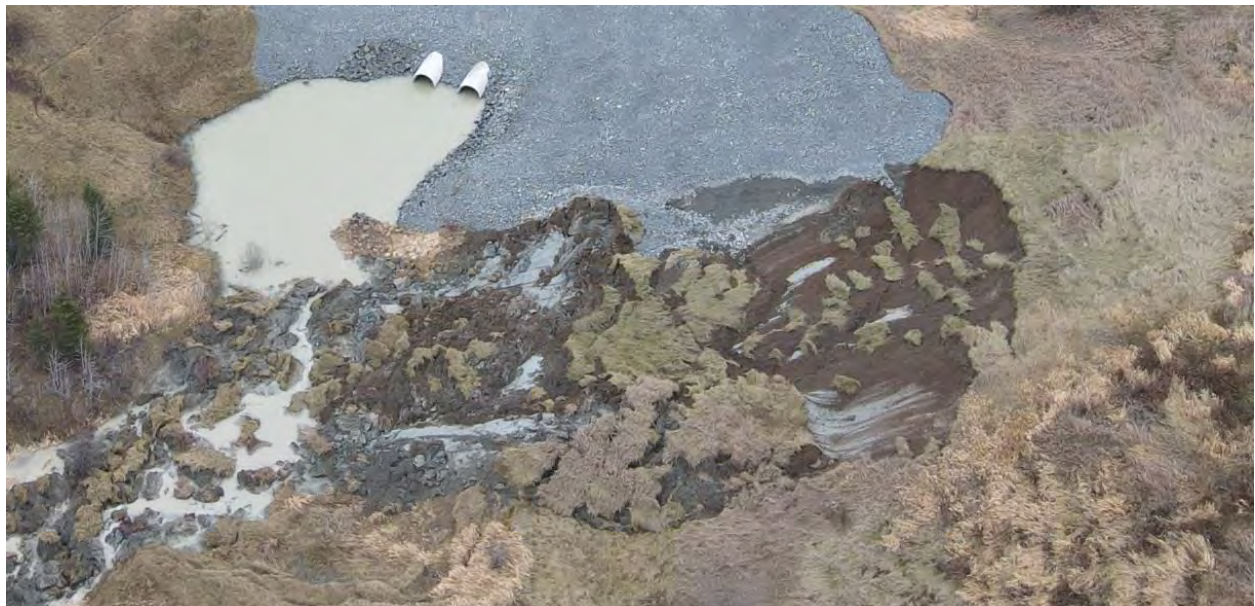
Figure 2: After Slope Failure

The CA team noted that water from the culvert outlets are still draining at a low rate as the new stream is taking shape. The slow movement of water through the stream made the pond at the outlet wider (Figure 1 when compared to figure 2).

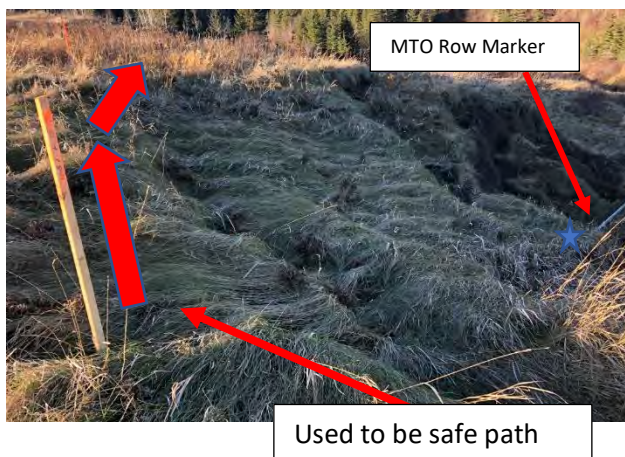
The CA team noted that a new tension crack hidden under the tall grass at the top of the failed slope was discovered today in the path that the CA used for the last 2 days as it was deemed safe then.

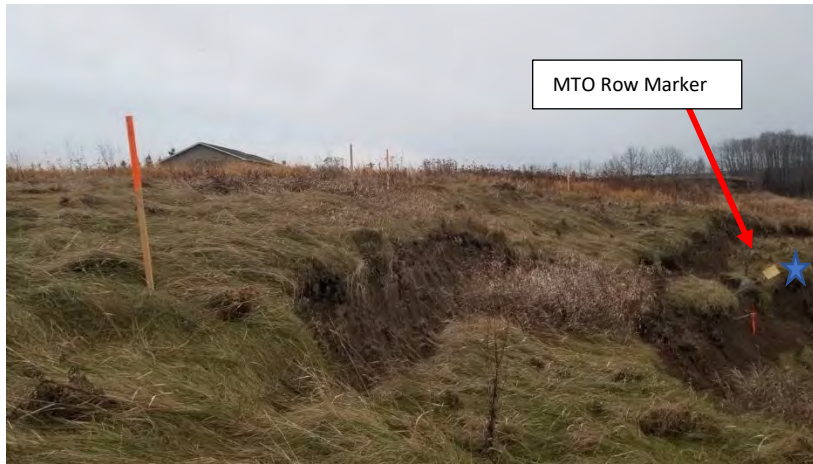
Figure 8: Top of Slope Failure on Friday 13th of Nov 2020 - No Changes from Wednesday 11th of Nov 2020

We conducted our daily survey for today. We did not note any changes from yesterday. However, in the case it will rain, the situation is most likely to change. Water level has receded to an elevation to (194.80) making a difference of .250mm since Wednesday 11 Nov 2020.

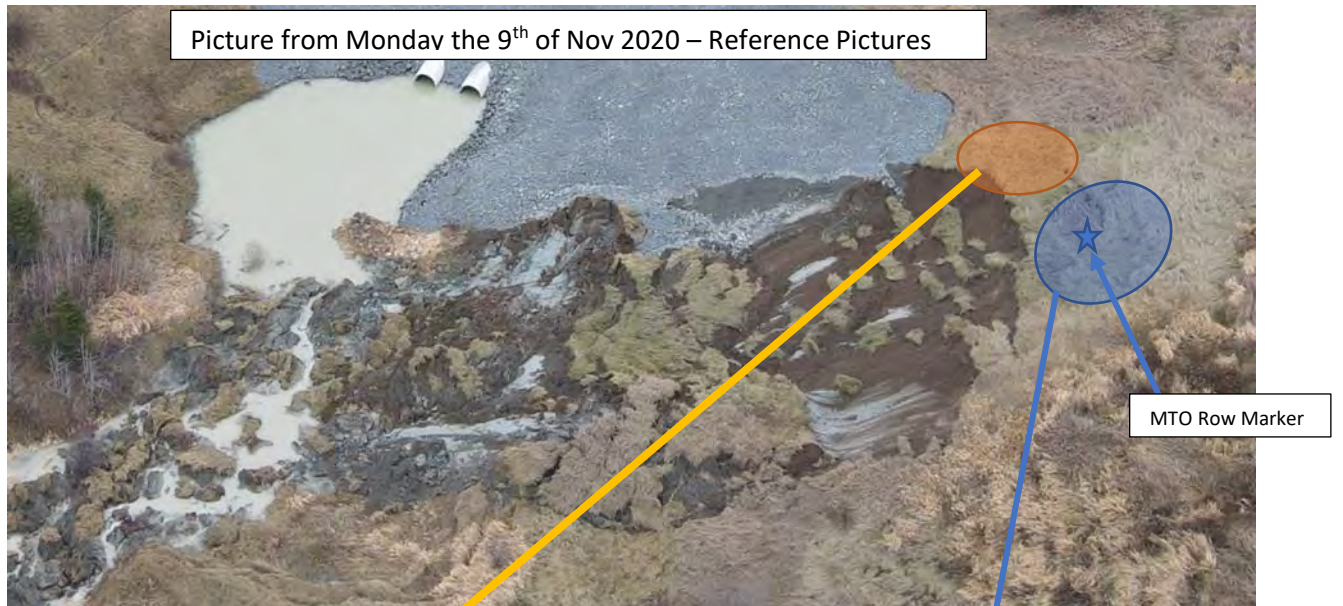
Figure 10: Top of Failed Slope Facing Easterly – 16th Nov 2020

- 1- Since Friday, the failed upper portion of the slope has shown further movement by losing more ground (see figure 10) and more tension crack appeared when compared to last Friday Nov 13th, 2020.
- 2- A new additional tension cracks has been observed East of the original noted failure (See Figure 9).

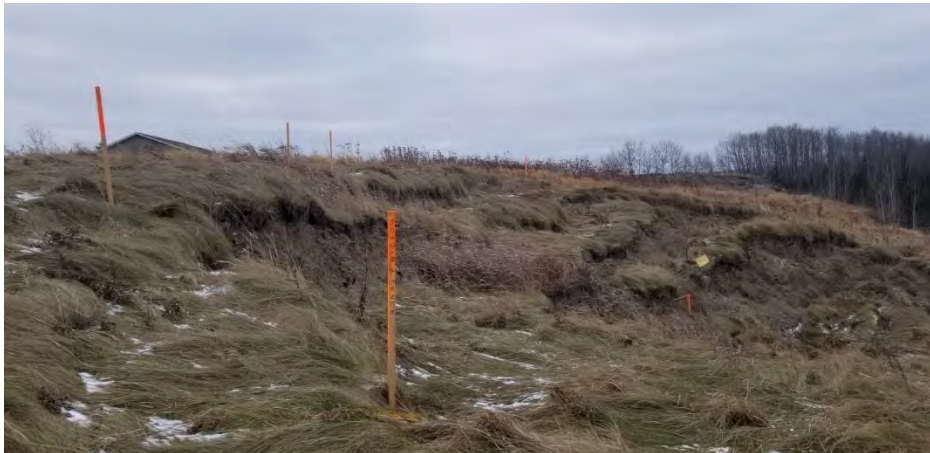
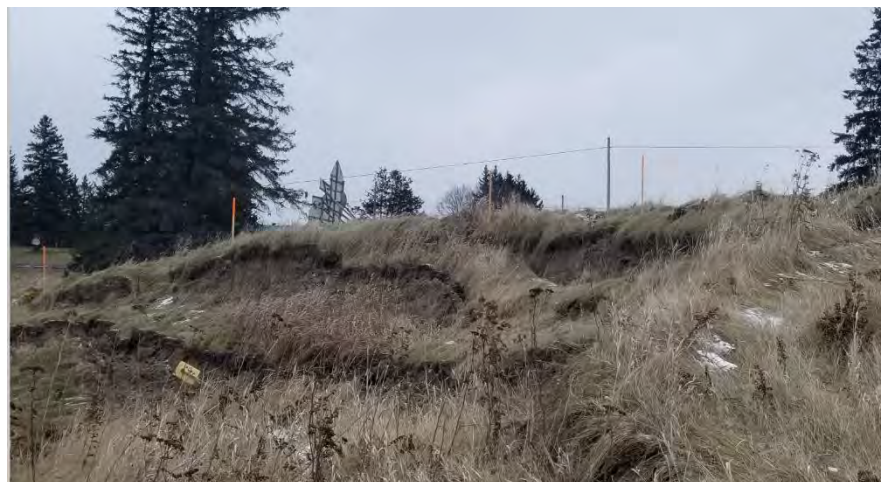
- 1- Evolution the **Blue Marked Area**: More movement were noted today when compared to yesterday pictures.

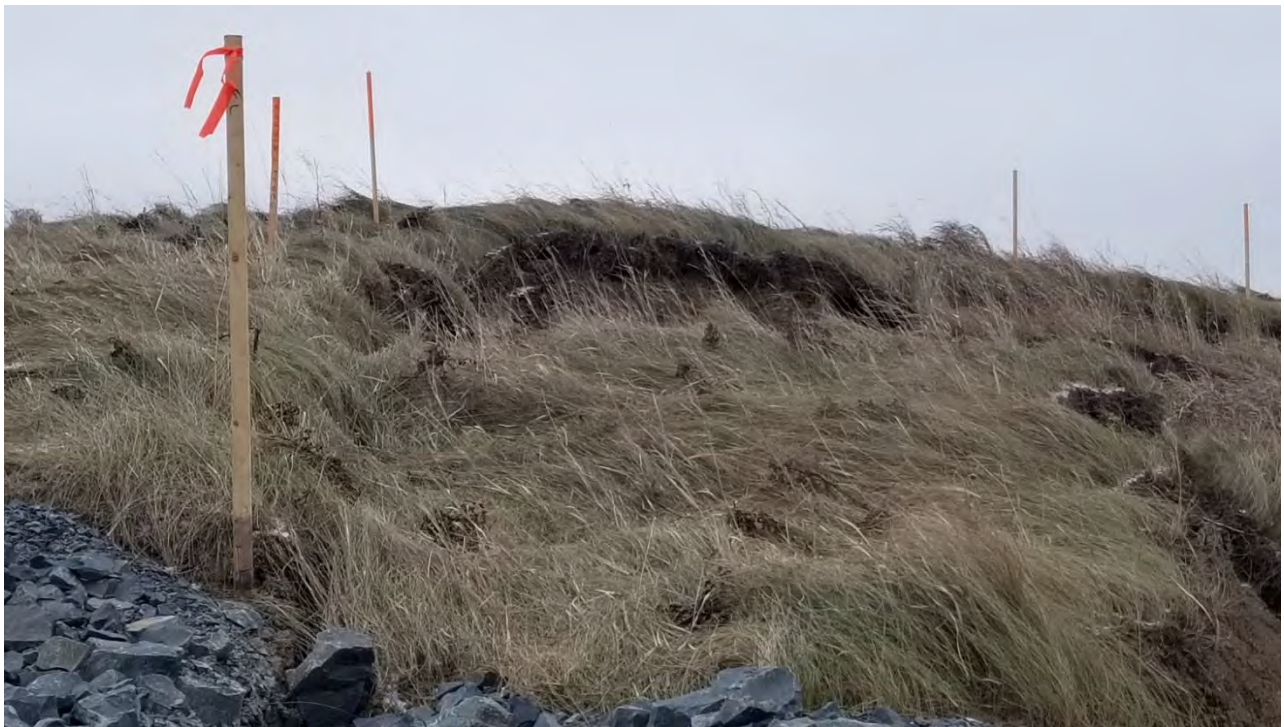
- 2- Evolution the **Orange Marked Area**: More movement were noted today when compared to yesterday pictures. The tension crack that developed between the failed slope and the rock protected area is increasing in width and length. We added (2) additional survey stakes adjacent to the ground tension cracked noted yesterday.

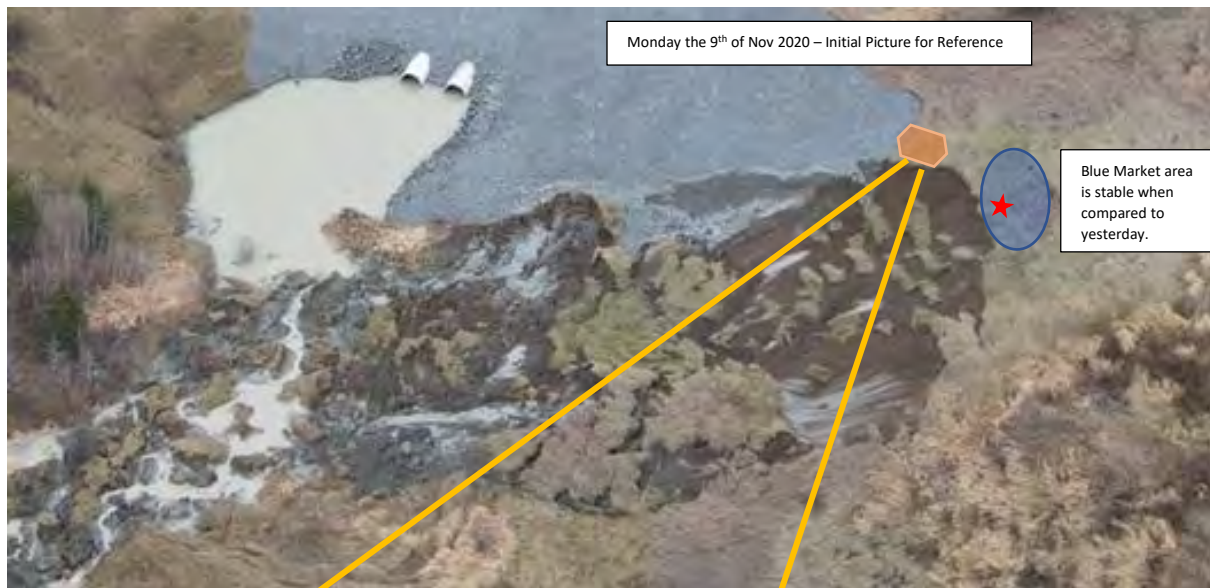
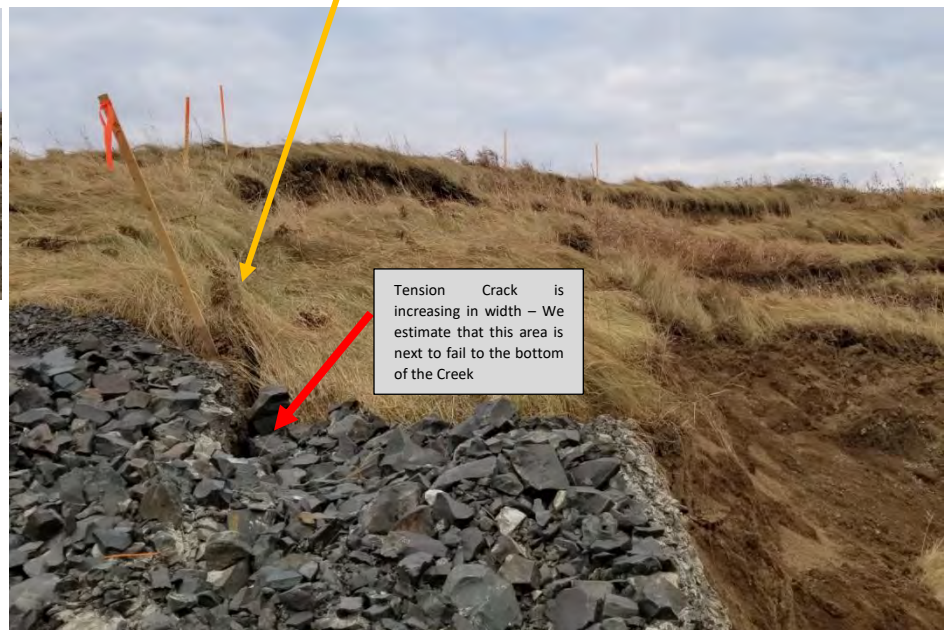
The upper portion appears to show no sign of movement. On the other hand, the recent tension crack that developed this week has showed signs of movement (Marked in Orange). Survey stake that was placed earlier this Wednesday (18th of Nov 2020) commenced to shift – See picture below.

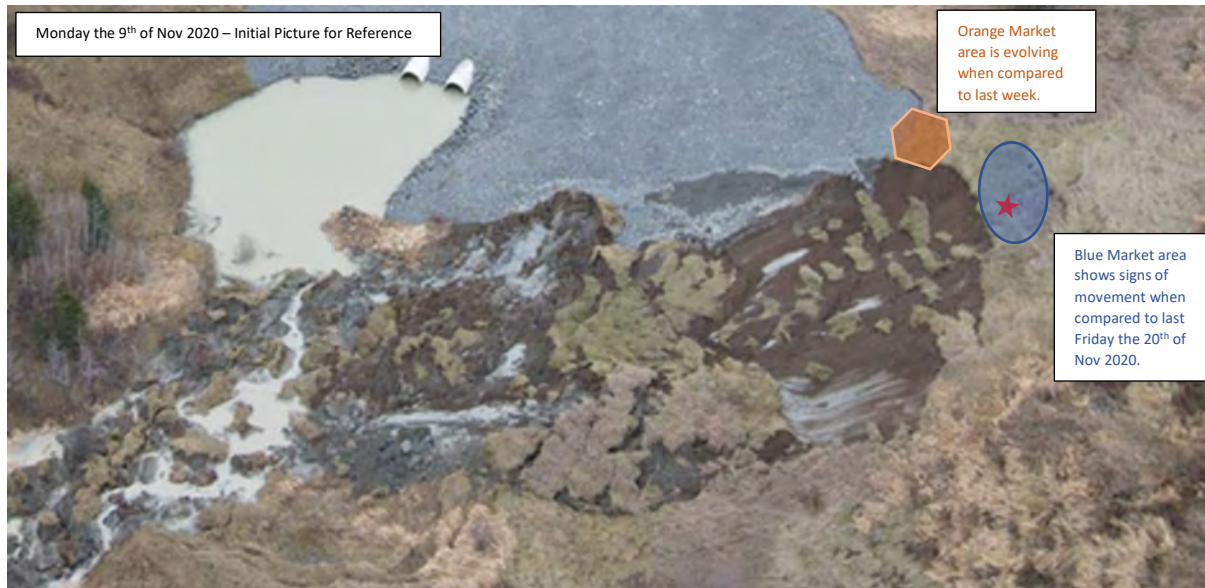
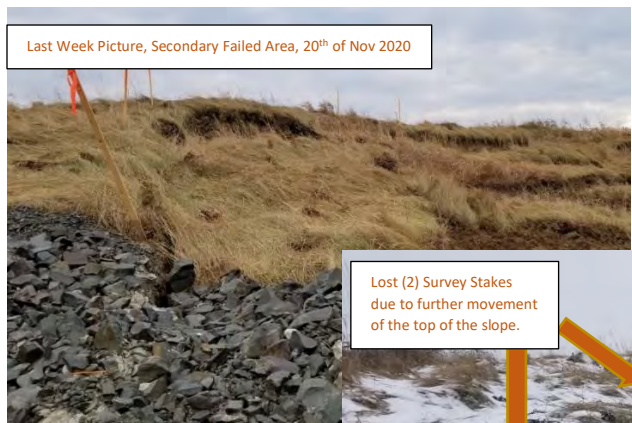
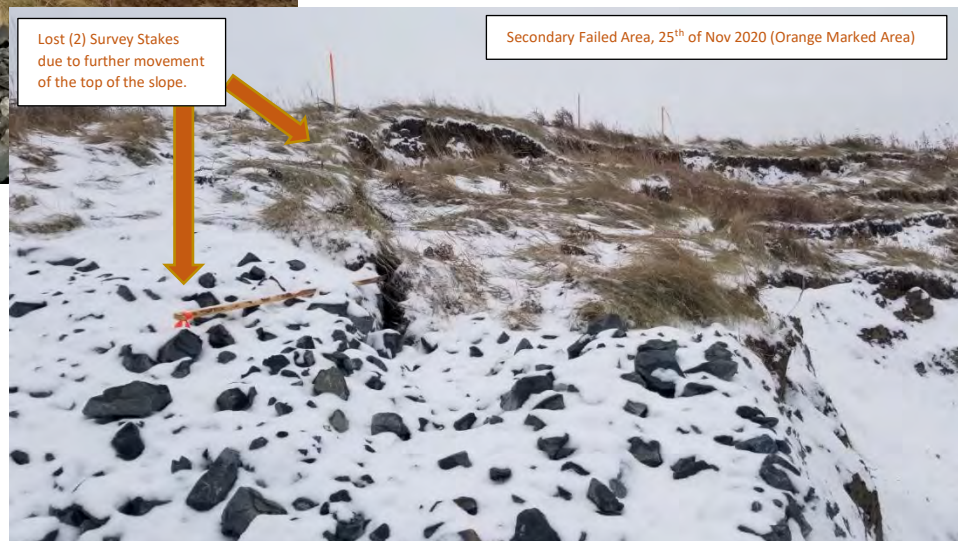
Based on today site visit, the Inspector identified that the upper portion of the south slope (Blues marked area) shows signs of movement. The secondary location (Orange marked area) that was developed last week has shown signs of further movement. There have been additional tension cracks more easterly. Inspector Installed new reference survey stakes to monitor them.

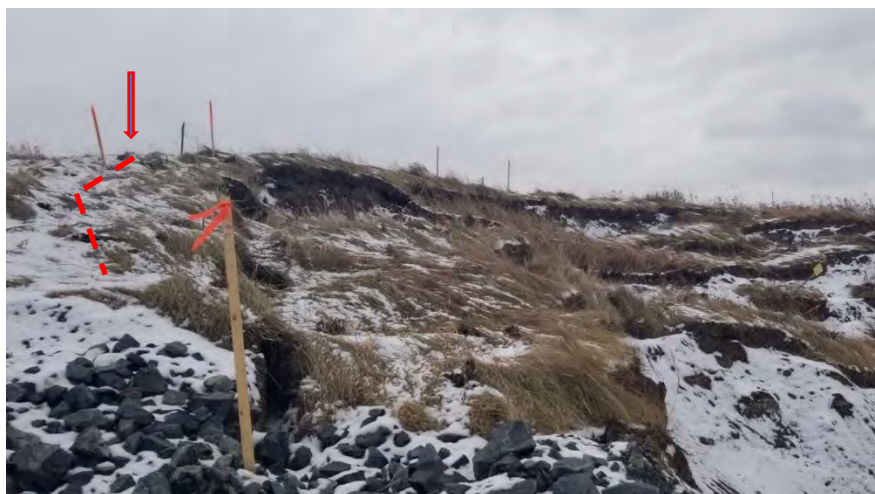
Monitoring has taken place at 12:40pm today. From observations there are no signs of changes to the downstream creek channel. On the upper portion, more Easterly, an additional tension crack has been observed at the second survey stake. The stake was placed at a predetermined location (Where a small Crack in the ground is detected). It has been confirmed that the area where stake #2 is located begun to show signs of movement.

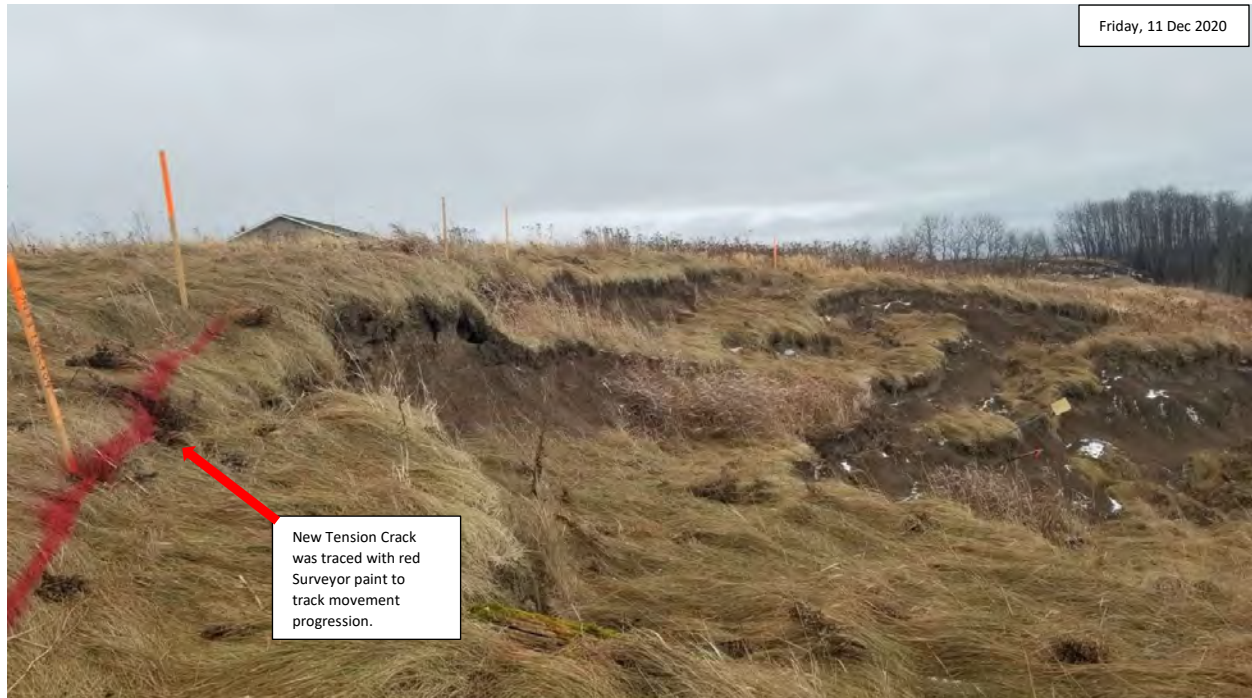
Site monitoring was conducted this morning. It was noted that the downstream creek channel shows no changes. On the upper portion of the failed slope, the latest tension crack shows signs of further movement.

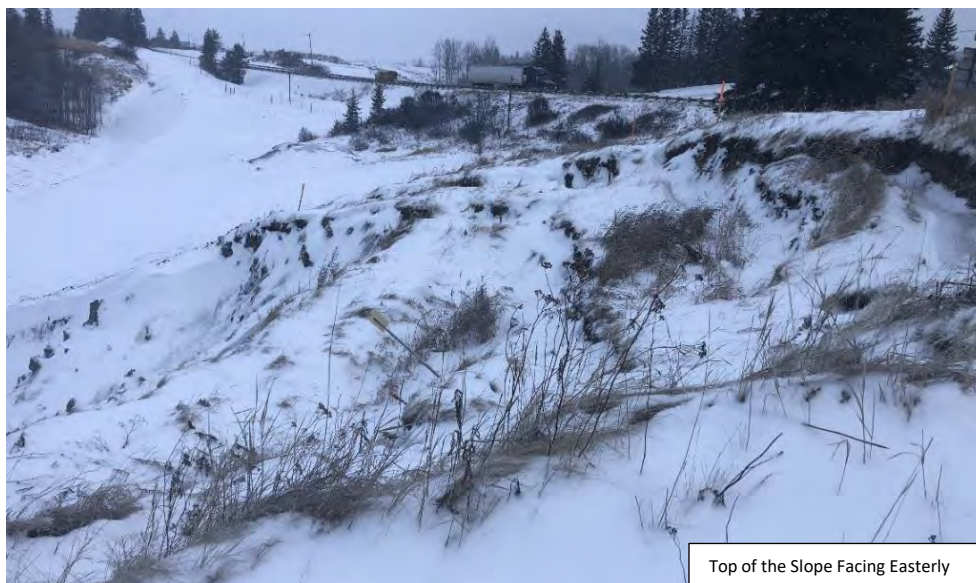
Site monitoring was conducted this morning. The upper portion of the failed slope and the latest tension crack shows no signs of movement when compared to last week.

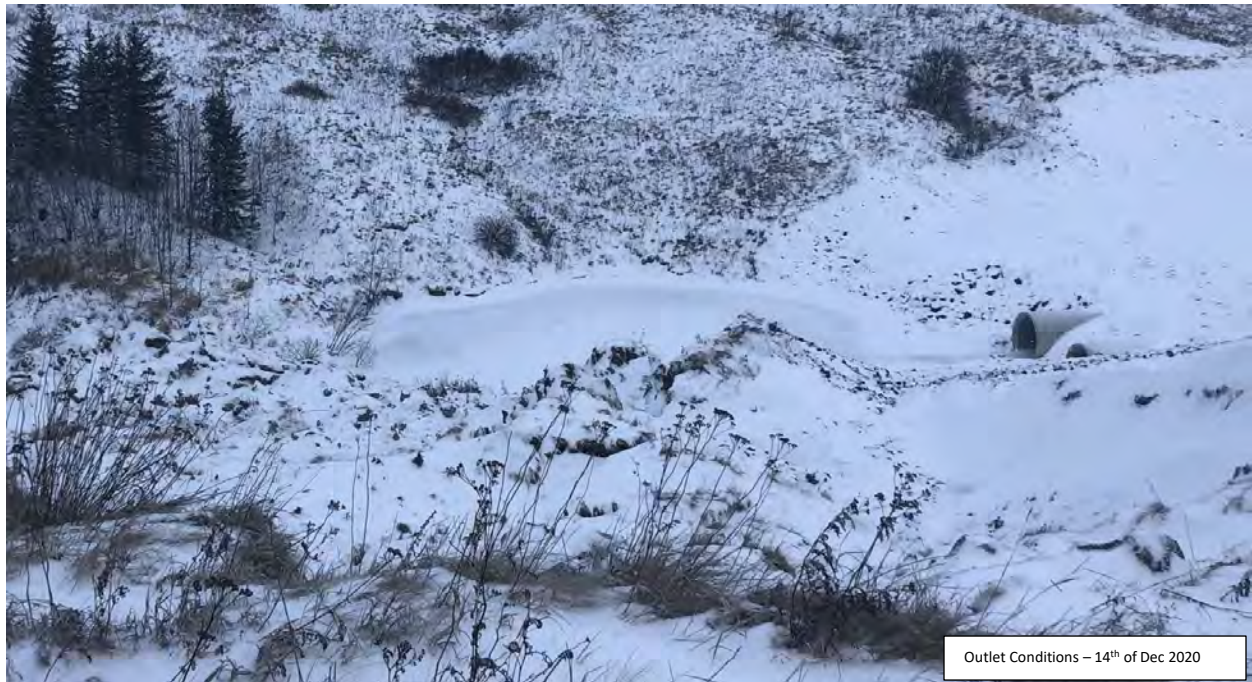
It was noted that the downstream creek channel shows no changes with exception of snow accumulations.
