**CALAMITY CREEK SLOPE FAILURE INVESTIGATION
HIGHWAY 11, 2.9 KM NORTH OF HWY 65 JUNCTION
NEW LISKEARD, ONTARIO
5018-E-0010, WORK ITEMS #7 AND #11**

G.W.P. NO. 5159-12-00

Geocres Number: 31M-133

March 2022

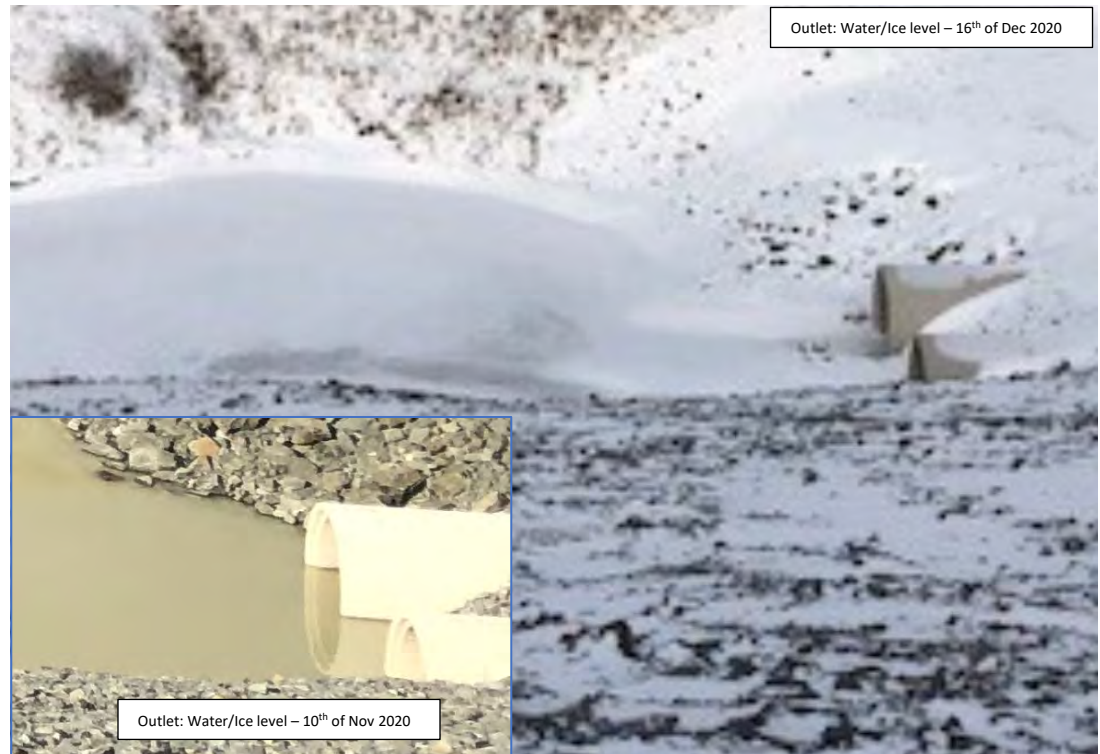
It was noted that the downstream creek channel shows no changes with exception of snow accumulations. The ice level at the culvert outlets is below the level registered on the 10th of Nov 2020.

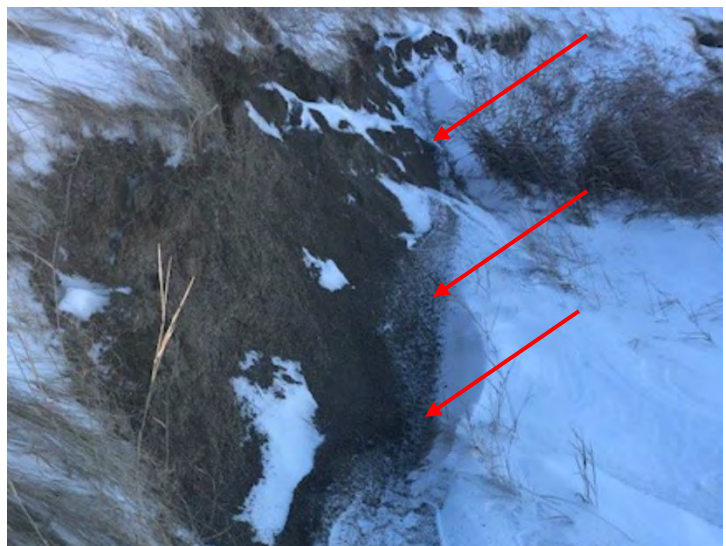
Site monitoring was conducted this morning. The upper portion of the failed slope and the latest tension crack shows no signs of movement when compared to Wednesday the 16th of Dec 2020. However, it was noted that at the top of the slope face, there were accumulation of soil on top of the snow on the ground that was not noted last Wednesday (16th Dec 2020). It is in the CA opinion that the wind blew around soil particles on top of the snow on the ground and it is not a sign of any movement. .
