FOUNDATION INVESTIGATION REPORT
For

Failure of Approach Embankments
Overhead Structure at the Crossing of
Hwy. #140 and C.N.R.

Township of Humberstone, County of Welland
W.O. 72-11025 --- W.P. 60-60-02

FOUNDATION INVESTIGATION REPORT
For
Failure of Approach Embankments
Overhead Structure at the Crossing of
Hwy. #140 and C.N.R.
Township of Humberstone, County of Welland
W.O. 72-11025 -- W.P. 60-68-02

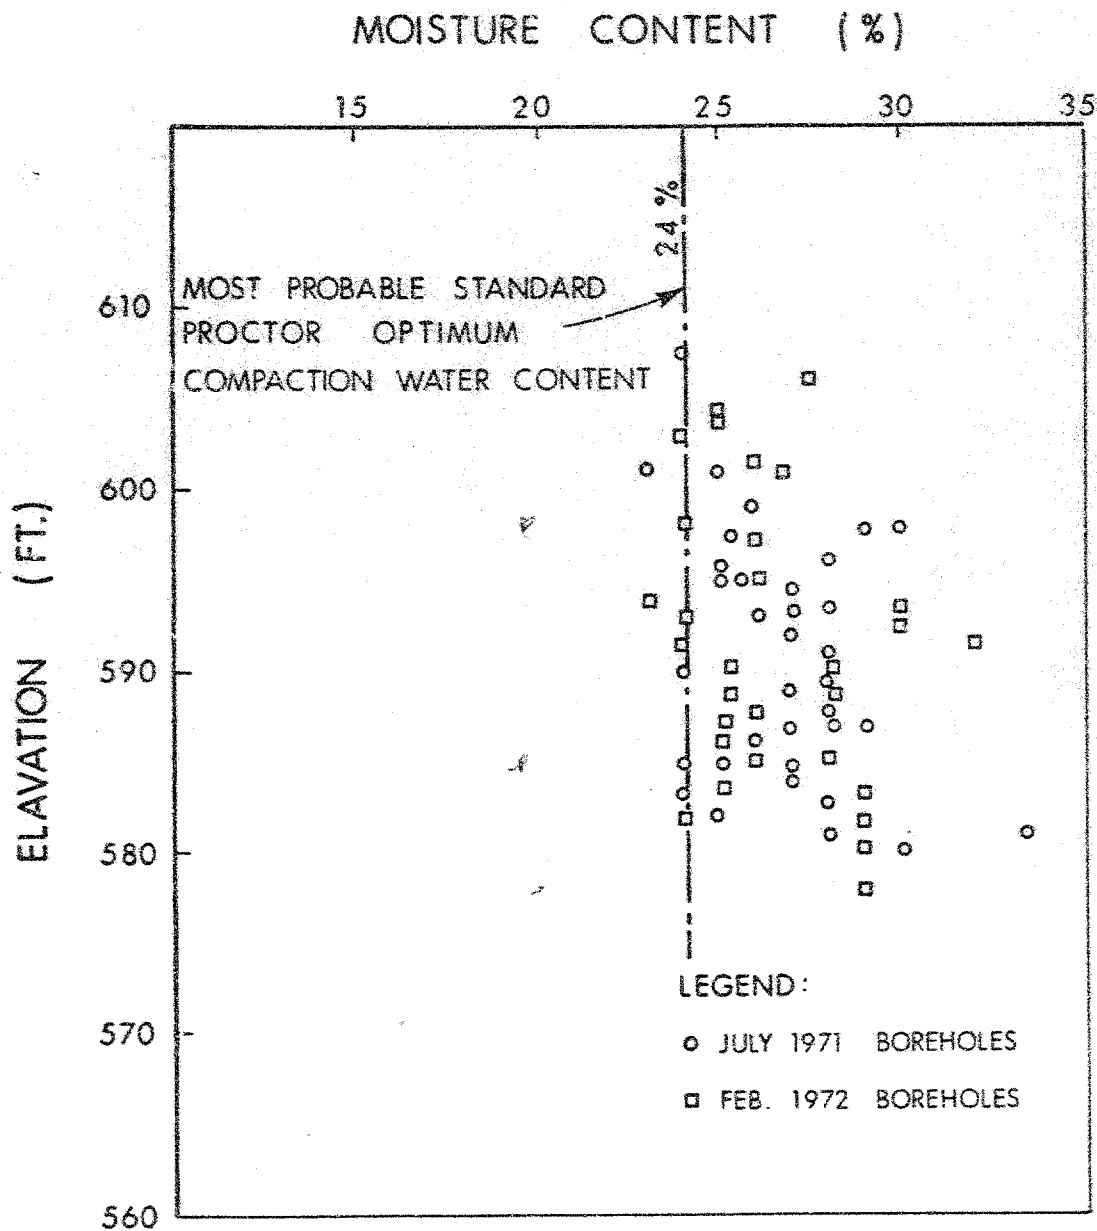
FIG. 3

Referring to these values it can be seen that in many areas throughout the fill, particularly in the lower zones, the in-place moisture content is considerably higher than the optimum compaction water content. This is graphically illustrated on Figure #3 appended to this report.
