DEPARTMENT OF HIGHWAYS ONTARIO

FOUNDATION INVESTIGATION

D.H.O. Patrol Yard at Wainfleet,
Lot 7, Con. II, Twp. of Wainfleet,
Hwy. 3, District 4.
W.J. 63-F-105 -- W.P. (Nil).

WAINFLEET PATROL YARD

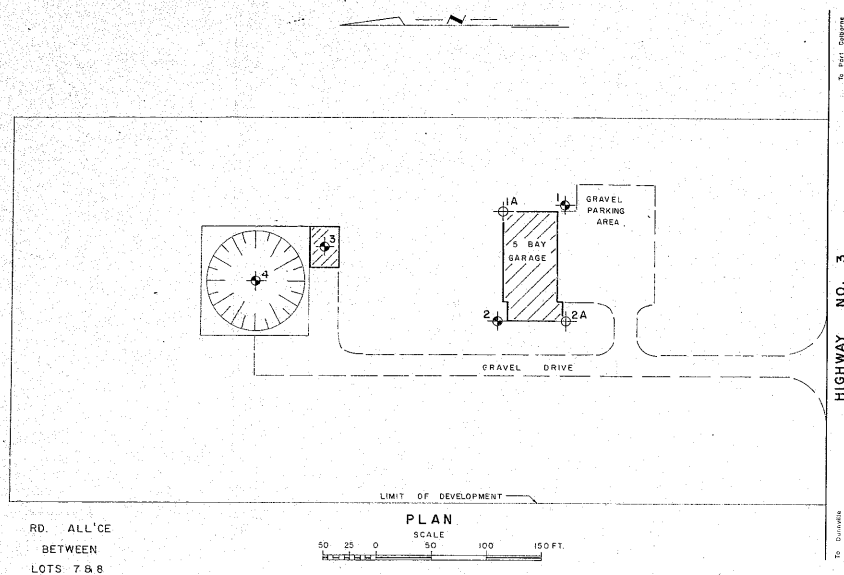
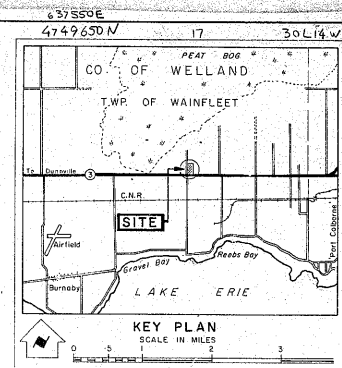
ORIGINATED V. KORLU 7/74	DISTRICT NO. 4	DATE OCT 4, 1963
DRAWN F. CLARK	W.P. NO.	JOB NO. 63-F-105
CHECKED J. J. J.	SCALE	DRAWING NO.
APPROVED P. J. J.	AS SHOWN	63-F-105 A

The field investigation consisted of three sampled boreholes and two dynamic cone penetration tests. The locations and elevations of these boreholes are shown on the attached Dwg. No. 63-F-105A.

The site is generally covered with a thin layer of topsoil followed by 2 to 5.5 ft. thick silty clay till followed by limestone bedrock.

No water was observed in any of the boreholes during the time of the investigation.

The proposed garage and other buildings can be supported on spread footings founded on limestone bedrock. No stability problems are anticipated for the proposed sand pile.
