FOUNDATION INVESTIGATION REPORT

For  
Embarkment Settlements at Hwy. #58 and  
Forkes Road  
District #4, Hamilton

W.P. 78-73-01

W.O. 73-11097

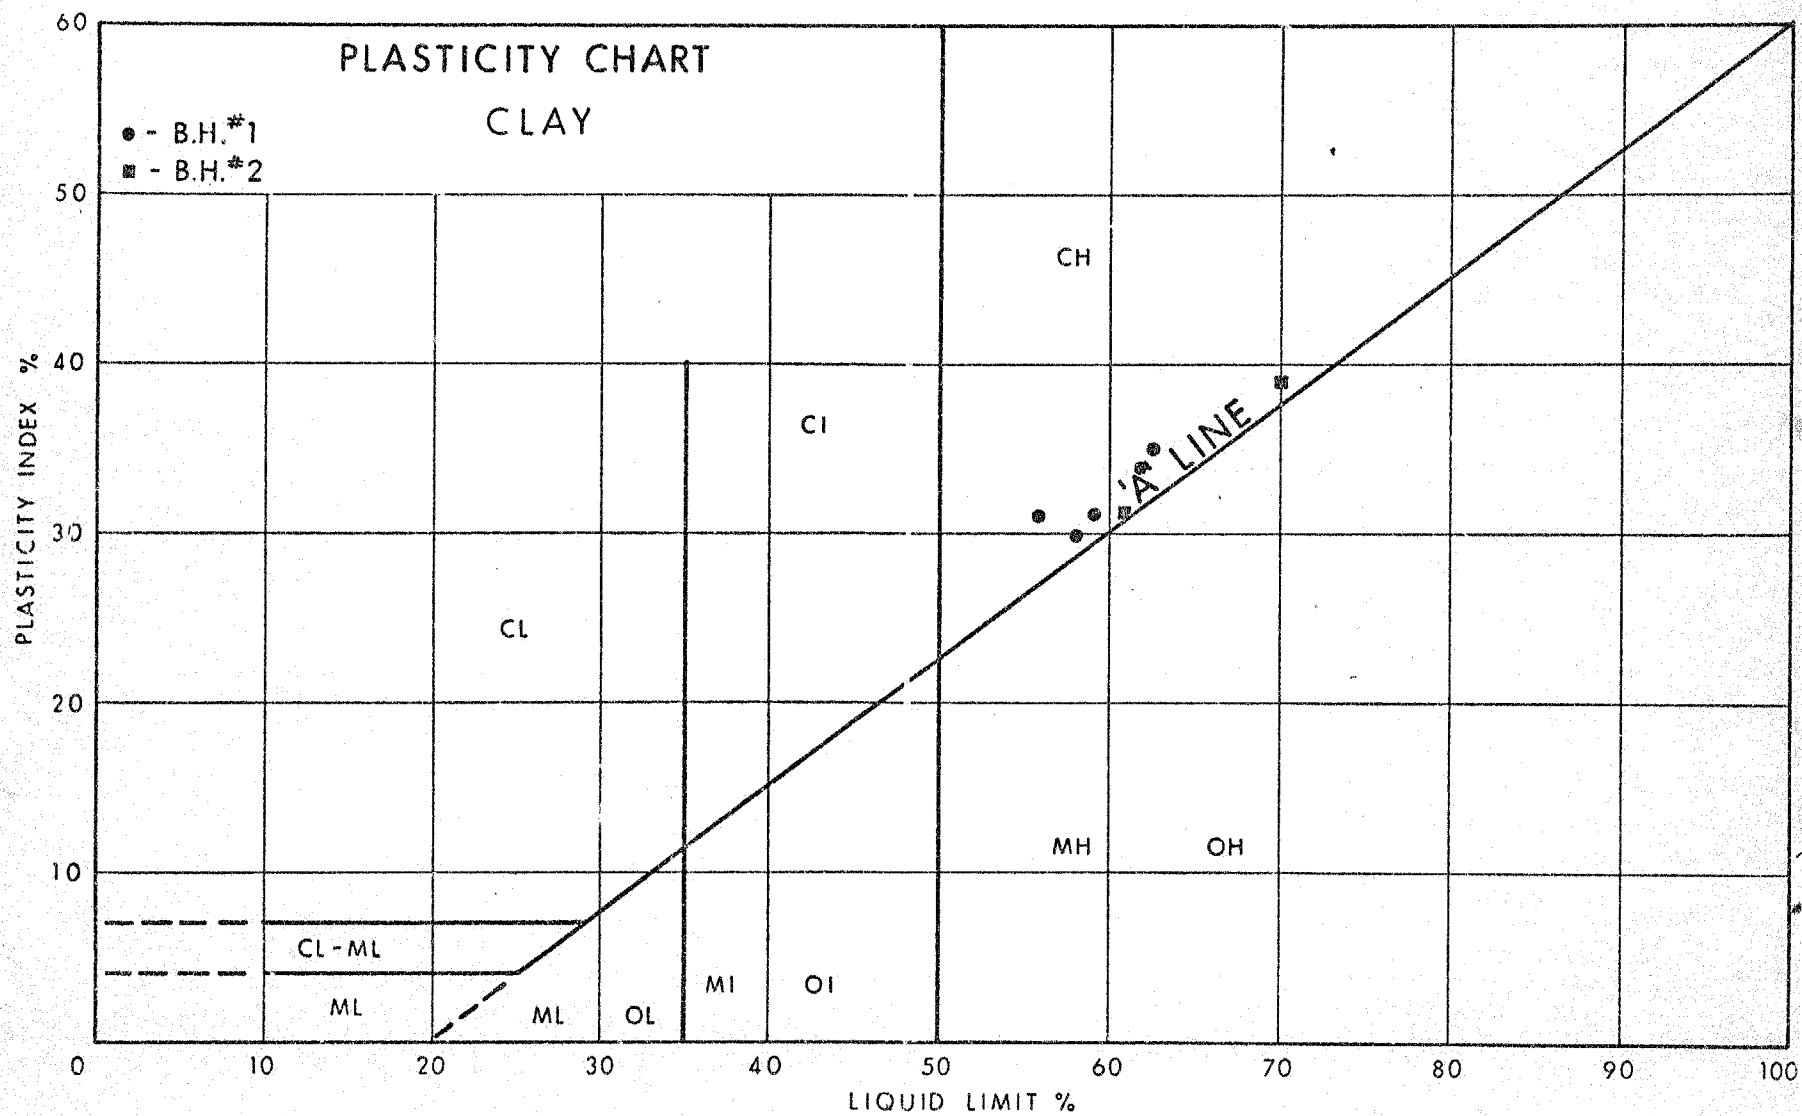
FIG. 1

The layered and mottled material had liquid limits ranging from 62-70%, plastic limits ranging from 28-31% and natural moisture content ranging from 27-37%. In general, the moisture content was below the plastic limit indicating the material to be overconsolidated; due probably to desiccation. The layered material was slightly more plastic than the mottled material. Figure 1 is a detailed plasticity chart for the entire cohesive deposit.

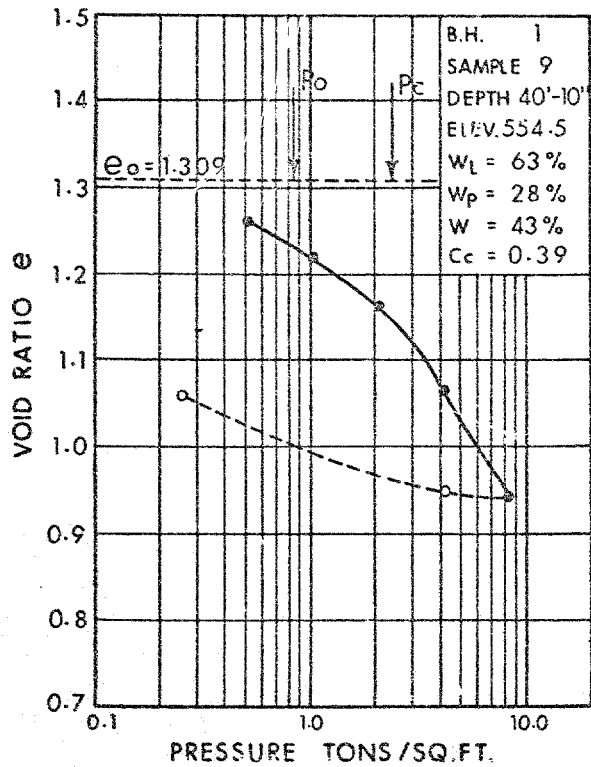
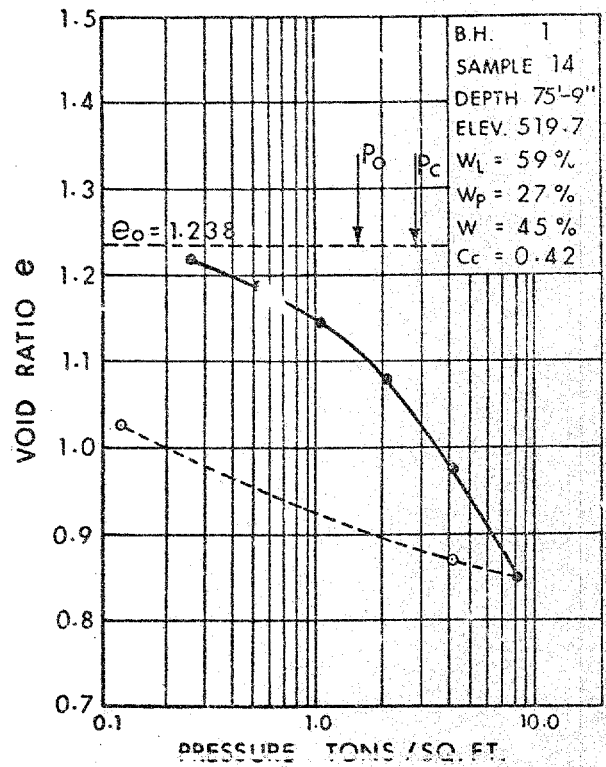
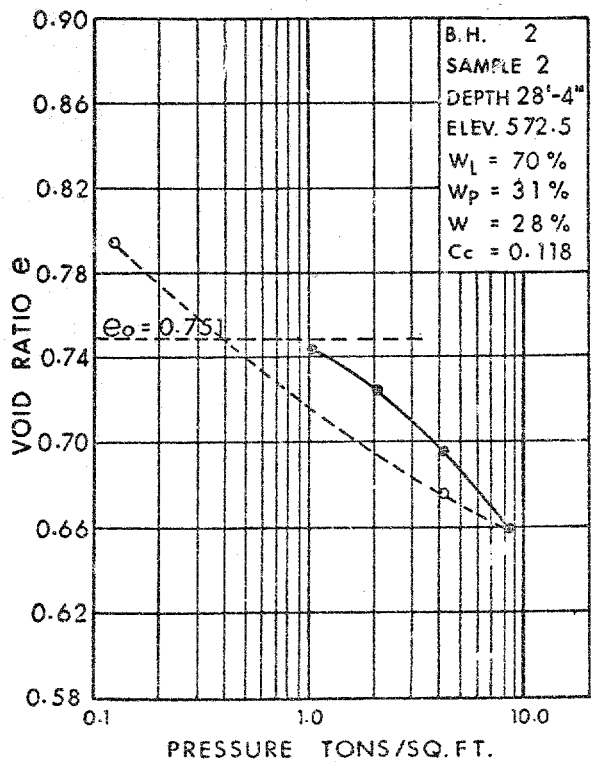
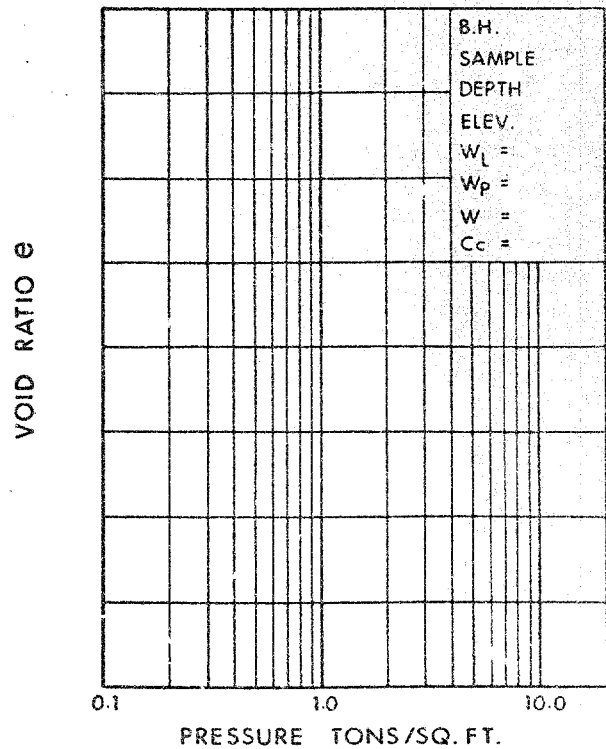
FIG. 2

The results of the consolidation tests conducted are presented in graphical form in figure 2. Interpretation of these results to obtain preconsolidation pressures was made using the Casagrande and Schmertmann construction if possible.

Based on the consolidation test results, it appears that the deposit is lightly overconsolidated below elevation 565  $\pm$  ft. (172.2 m). Above this elevation, the material is more heavily overconsolidated due probably to desiccation. Within this desiccated crust very little if any consolidation settlement can be expected.

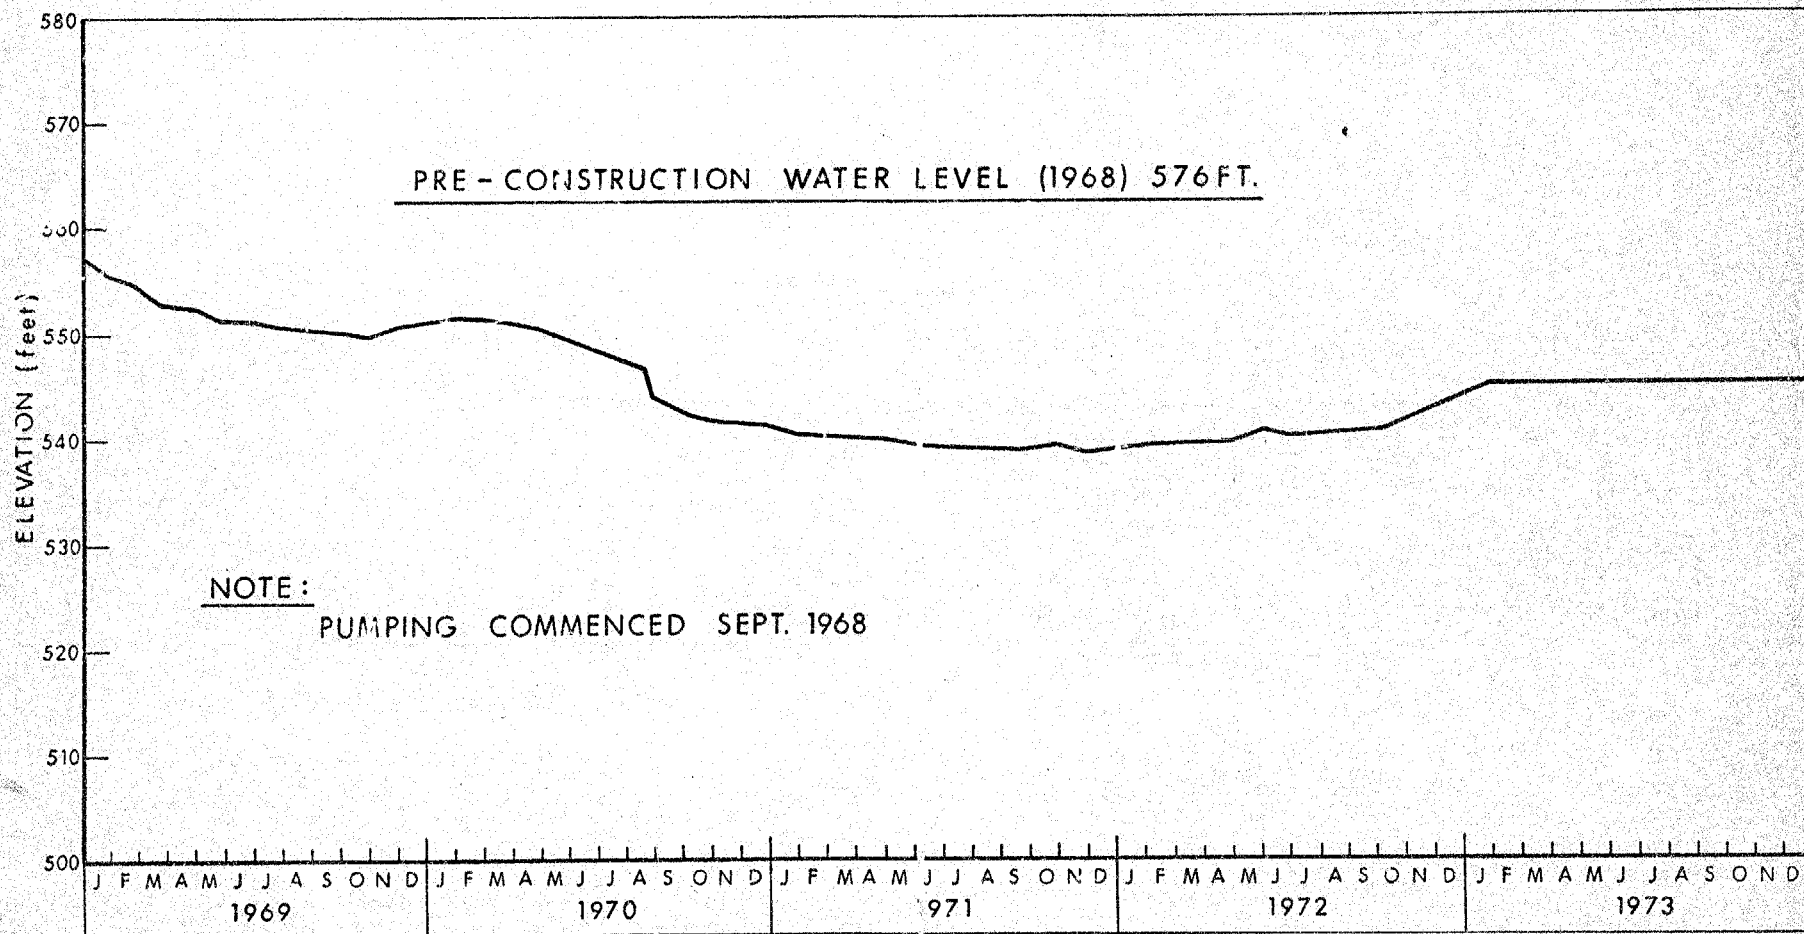
FIG. 6

Pre-channel relocation groundwater levels at Forkes Road and Hwy. 58 (ie. prior to 1969) were at elevation  $575 \pm$  ft. (175 m). By mid 1971 the steady state drawdown conditions had lowered the water levels some 35 ft. (10.7 m) to elevation  $540 \pm$  ft (164.5 m). The piezometer reading in December 1973 indicated groundwater levels to be at elevation  $545 \pm$  ft. (166.1 m). See figure 6 for a plot of water level variations versus time.

As previously discussed under the section on groundwater conditions there has been a lowering of the general groundwater levels in this area by some  $30 \pm$  ft. (9.14 m); this drawdown being the result of pumping water from the aquifer below the cohesive deposits in the area, by the St Lawrence Seaway Authority, in connection with the relocation of the Welland

VARIATION IN PIEZOMETRIC LEVEL IN ROCK AQUIFER, VICINITY OF FORKES ROAD AND HWY. 58  
DUE TO GROUND WATER DRAWDOWN BY: ST. LAWRENCE SEAWAY AUTHORITY PUMPING OPERATIONS.
