FOUNDATION INVESTIGATION REPORT  
For  
Embankment Settlements at Hwy. #58 &  
C.N.R. Overpass  
District #4, Hamilton  
W.P. 78-73-02 W.O. 73-11098

# FOUNDATION INVESTIGATION REPORT

Embankment Settlements at Hwy. #58 and C.N.R. O'Pass  
District #4, Hamilton

W.P. 78-73-02

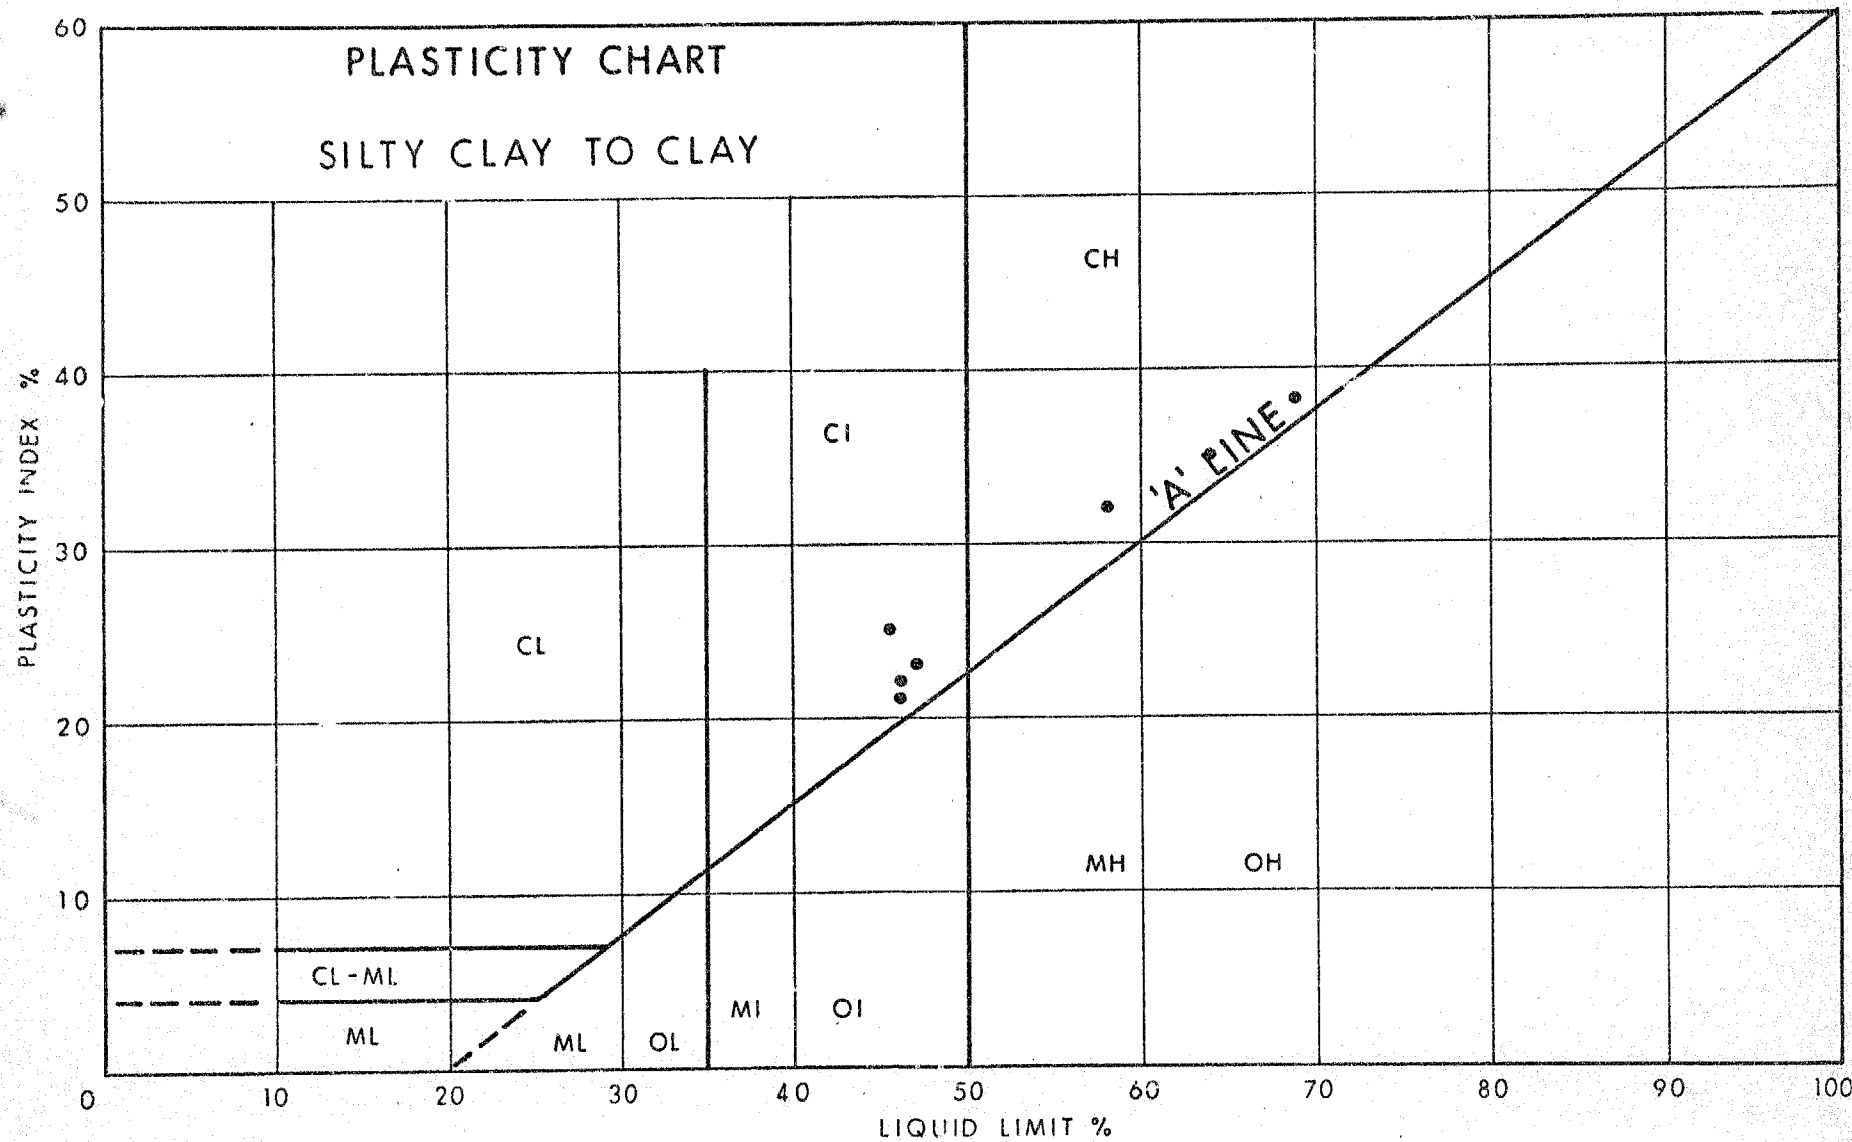
FIG. 1

The layered and mottled material had liquid limits ranging from 58-69%, plastic limits ranging from 26-31% and natural moisture content ranging from 25-40%. In general, the moisture content was below the plastic limit indicating the material to be overconsolidated, due, probably to desiccation. The layered material was slightly more plastic than the mottled material. Figure 1 is a detailed plasticity chart for the entire cohesive deposit.

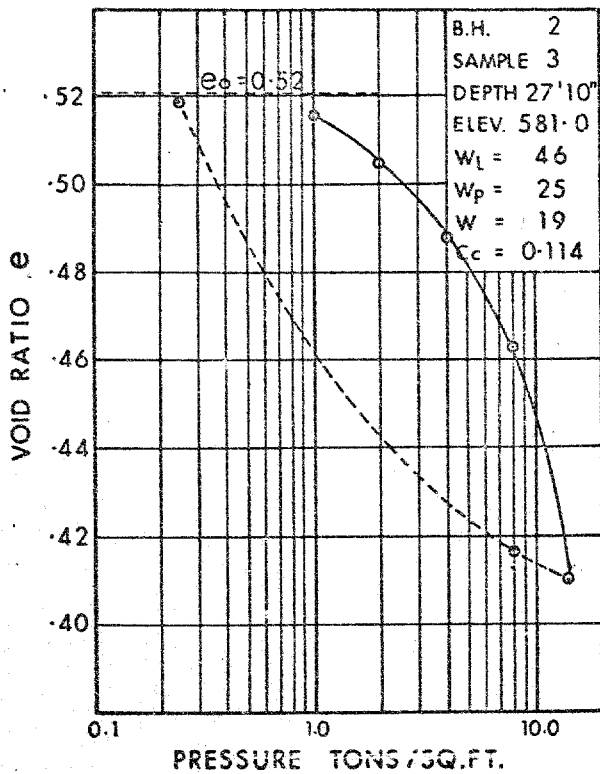
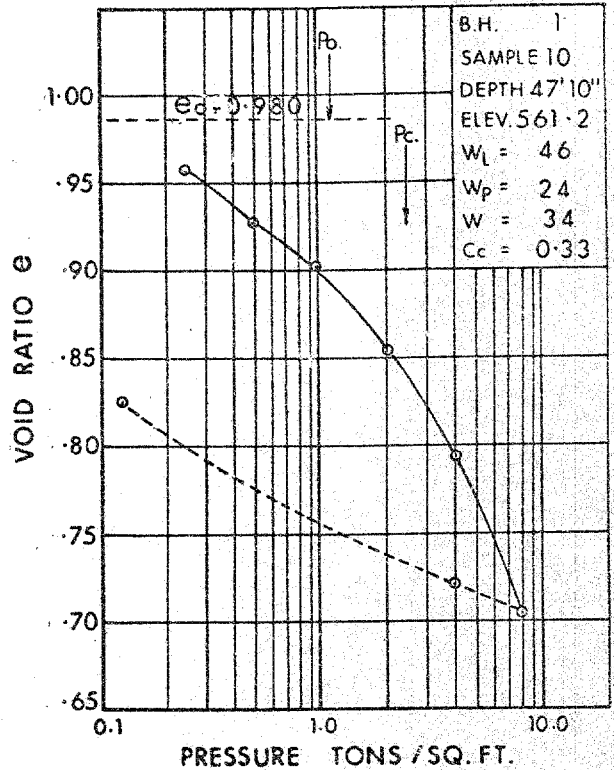
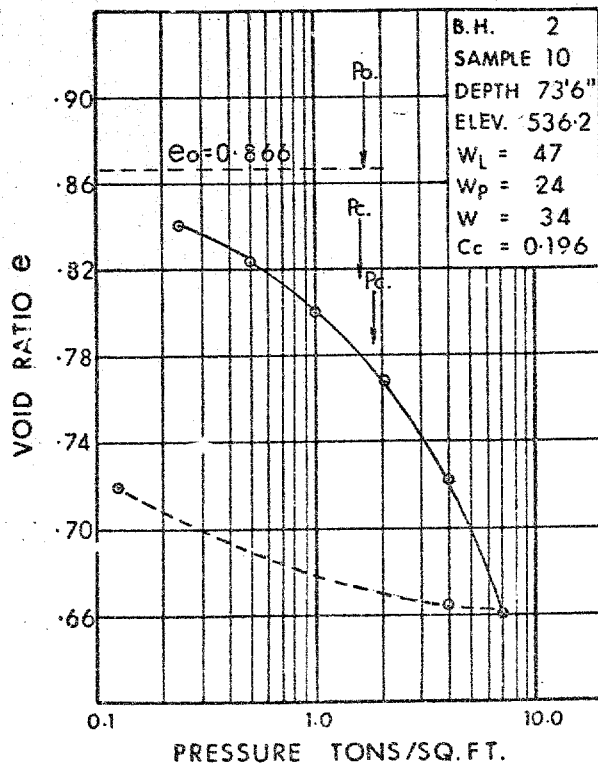
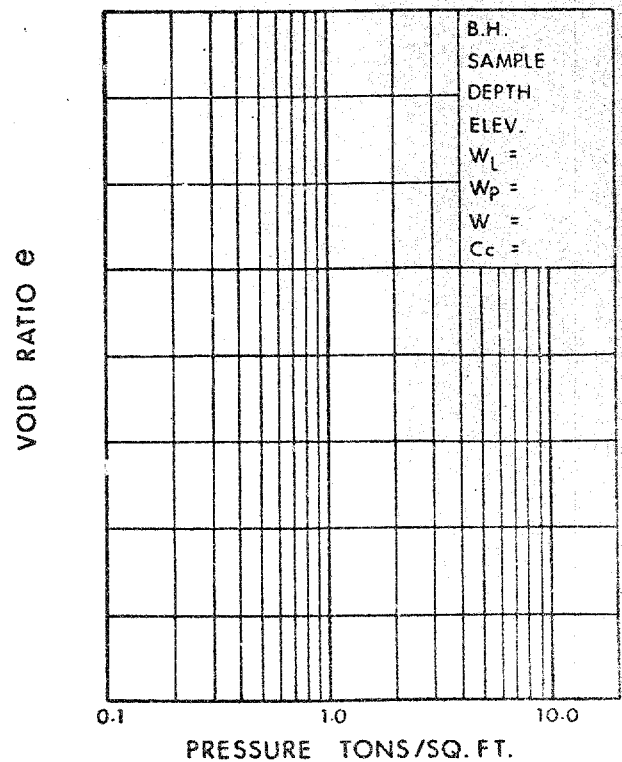
FIG. 2

The results of the consolidation tests conducted are presented in graphical form in figure 2. Interpretation of these results to obtain preconsolidation pressures was made using the Casagrande and Shmertmann construction if possible.

Based on the consolidation test results, it appears that the deposit is lightly overconsolidated below elevation 565+ ft. (172.2 m). Above this elevation, the material is more heavily overconsolidated due probably to dessication. Within this dessicated 'crust' very little if any consolidation settlement can be expected.

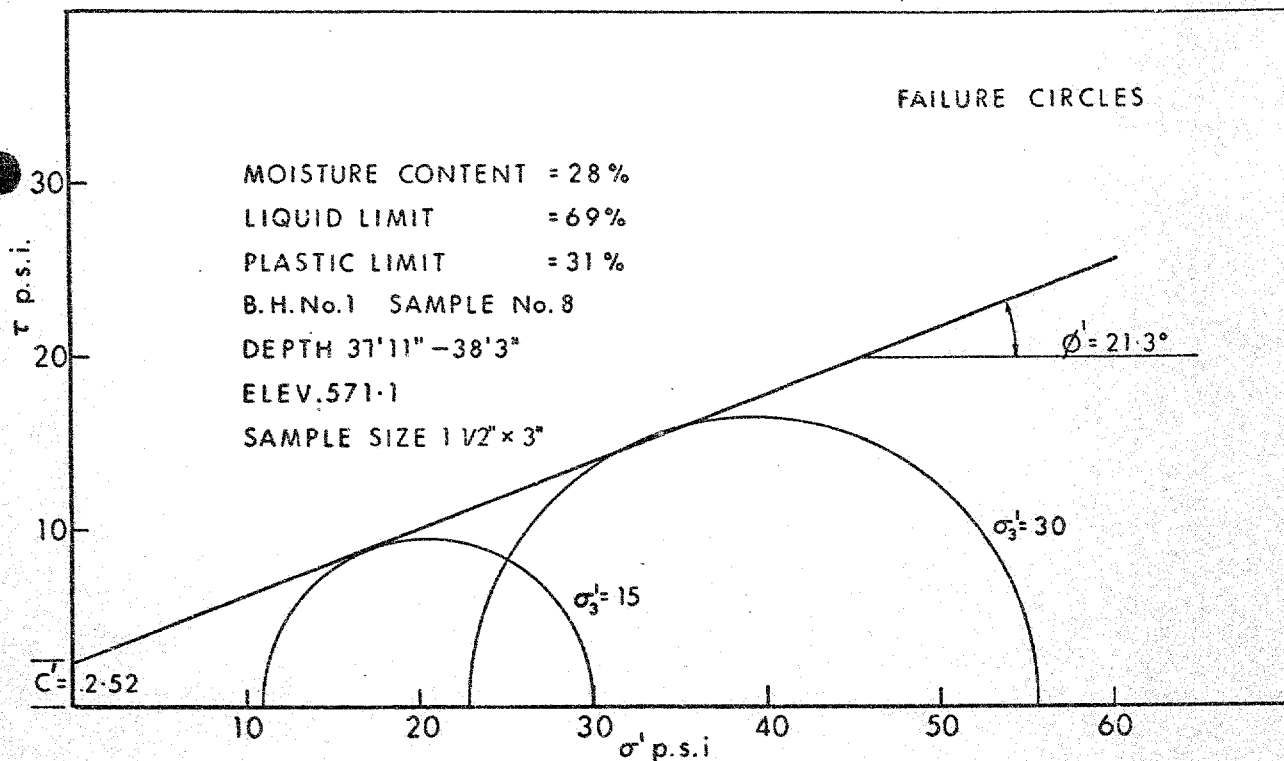
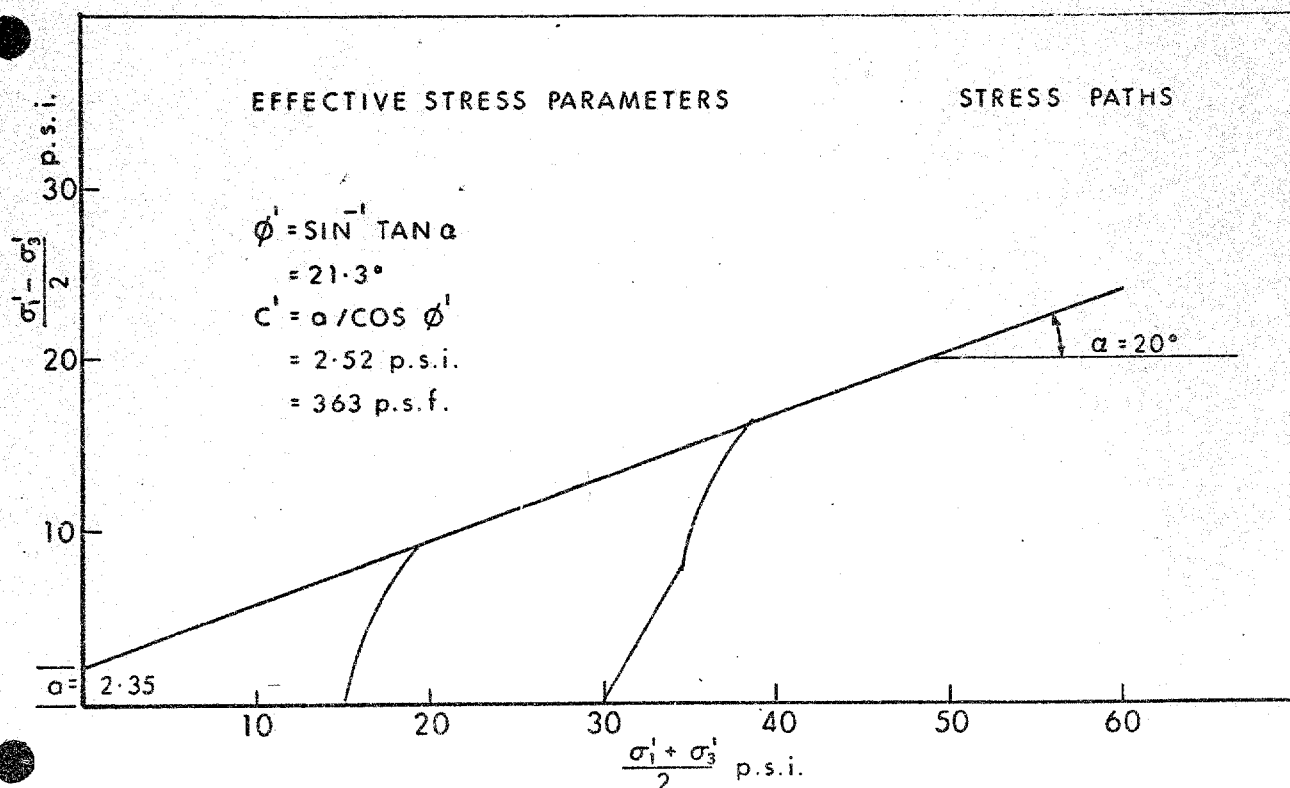
FIG. 3

The detailed test results for consolidated undrained tests (stage tests) with pore pressure measurements are presented in figures 3 and 4.

The effective stress parameters are quite consistent throughout the cohesive deposit with  $C' = 360 \text{ psf}$  and  $\phi' = 21^\circ$  above elevation  $565^{\pm}$  ft. ( $172.2^{\pm}$  m) and  $C' = 0 \text{ psf}$ ,  $\phi' = 22^\circ$  below elevation  $565^{\pm}$  ft. ( $172.2^{\pm}$  m). For effective stress stability analysis, values

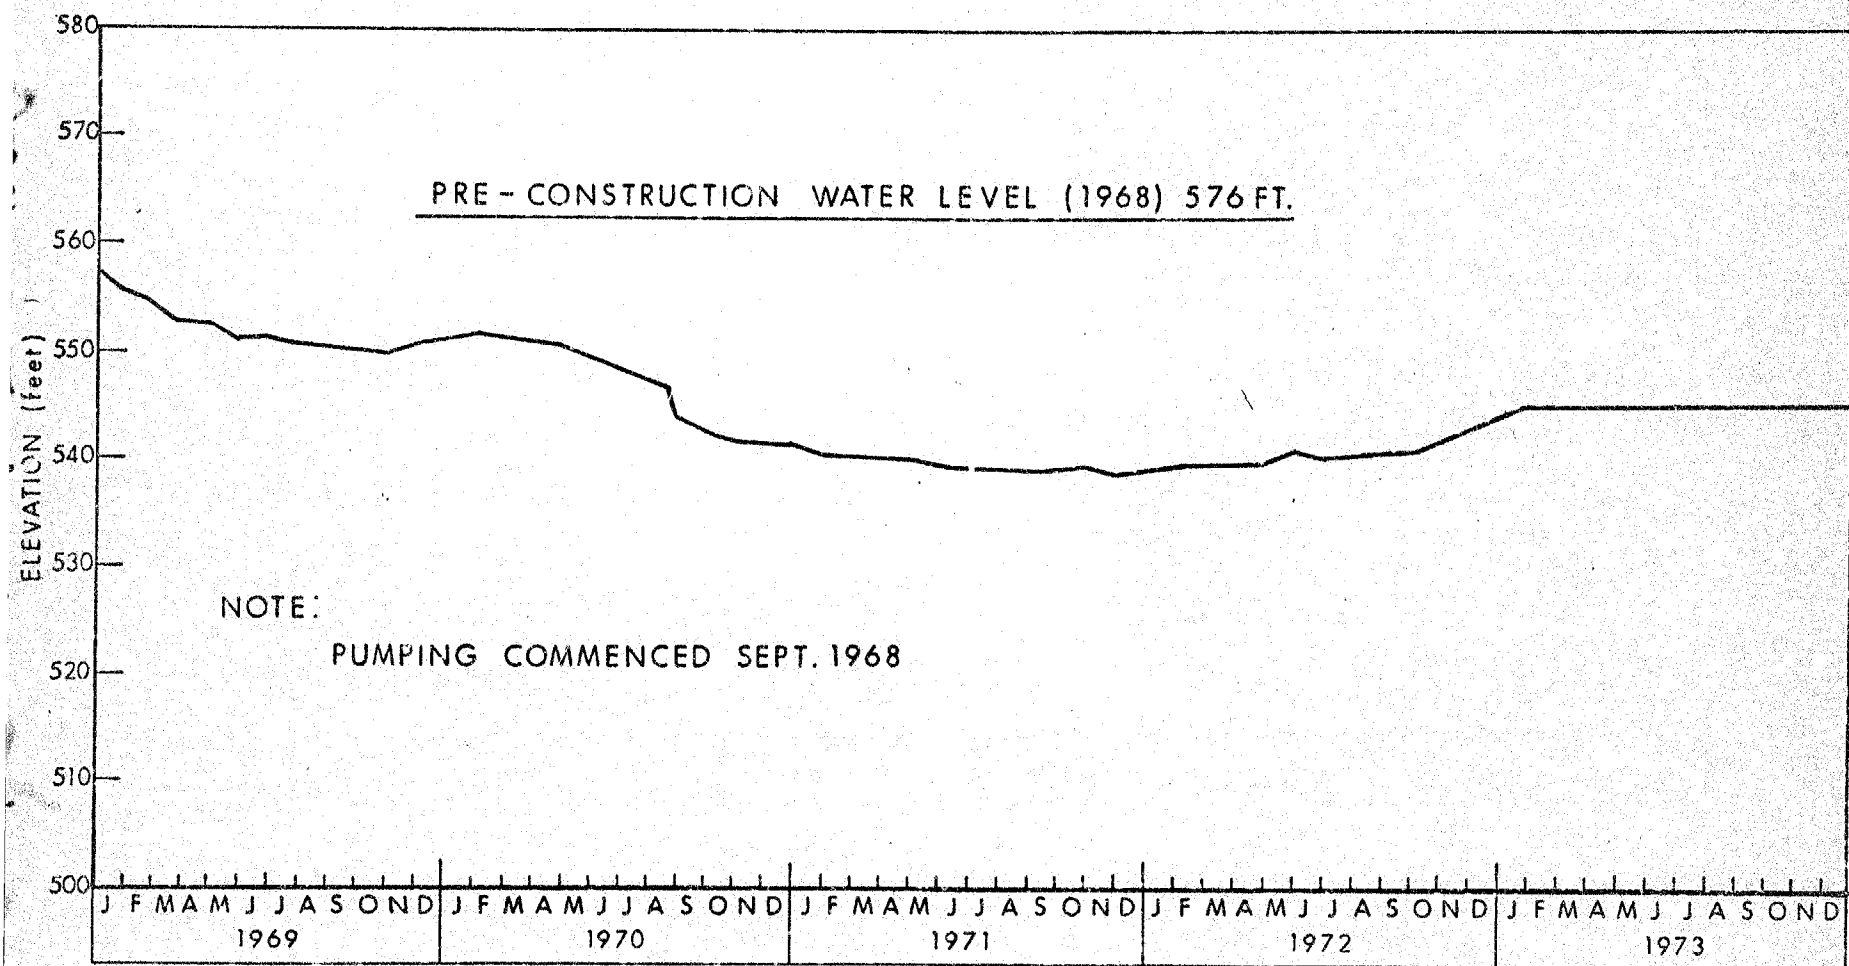
FIG. 5

Pre-channel relocation groundwater levels at the C.N.R. line and Hwy. 58 (i.e. prior to 1969) were at elevation  $575^{\pm}$  ft. (175 m). By mid-1971 the steady state drawdown conditions had lowered the water levels some 35 ft. (10.7 m) to elevation  $540^{\pm}$  ft. (164.5 m). The piezometer reading in December 1973 indicated groundwater levels to be at elevation  $545^{\pm}$  ft. (166.1 m). See figure 5 for a plot of water level variations versus time.

VARIATION IN PIEZOMETRIC LEVEL IN ROCK AQUIFER, VICINITY OF C.N.R. AND HWY.58 DUE TO GROUND WATER DRAWDOWN BY ST. LAWRENCE SEAWAY AUTHORITY PUMPING OPERATIONS
