HWY. No. 140LOCATION CN Overpass  
Slope FailureNo of PAGES - 1

TYPICALS

# SLOPE FLATTENING & TREATMENT HWY 140 & CN OVERPASS SE QUADRANT

Re: Slope Instability  
Highway 140 and CN Overpass  
Central Region

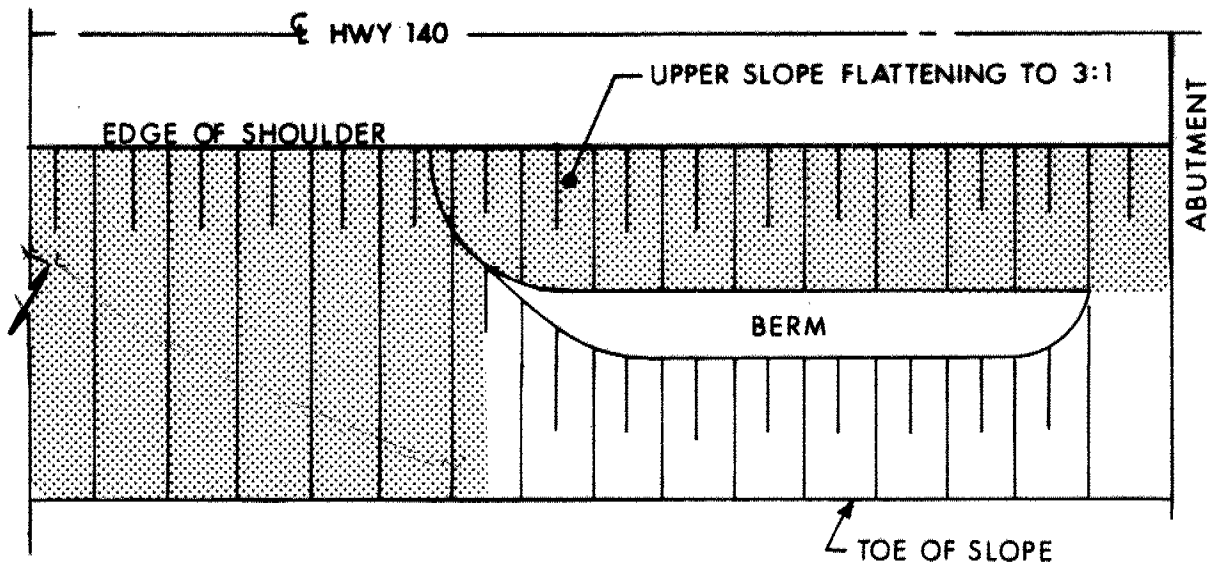
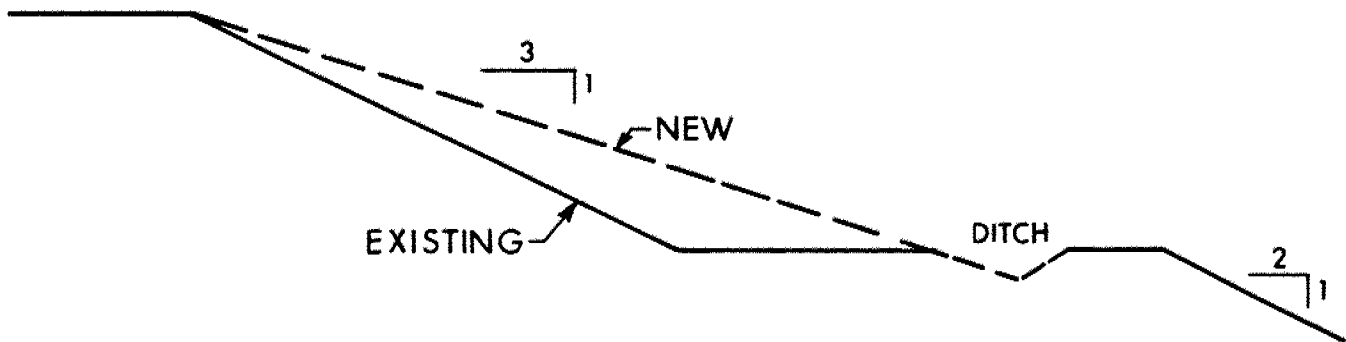
This memo is prepared in response to your request for recommendations regarding the slope instabilities at the approaches to the CN overpass on Highway 140. A site visit was made on August 9, 1997. As mentioned in your request, the crest of the slope in the south-east quadrant shows evidence of movement in the tension cracks in the shoulder of the roadway and the tilting guide rail. At various locations along the embankments, large crevices (150 mm wide and 300 mm deep) were observed.

From the existing data at this site, it is apparent that the approach embankments have been an ongoing problem. Global stability is not a concern. It is the fill itself that is experiencing distress. Remedial measures have been carried out on the slopes in the past, from the construction of wider berms to the placement of granular blankets. It appears, from observations made during this latest site visit, the movements are confined to areas close to the top of the slope. Below the berms, no instabilities were identified.

- 1) REMOVE VEGETATION AND TOPSOIL
- 2) LEAVE IN PLACE EXISTING GRAVEL/CLEAR STONE
- 3) GRANULAR 'A' FILL TO BE USED FOR SLOPE FLATTENING

The request for foundation recommendations included examining the possibility of flattening the slopes at the south approach, east side. This would provide the most economical solution. A stability check was made using a slope of 3H:1V. There is no stability concern if the slopes are flattened. It would be sufficient to reduce the slope for the portions of the embankment above the berm only. However, this alone may not eliminate the surficial movements of the slope.

It is further recommended to incorporate french drains along the face of the upper slope. These would take the form of armoured channels excavated to the frost penetration depth (1.2 m). They should be spaced at 10 m intervals and filled with rip-rap. A shallow ditch or toe drain should be constructed along the base of the upper slope to control the surface runoff that the french drains may create. Where the berm is eliminated due to the flattening of the slope, the armoured channels should extend to the base of the embankment. During construction, it is recommended that all vegetation and topsoil be removed prior to regrading the slopes to 3H:1V. The slopes should be re-vegetated as soon as possible to minimize erosion.
