LOCATION HWY 140 / CNR & CPR STRUCTURES
EMBANKMENT FAILURE

Re: Slope Flattening of Approach Embankment
Highway 140, C.N.R. Overhead Structure
W.P. 174-87-00, Site 34-232
District 4, Burlington

Re: Instability of Approach Embankment
Highway 140, CNR Overhead Structure
W.P. 174-87-00, Site 34-232
District 4, Burlington

Re: Embankment Failure Highway. 140
W.P. 174-87-00, CNR & PCR O'Head Structure
Site No. 34-232

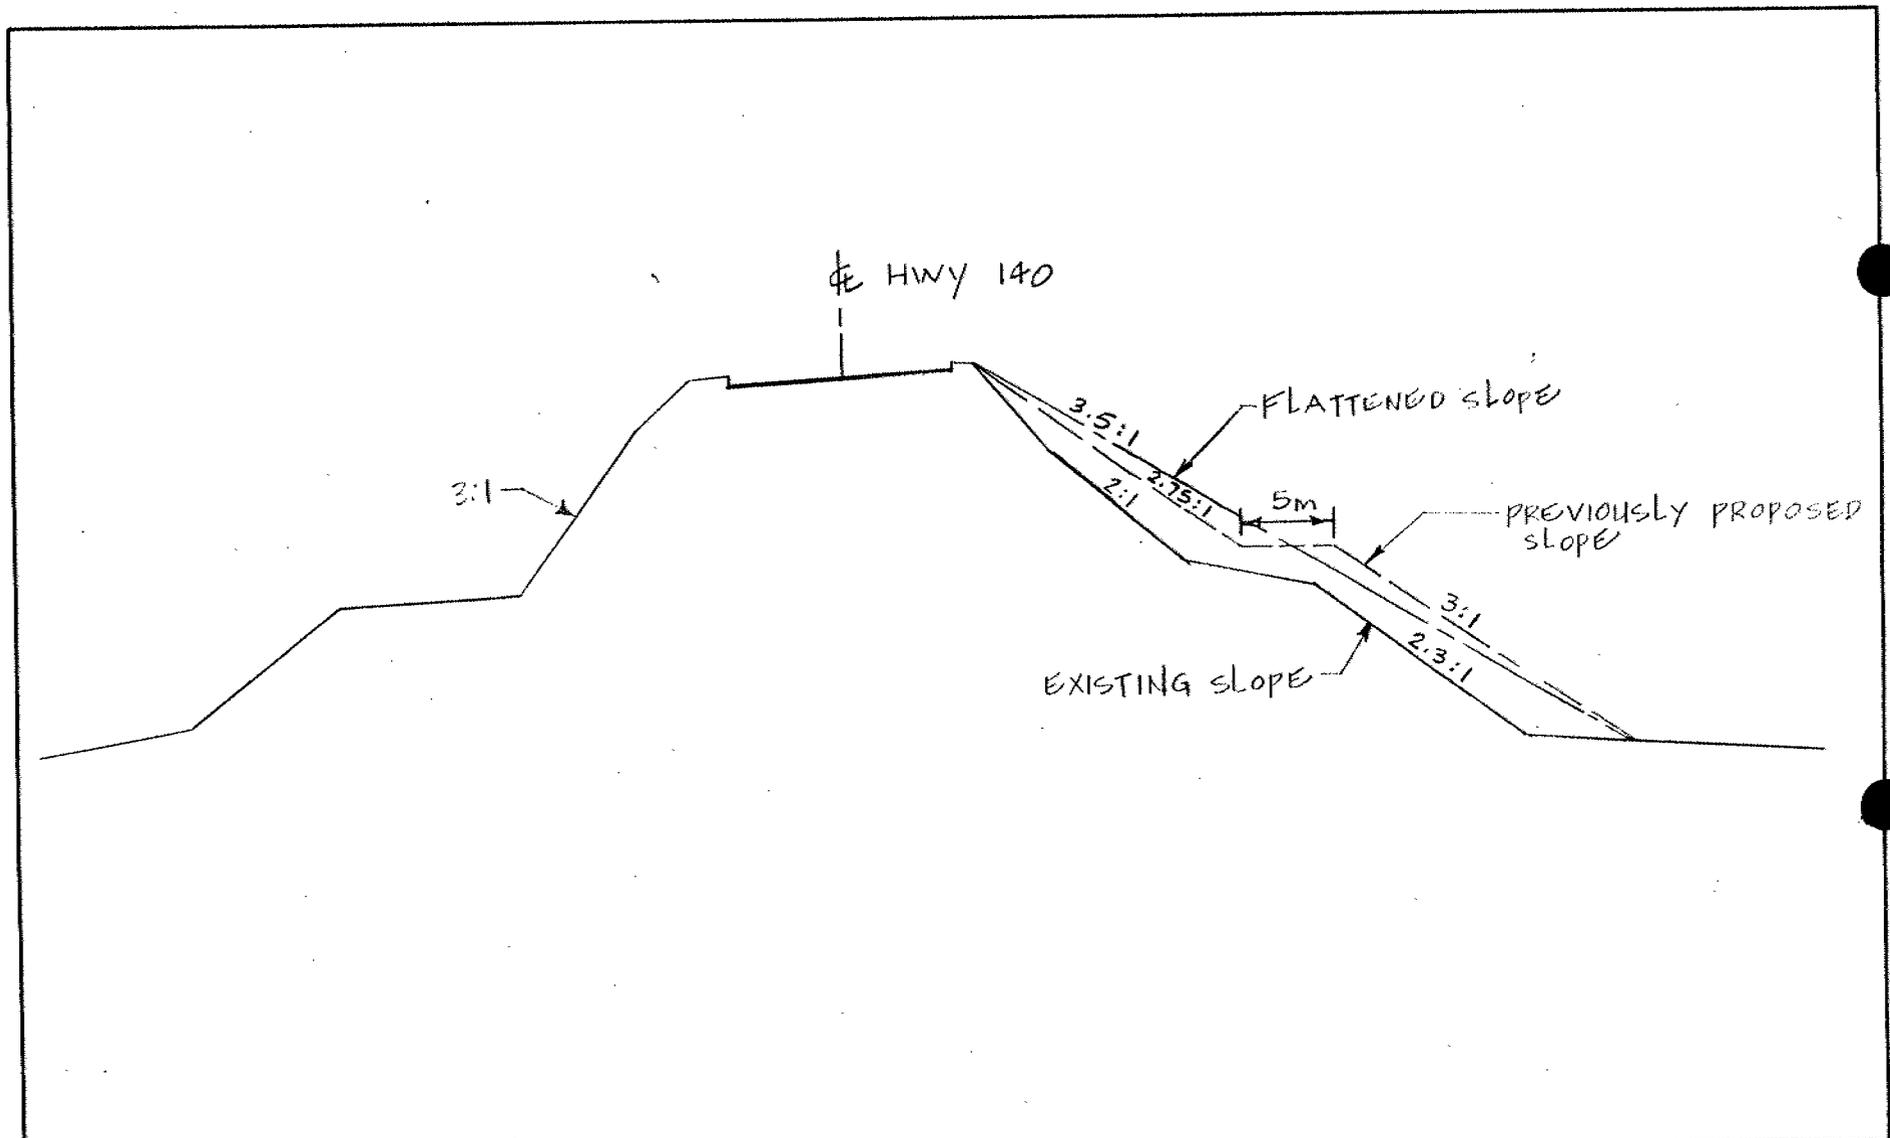
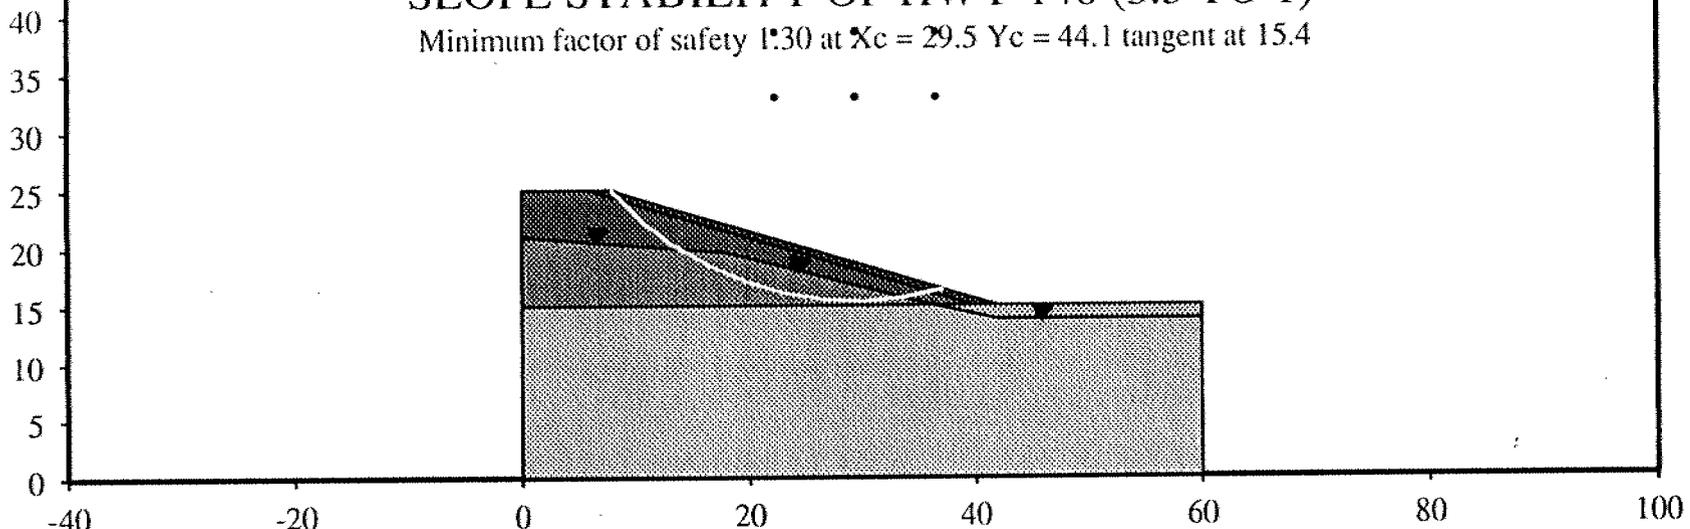
FIG No 1

SLOPE STABILITY OF HWY 140 (3.5 TO 1)

Minimum factor of safety 1.30 at $X_c = 29.5$ $Y_c = 44.1$ tangent at 15.4

- 1) For fills higher than 5 m, permanent slopes will be stable at 3.5H:1V side slopes.
- 2) For fills higher than 3.5 m and equal to or lower than 5 m, permanent slopes will be stable with side slopes of 3H:1V.
- 3) For fills equal to or lower than 3.5 m, permanent slopes will be stable provided side slopes of 2.5H:1V.

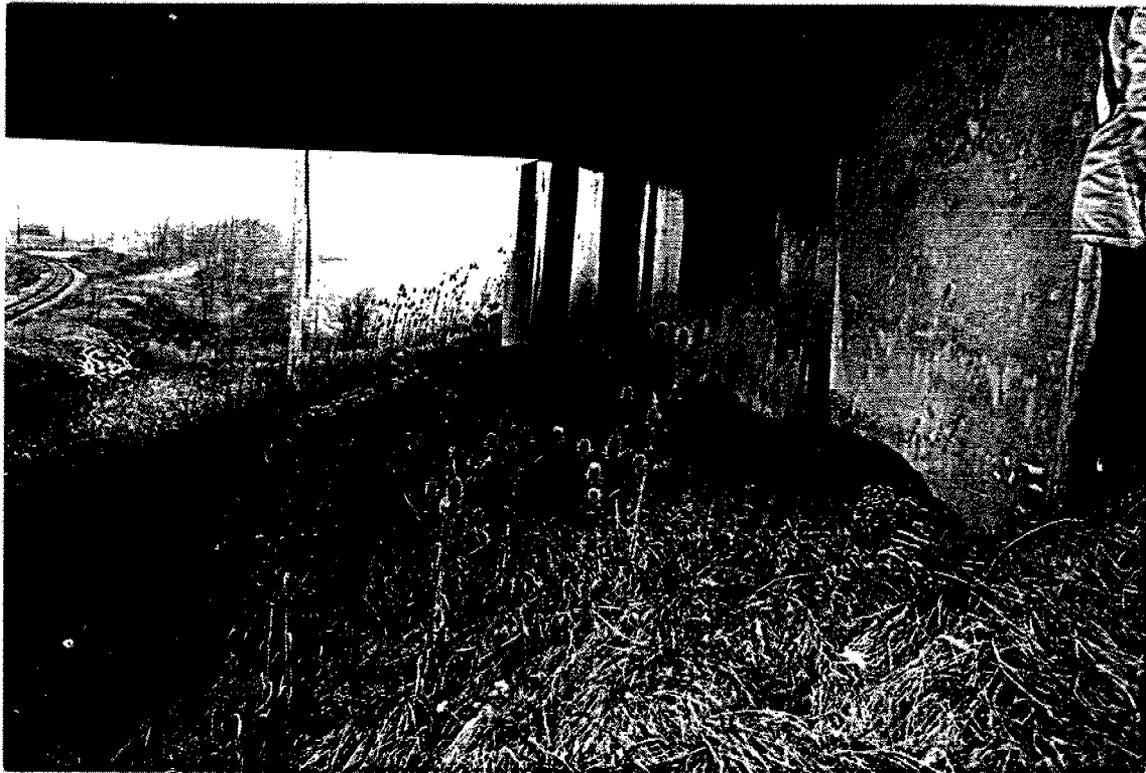
1. The void between the concrete abutment and the earth fill at the north abutment had been backfilled with cohesive soil by MTO maintenance crew when we visited the site (see photo #1).
2. Localized surficial sloughing was noted on the portion of the upper slope (2:1) above the berm, particularly the east and west side of the north approach fill (see photos #2 and #3). However, it would appear that these conditions are confined to an area where the Granular 'A' blanket was placed.
3. The 2:1 slope, below the berm appears to be reasonably stable.

PHOTO #1. NORTH ABUTMENT (LOOKING WEST)

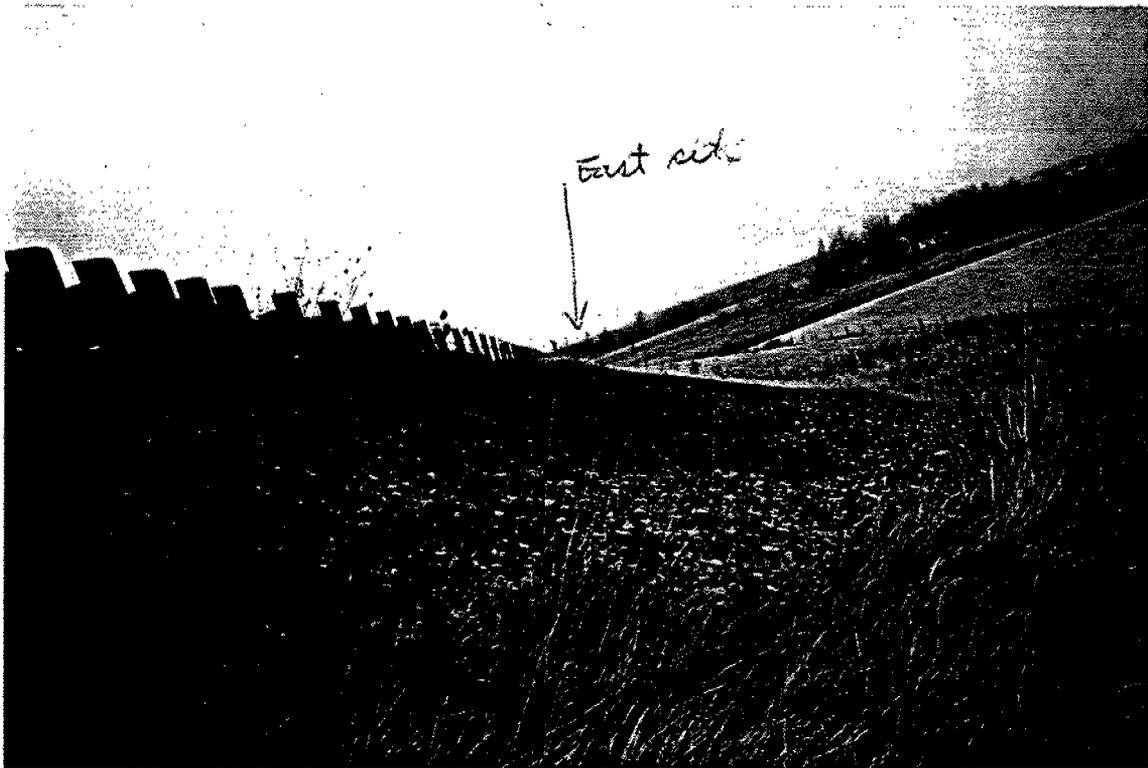
PHOTO #2. NORTH APPROACH FILL, UPPER SLOPE
(EAST SIDE, LOOKING NORTH)

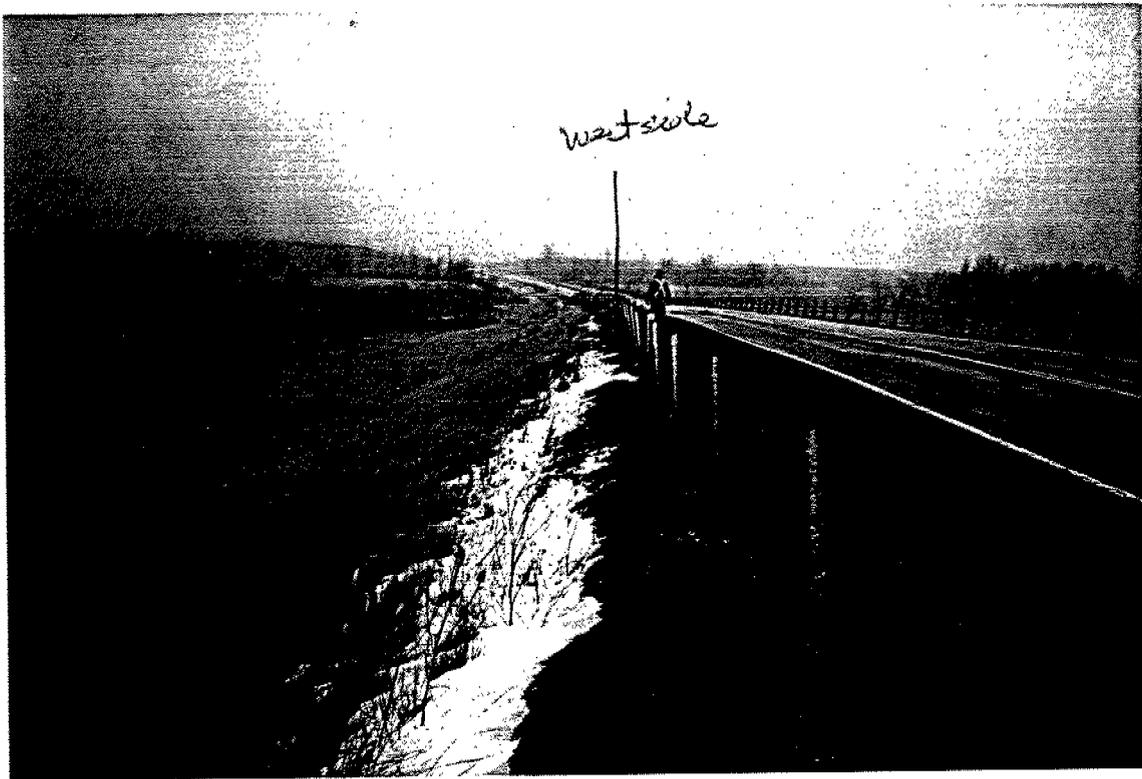
PHOTO #3. NORTH APPROACH FILL, UPPER SLOPE
(WEST SIDE, LOOKING NORTH)

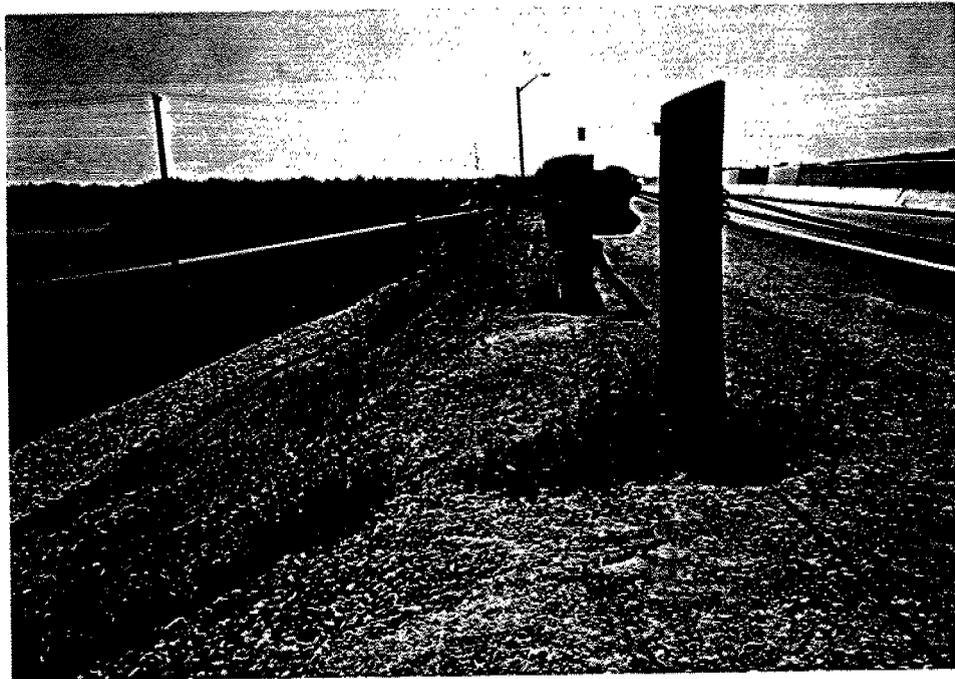
1. Tension cracks, running parallel to the roadway, were noticed at both sides on the upper slopes. These cracks generally are present along the shoulder, outside of guide rail, and extended to about 200 m north from the end of concrete slab. The District Construction personnel have indicated that these cracks were originally minor (0.3 cm); however, they were as wide as 5 cm near the bridge abutment during the time of this site visit (see photos #4, #5 and #6).

PHOTO #4. LONGITUDINAL CRACKS ON NORTH
APPROACH (EAST SIDE, LOOKING SOUTH)

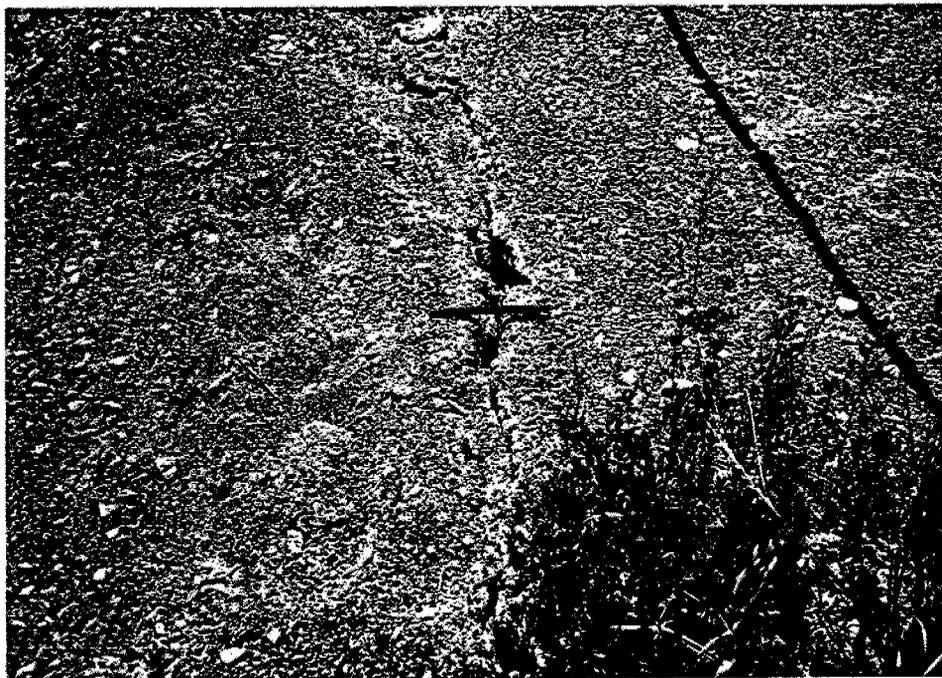
PHOTO #5. CLOSEUP OF LONGITUDINAL CRACKS
ON NORTH APPROACH

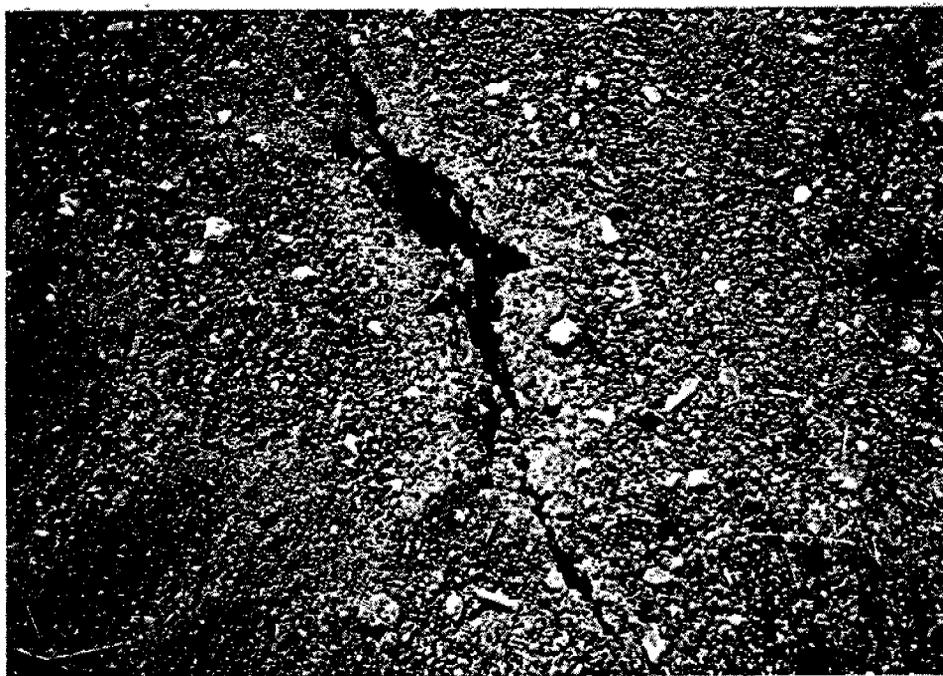
PHOTO #6. CLOSEUP OF LONGITUDINAL CRACKS
ON NORTH APPROACH

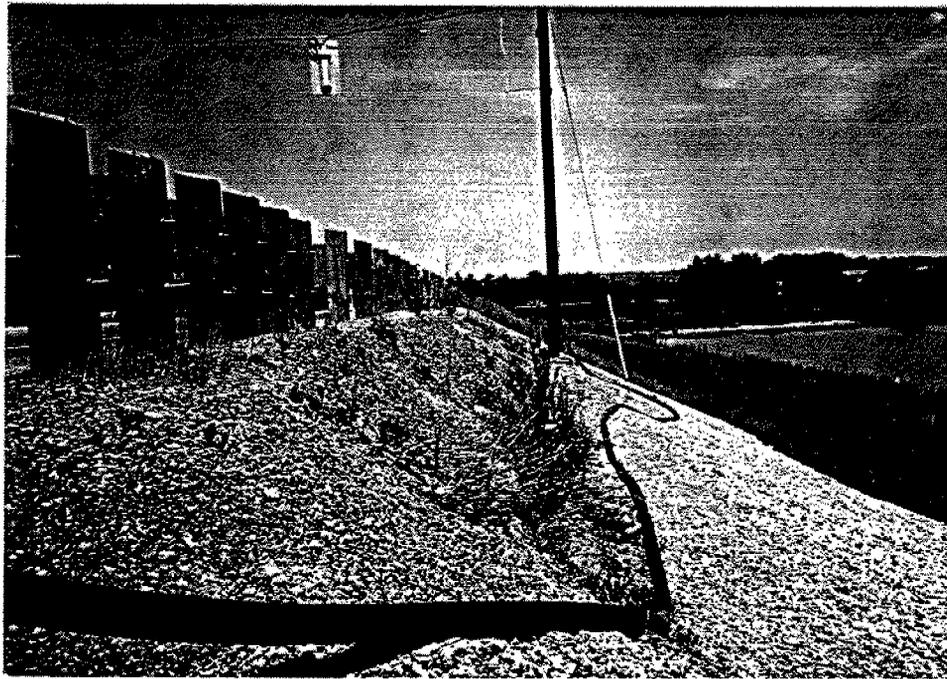
2. It was found that localized surficial sloughing was further extended to the north (about 30 m long) on the upper slope above the mid-height berm, particularly the east side of the north approach fill (see photo #7).

PHOTO # 7. SURFICIAL SLOUGHING AT
NORTH APPROACH FILL
(EAST SIDE, LOOKING NORTH)

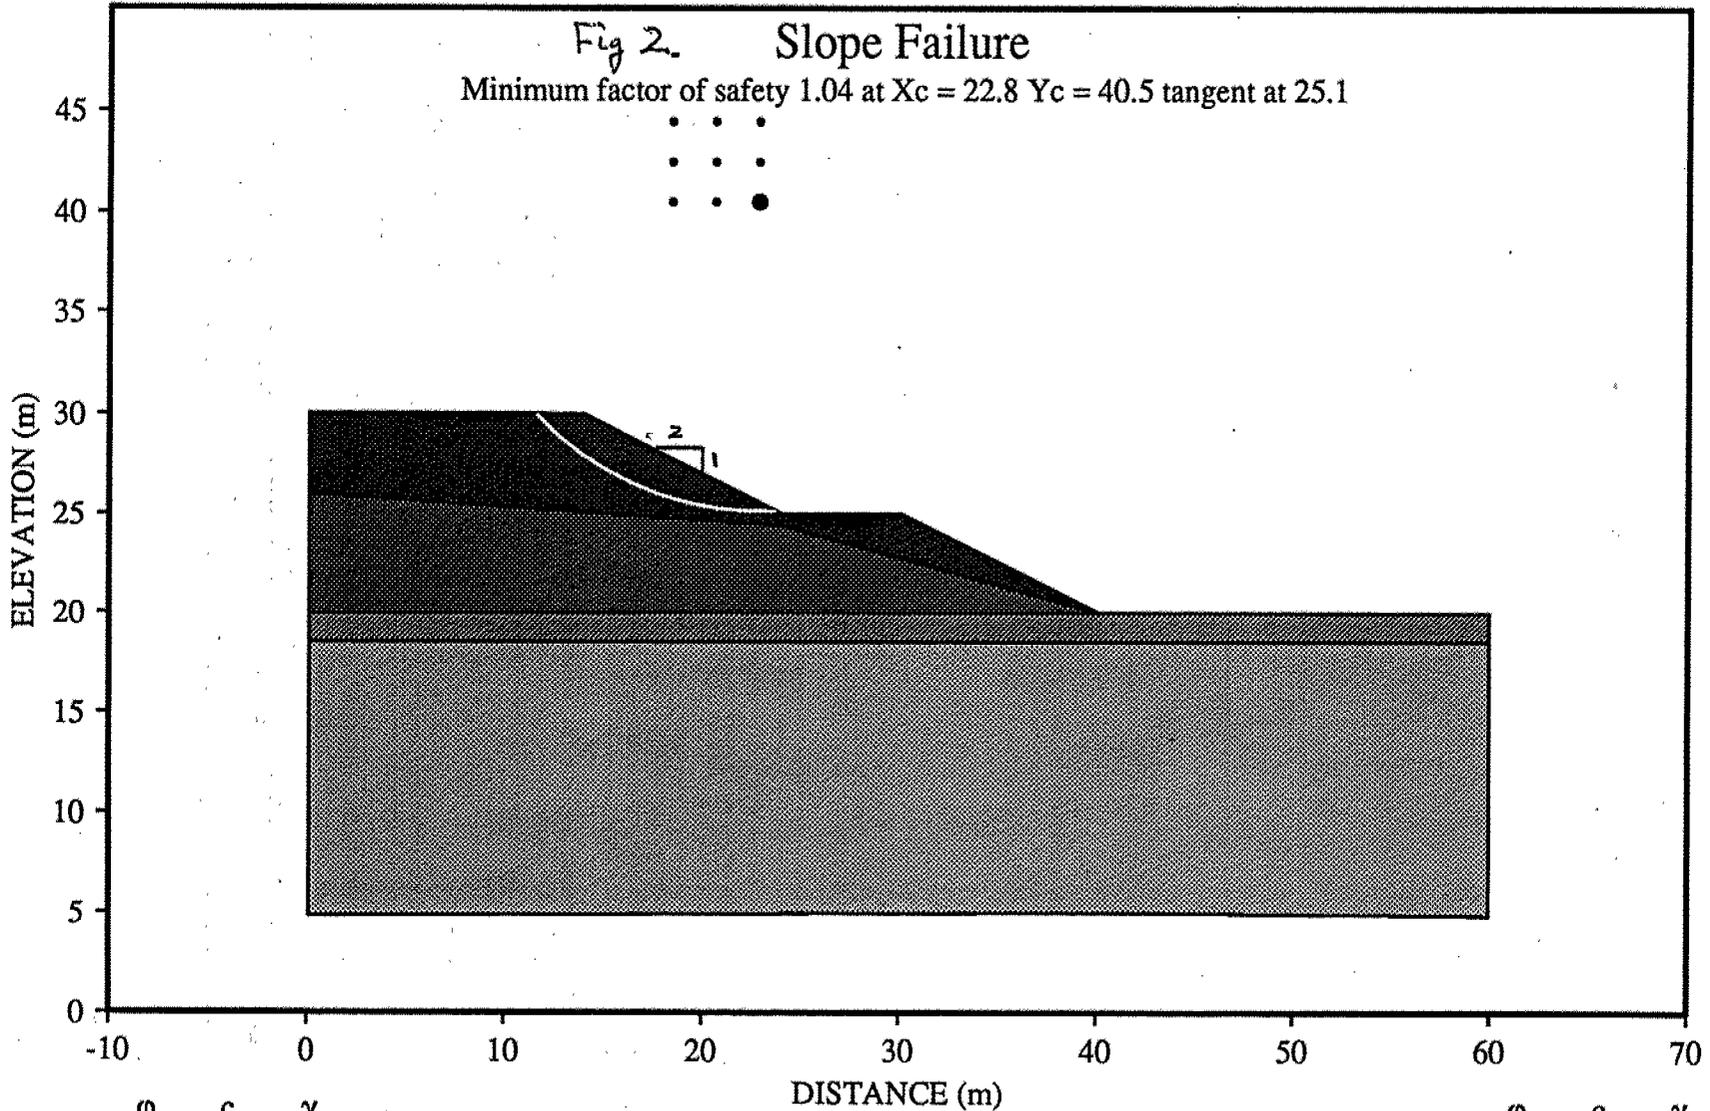
Fig 2. Slope Failure

Minimum factor of safety 1.04 at $X_c = 22.8$ $Y_c = 40.5$ tangent at 25.1

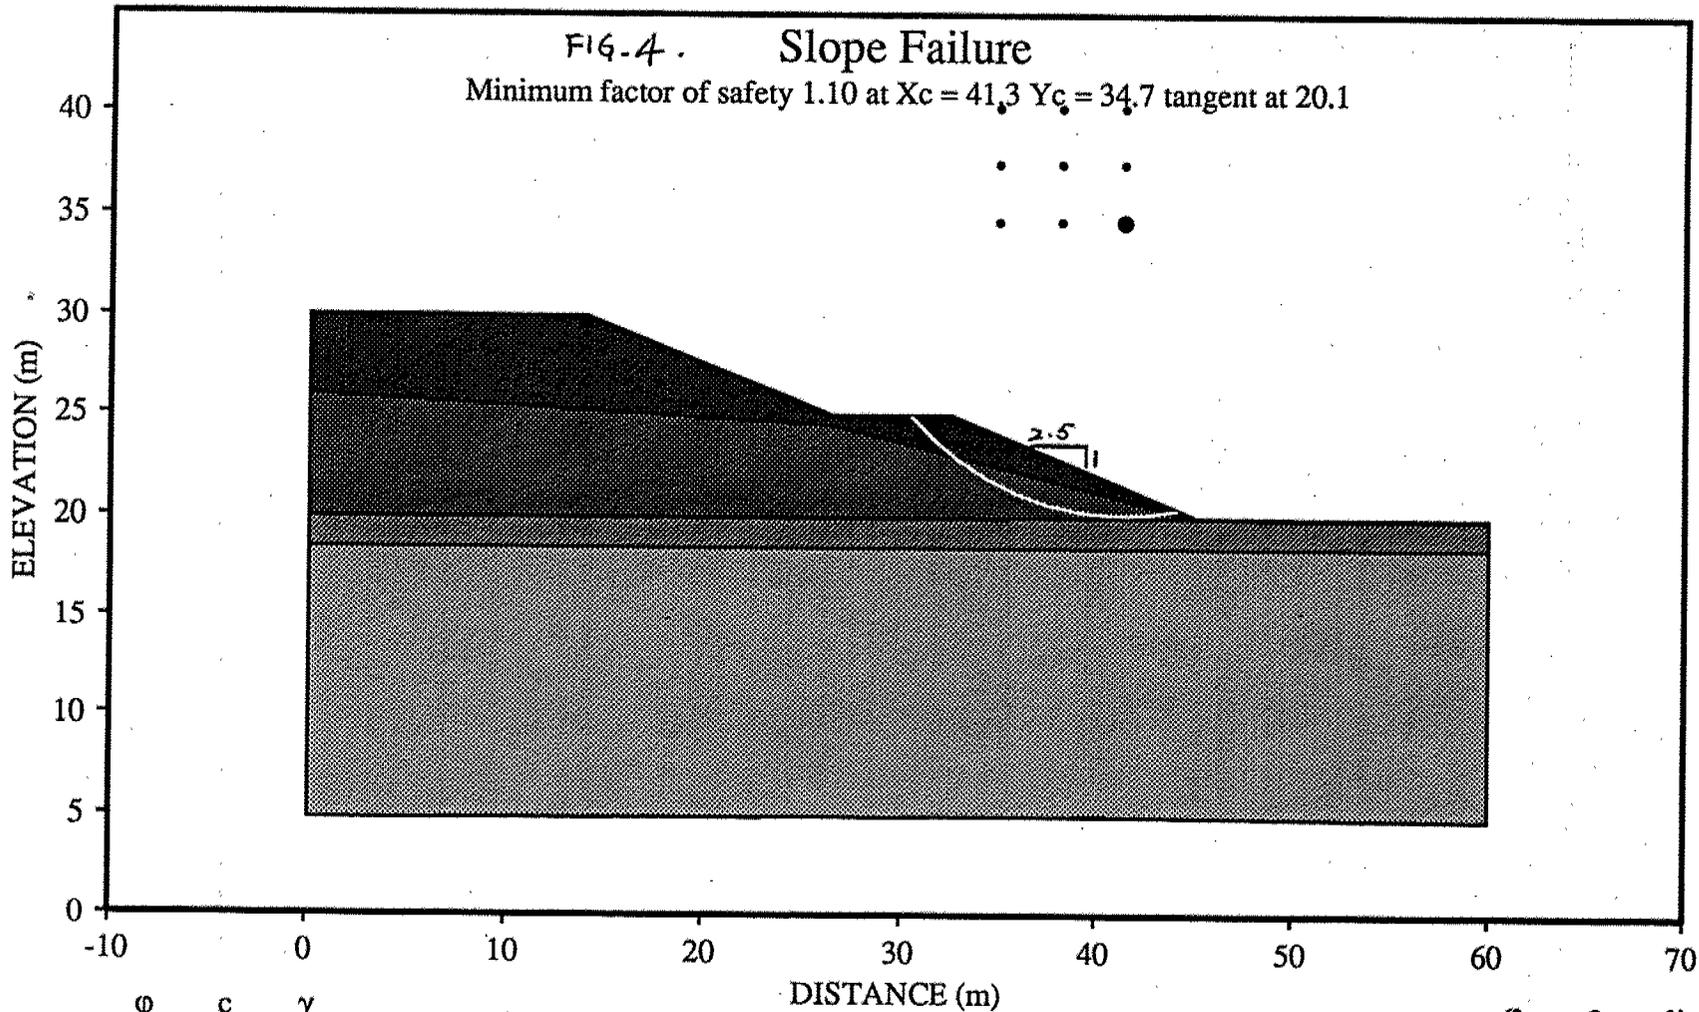
FIG-4 . Slope Failure

Figure 4 shows a typical section of the lower slope. Stability analyses were also carried out for different height of fill with different side slope as shown on Figure 5. It should be noted that for the existing 5 m high lower slope, a flatter side slope of 3H:1V will be required to ensure the stability as shown on Figure 5.

Minimum factor of safety 1.10 at $X_c = 41.3$ $Y_c = 34.7$ tangent at 20.1
