EMBANKMENT INSTABILITY -

Re: Queen Elizabeth Way, Welland River
Bridge Approaches - W.J. 61-F-70.
District 4.

SUPPLEMENTARY INFORMATION --

INSTRUMENTATION OF APPROACH FILL

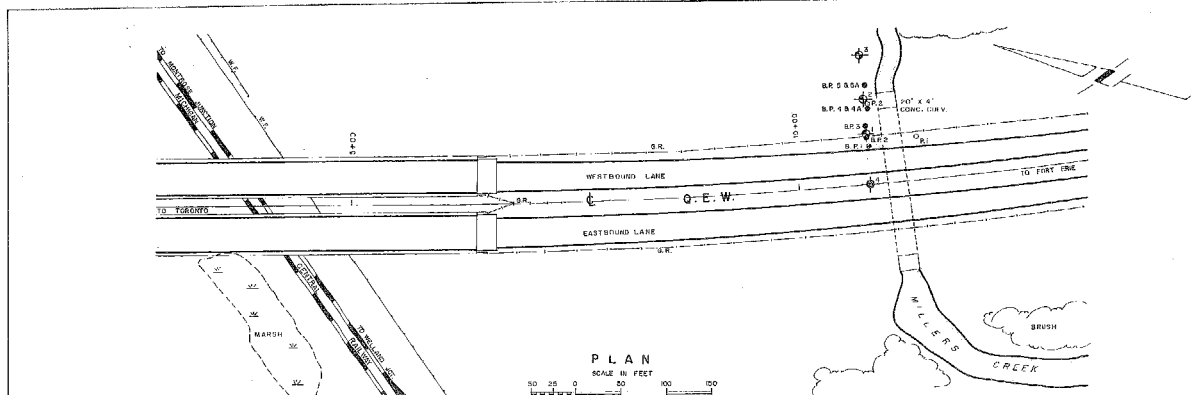
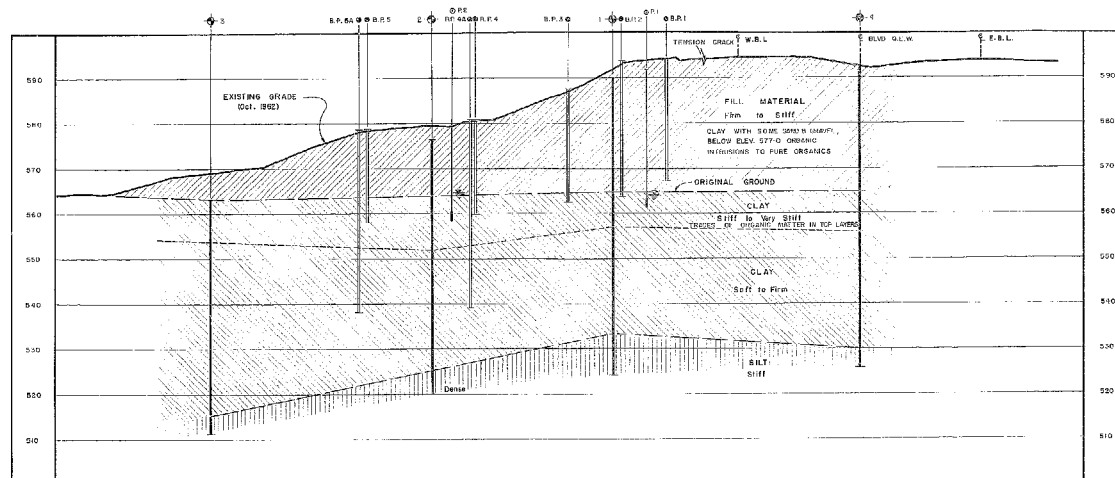
Three borings were completed. They were located as follows: B.H. 1 on the embankment shoulder, B.H. 2 on the middle of the slope, and B.H. 3 on the toe of the slope, all at Station 10 + 80. In all the borings a relatively soft clay layer was determined at some depth in the subsoil. The lowest shear strength, 212 p.s.f., was determined on a sample from B.H. 1, depth 37.5 ft., elev. 552.0. The value may be a little low because of some sample disturbance. Nevertheless, other shear strength values of this layer vary between 500 and 800 p.s.f. and a stability analysis using these values, indicates that this is a borderline case.

In B.H. 1, layers of organic matter were found in the embankment between elev. 576.0 and 569.0, and in B.H. 2, an approx. 2" thick layer of organic matter with practically no shear strength at all, was established at elev. 561.5, which would correspond to the original ground level.

The above findings point to two possible failure zones, one reaching deep into the subsoil, into the described soft clay layer, and the other much shallower, passing through the organic material in the fill (in the area of B.H. 1) and the possibly unstripped organic surface layer (in the area of B.H. 2) of the original ground.

From the deformation of the slope line it can be concluded that the sliding surface does not reach beyond the embankment toe. This would mean that either the failing of the subsoil beneath the embankment or the failing of the embankment, itself, is occurring, resulting in the described movement. These two assumptions are in accordance with the above described areas of low shear resistance.

For either of these movements, the placing of the balancing berm would be the most appropriate remedial measure. The berm should cover the lower part of the embankment slope that was pushed out as a result of the described movements. In this way, the resisting or balancing movements will be increased.

It is our recommendation that the embankment slope, extending for 20 ft. on each side of the clearly visible movement marks on the embankment top, be flattened to 3:1 and a berm be built having a width of 40 ft. and an end slope of 2:1. The slope of the berm top should be 20:1 to facilitate drainage. The berm height at contact with the embankment slope, should equal half the embankment height.

The berm should be built between Station 8 + 00 and 13 + 50, i.e., for a length of 550 feet on the left side of the centre line. The berm top should be 40 ft. wide.
