GEOCRES No. 30M3-124DIST. 4 REGION W.P. No. CONT. No. EMBANKMENT FAILUREW. O. No. 73-11070 (x)STR. SITE No. -HWY. No. 406LOCATION EMBANKMENT INSTABILITY, EASTSIDE OF HWY 406No of PAGES - 1=====  
OVERSIZE DRAWINGS TO BE INCLUDED WITH THIS REPORT. REMARKS:

Instability of Embankment,  
East Side of Hwy. 406,  
W.O. 73-11070 (X),  
District No. 4 (Hamilton).

Slope Failure  
Highway 406, St. Catharines  
Hamilton District

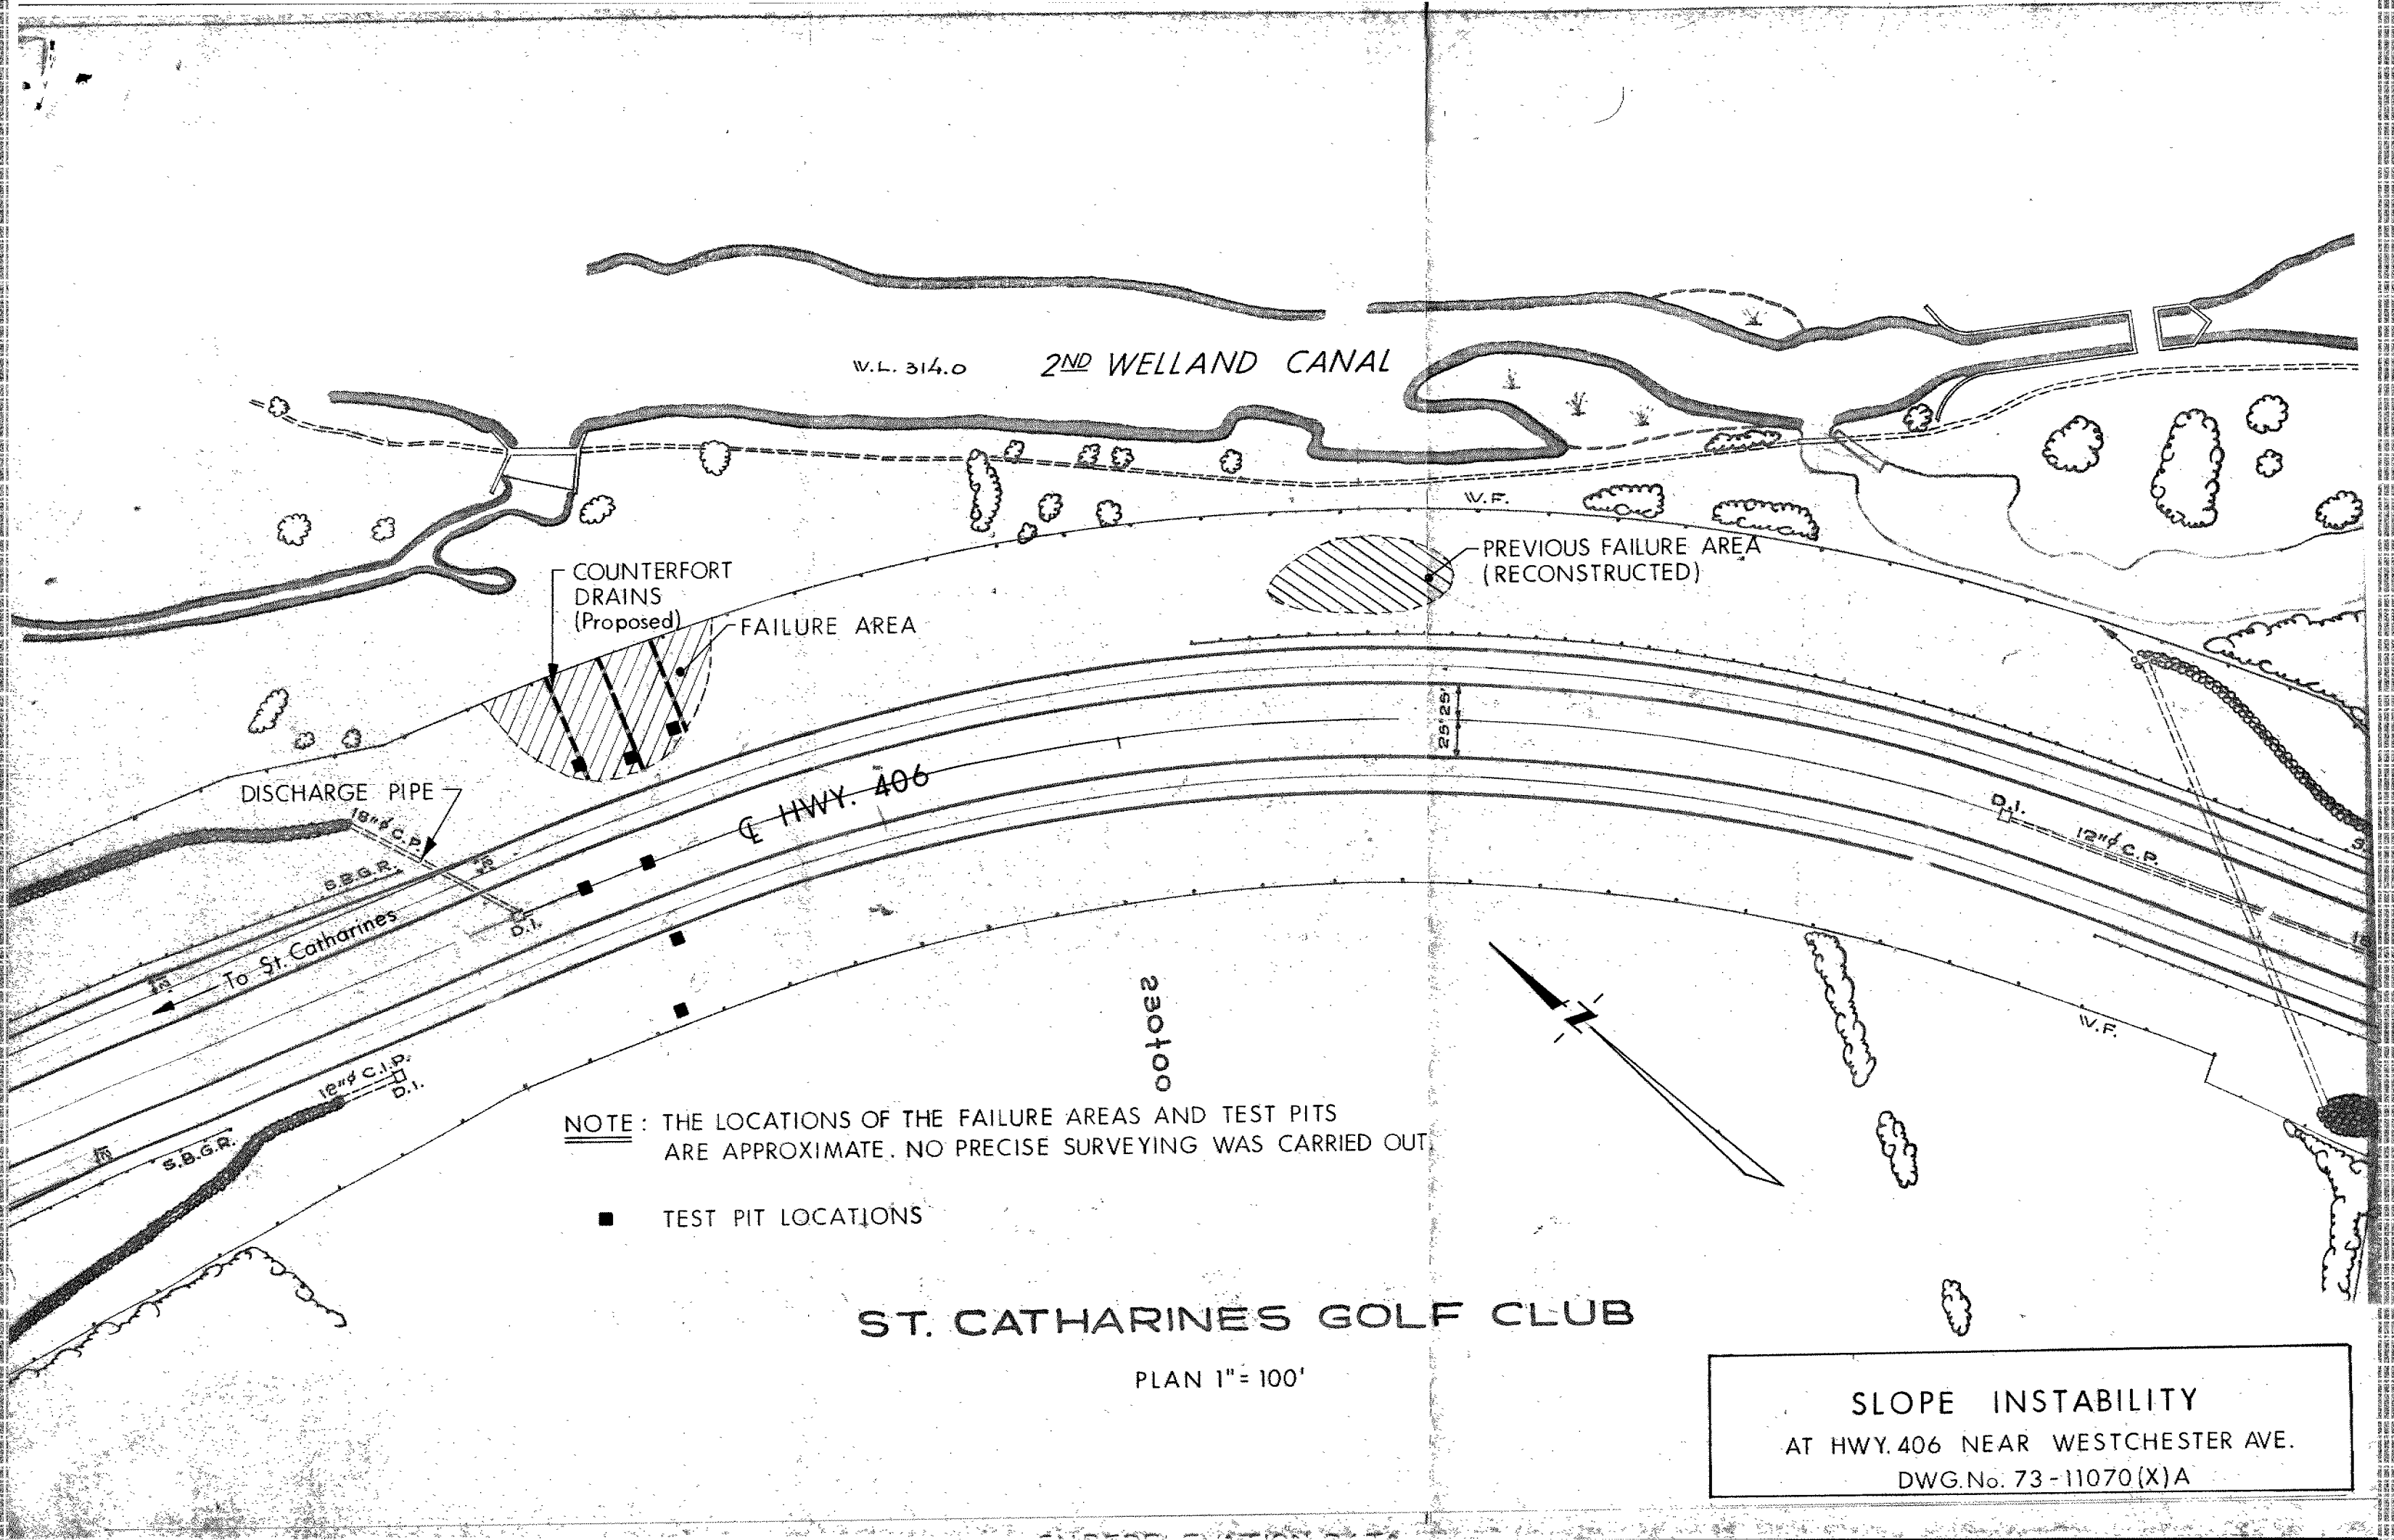
EXCAVATE AT CENTER OF  
FAILURE: NAT. FILL (CLAY)  
SEEPAGE AT 9' B.G.L.  
EXCAVATE 2' DEEPER —  
LEAVE HOLE OPEN  
AT 10': BLACK - ORGANIC  
NAT. WET SOFT - ROOTS ETC.

TO 7<sup>th</sup> FT. OK. FILL  
WET BELOW THIS DEPTH  
(SLOPES DRAWING IN)  
ORGANICS AT 8' - 10'  
NO SEEPAGE

Brown - sil. cl. Fill  
well compacted. O.K.  
DEPTH. 12'

TO 3.5' BR. CL.  
WELL COMPACTED  
AT 3.5' SAND - BRIDGING  
FOR DITCH DRAIN, COND. PIPE.  
POOR BACKHOE  
ORIGINAL MAT'L FROM 3'?

EXC. TERMINATED AT 11' -  
NO EVIDENCE OF SEEPAGE

MOOR APPROX 50' S ON  
MEDIAN TO LOCATE TILE DRAIN  
APPROX 10'-12' LONG STRIP  
5' DEEP - ORIGINAL MAT'L.  
NO SIGN OF DRAIN

LOCATION: WEST DITCH  
SOFT ON TOP (2' W/ OFF  
WATER) TILL (ORIGINAL  
MATERIAL,  
EXCAVATED TO 8'  
ORIG. MAT'L. - ~~NO EVIDENCE~~  
EVIDENCE OF SOFTENING.

3. Counterfort drains having a minimum base width of 2 feet should be constructed transversely as shown on Drawing No. 73-11070(X). The spacing of these drains should not exceed 30 feet. The material to be used for construction of the counterfort drains should consist of a free draining granular material such as Granular 'A'.
