memorandum

Subject: South Approach Embankment, QEW SBL
Structure Over Welland River and N.Y.C. Railway
W.O. 93-11022
Site 34-65, District 6, Burlington

Date: 94 12 19

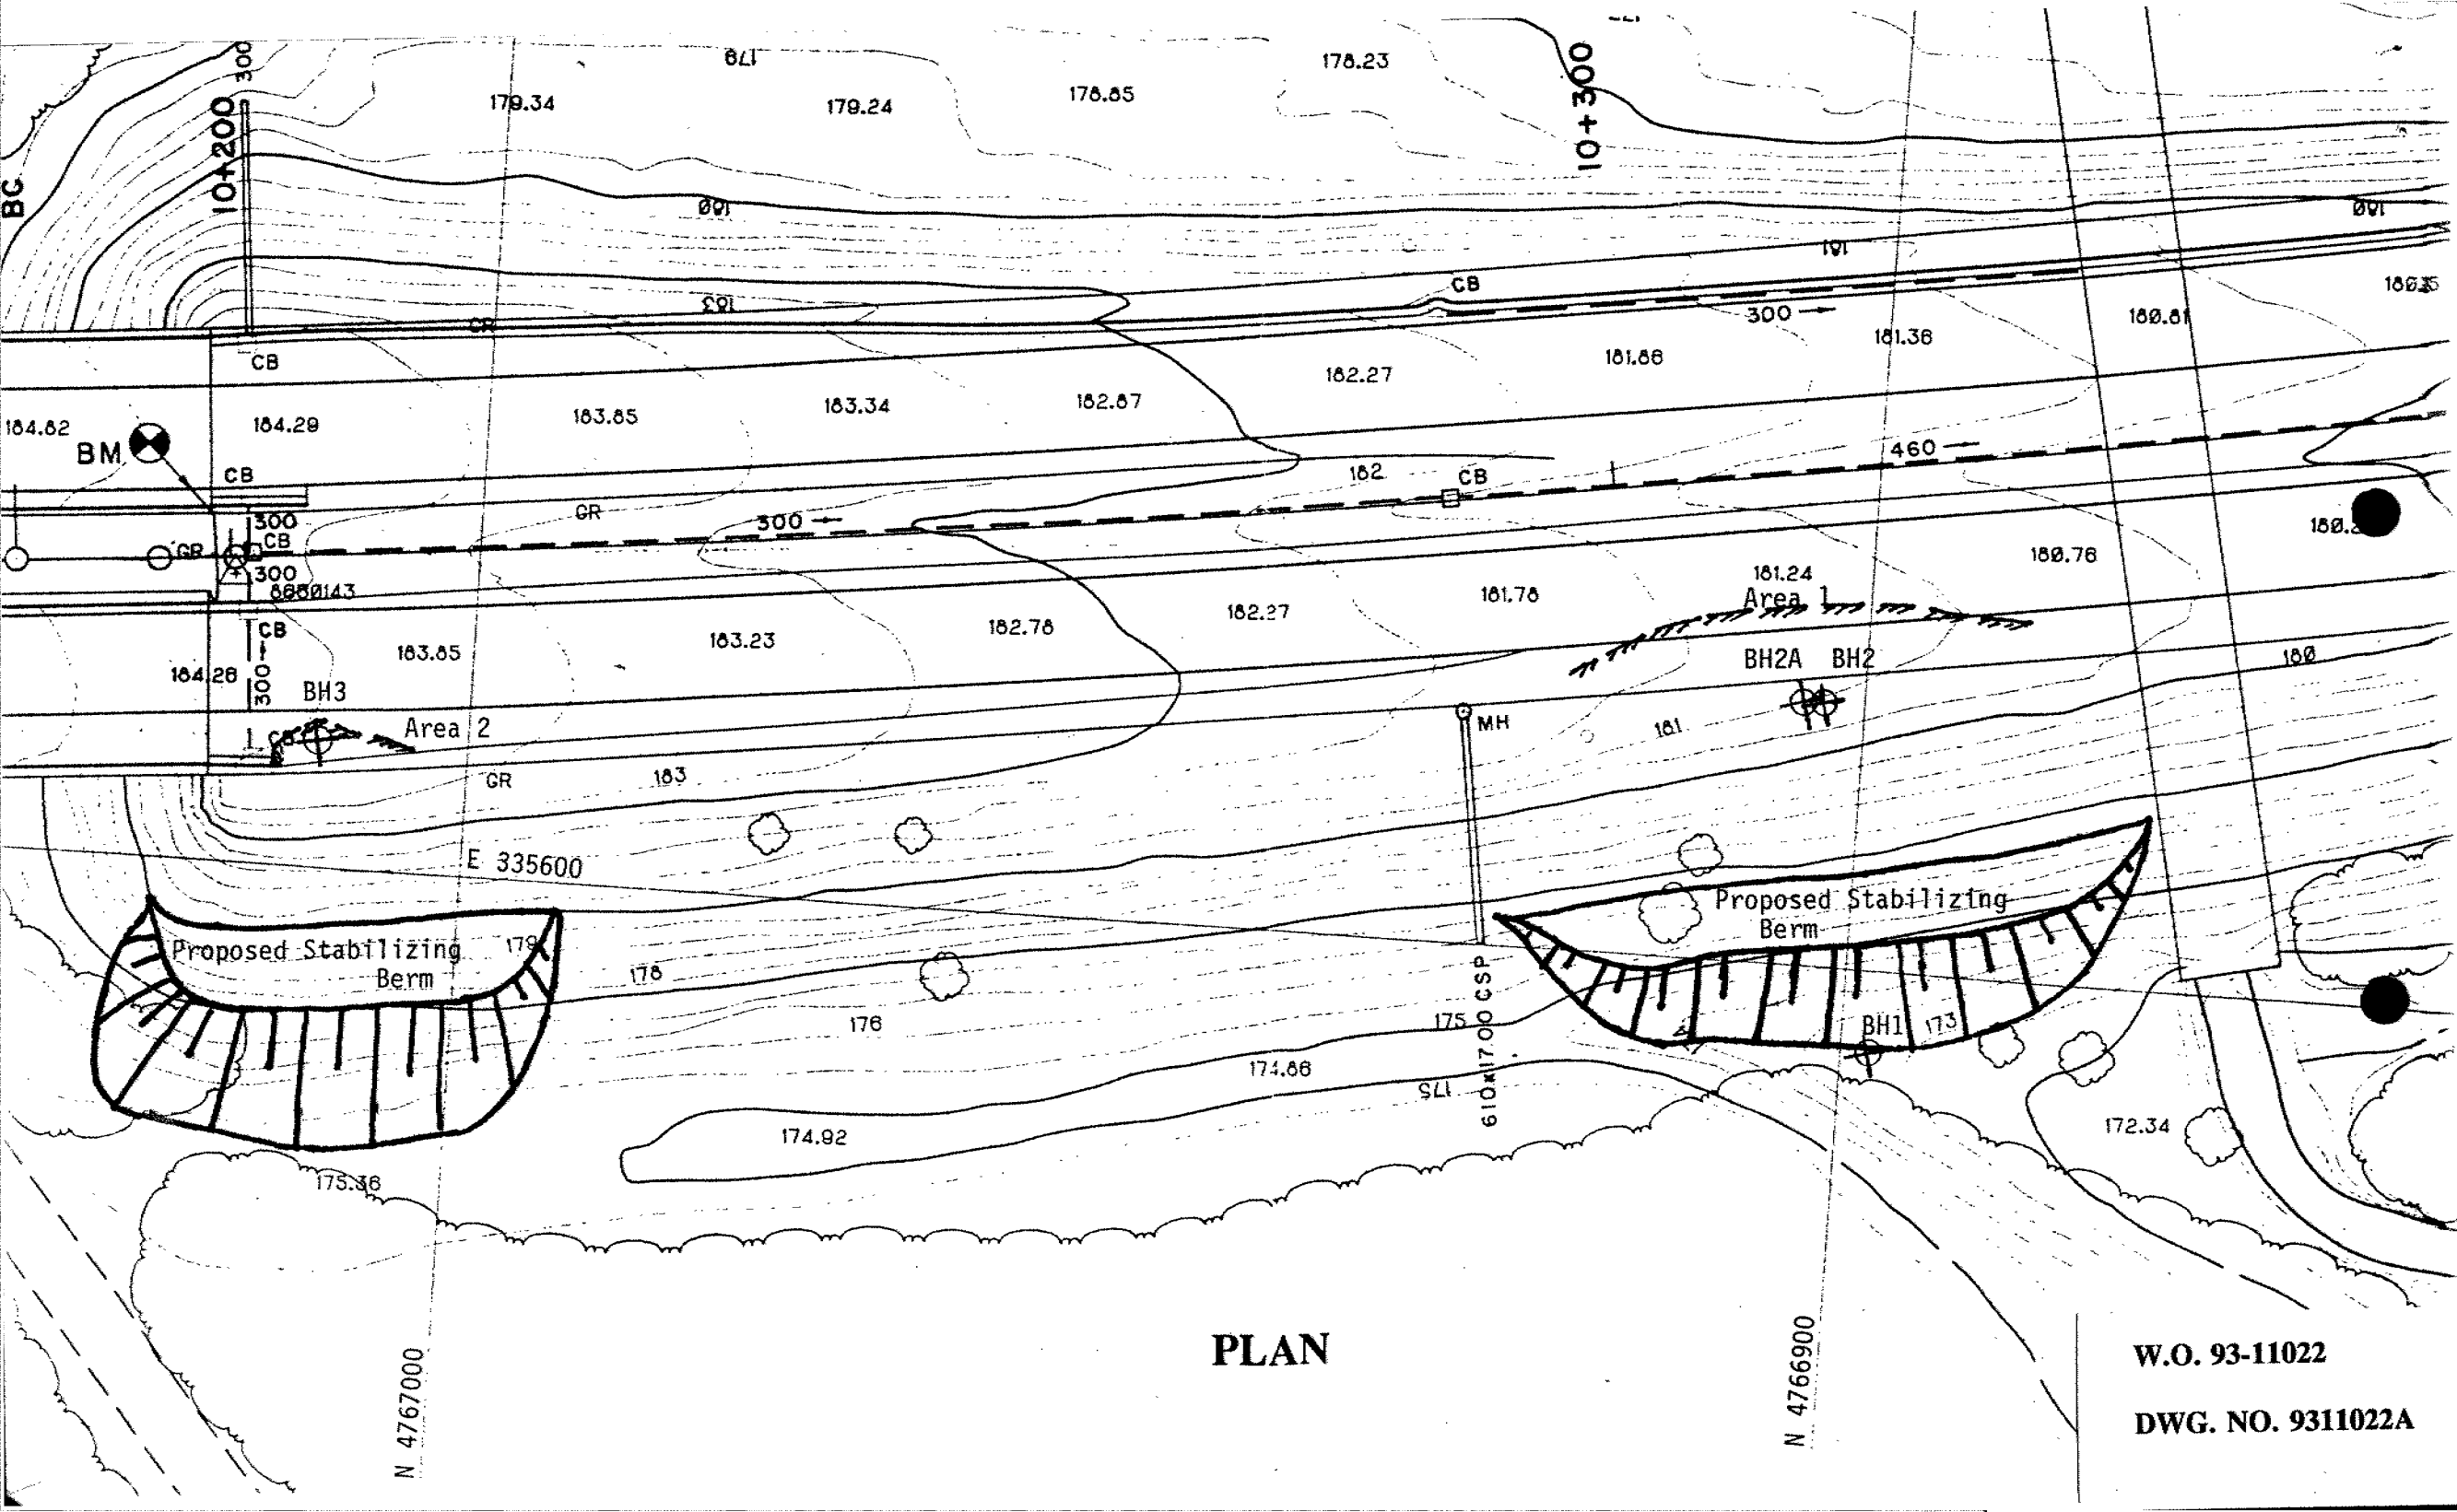
DWG. NO. 9311022A

The site was visited on 93 08 24 with Rob Kohlberger from your office. During the site visit, Two problem areas were identified and field investigation was planned for these areas. Area 1 is located around Sta. 10+310 with a longitudinal crack running near the edge of the SBL and curving towards the shoulder at both ends. The shape of the distress area suggests possible shear failure. Area 2 is located at the south abutment of the SBL structure. It consists of a crack that runs around a catchbasin in an arch shape at approximately Sta. 10+200 just south of the approach slab. Drg. No. 9311022-A attached indicates the location and extent of the distressed areas.

The attached plan and Record of Borehole sheets illustrate borehole locations and the subsurface conditions at the boreholes respectively. Figures 1 and 2 illustrates cross-sectional profiles at Areas 1 and 2 respectively.

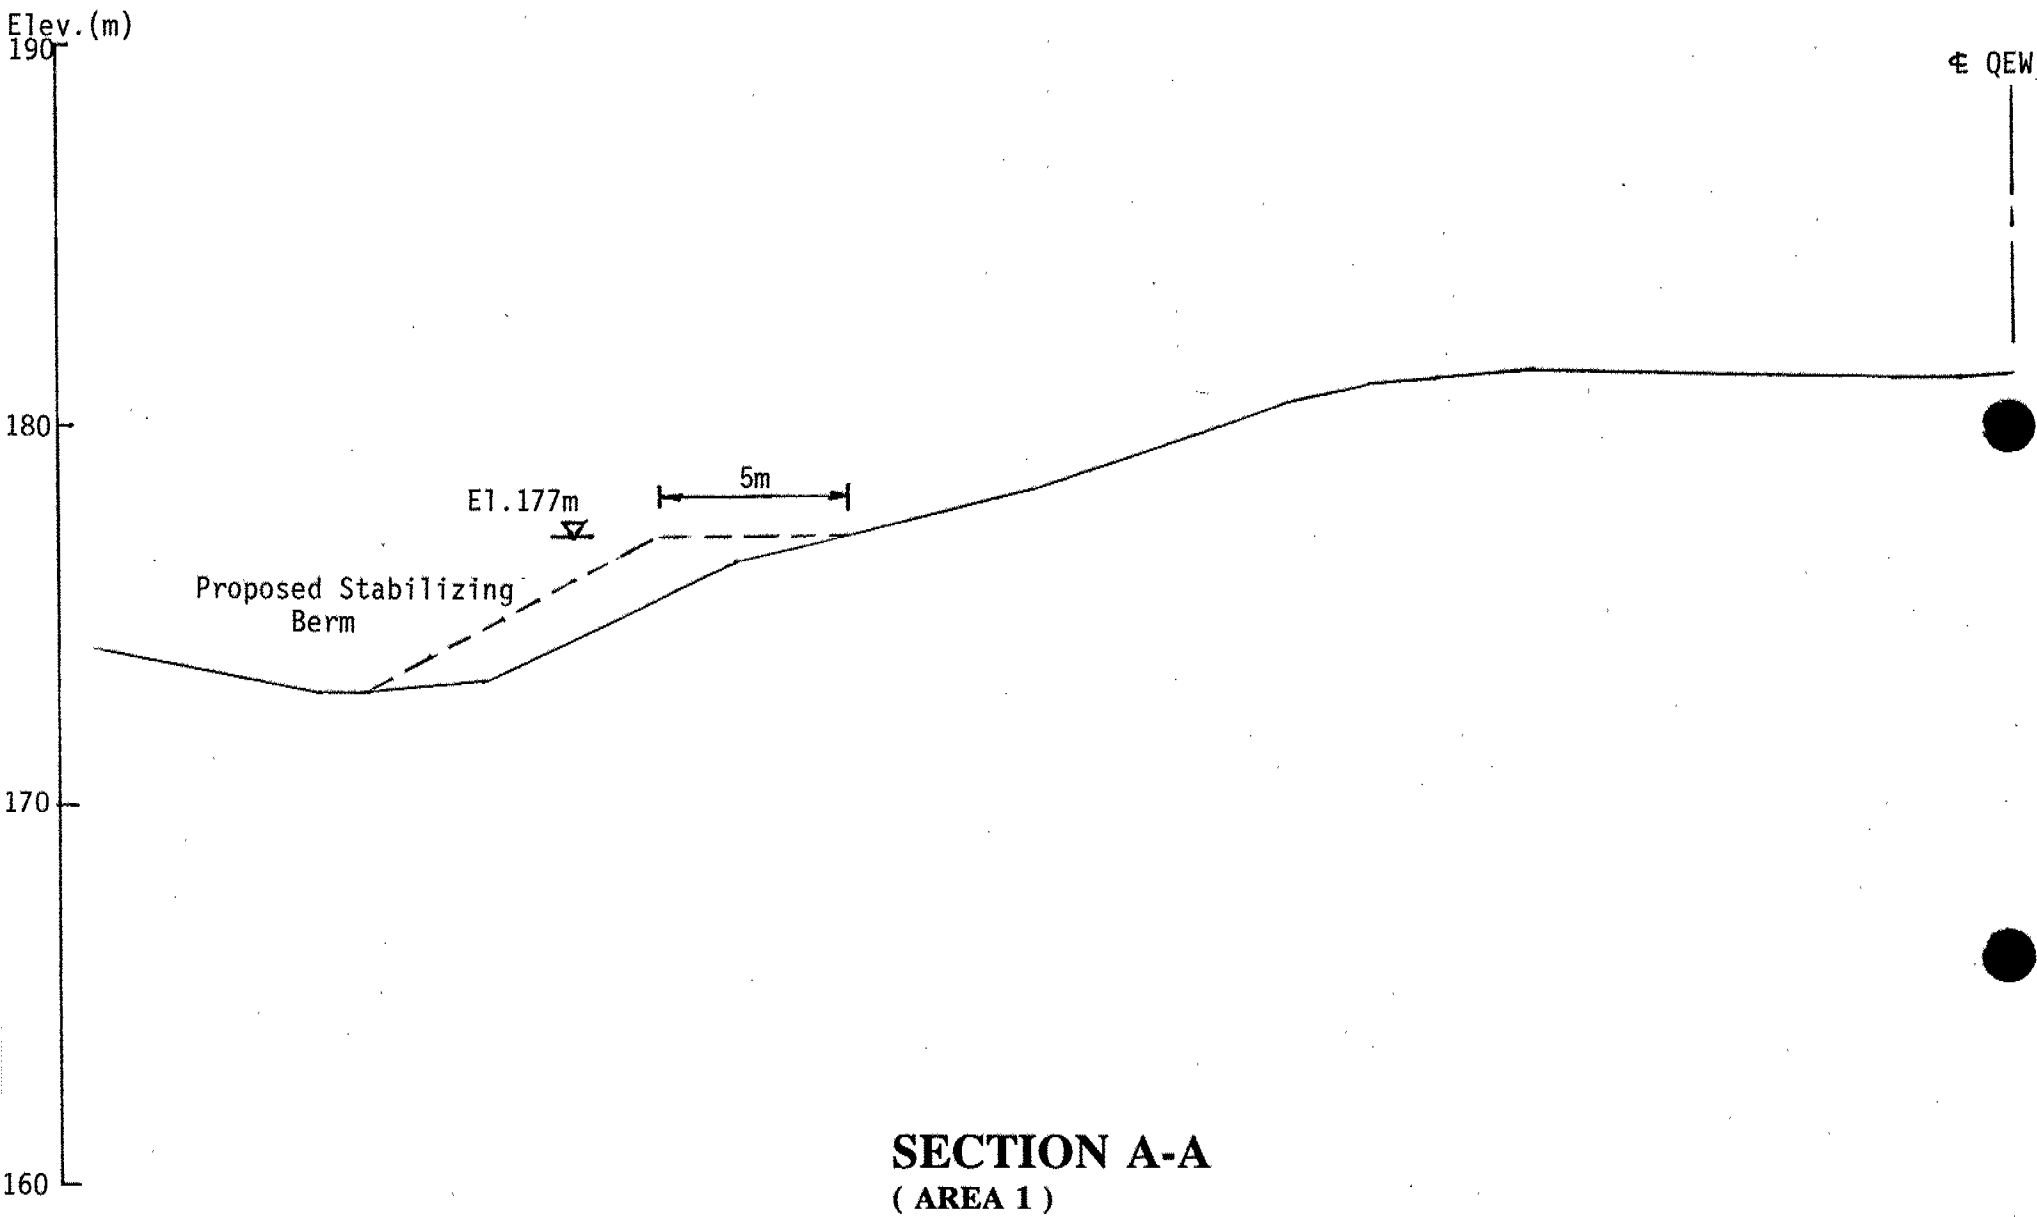
W.O. 93-11022
Figure 1

Stability analyses were carried out on cross-sectional profiles at Areas 1 and 2 using effective stress parameters. In Area 1, perched water condition was assumed and the safety factor obtained was marginal for long term stability. A stabilizing berm is required to increase the factor of safety to acceptable levels. In Area 2, a back analysis was carried out assuming the current condition has a safety factor of 1.0. A berm was then added to raise the factor of safety to satisfactory levels.

SECTION A-A
(AREA 1)

As discussed above, it is recommended to construct some mid-height berms at Areas 1 and 2 to ensure adequate factor of safety for overall stability. In addition, it is recommended to bench the existing slope for the full height and reconstruct the slope face above the berm level with compacted granular fill. This will ensure the new fill key in well with the existing cohesive fill to prevent shallow slips within the fill material. Geometry and extent of the proposed works are shown in Figures 1 & 2 and Drg. No. 9311022A respectively. Figure 3 shows a schematic design of the proposed works. The finished slope should be properly protected with vegetation cover.

Proposed Stabilizing
Berm

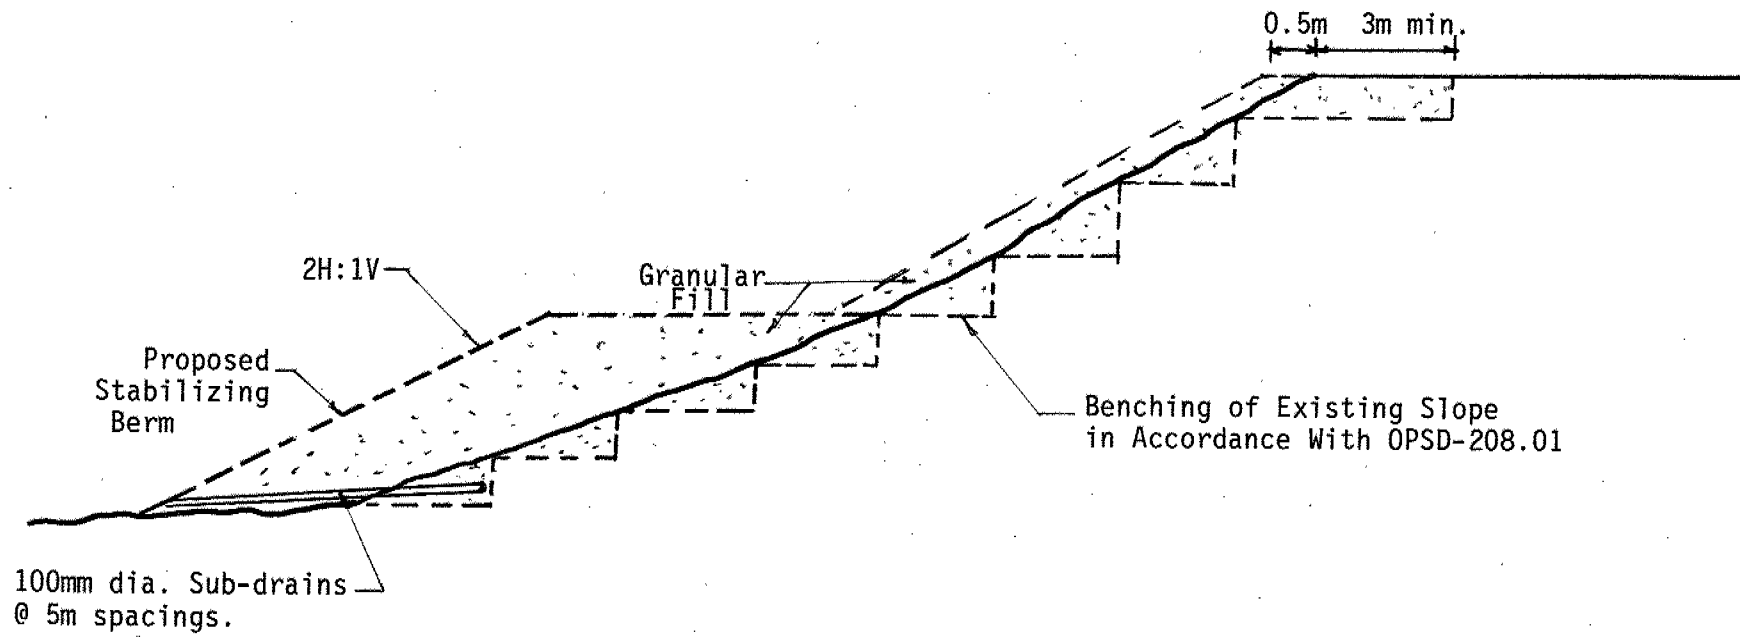
W.O. 93-11022
Figure 2

SECTION B-B
(AREA 2)
