**Foundation Investigation and Design
Report - Slope Stability Analysis
Proposed Embankment Rehabilitation
N-E Ramp, Collier Road to
King's Highway 58, WP 312-97-00
City of Thorold, Region of Niagara**

BRGE0050774A

November 18, 1998

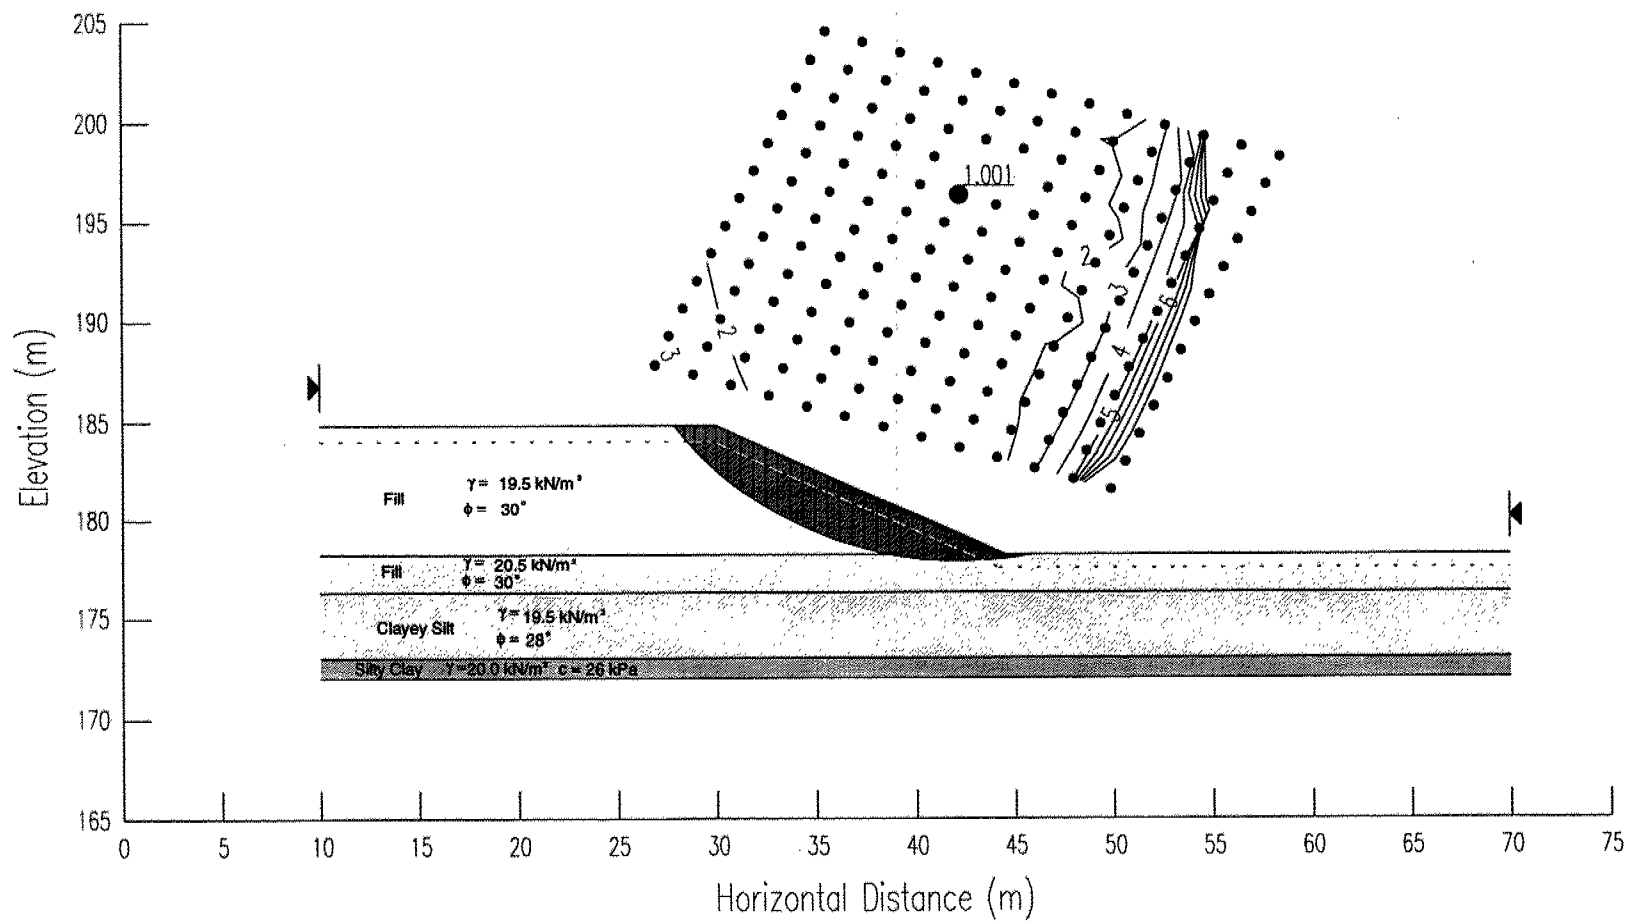
Highway 58 - Collier Road N-E Ramp
Figure 2

This situation assumes that the embankment drainage is poor and the water table is near the surface. Such a situation could occur during wet periods in the spring and is likely exacerbated by poor drainage within the embankment fills. The Factor of Safety against failure of the slope in this case is near unity or failure. It is believed that this is the likely failure condition for the subject slope.

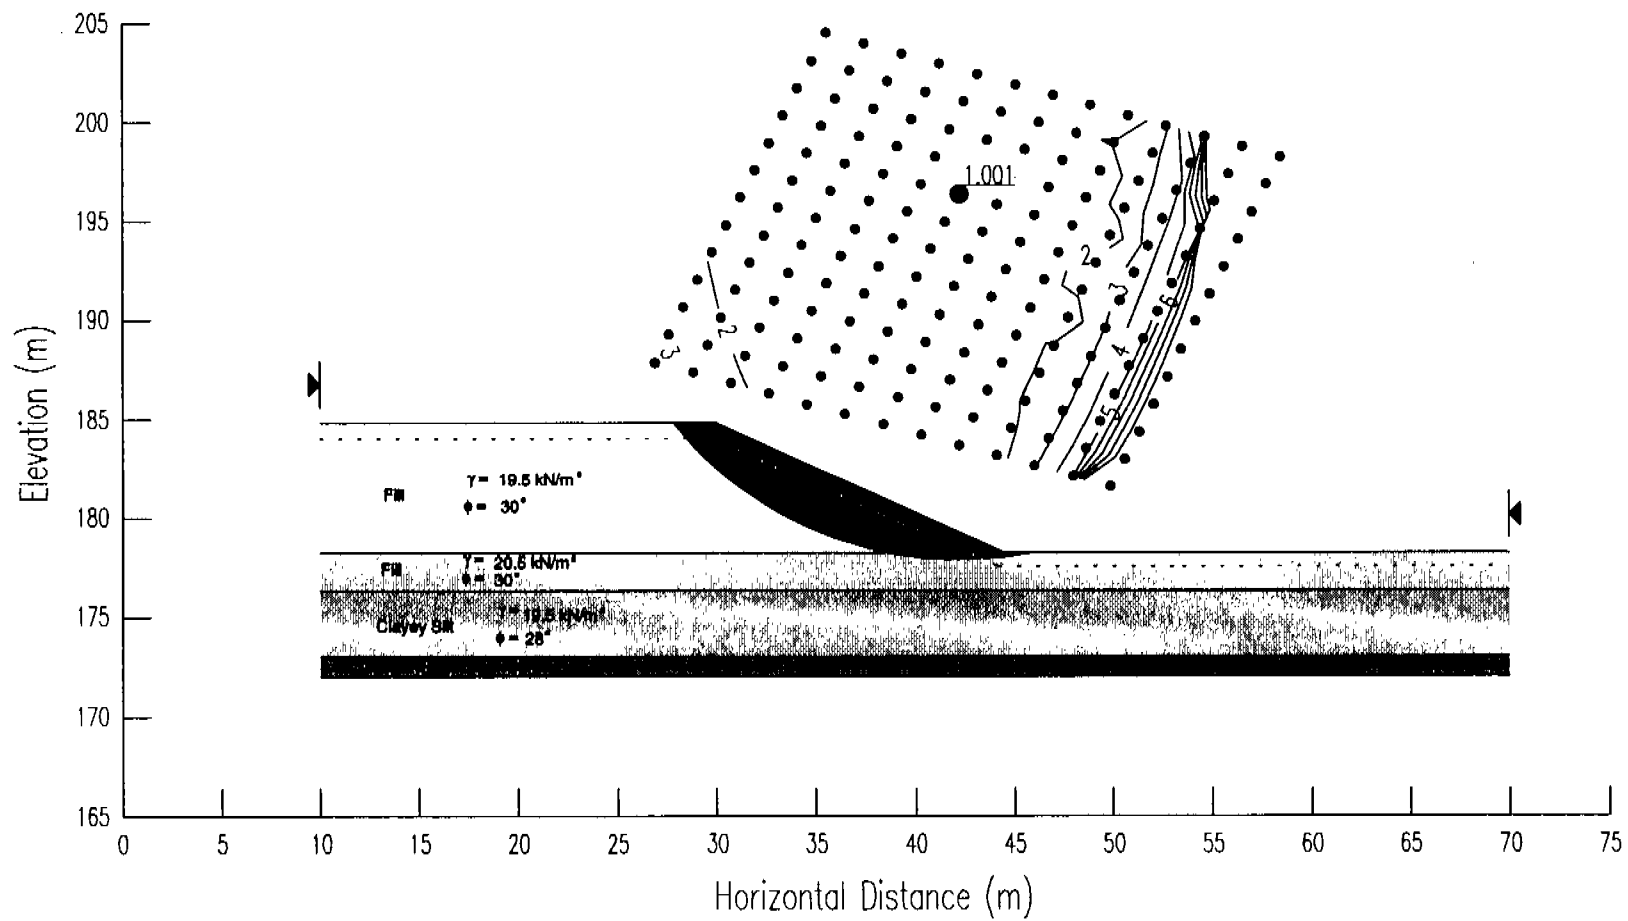
Highway 58 - Collier Road N-E Ramp
Figure 2

This situation assumes that the embankment drainage is poor and the water table is near the surface. Such a situation could occur during wet periods in the spring and is likely exacerbated by poor drainage within the embankment fills. The Factor of Safety against failure of the slope in this case is near unity or failure. It is believed that this is the likely failure condition for the subject slope.
