65-T-128 R

Subject - Slope Indicator Installation - New Mountain Road
- County Suburban Road No. 25.

65-F-(R)-128
COUNTY
SUBURBAN RD.
25
NEW MOUNTAIN RD.
STONE
CREEK

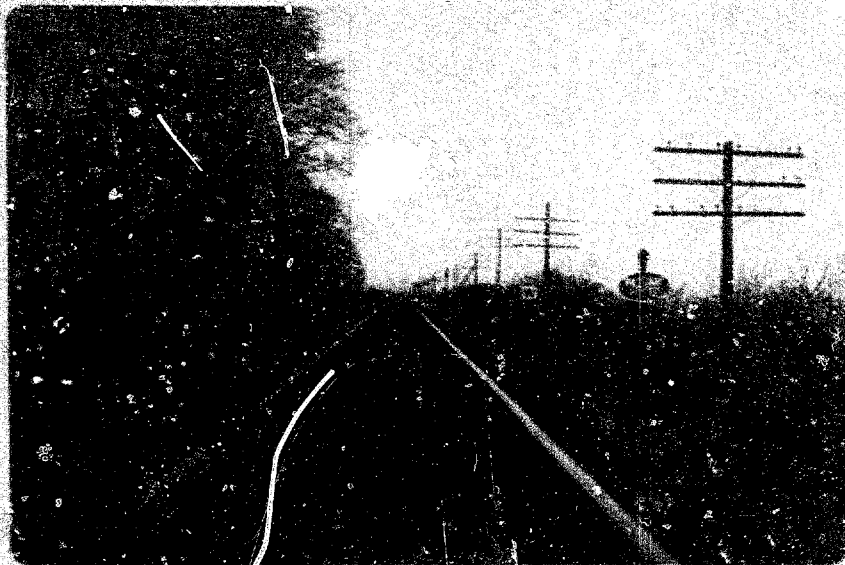
Taken south of rail track where section 20+50 crosses track and is looking west. Note this is the restored area of the rail track where instability occurred in early 1965.

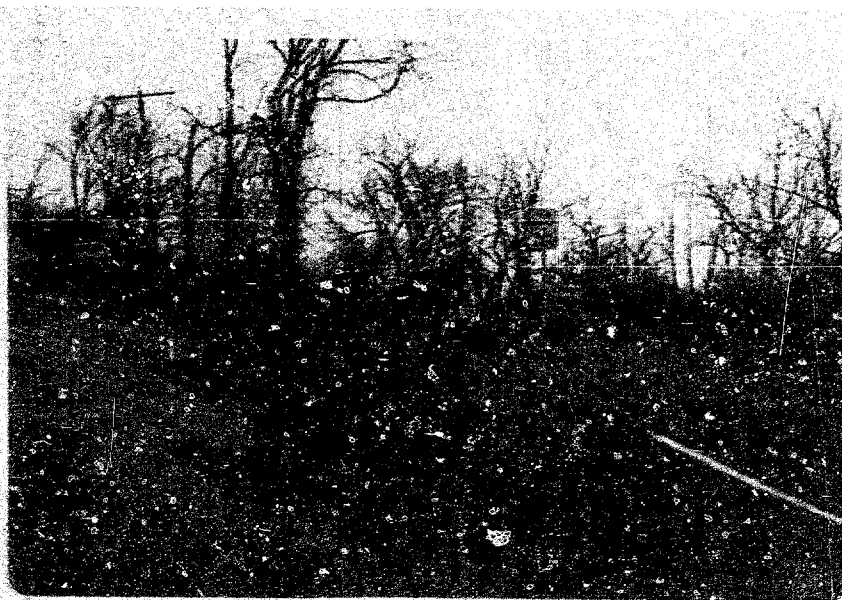
Taken at a point on top of the escarpment, looking west and 150 ft. east of junction of New Mountain Rd. and Scenic Route.

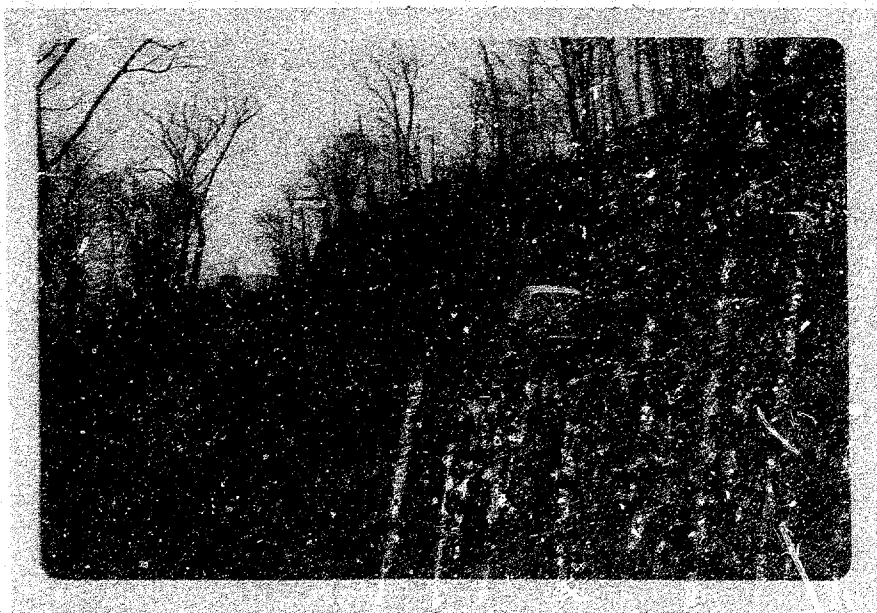
Looking east and uphill from Chainage 18+00, approx.
and just south of old guard rail.

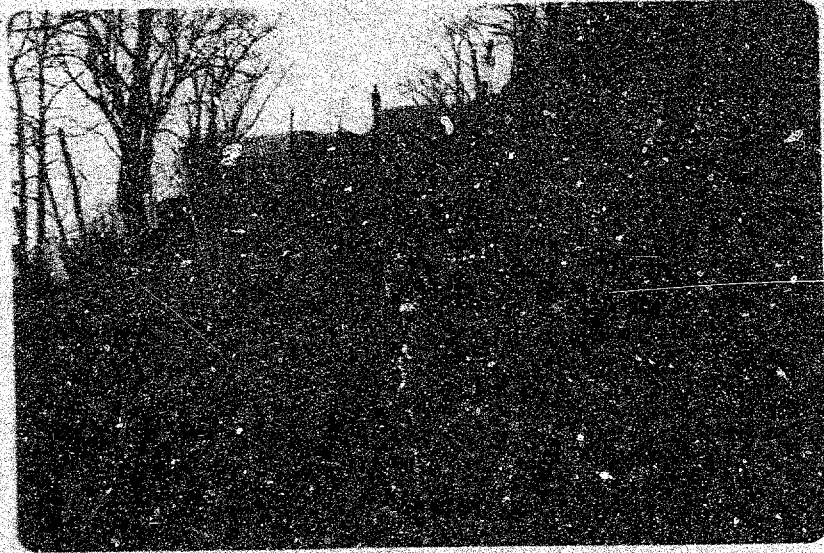
Taken from point between barracade and line of white guard posts, chainage 19+50 approximately, looking east and uphill.

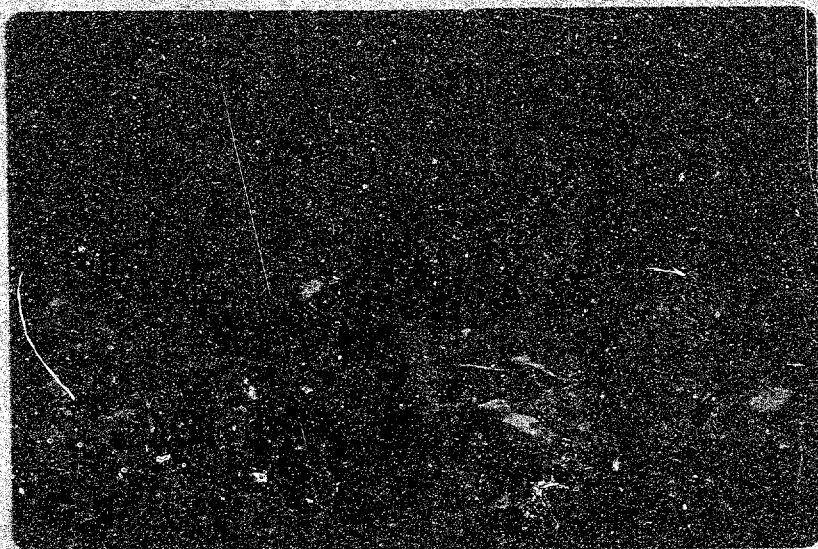
Looking west downhill just south of old guard rail at about Chainage 22+50. Note trickle of water discharging down slope face.

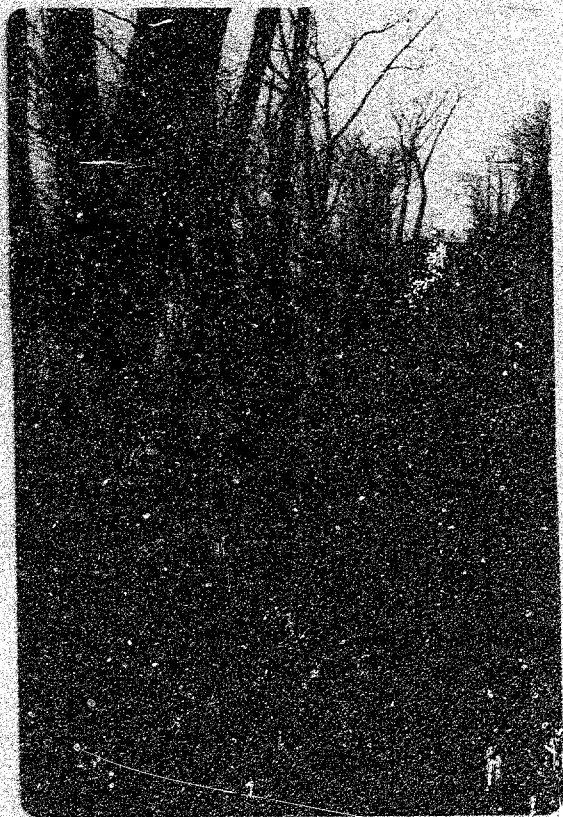
Looking east and uphill, north of guard rail and shows culvert under the road. Taken from Chainage 18+00 approximately.

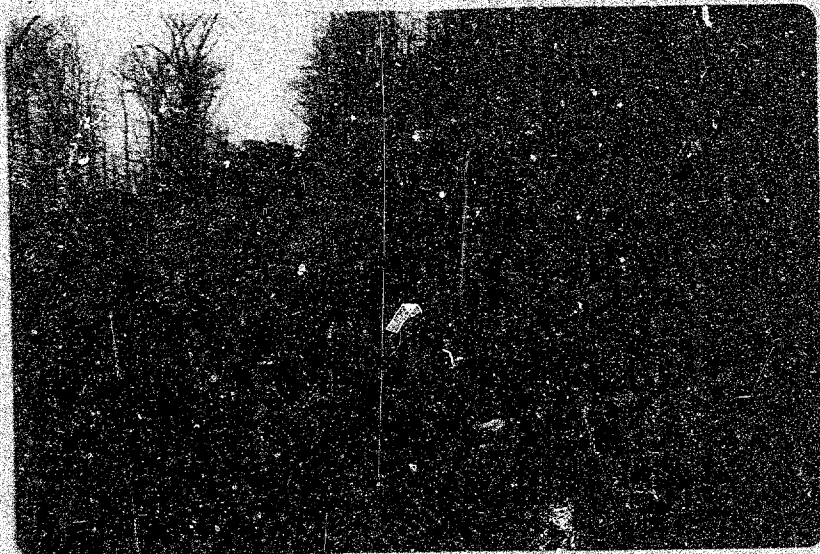
Looking east and uphill on south side of road in ditch line, about chainage 17+50.

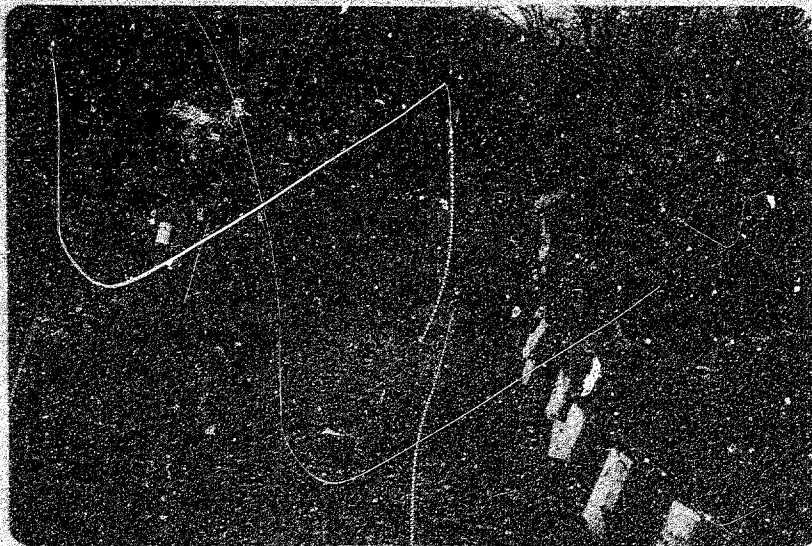
Looking west and downhill, from a point just east of intersection with Scenic Route.

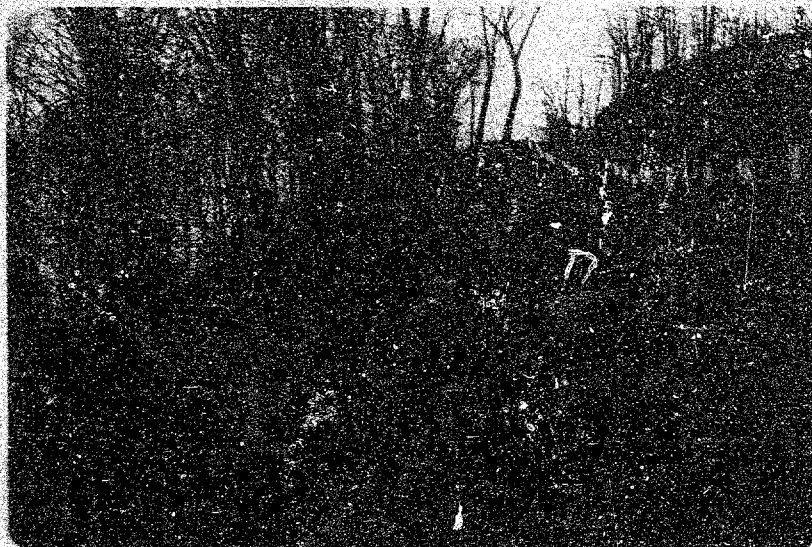
Looking East - Southeast uphill and from above
chainage 17+50 and to the North of guard rails.
Note leaning trees.

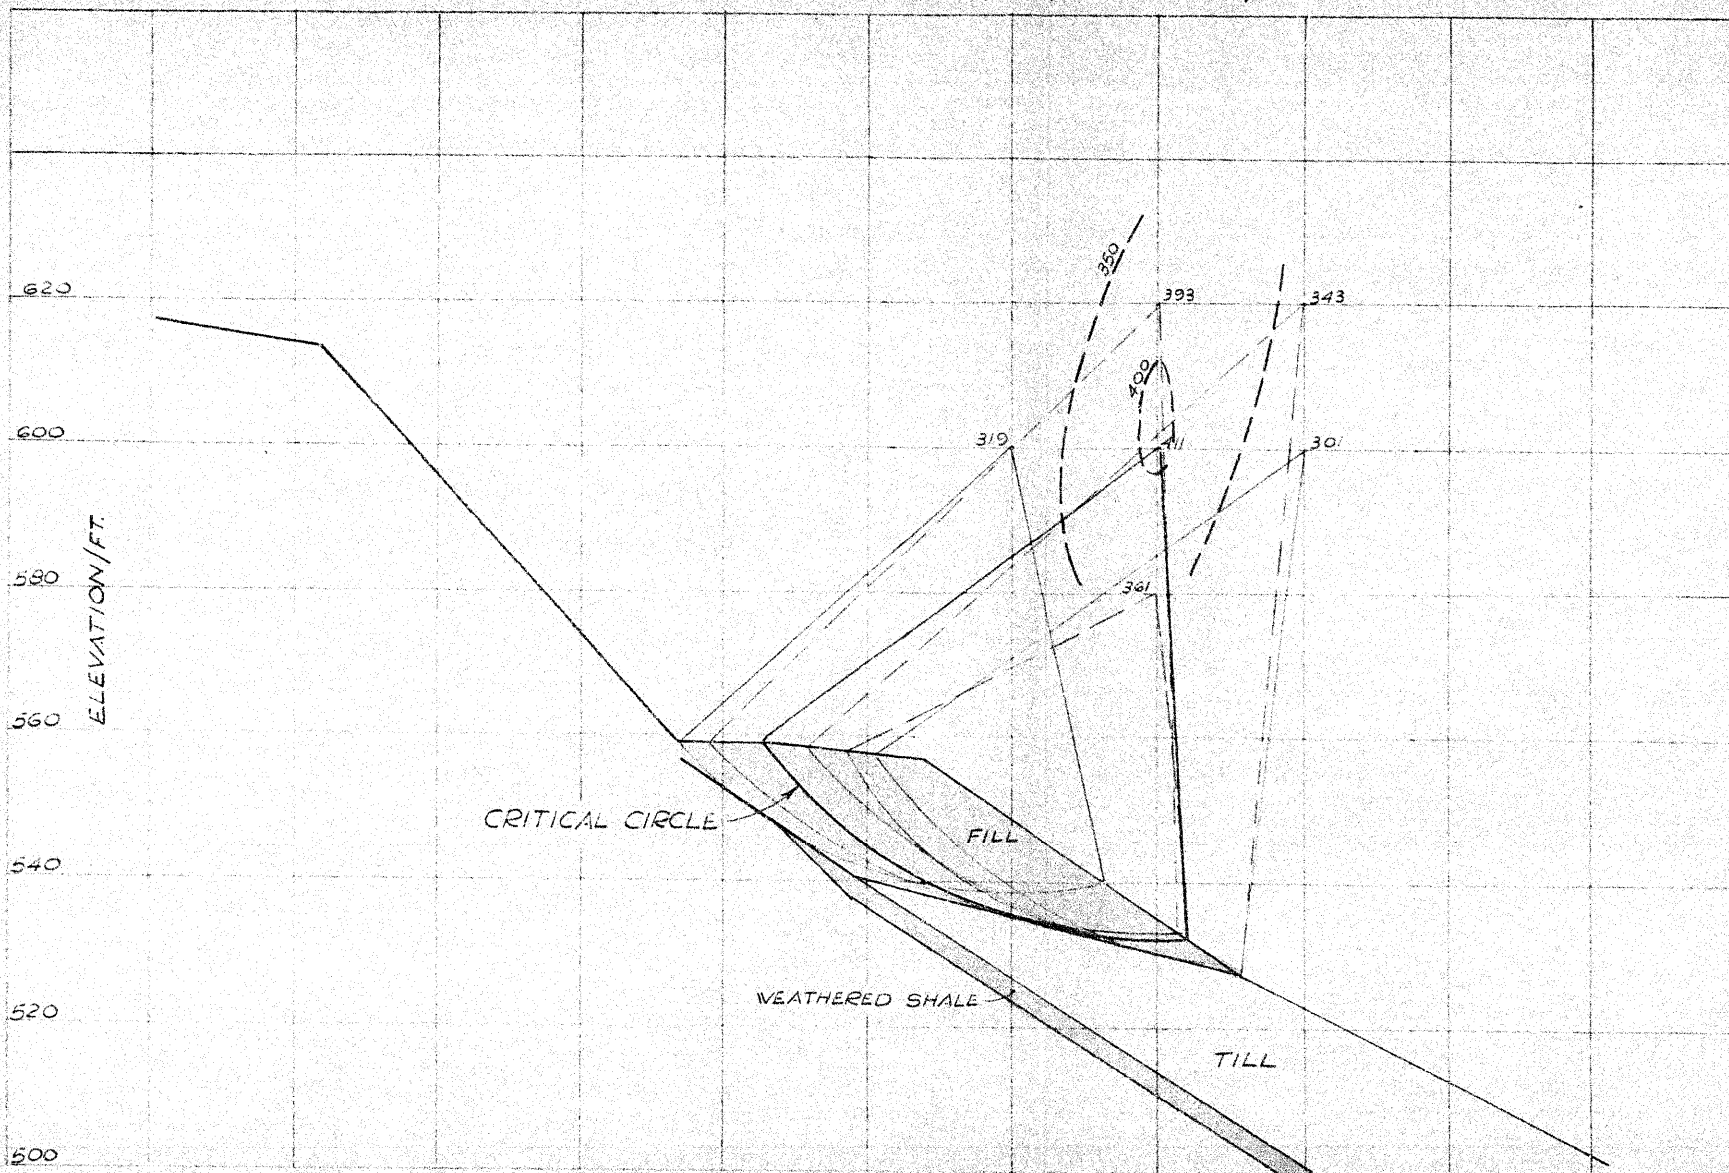
FIG. 8

Figure 8 shows the total stress analyses for the upper portion of the slope, and deals in particular with the fill resting upon the over consolidated till at chainage 19+00. Here it is seen that for a factor of safety of 1 the critical circle requires a minimum undrained shear strength of 411 lbs./sq.ft. in order to maintain minimum equilibrium conditions. On the basis of this information a detailed effective stress analysis was performed on the same fill section, and is shown on Figure 9. It can be argued that the critical circle for the total stress condition is not necessarily the same as the effective stress critical circle, and that this is an over simplification; however, in view of the large factors of safety obtained for the critical circle passing through the fill and tangential to the underlying till, and for the critical circle tangential to the underlying weathered shale, it becomes apparent that any failure in terms of effective stress must occur in the fill, and not in the till or the underlying weathered shale. It was to establish this point that this particular type of approach was adopted. It is of interest to note that in terms of effective stress the failure along the till surface has a factor of safety of 1.65 whilst the failure along the surface of the weathered shale has a factor of 1.74.

LOCATION OF CRITICAL FAILURE CIRCLE FOR UPPER SLOPE CH. 19+00

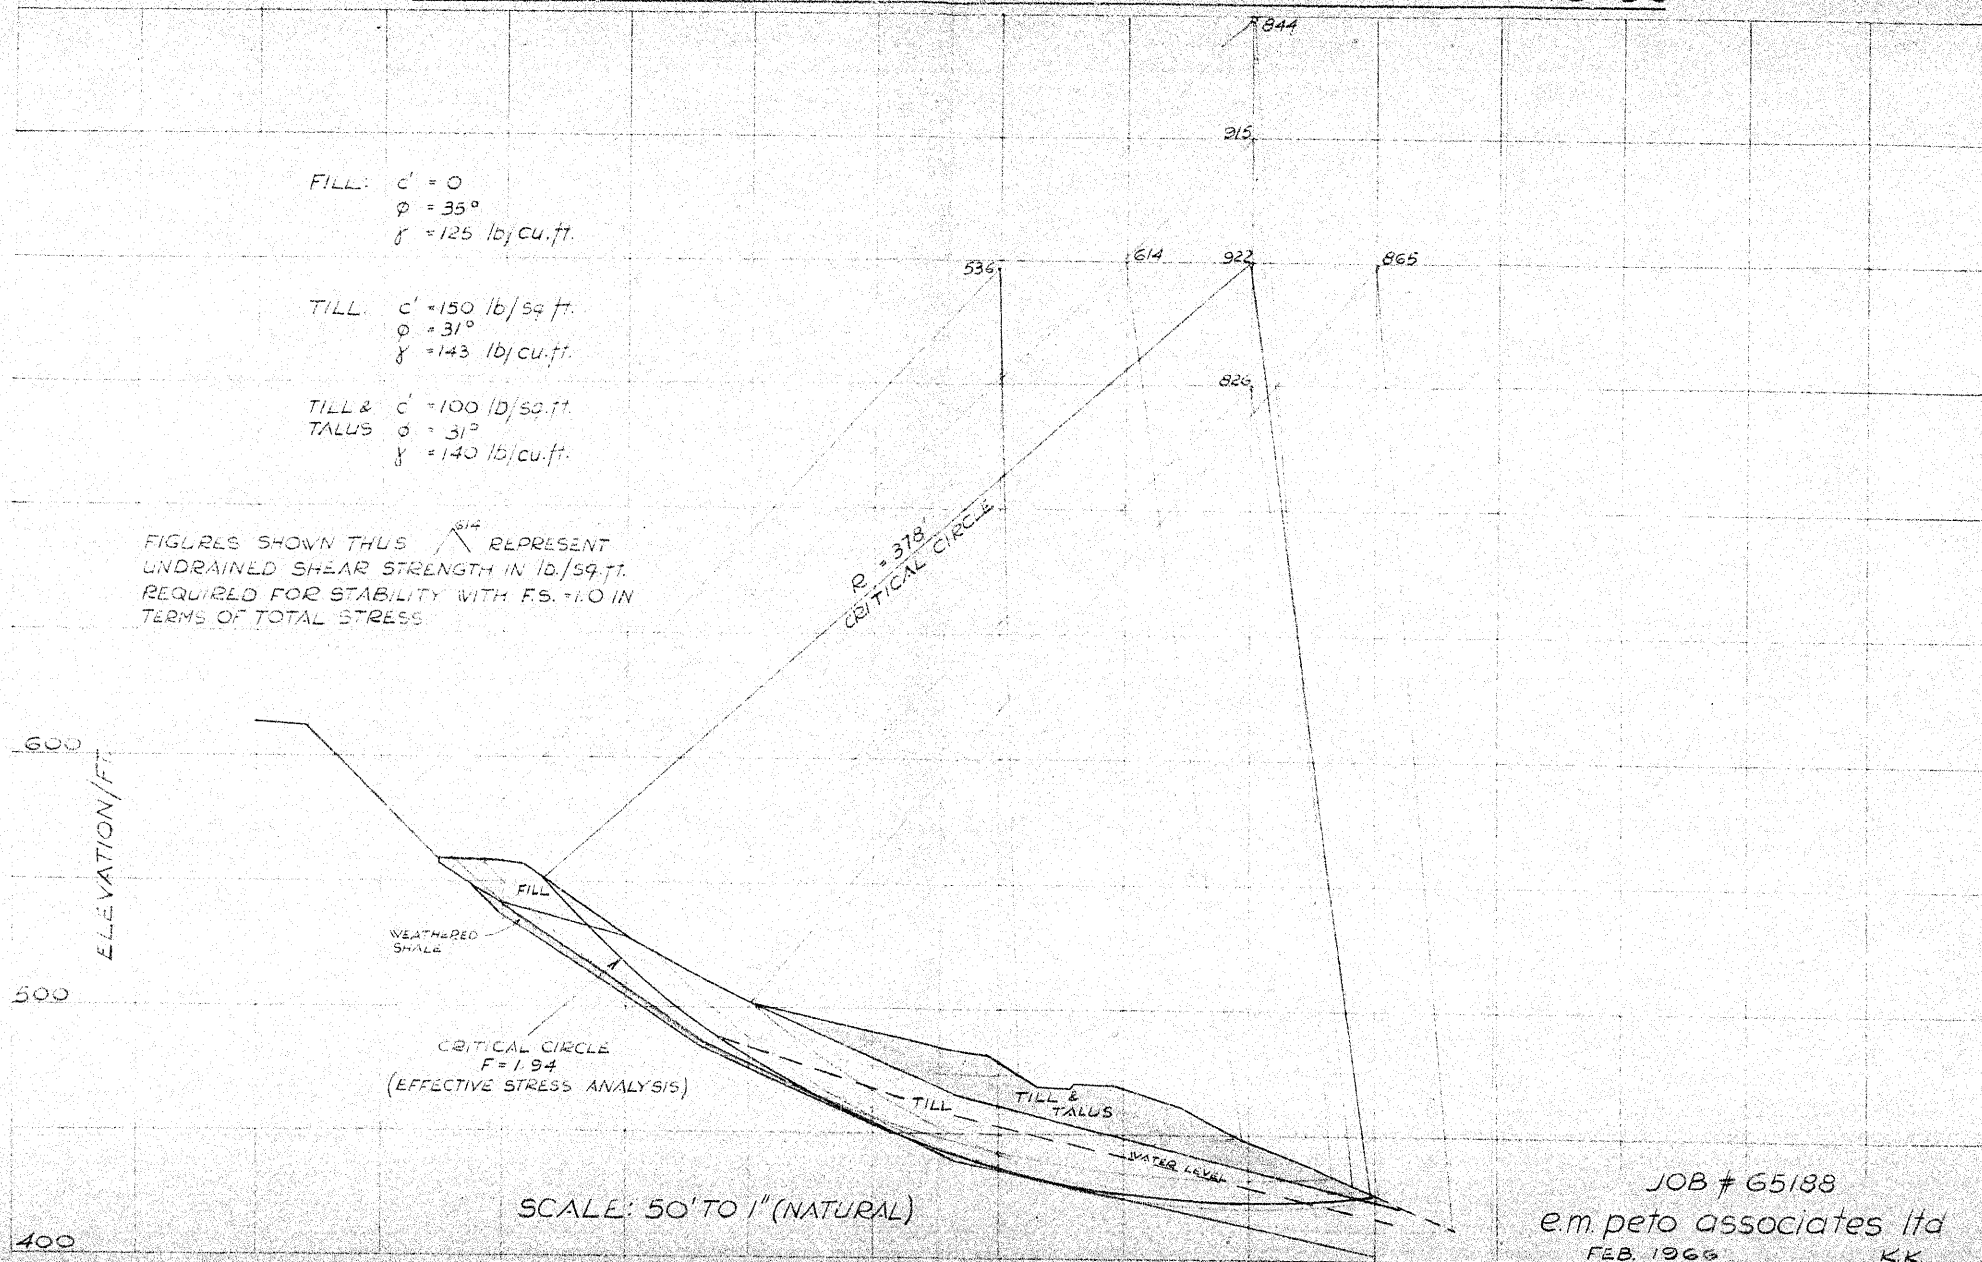
Fig. 9

The effective stress analysis was then performed along this same circle adopting the water levels obtained from the stand pipe readings; as a result the factor of safety for this circle is 1.94, a figure which can be considered as more than adequate, and an indication that failure under effective stress conditions is most unlikely to occur in the main till stratum (3).

Furthermore this result taken in conjunction with the effective stress analyses referred to above, and shown on Figure 9, suggests that any failure which has taken place cannot have taken place within the till, and must be confined to the upper portion of the slope which consists mainly of filled material.

EFFECTIVE STRESS STABILITY ANALYSIS FOR CRITICAL CIRCLE IN THE UPPER SLOPE (CH 19+00)

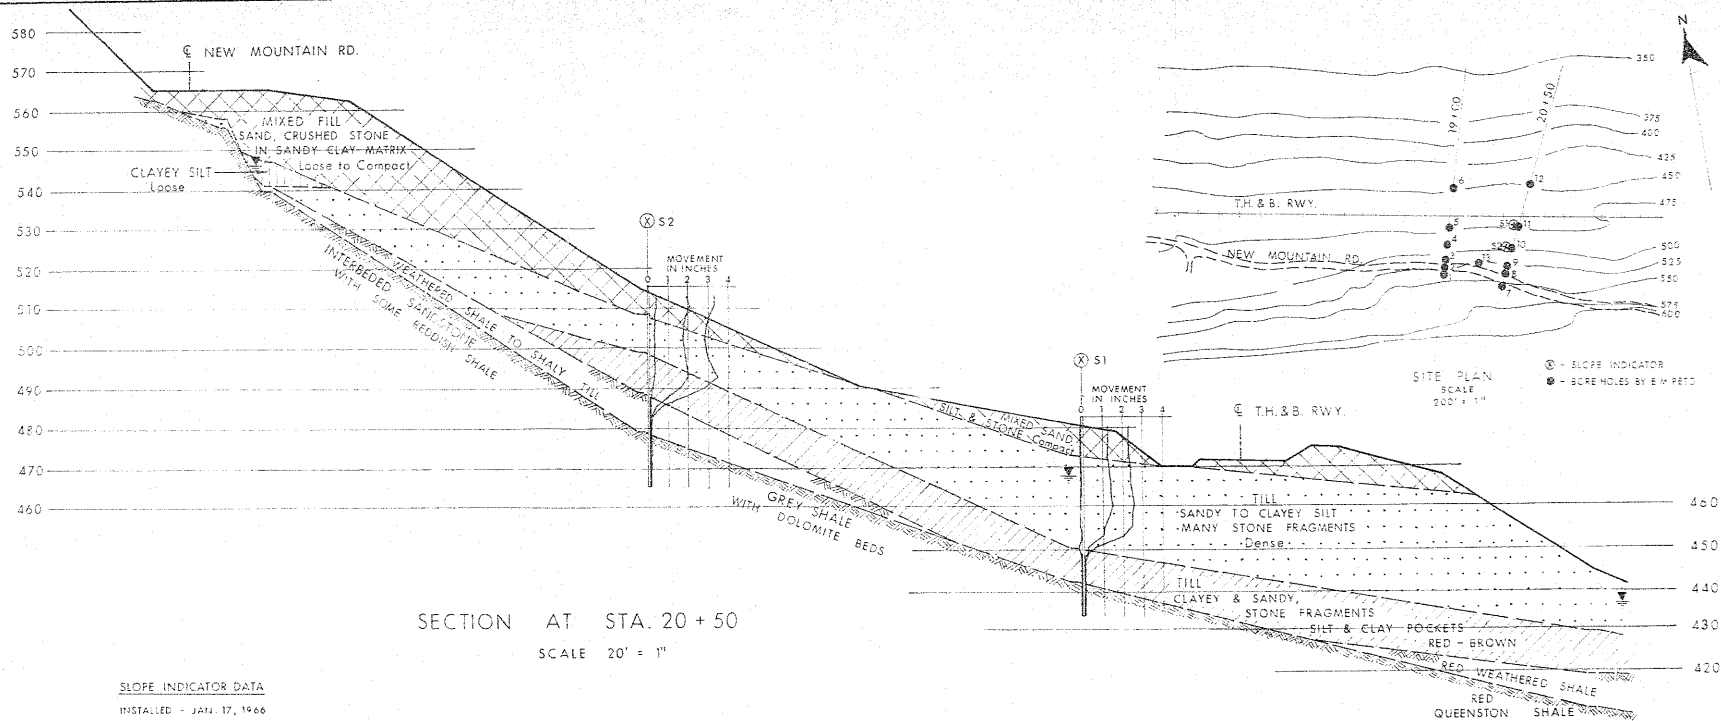
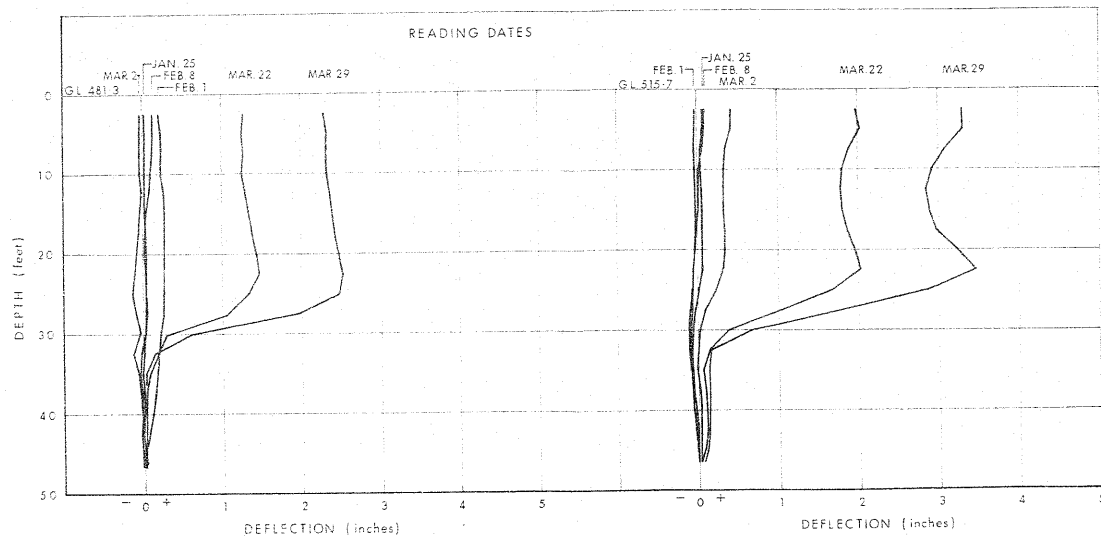
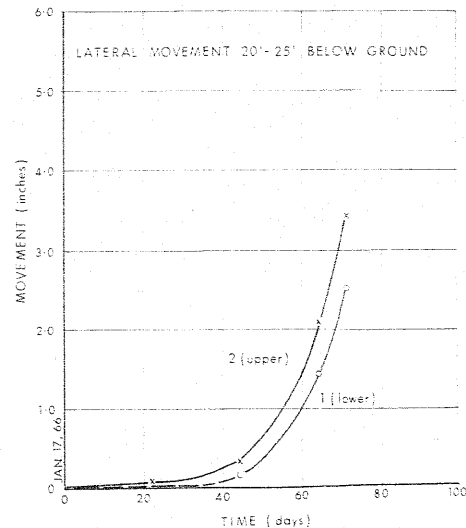
Lateral earth movements of magnitude 2.5-3.5 inches have been recorded in the slope indicators during the period March 2nd to March 29th '66. The maximum movement occurred in a zone some 20-25 feet below ground surface. It has also been reported that a 4½-inch lateral movement of the T.H. & B Hwy. track took place or was observed on March 22nd. This displacement was immediately corrected but on March 24th a further movement of 2 inches took place.

It is believed that the above observations show that a potentially dangerous condition exists at this site and therefore remedial measures should be carried out with the utmost expediency. Whilst it cannot be concluded with certainty that the road fill is the sole cause of the slope movements and the escarpment itself is not inherently unstable it must be assumed that the fill is a definite contributing factor and that removal of the latter can have only beneficial effects.

- (1) The road should be realigned so as to be founded entirely on bedrock over the whole length of the affected zone.

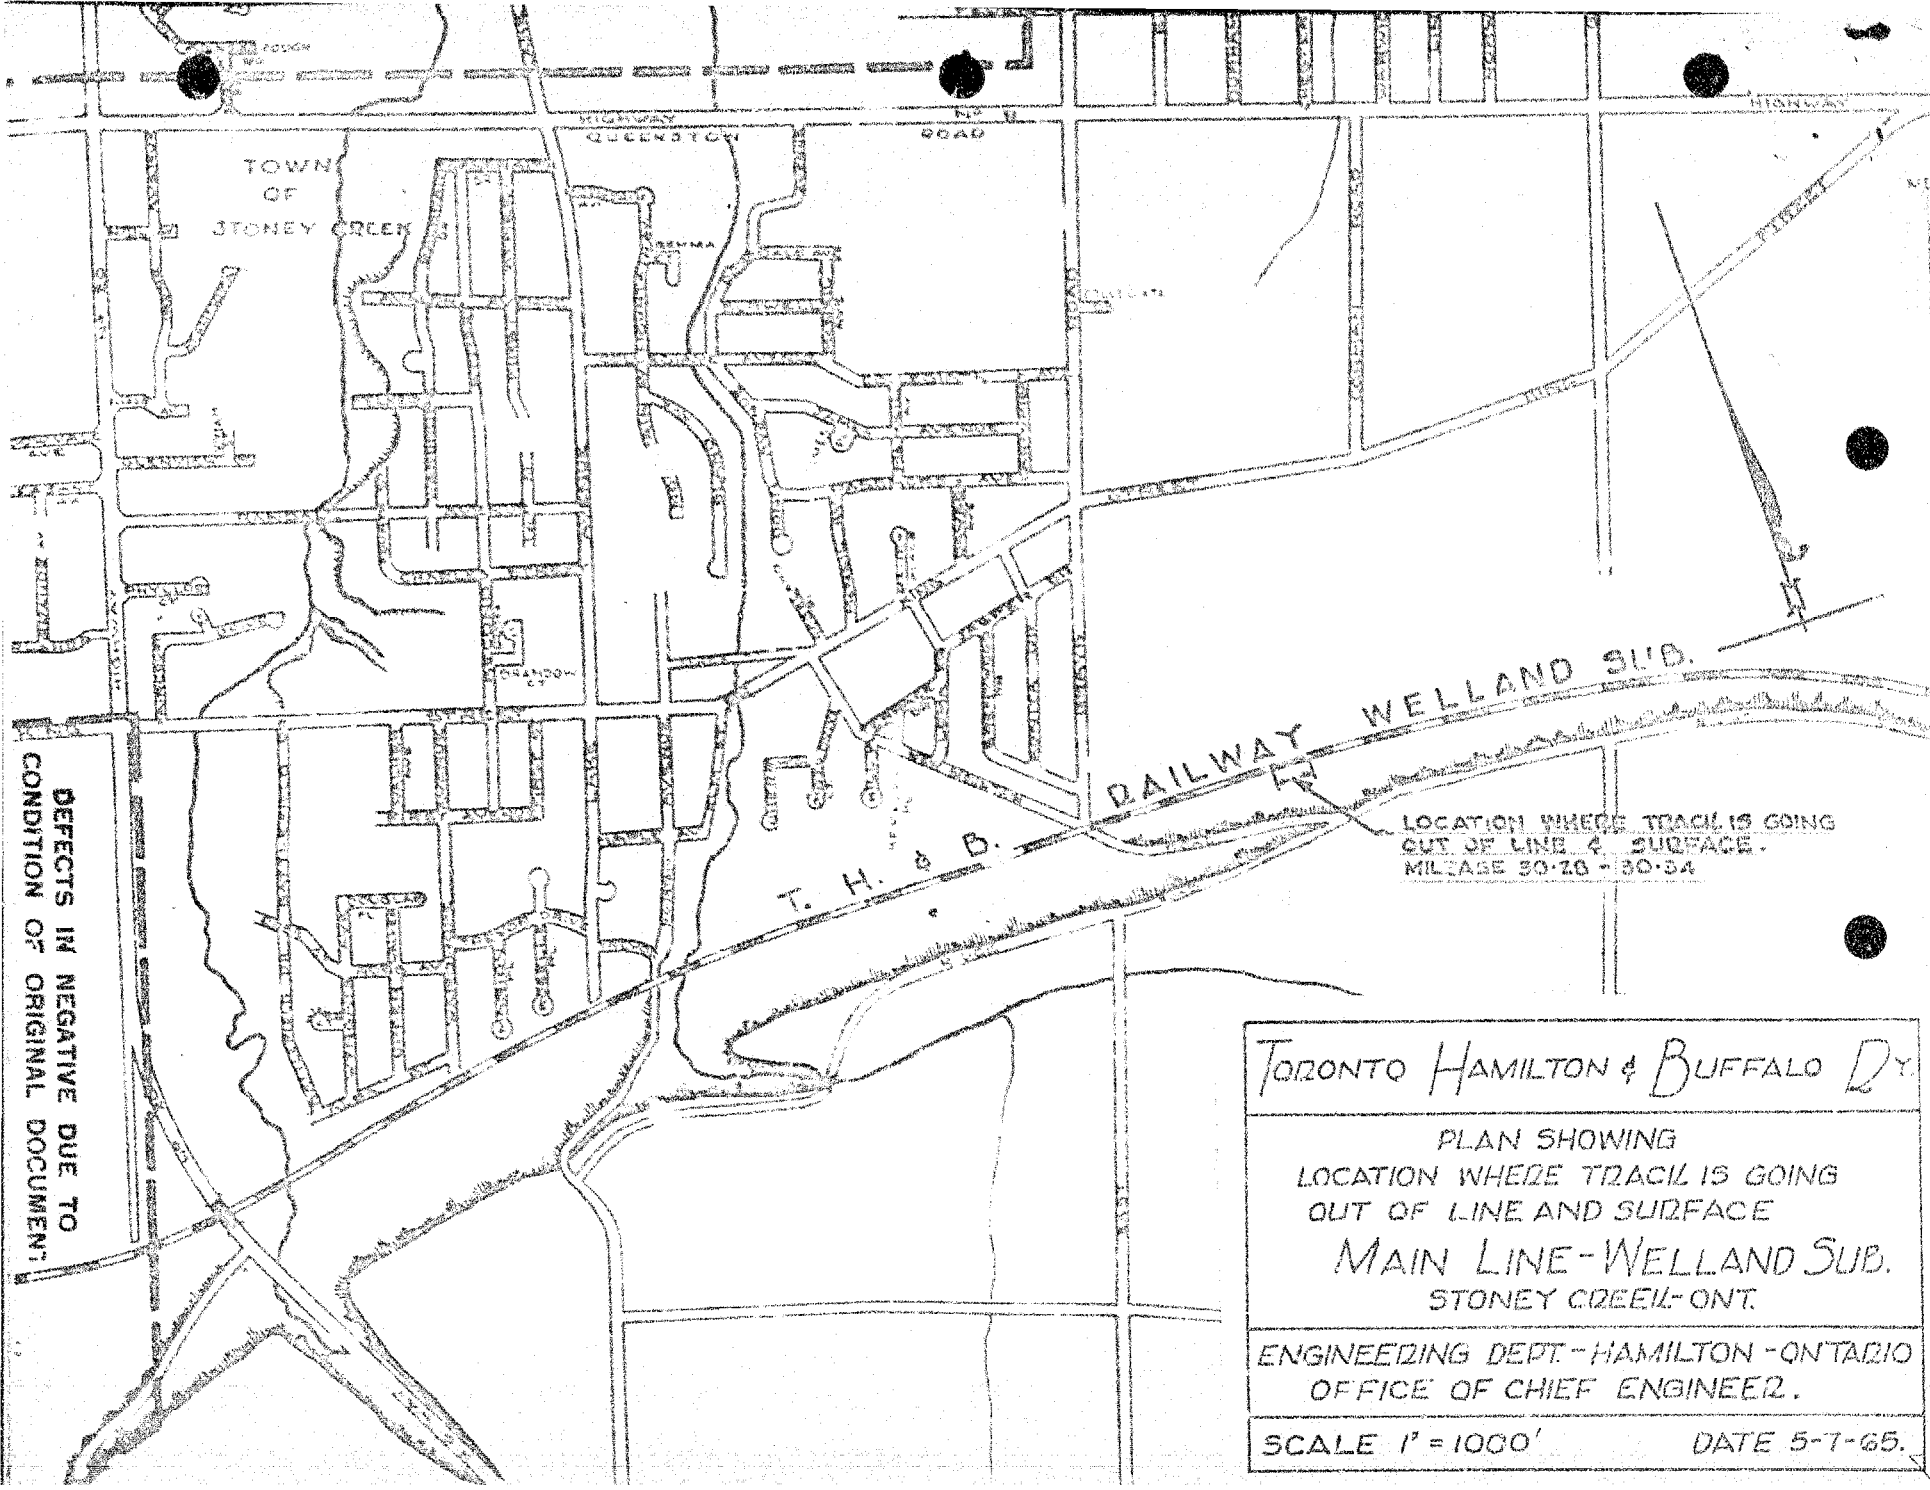
TORONTO HAMILTON & BUFFALO RY.	
PLAN SHOWING LOCATION WHERE TRACK IS GOING OUT OF LINE AND SURFACE	
MAIN LINE - WELLAND SUB. STONEY CREEK - ONT.	
ENGINEERING DEPT. - HAMILTON - ONTARIO OFFICE OF CHIEF ENGINEER.	
SCALE 1" = 1000'	DATE 5-7-65.

A very serious and dangerous condition exists on the Railway line between Mileages 30.28 and 30.34, which is due north and approximately 80' below the level of the New Mountain Road, in the Township of Saltfleet, whereby the track is constantly being shifted to the north. I enclose copy of a plan showing the location.

In the opinion of the Railway Engineers, this is due to the subsidence of part of the New Mountain Road, which causes the whole surface to be pushed downhill and across the Railway right-of-way.
