FOUNDATION INVESTIGATION REPORT

Slope Failure - Hwy. 403, Culvert
Sta's. 105+10 - 106+70, District 4.

W.J. 64-F-39 - W.P. ~~231-58-3~~

Cont. 63-116 140-57-1

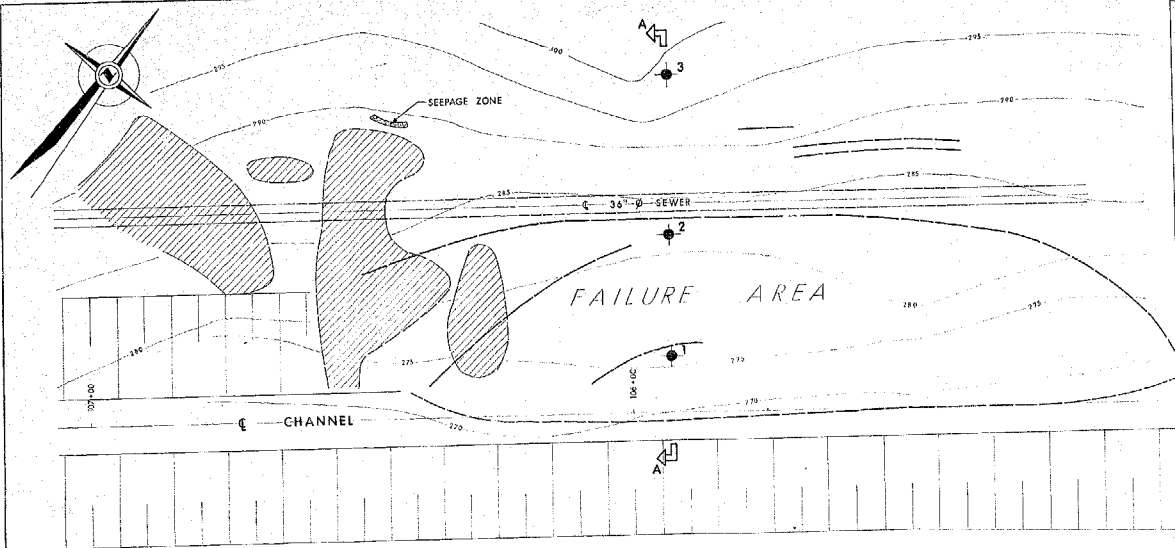
PLAN
SCALE
10 5 0 10 20 FT

Examination of the site at the time of the field investigation disclosed several areas of wet ground in the failure area. Further investigation showed the source of this water to be from one or more outcropping water-bearing sand and gravel seams approx. 9 inches thick, which are exposed on the upper slopes of the valley wall. A rough measurement of the flow was 16 ozs. ⁺ in 3 min.

In the same figure the observed water levels are also plotted. It is seen that the water levels recorded by the piezometers within the failure area decrease slightly towards the toe of the slope.

It can be seen that an artesian condition exists in the area of B.H. #1 with respect to the ground surface before failure occurred.

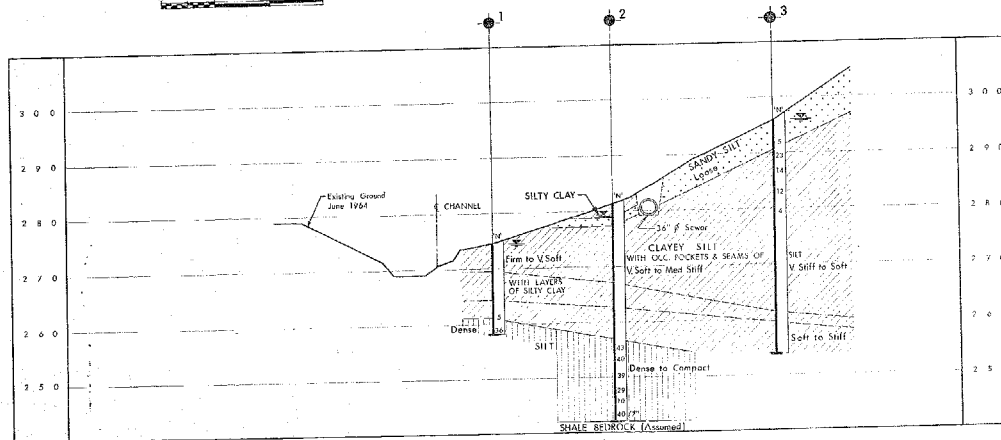
SECTION A-A
SCALE
10 5 0 10 20 FT

Analyses of the slope failure indicates that the failure was probably of a rotational type. The geometry of the slip area tends to confirm this.

The cause of the failure can be attributed to an extremely high water table during the spring plus the saturation and probable softening of the slopes due to water flowing from seepage zones outcropping on the upper banks.
